# Furnaces corrosion / prevention to improve the longevity of campaigns

## Th Roustan 2016/10

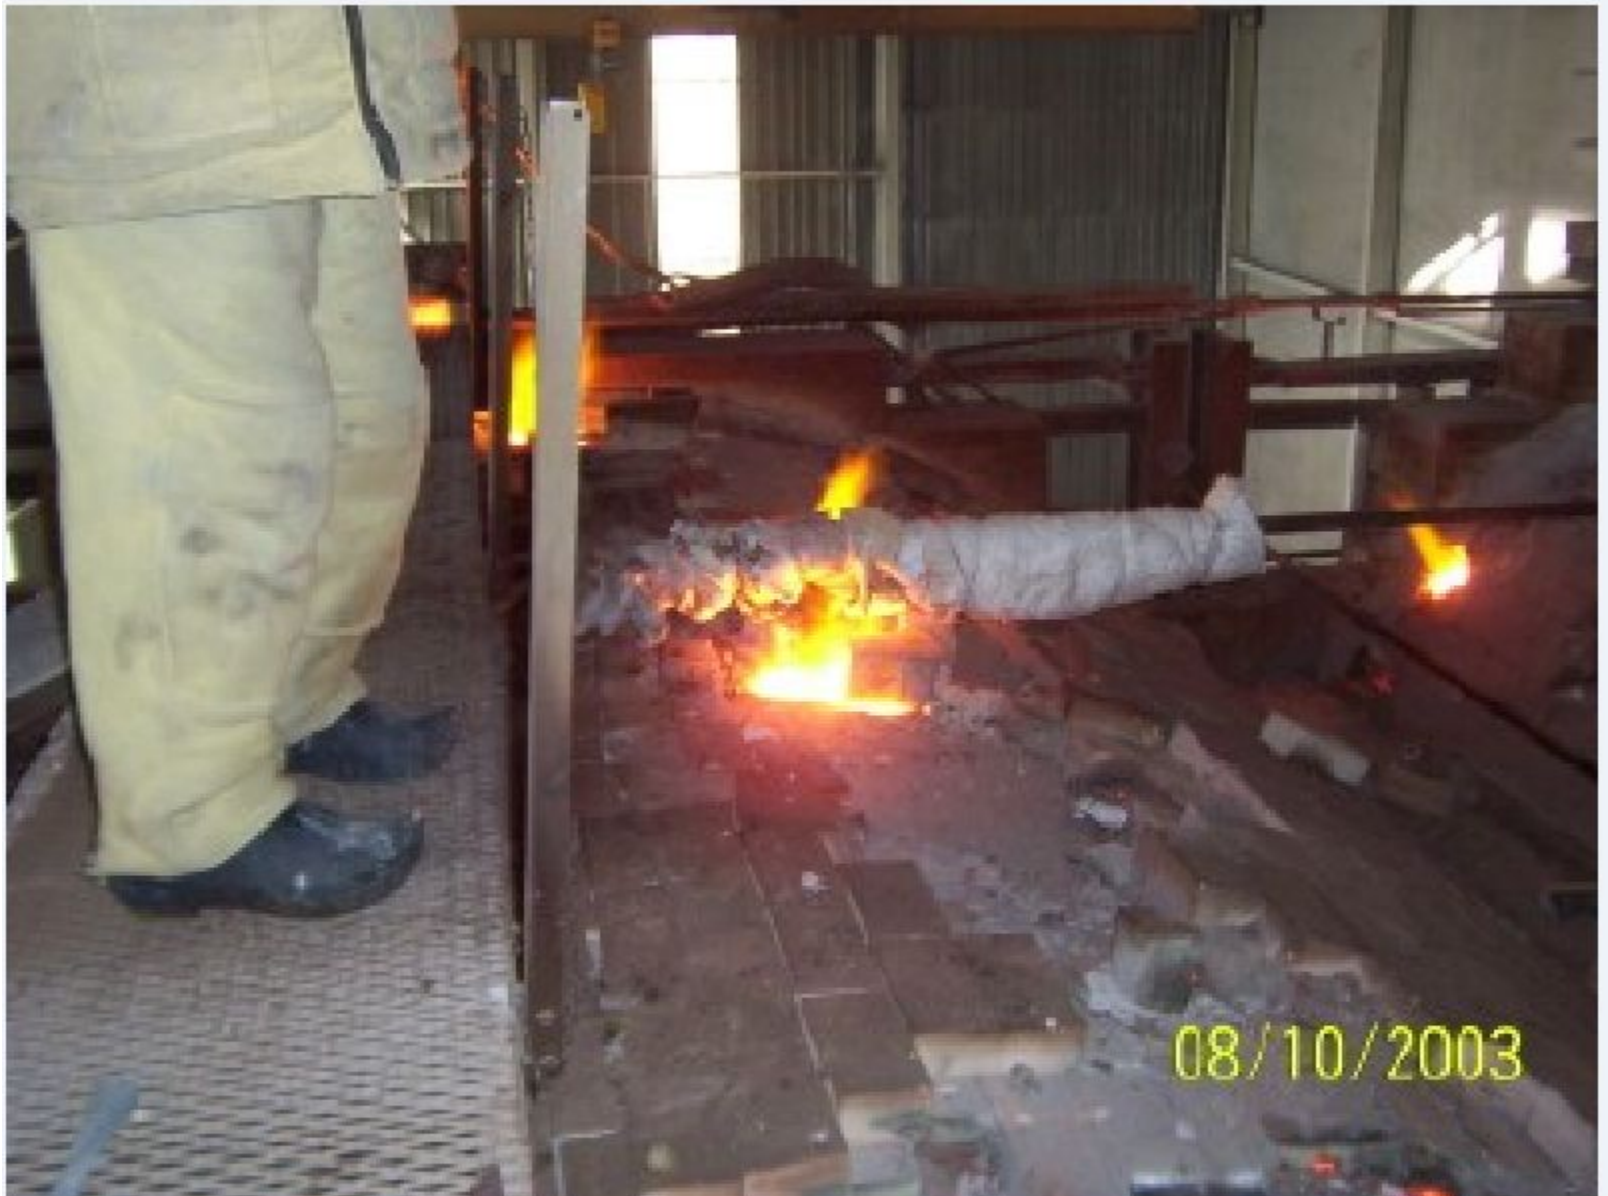
# Crown flames passages

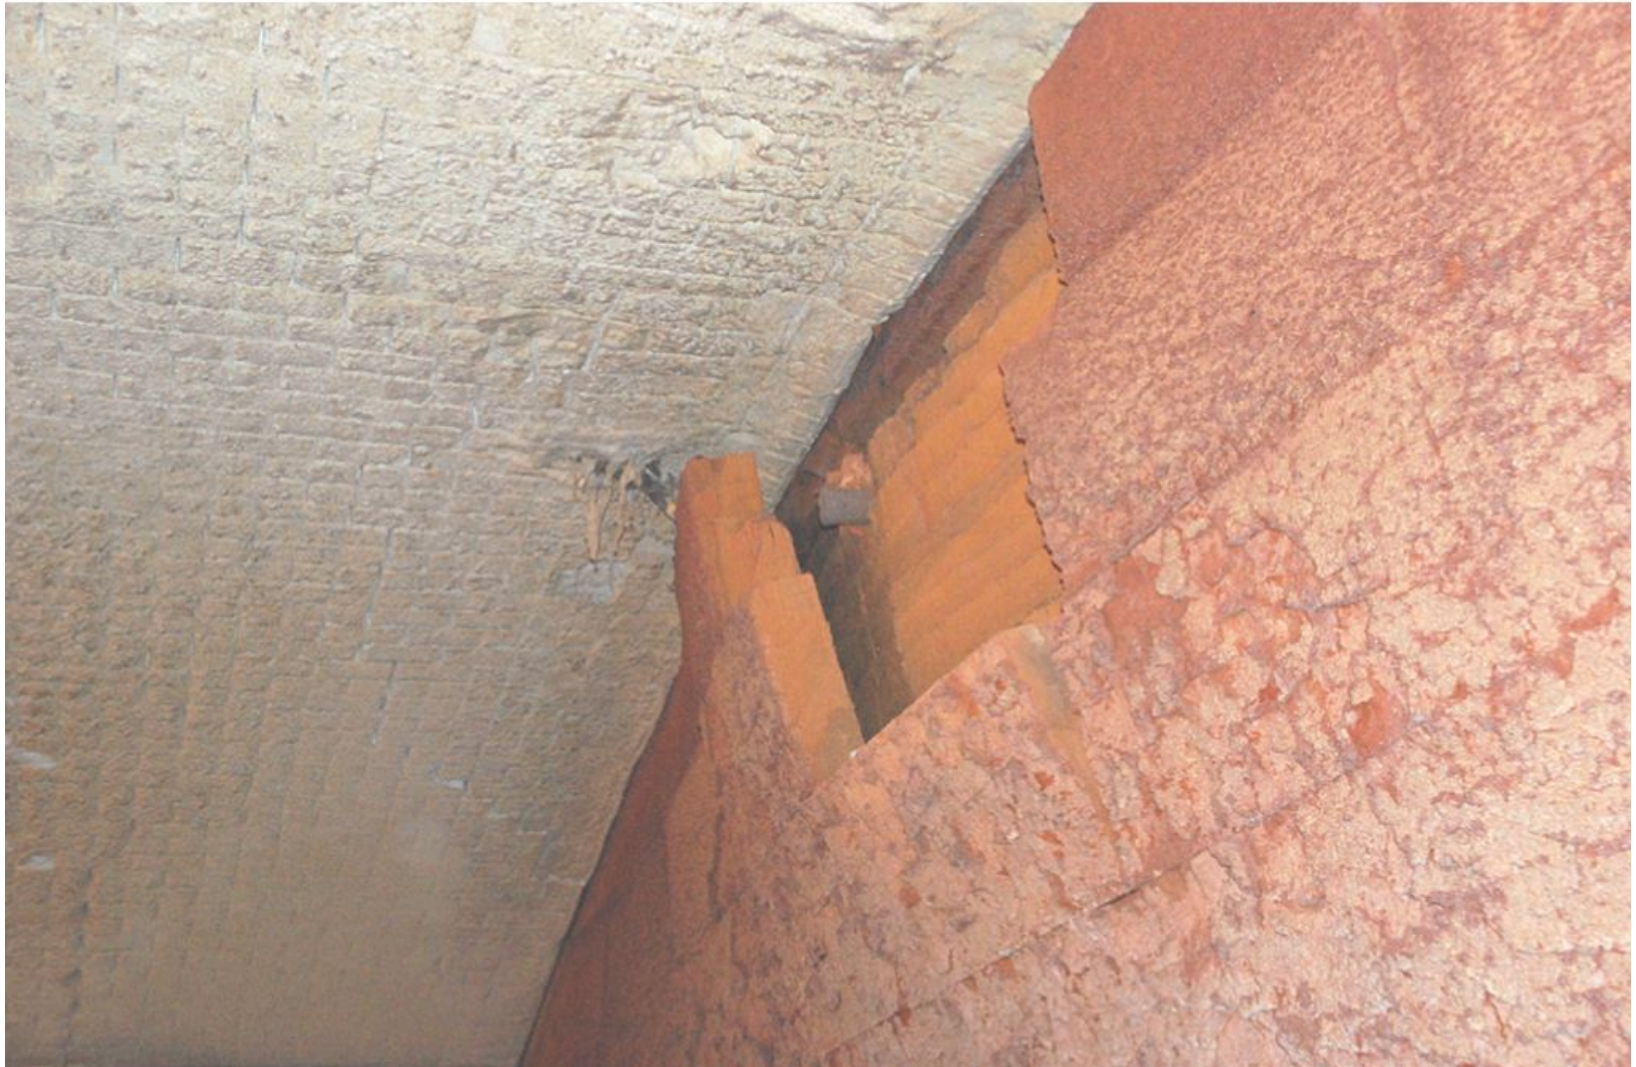
# Lagnieu F2 front wall / concrete wall protection

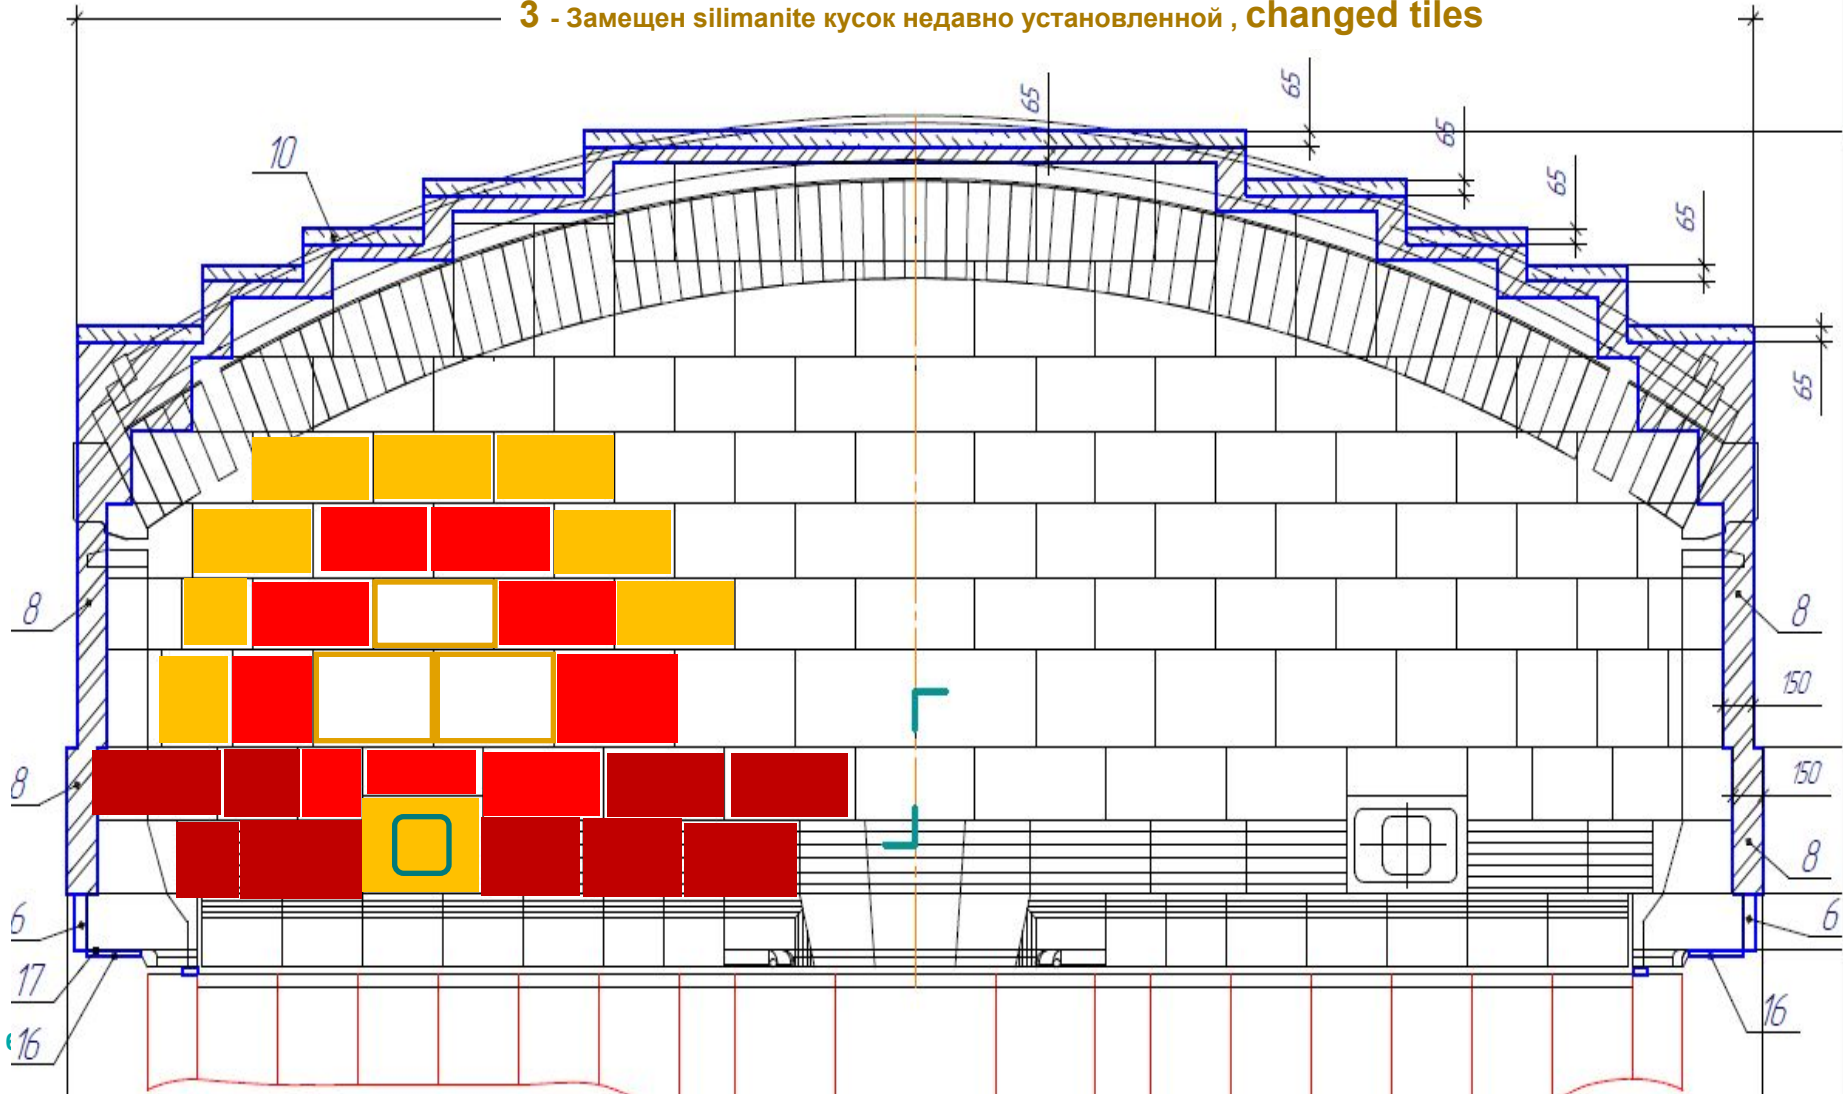
# Kamyshin F1 front wall repair

Визуальный  
осмотр со стороны  
горелочных блоков

0 - Уже упал, следующий слой видим ,

already felt down

1 - Коррозия или частично нарушена, но в положении, **heavy attack wit missed part**

2 - Нестабильный готов упасть.,

attacked

3 - Замещен silimanite кусок недавно установленной , **changed tiles**

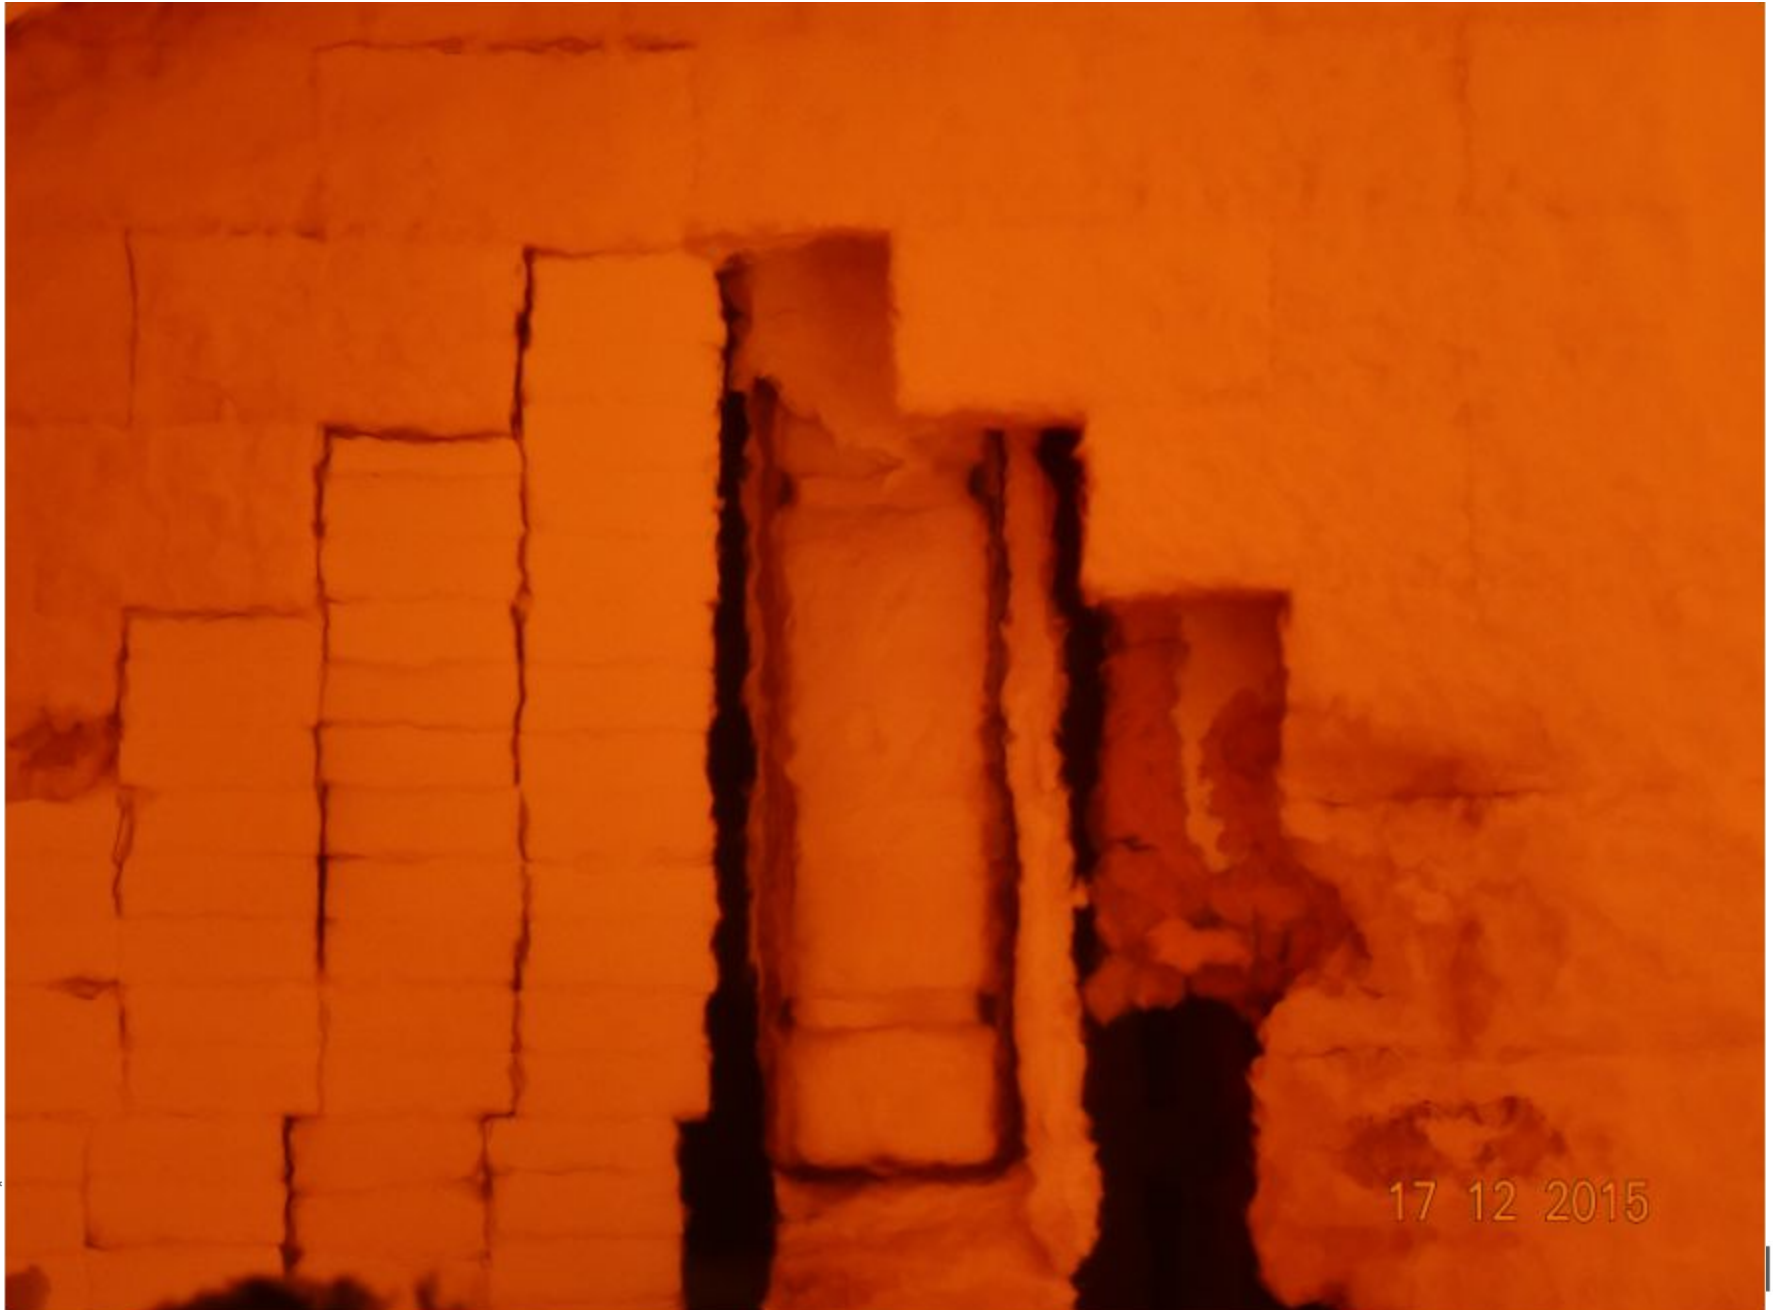
# Kamyshin F1 front wall repair with concrete blocks

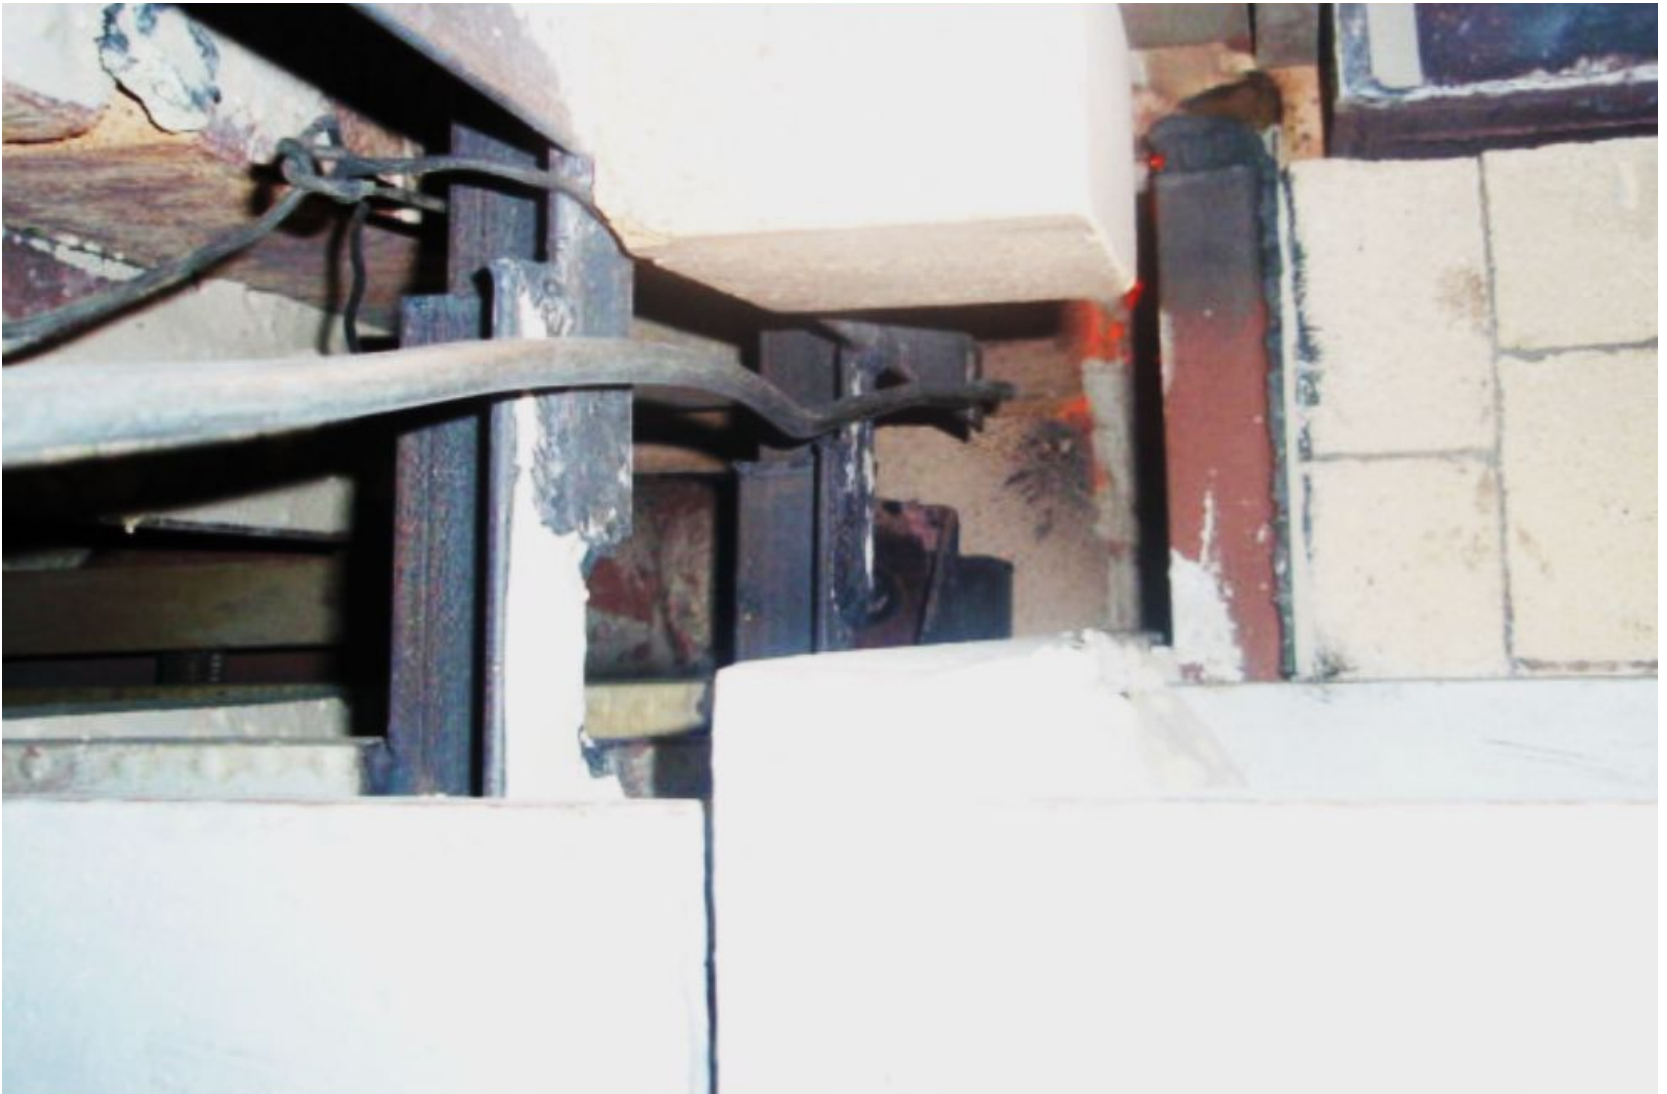
# Dog house angle bloc not enough air cooling

- Top tank cooling	- Top tank corrosion acceleration, premature over coating	- Hot point (red) on top tank - Ascertainment general air cooling shortage - Checking nozzles position and air pressure - Checking particularly downstream dog houses angle blocks and throat angle blocks

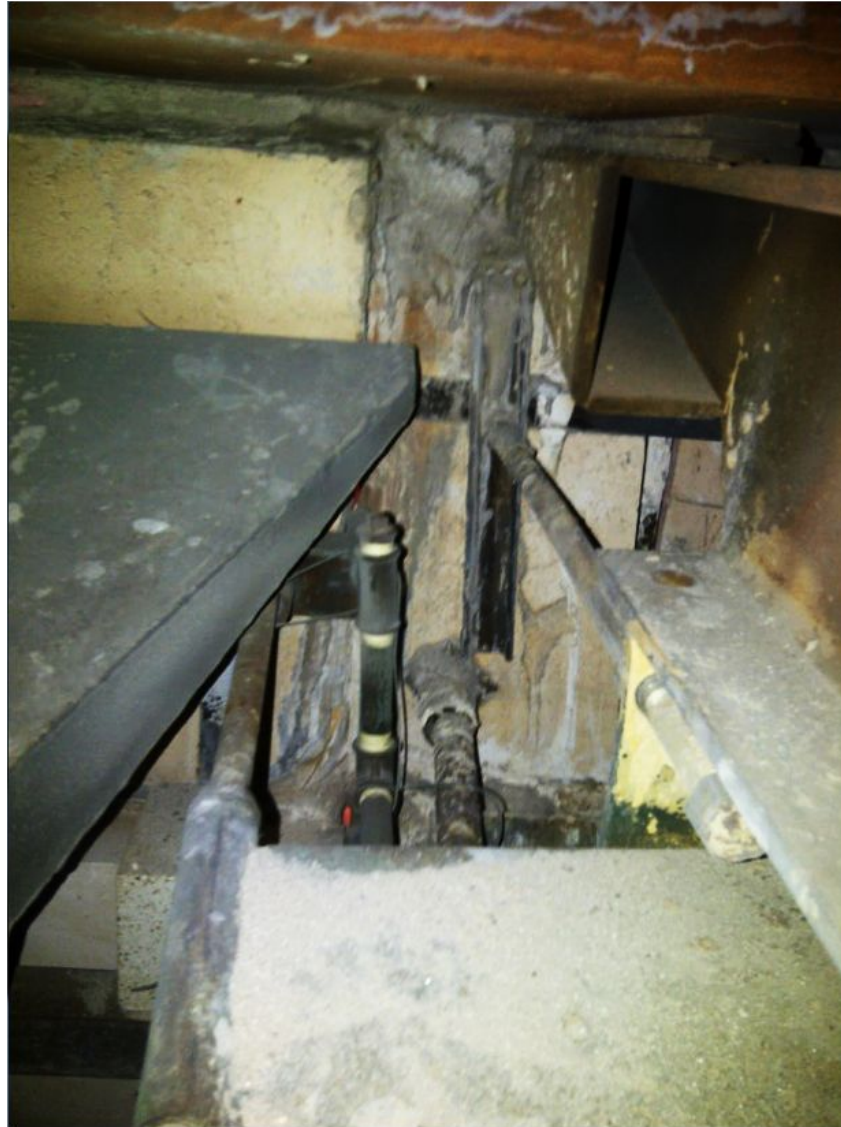
# Extremity angle tank joint glass infiltration

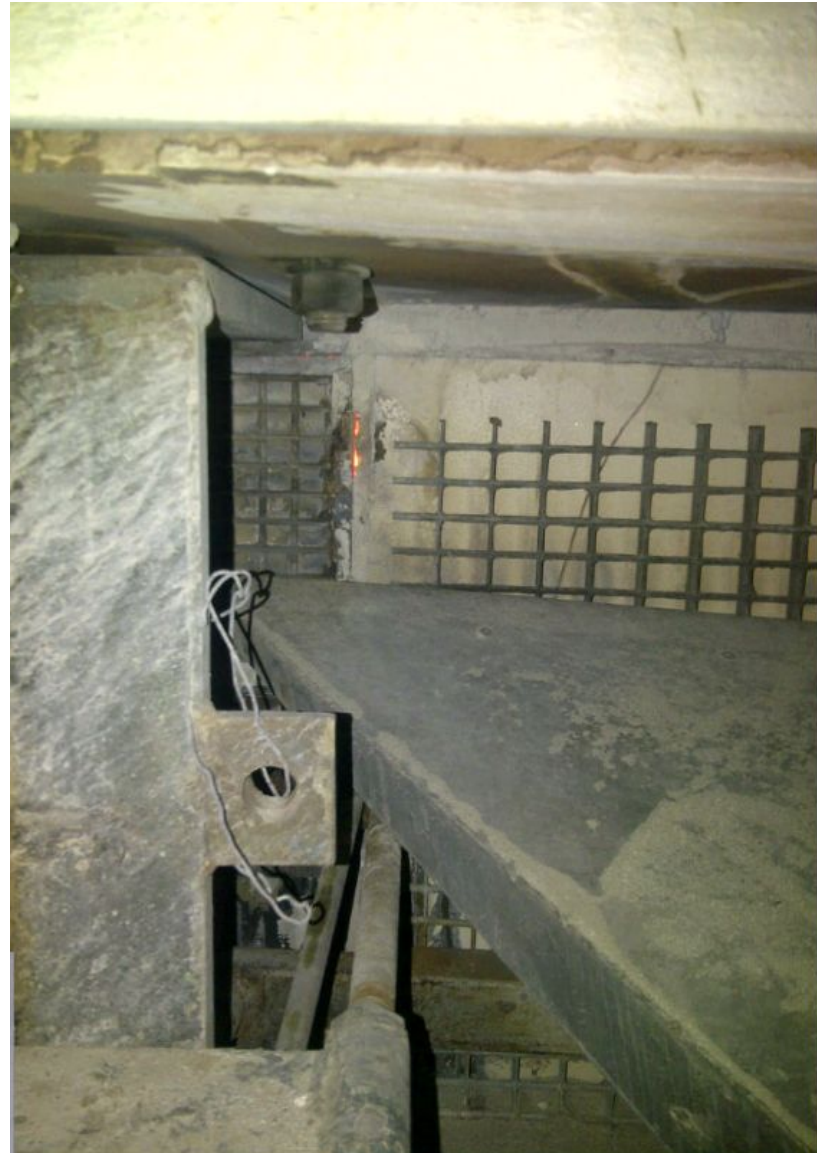
**Glass level corrosion,  
leakage potential ricks  
After 6 mouths in case of  
air cooling breackdown**

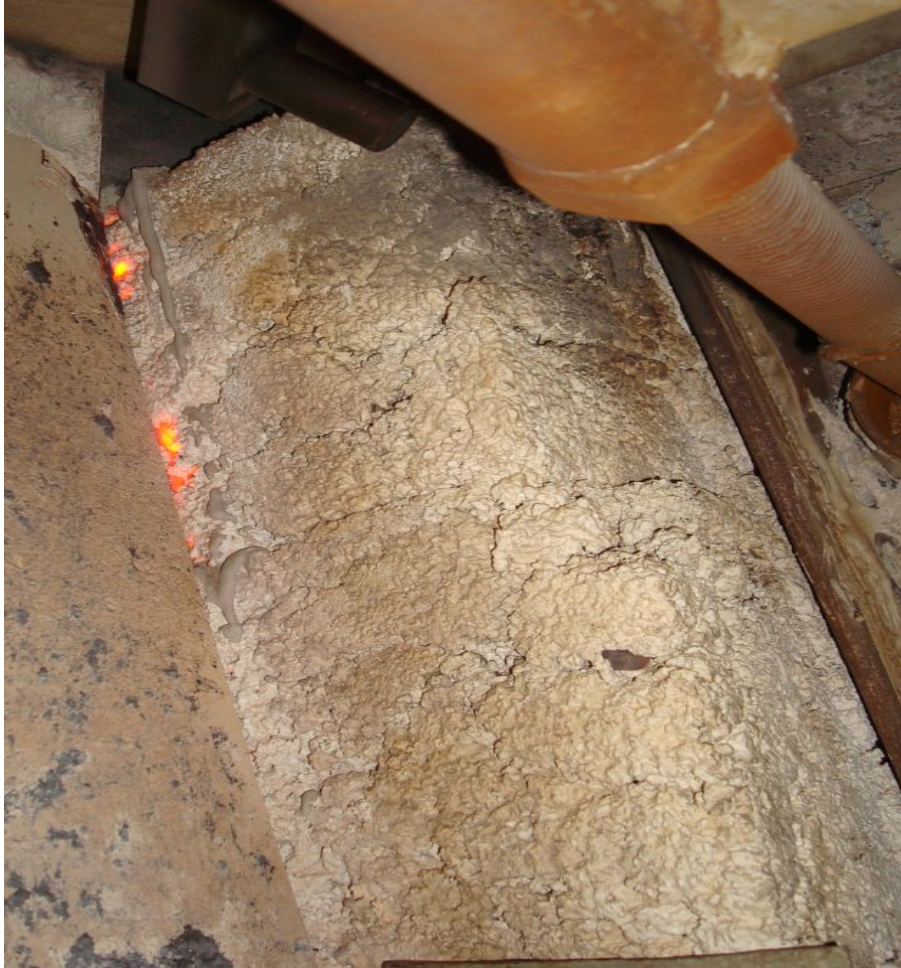
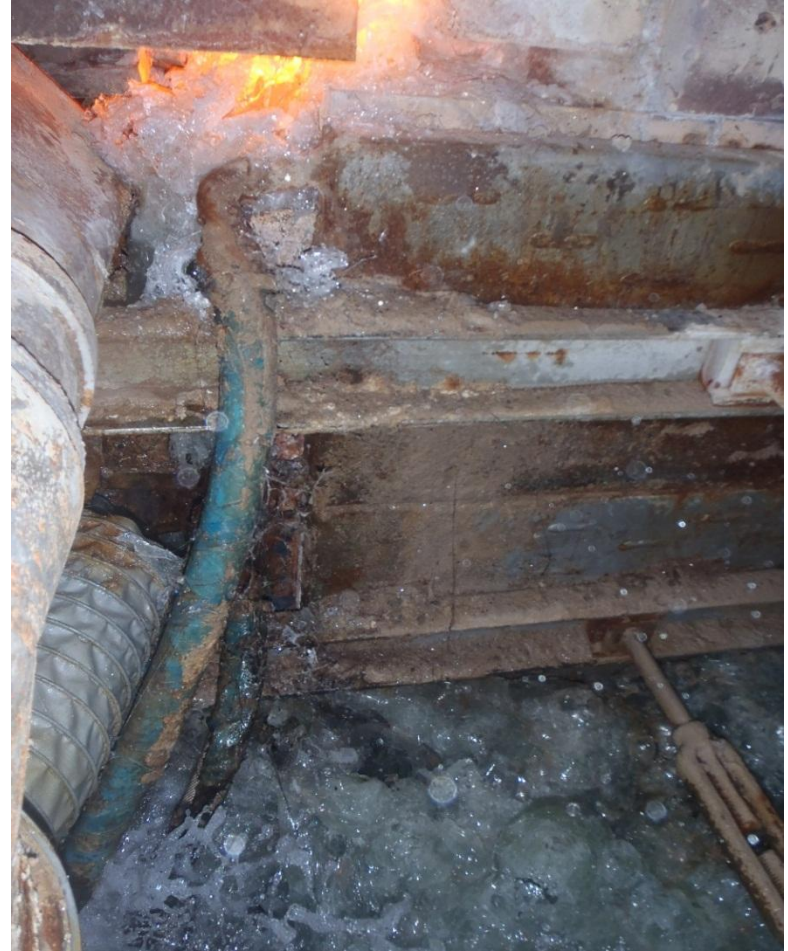
# Throat angle block corrosion with bad air cooling..... And glass leakage

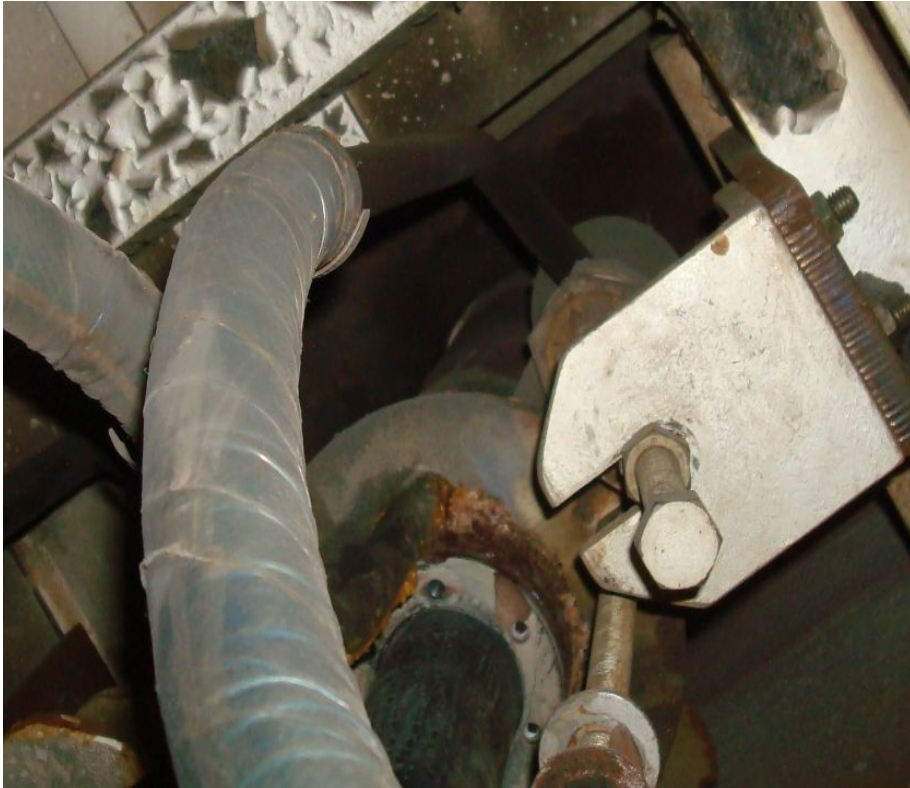
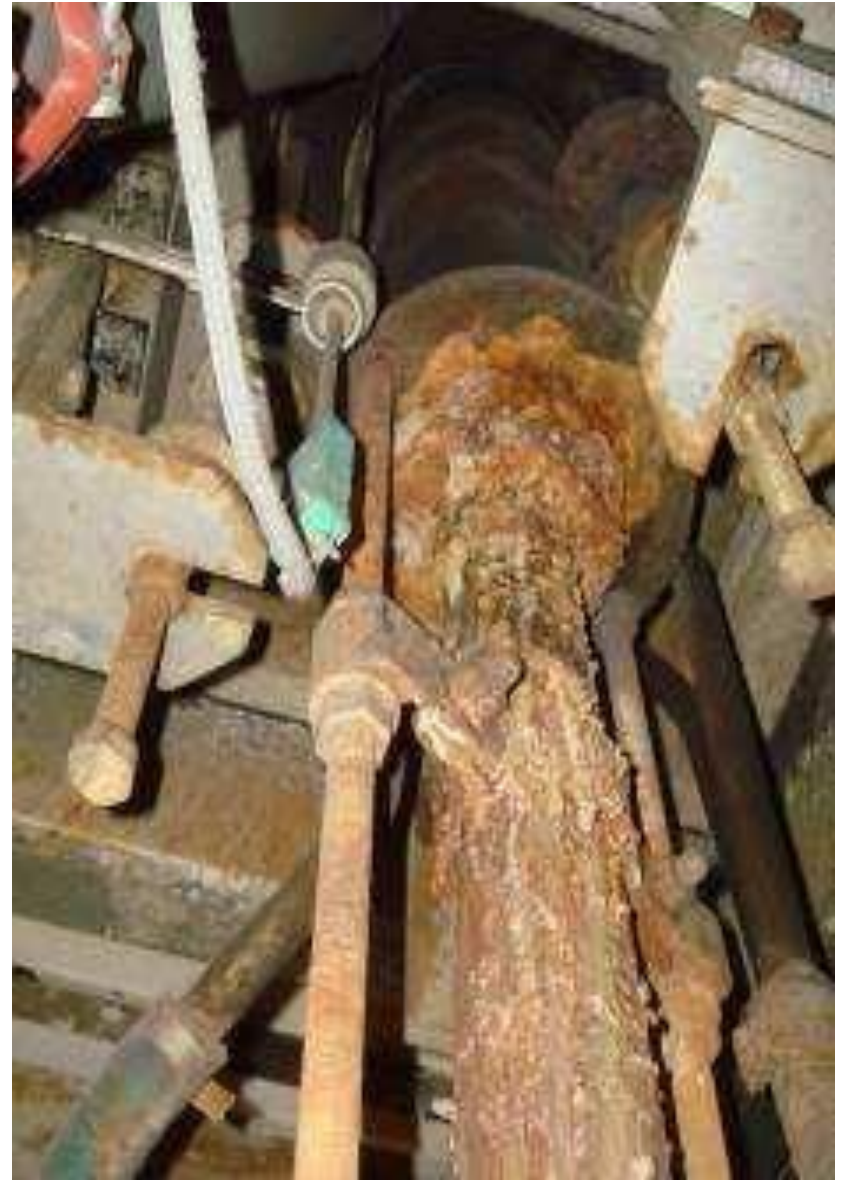
# Water leak on electrode water jacket during 2 years without repair

- Electrodes problems : broken, block infiltrated, deviation temperature, electrode inclined	-Glass leakage risks -Pull reduction	- Amperage measurement deviation, reporting - Visual checking, reporting - Stopping electrode group, reporting - Cooling provisory with compress air and water, reporting
	Water leak on electrode holder	Electrical short-circuit risks (electrical connection between electrode and framework by water ) and human risks electrocution. Oxidation of every mechanic and electrical holder and electrodes pieces.	Reporting for repairing or replacing holder. Stop water cooling and install compress air cooling

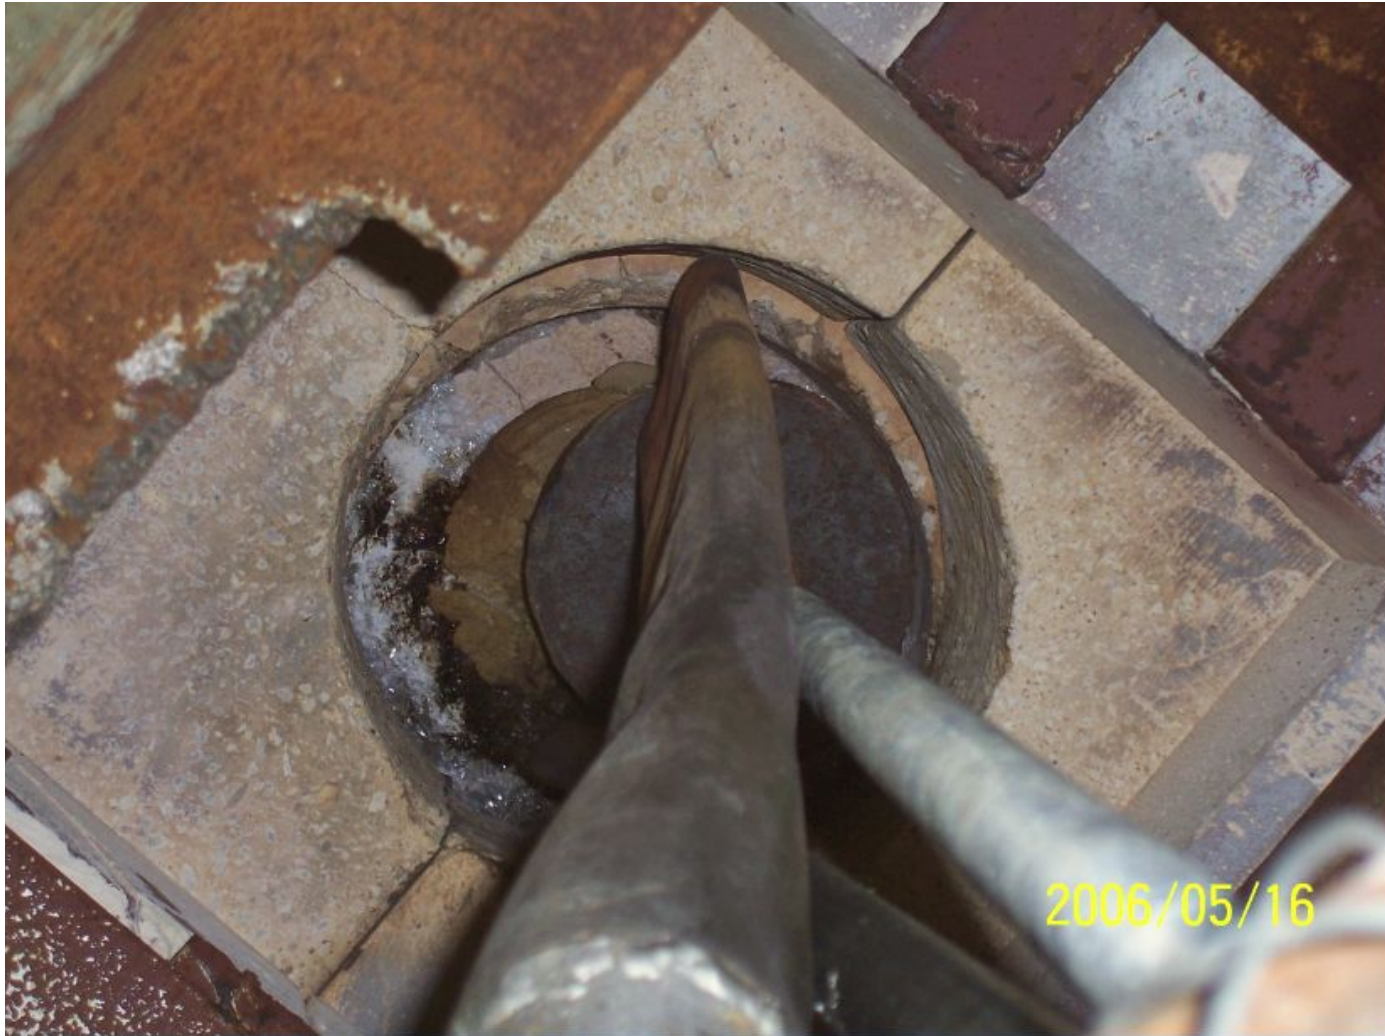
# Bubbler block corroded, important glass infiltration

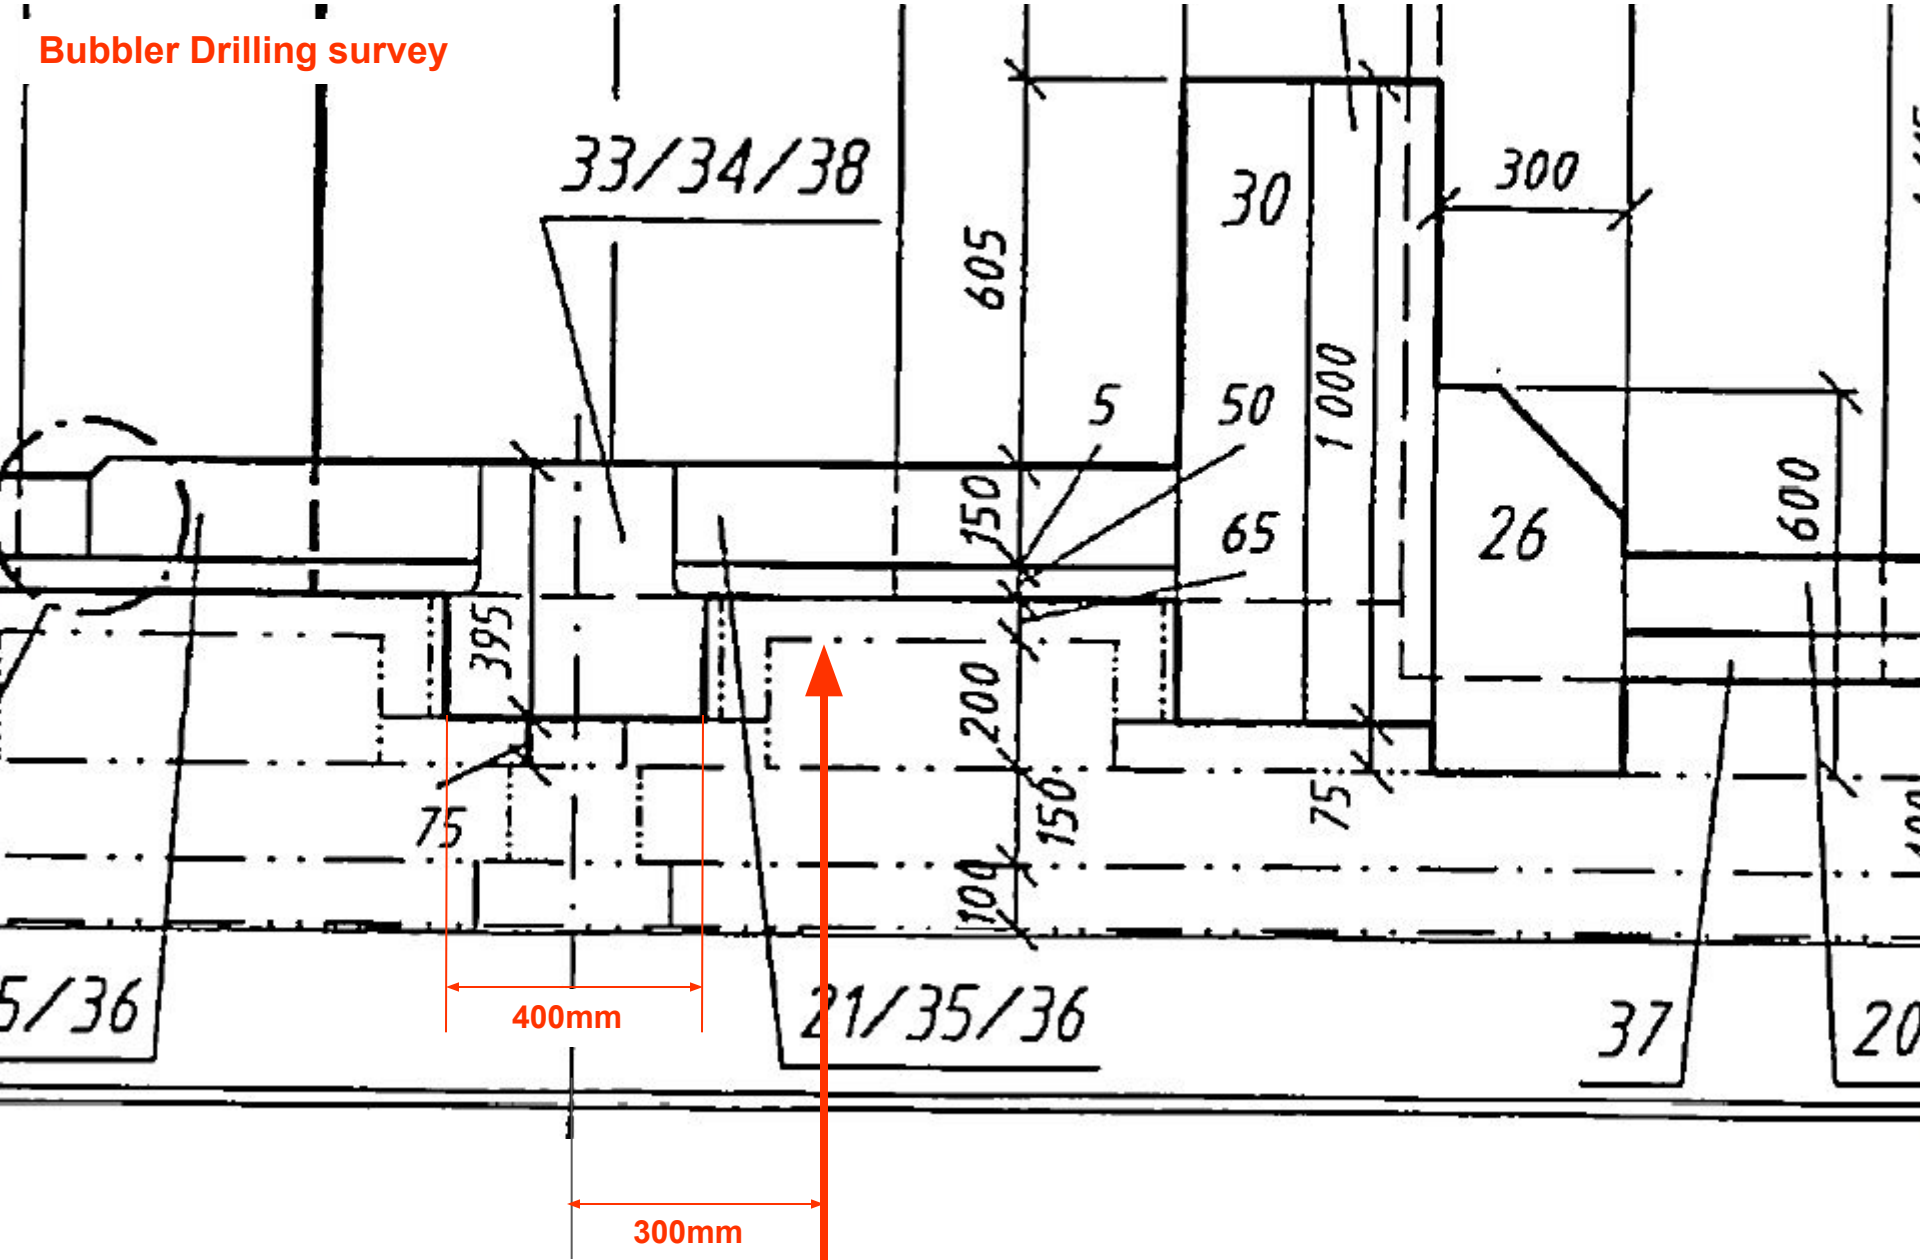
# Bubbler Drilling survey

drilling Ø 16mm  
Glass in contact of Zirmul, no AZS 150mm  
+ no ERSOL concrete 50mm

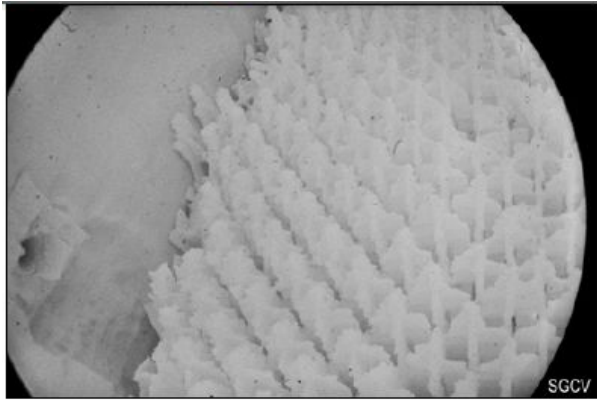
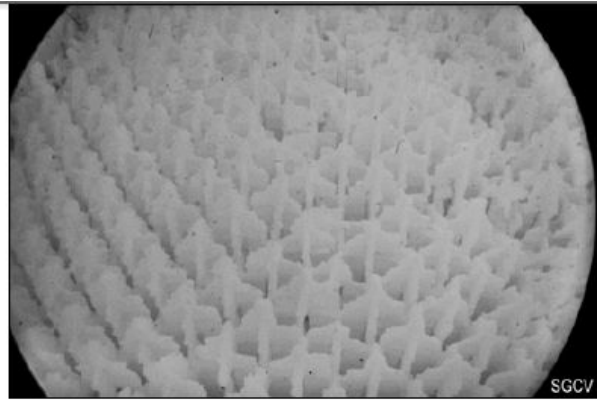
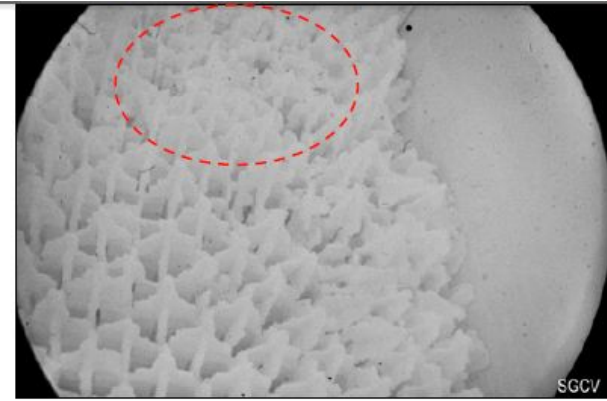
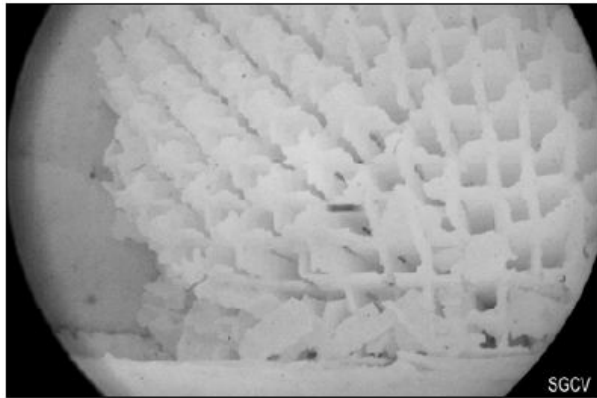
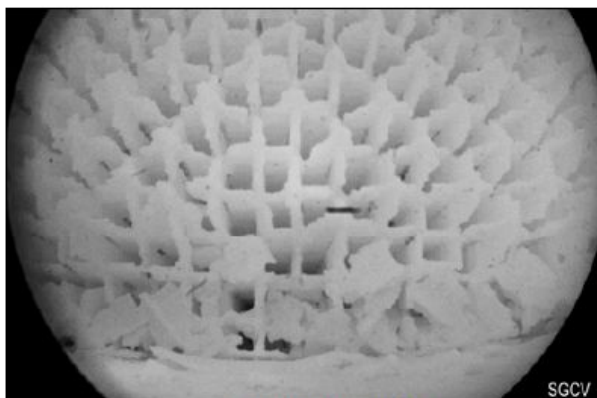
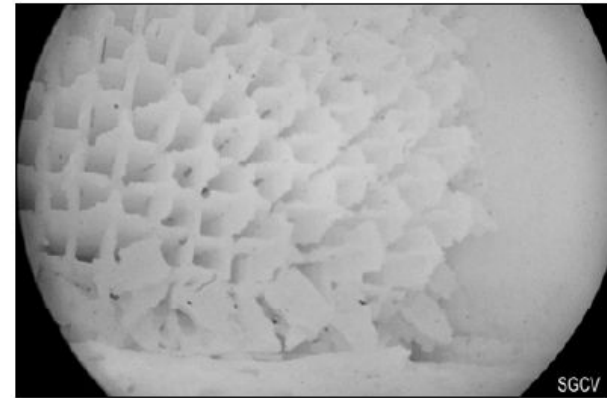
# Checkers corrosion.....

Raw material carry over	Mechanic checkers blockage	<ul style="list-style-type: none"> <li>- Dry raw material mix, dusty raw materials deposits around dog houses</li> <li>- Regulation butterfly percentage evolution</li> <li>- furnace pressure measurement increasing</li> <li>- Humidification raw materials mix, in mixer if possible, or just before batch charger.</li> <li>- Reporting for checkers cleaning</li> </ul>

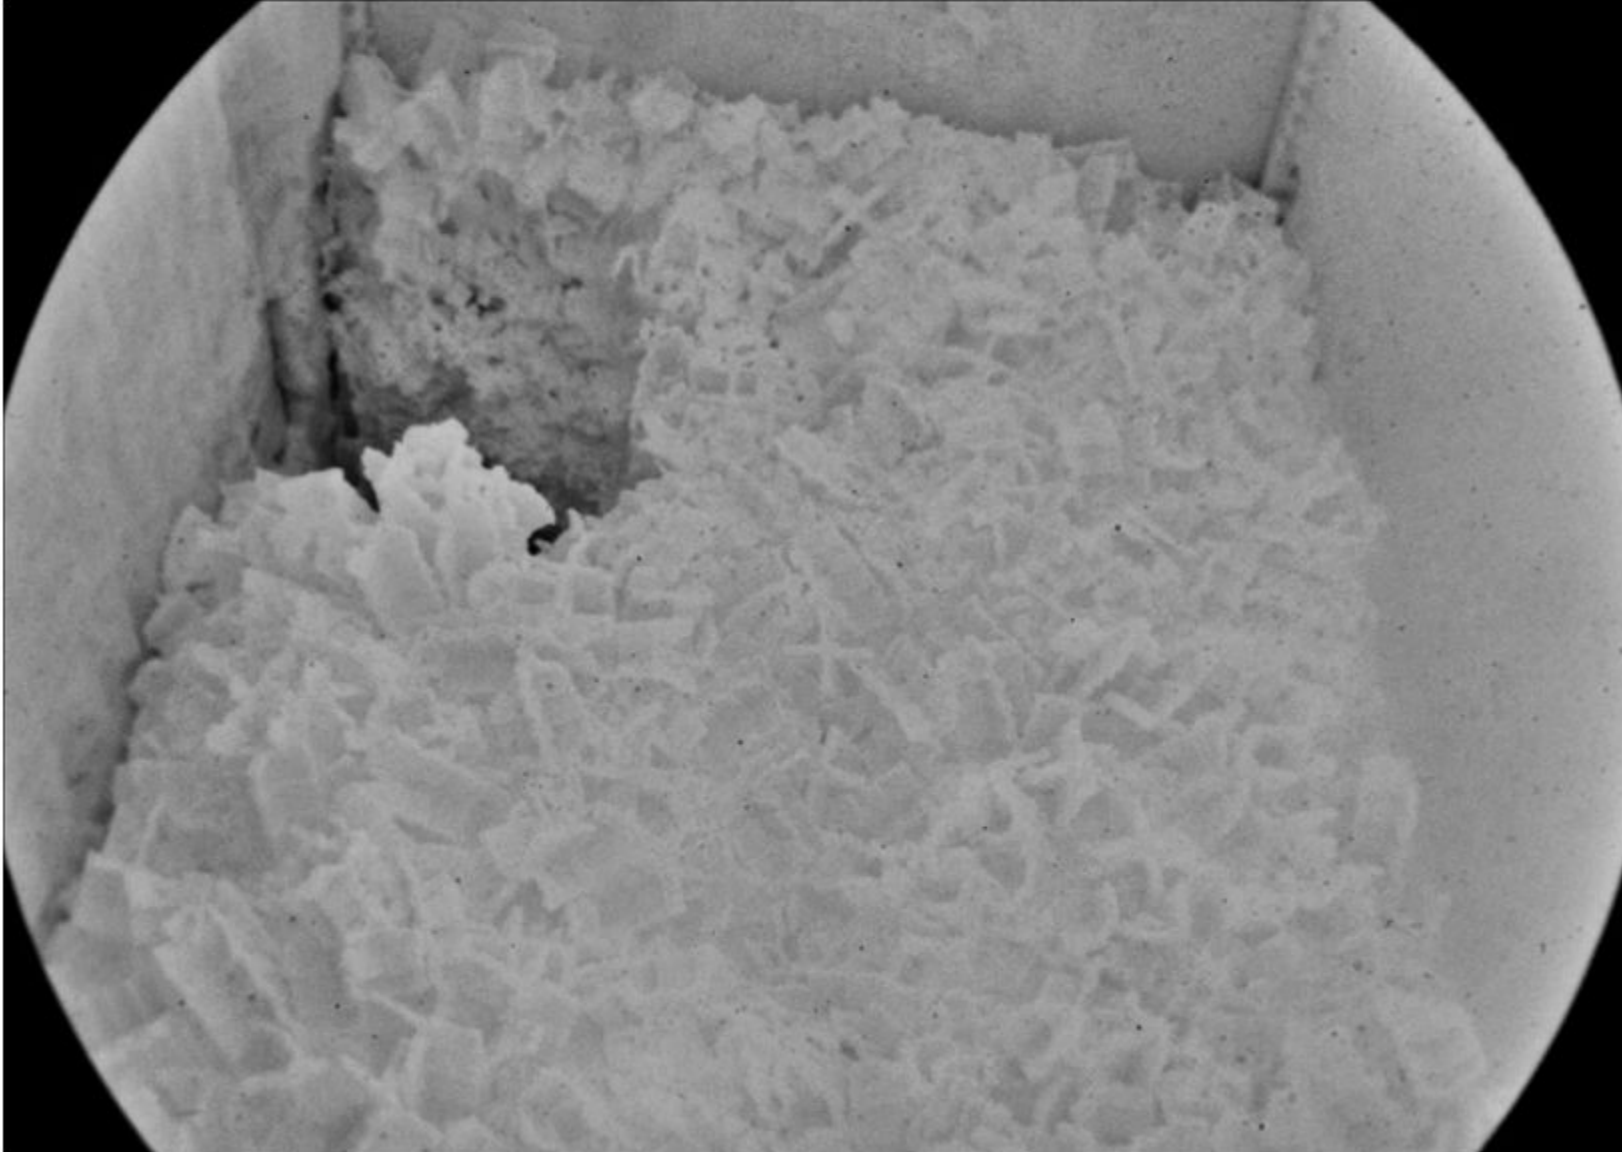
# ...and 3m checkers crushing, by-pass realization
