# Furnaces corrosion / prevention to improve the longevity of campaigns

## Th Roustan 2016/10

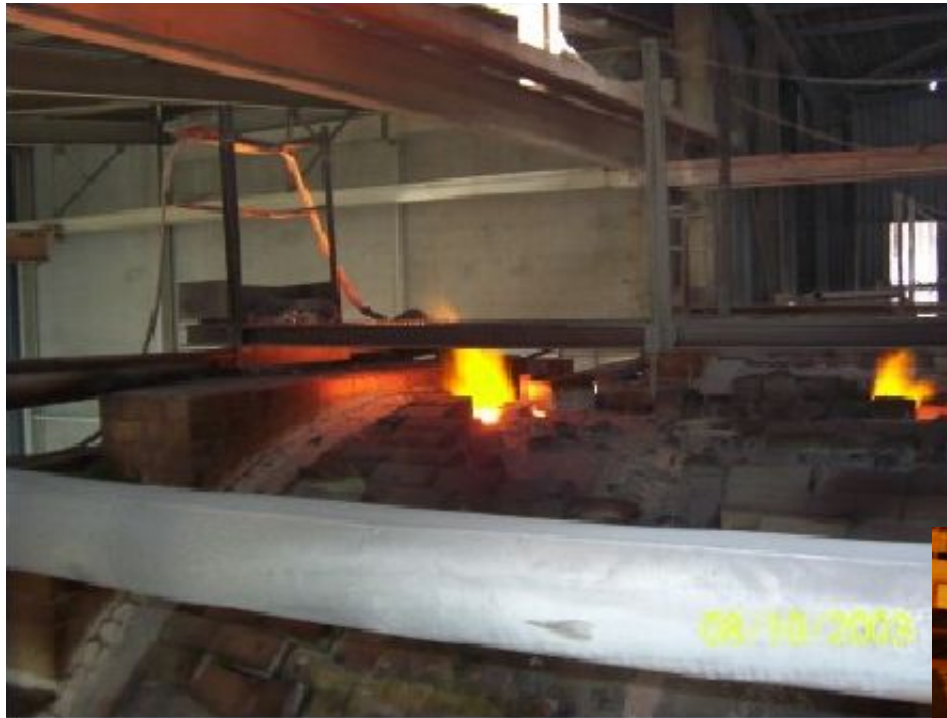
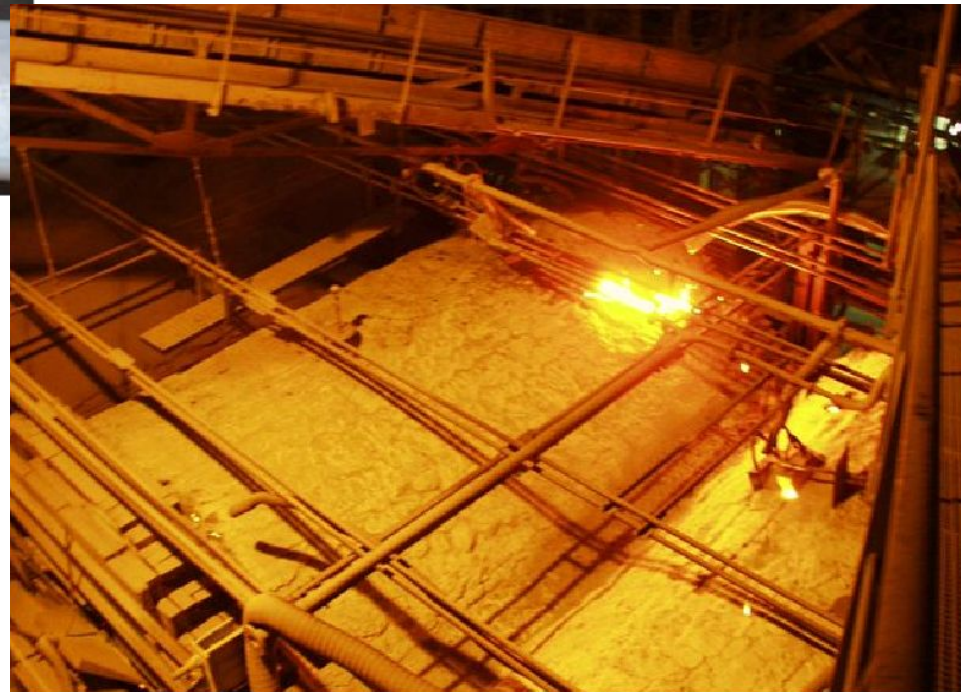
**Flames passage on  
regenerator's crowns  
(checkers frequently locked )**

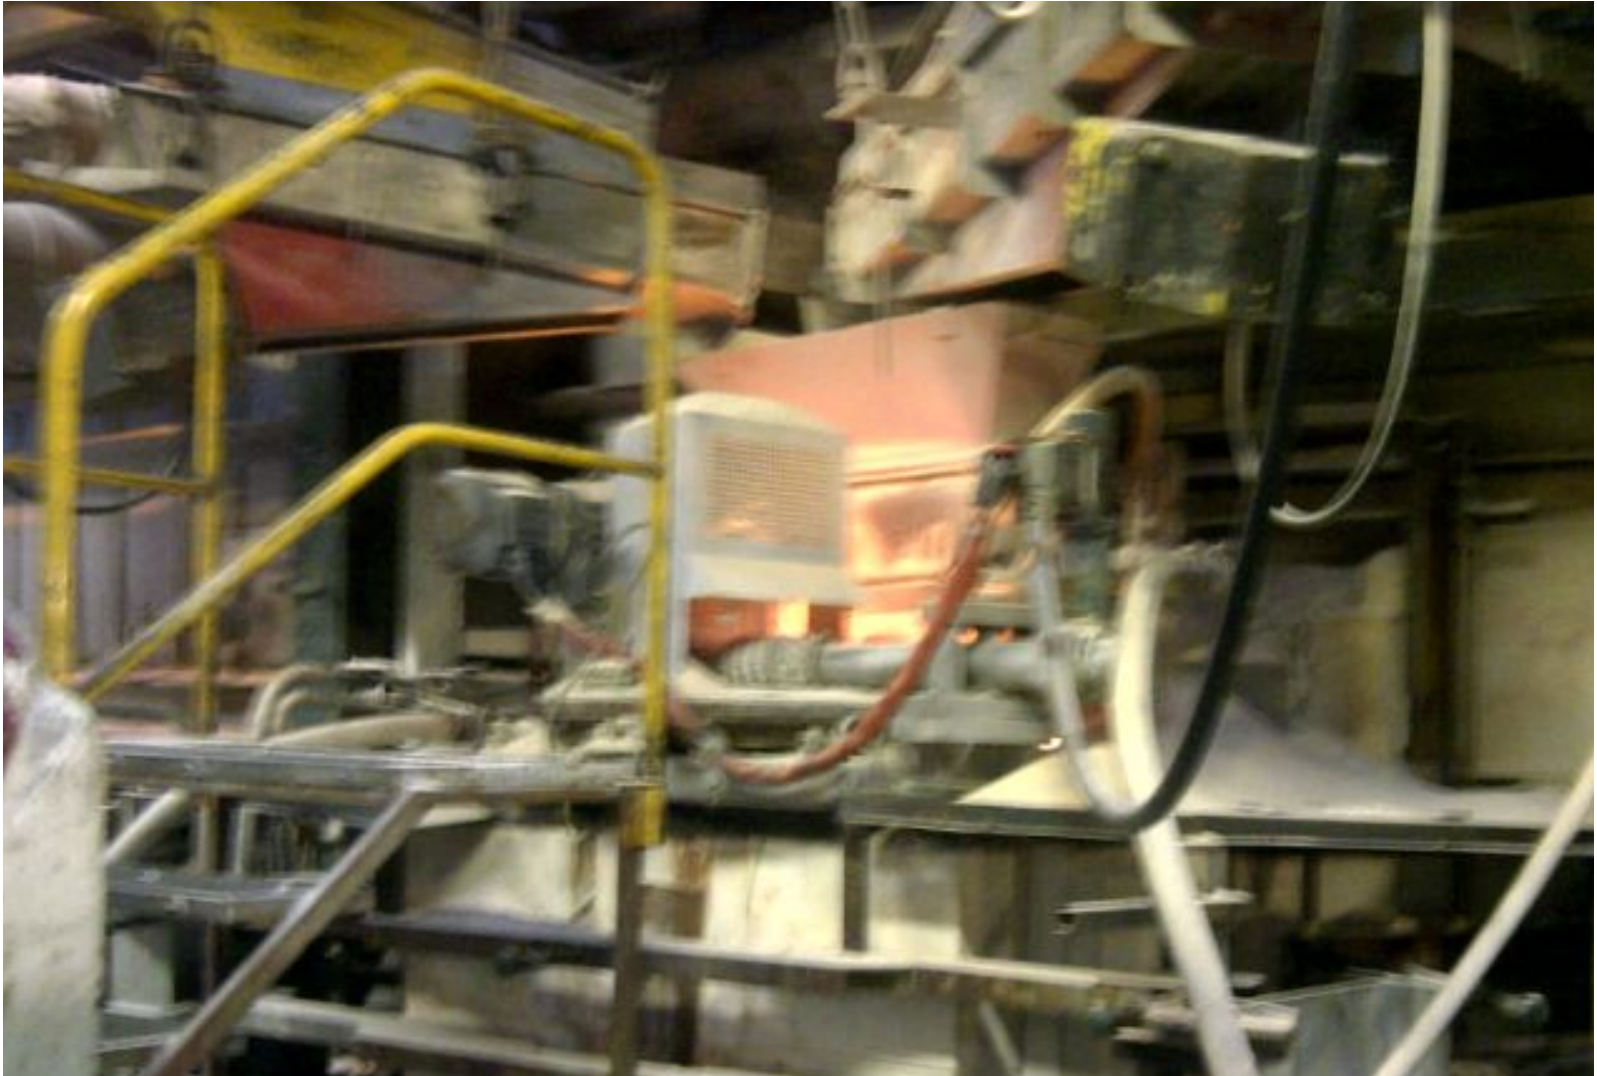
# Important raw materials deposits..... batch charger

## Mechanic problems

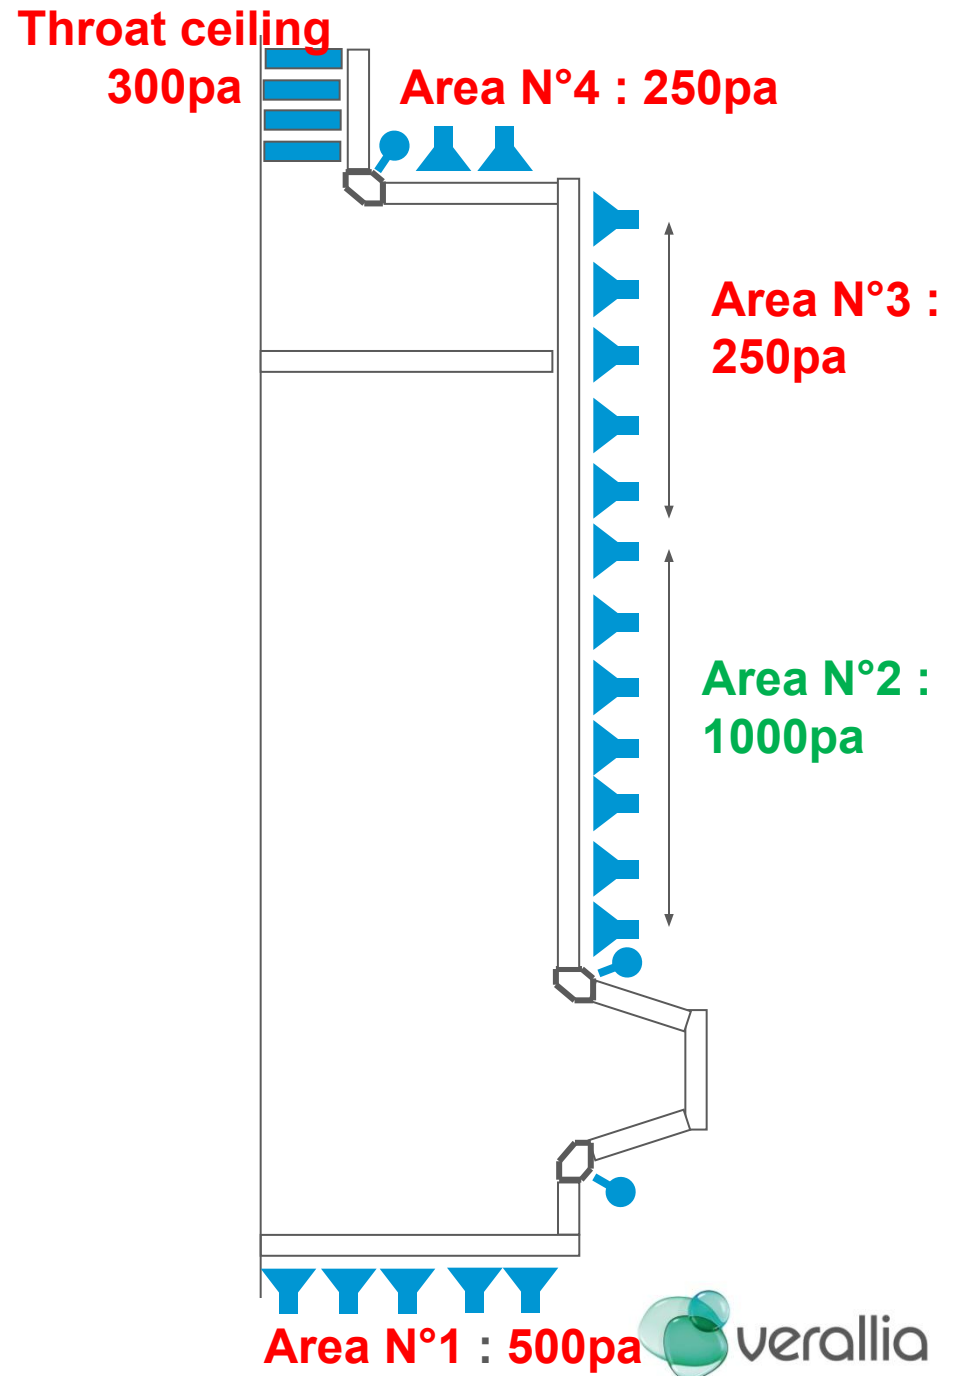
**Air cooling  
pressure measurement  
on nozzles example**  
**In red color insufficient  
air cooling quantity  
( $\geq 700$  Pa)**

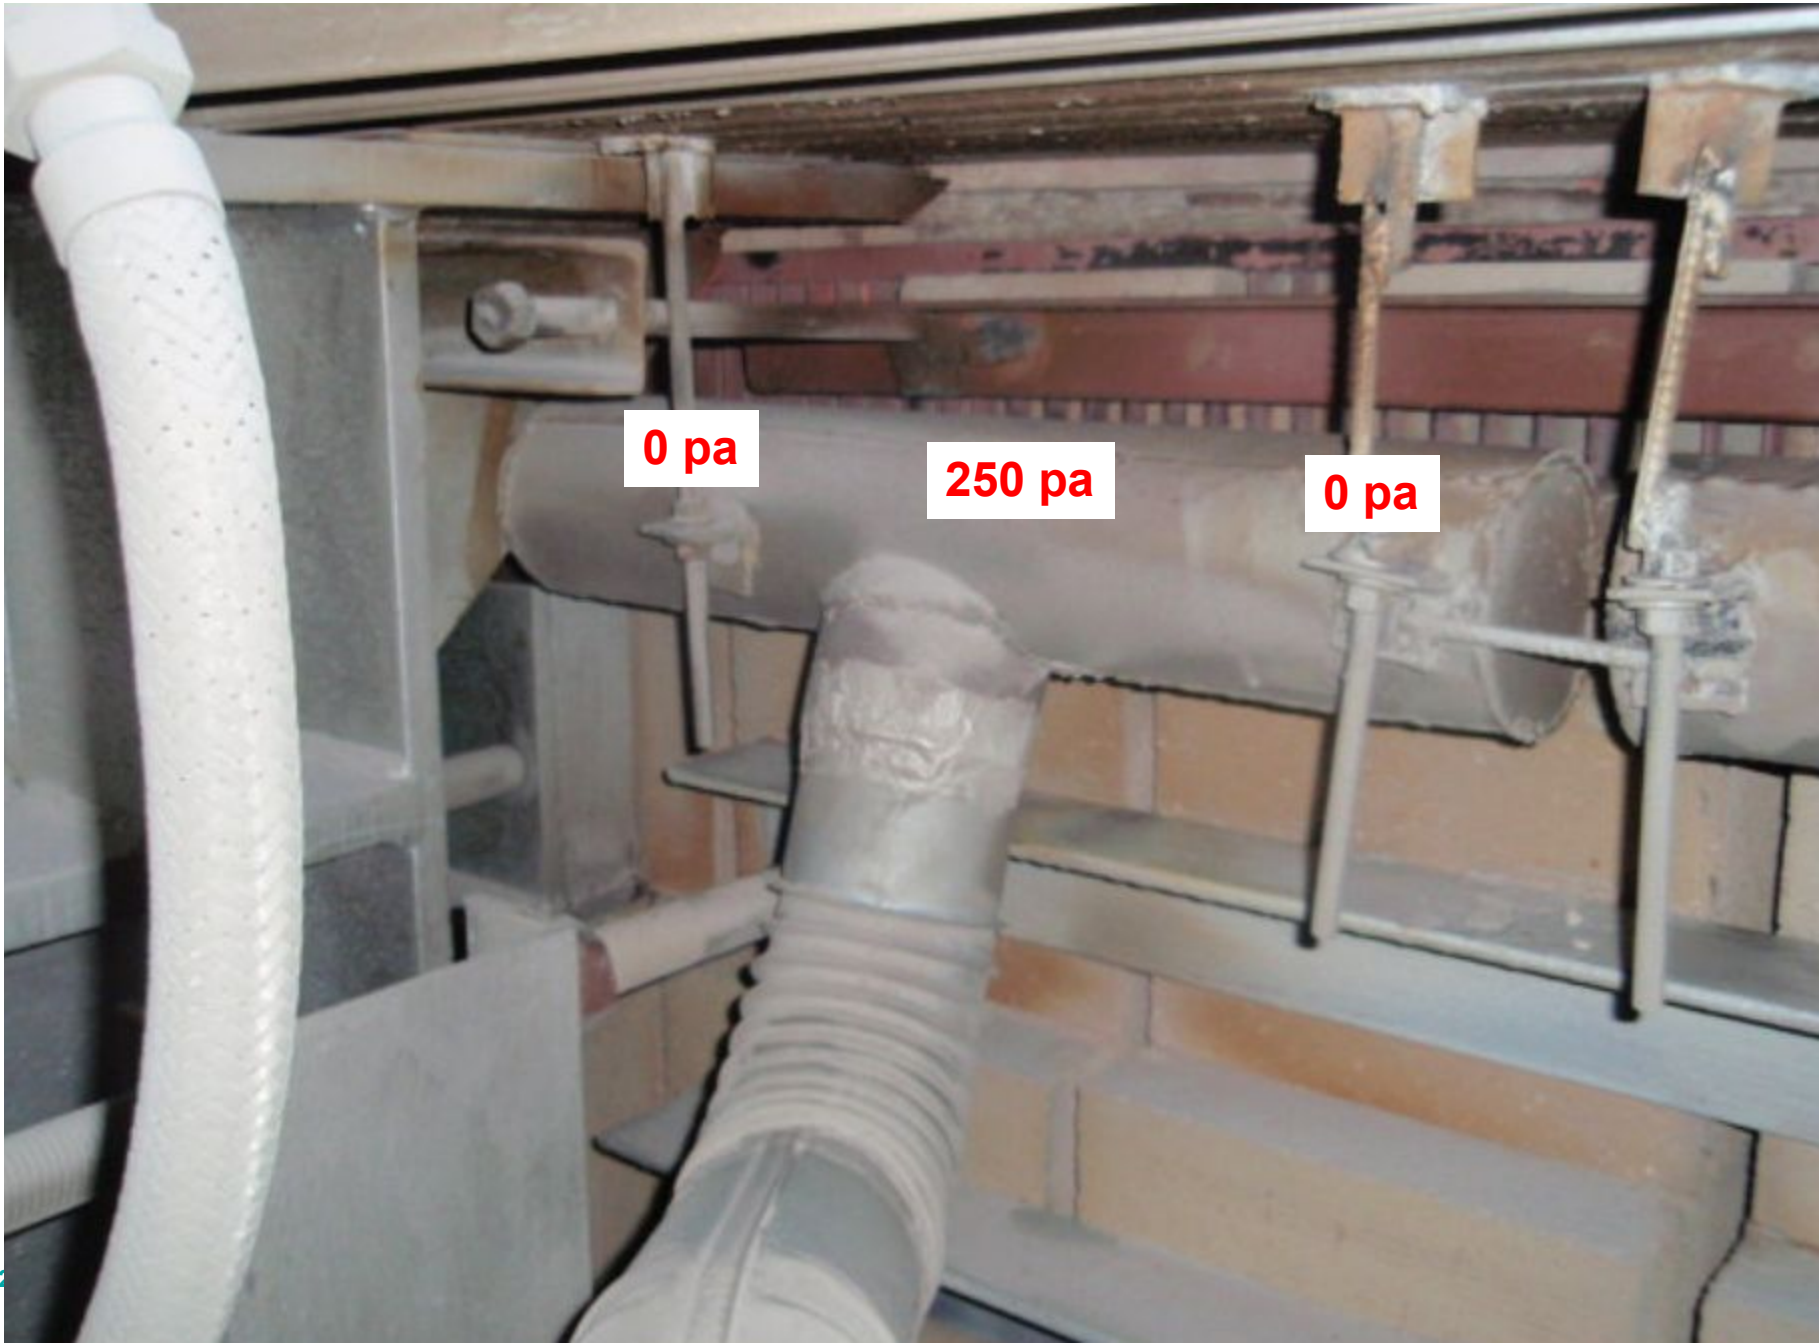
**Bad nozzles shape**

**0 pa**

**250 pa**

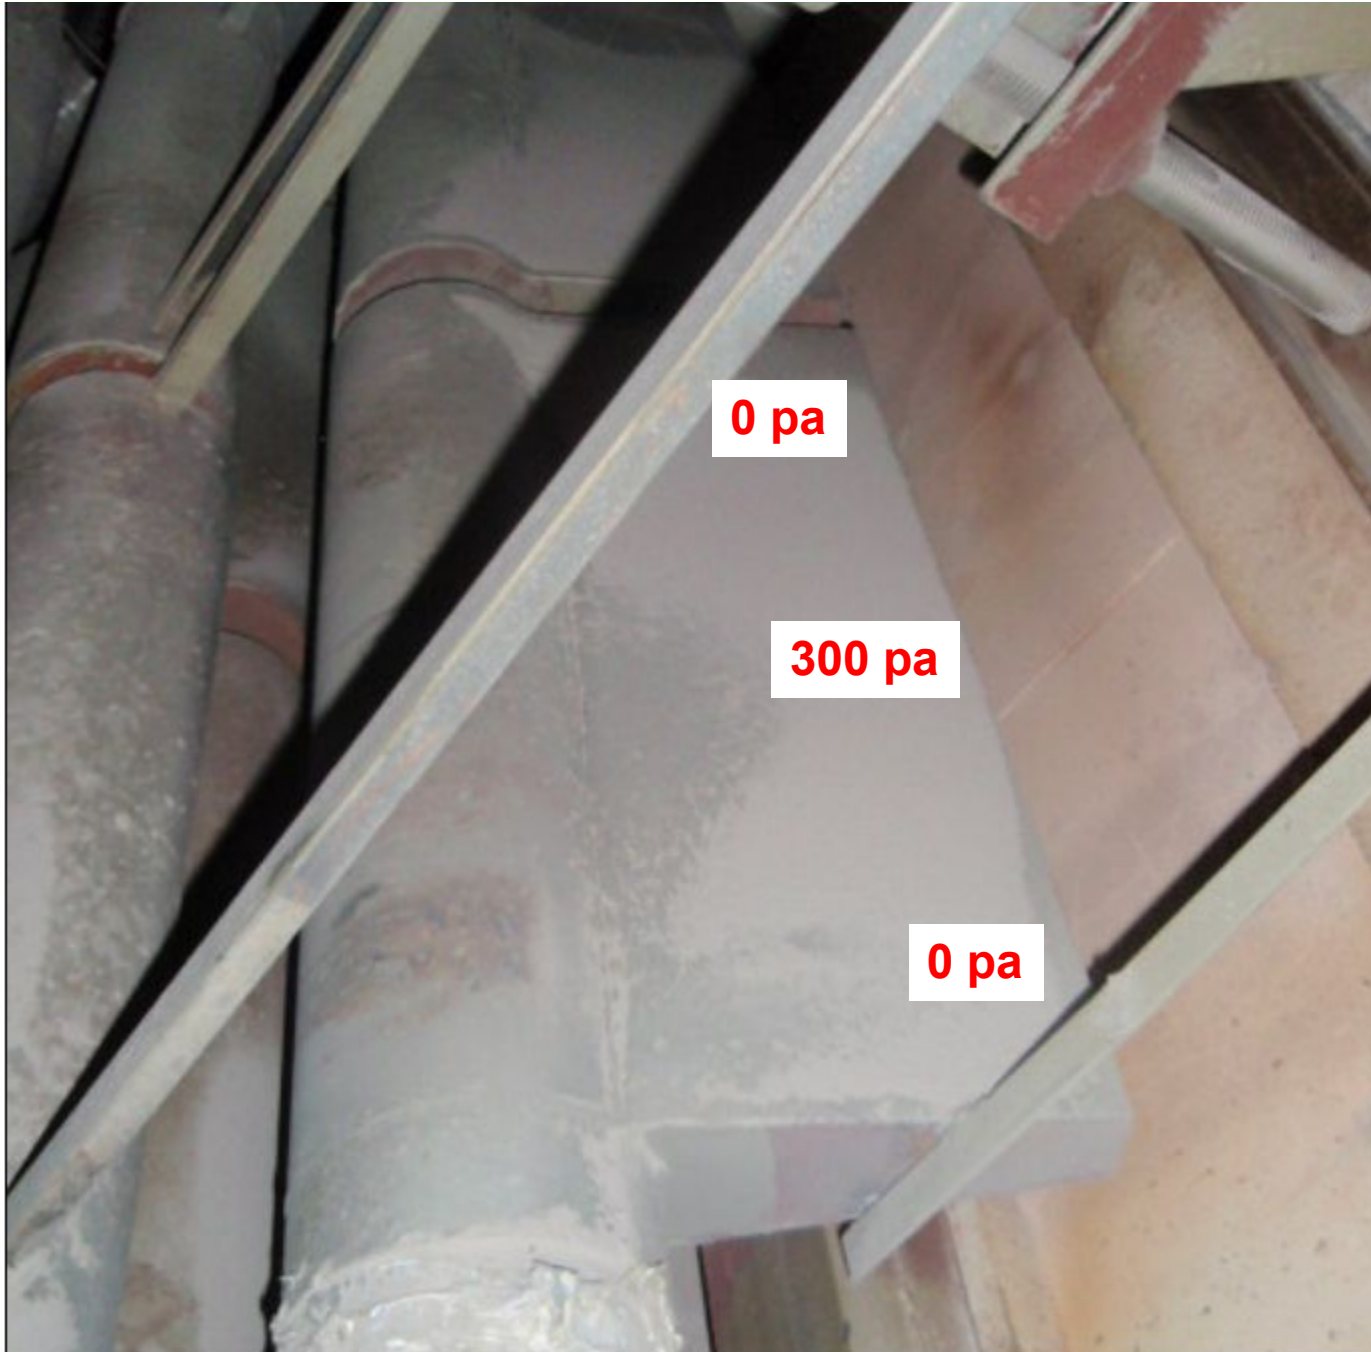
# Bad nozzles shape in throat

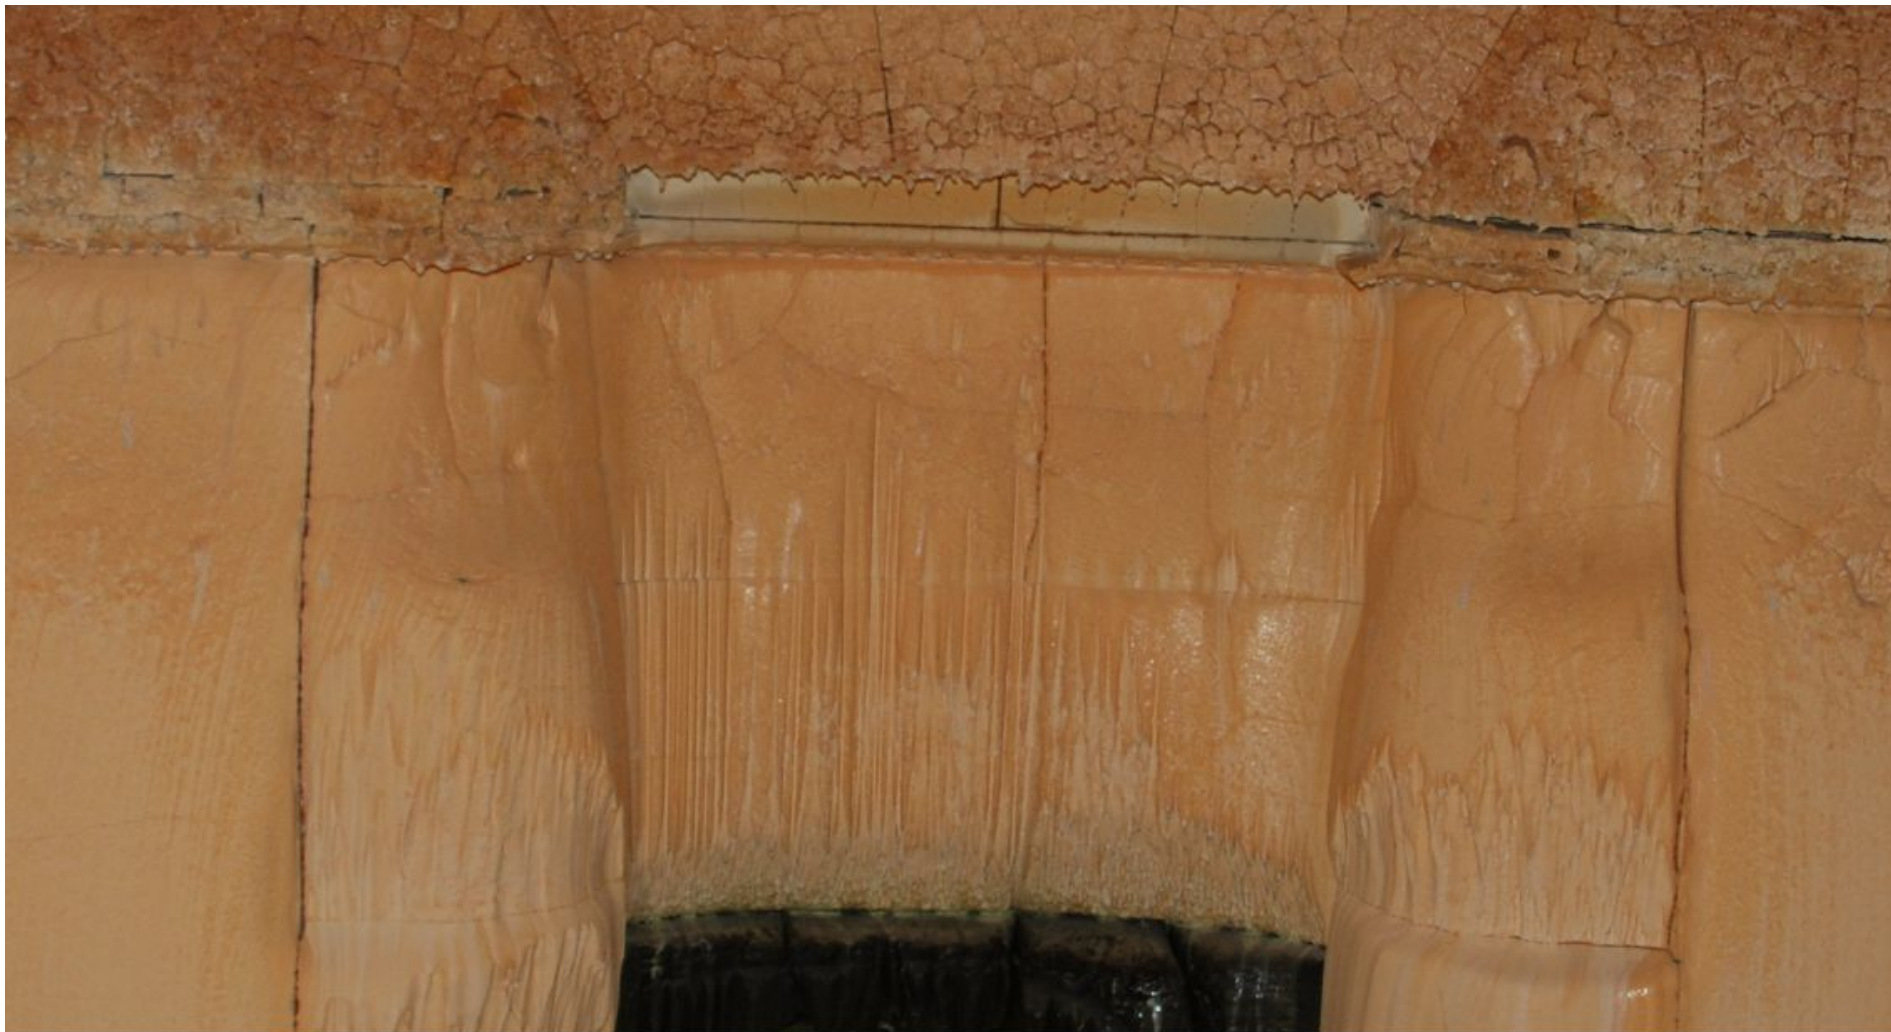
**Throat angle blocks after 11 years campaign with efficient air cooling  
(average air pressure nozzles : 1000 Pa)**

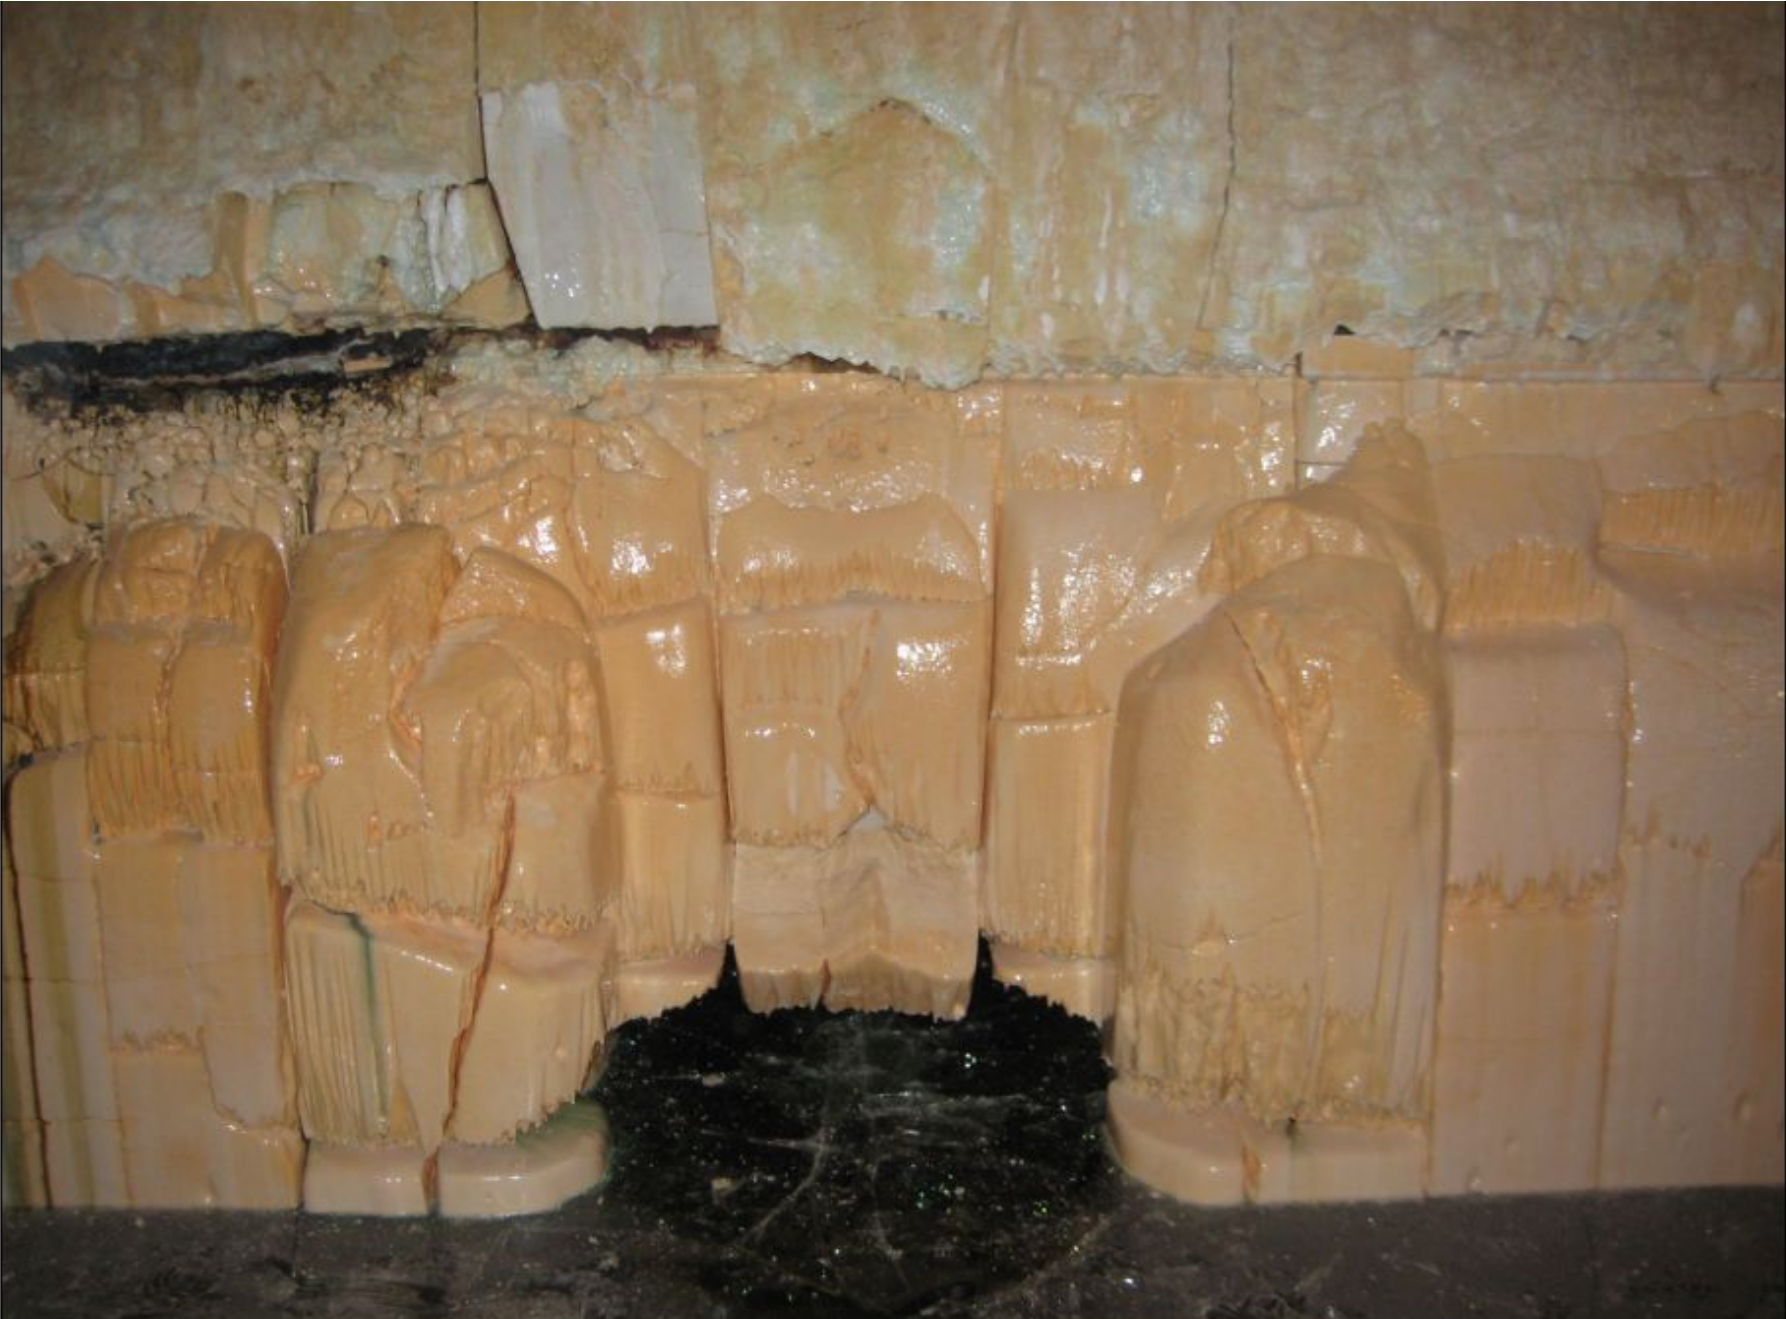
Throat angle blocks after 5 years campaign with insufficient air cooling

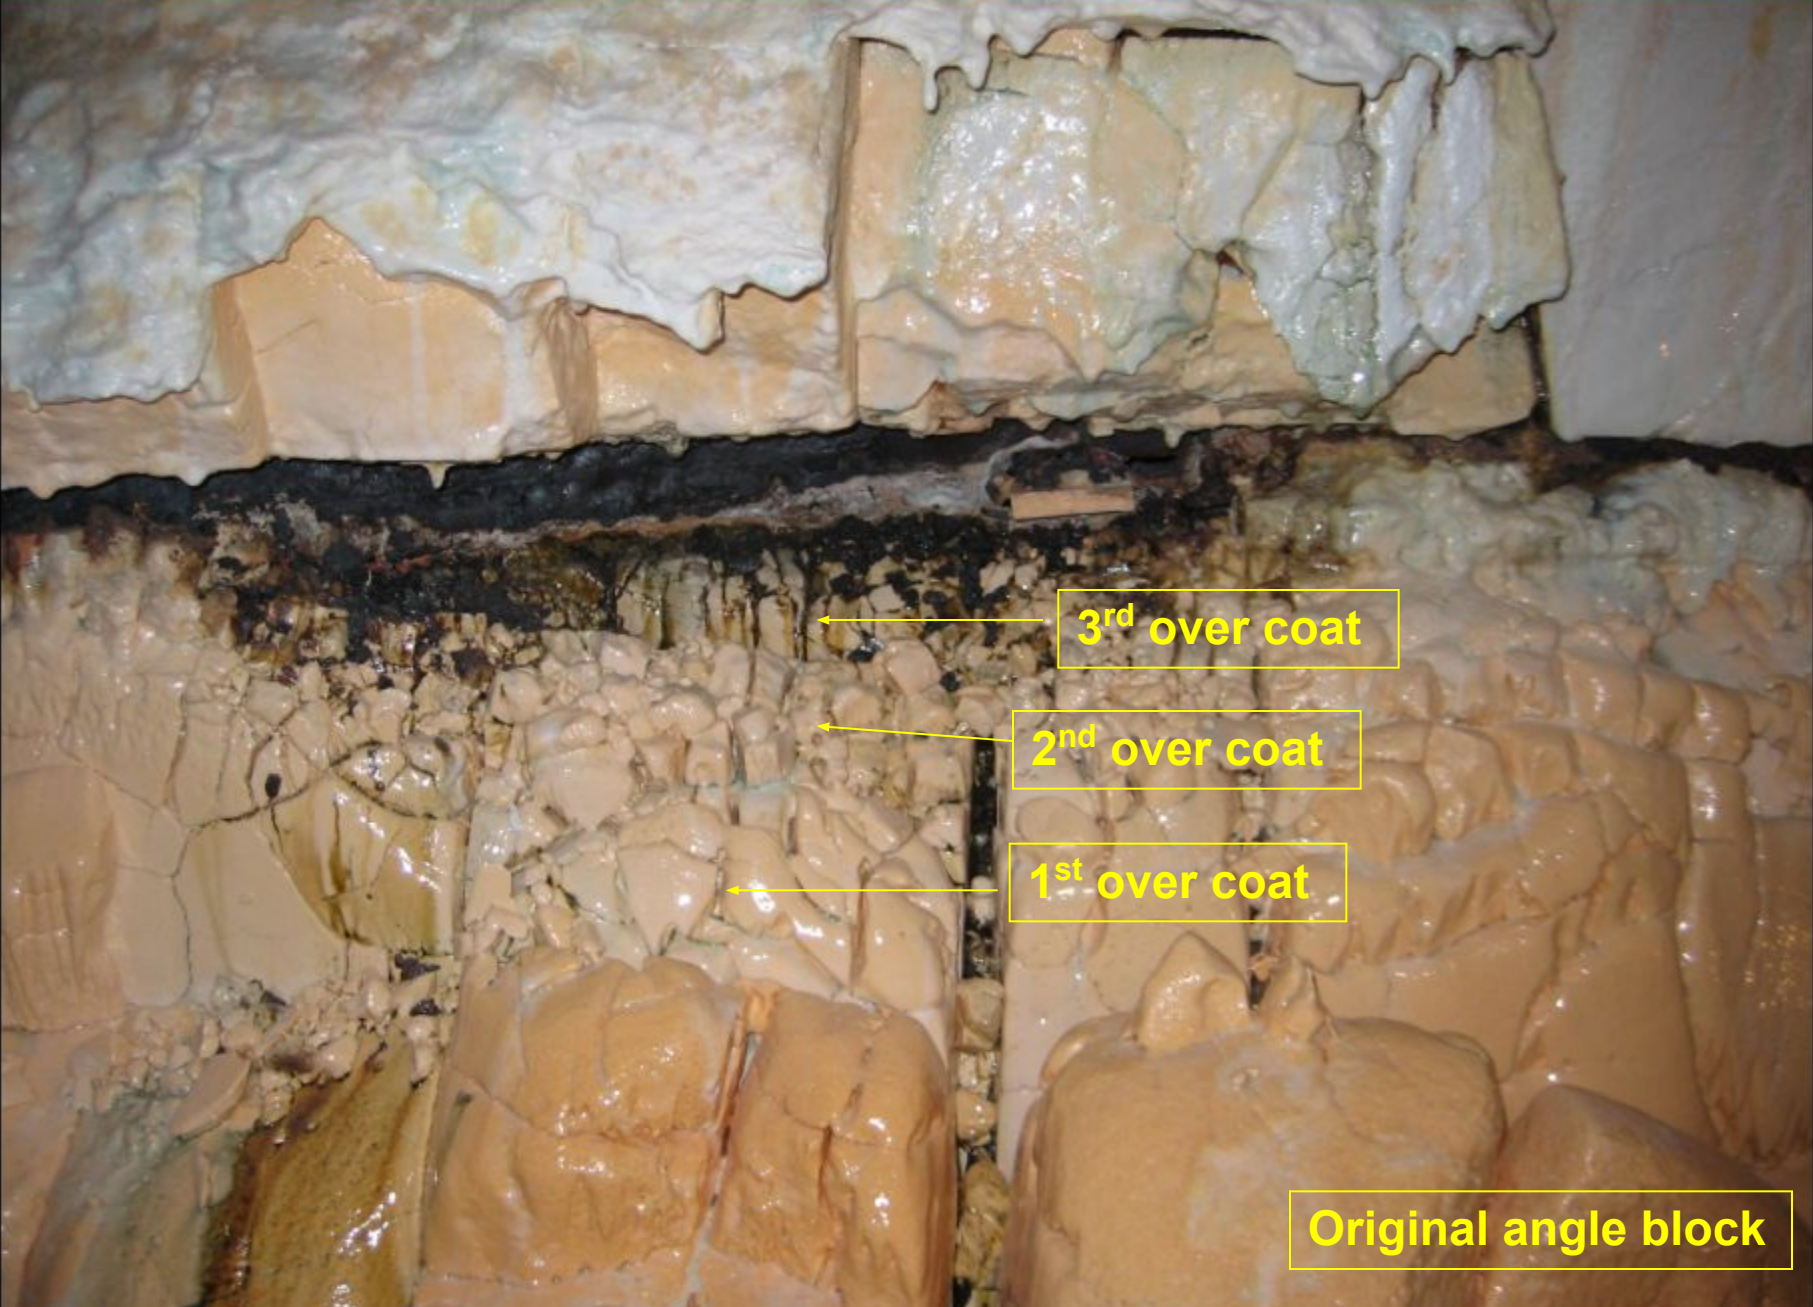
# Throat angle blocks after 5 years campaign with insufficient air cooling
