Repaired units

FX1800 SHO

The reason of occurrence of defects - transport damages

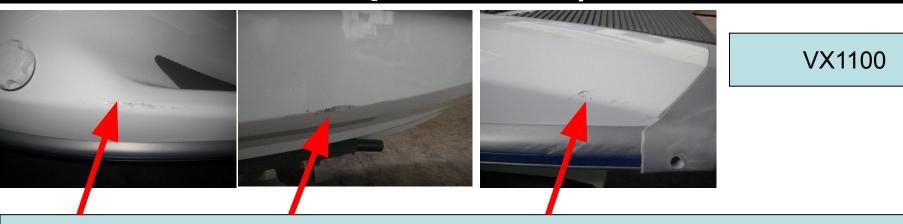
Damages inside package.

Result of moving (Insufficiently strong fastening of unit in packing).
Through damage of the case and damage of the painted surface.
The same damages are possible in a current of normal use (on water)

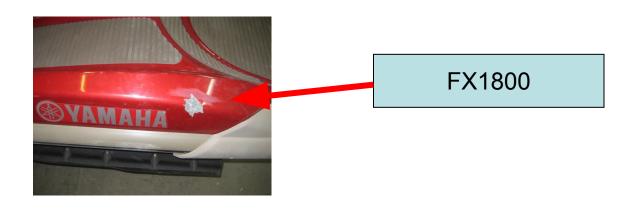
Other small damages of the top part of the hull. Paint scratch and cracks. All damages can be repaired.

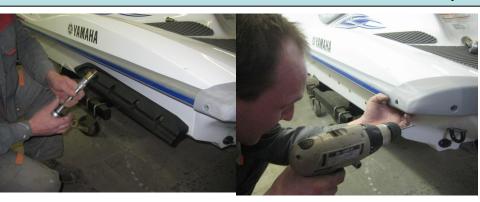
Installation and preparation for repair

Need remove all parts, near repaired place (fender, transom plates, plastic parts).

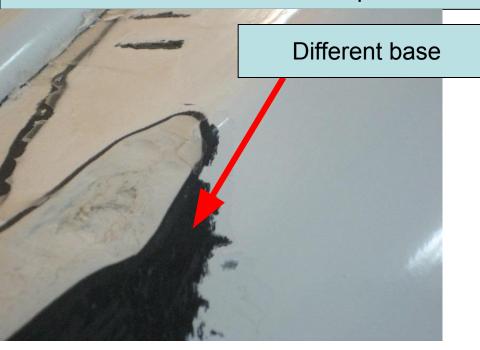
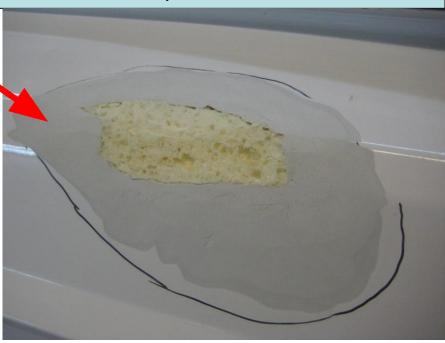
Upper side and lower side WV repair

Different paint base for lower and upper side of WV's hull.

Different paint and surface processing. The Metallic paint is applied sometimes.

In this case the extra time and expenses for a choice of a paint and after-treatment is required.
