LEFA Operations - Maintenance March 2010

Overview of Current Status

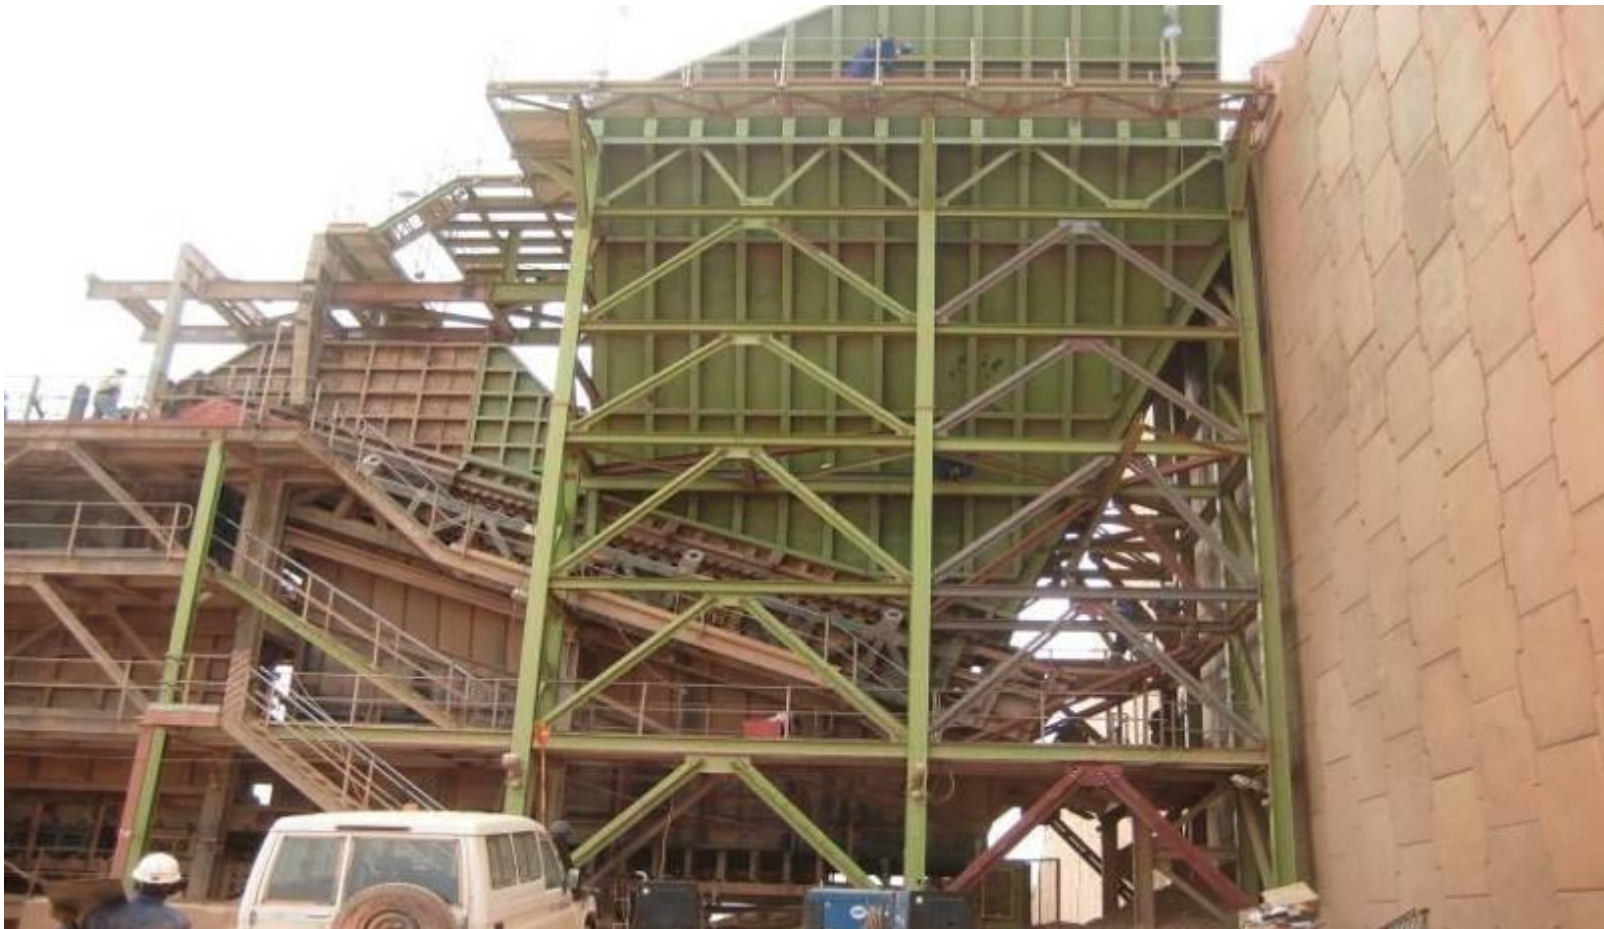
Lero & Fayalala Crushers

The ROM bin support structures were reinforced to stop movement.

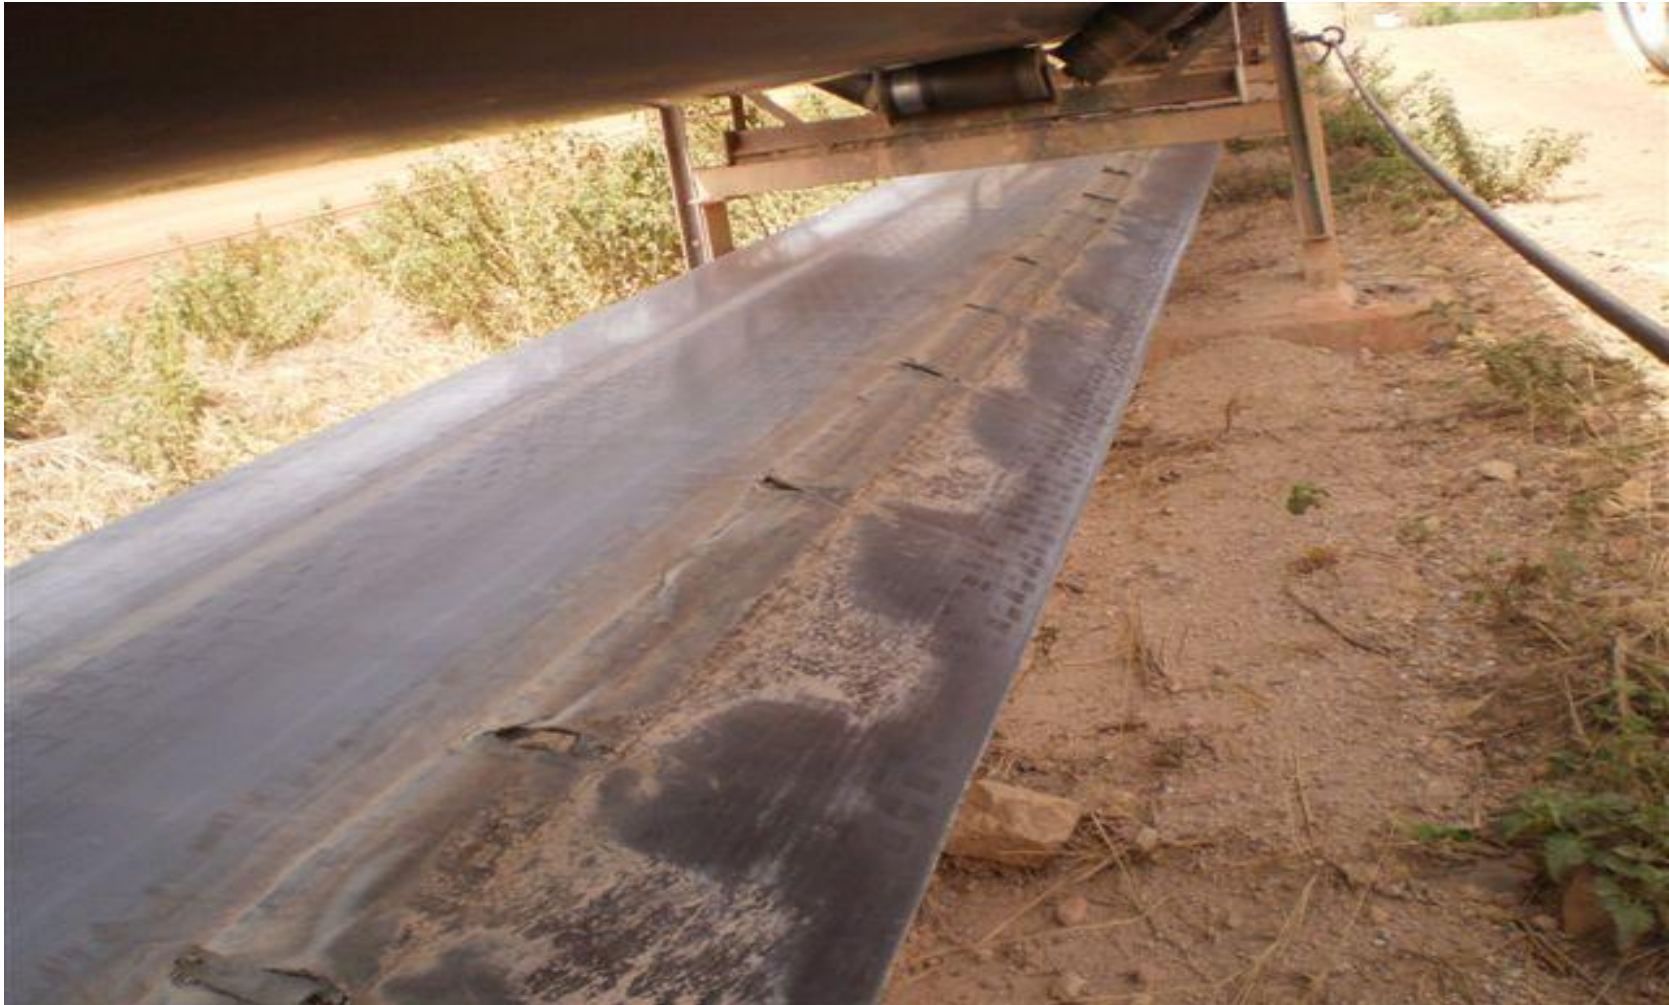
CV4 Overland Conveyor

CV04 clip repair

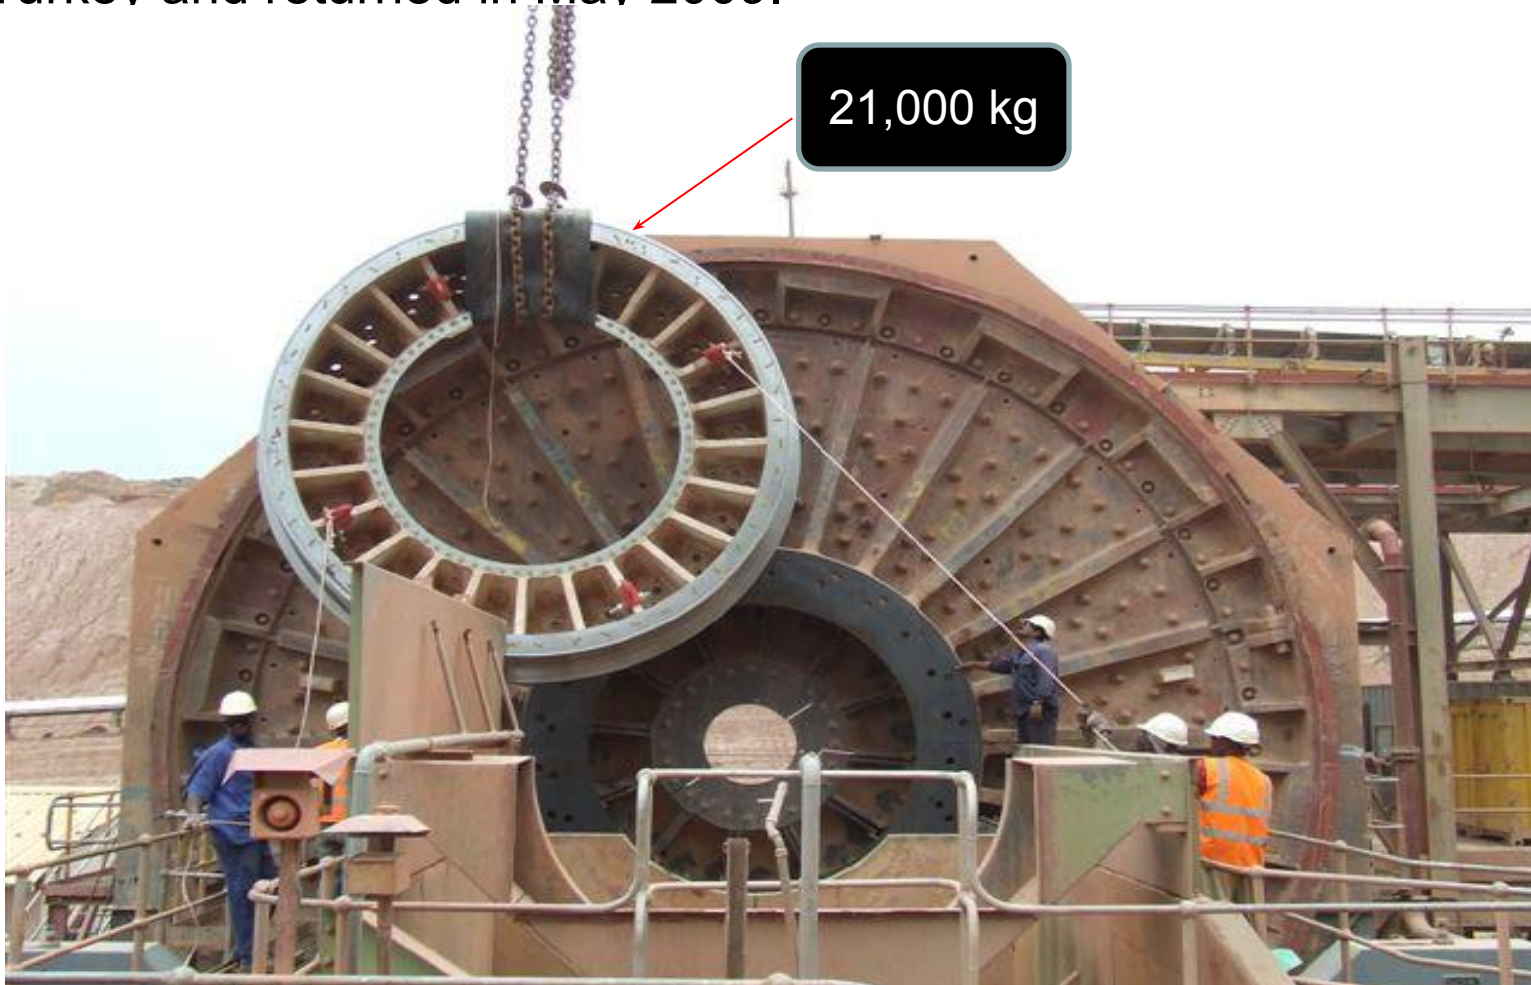
SAG Mill 2

The trunnion for this mill was removed for machining by REMAS in Turkey and returned in May 2009.

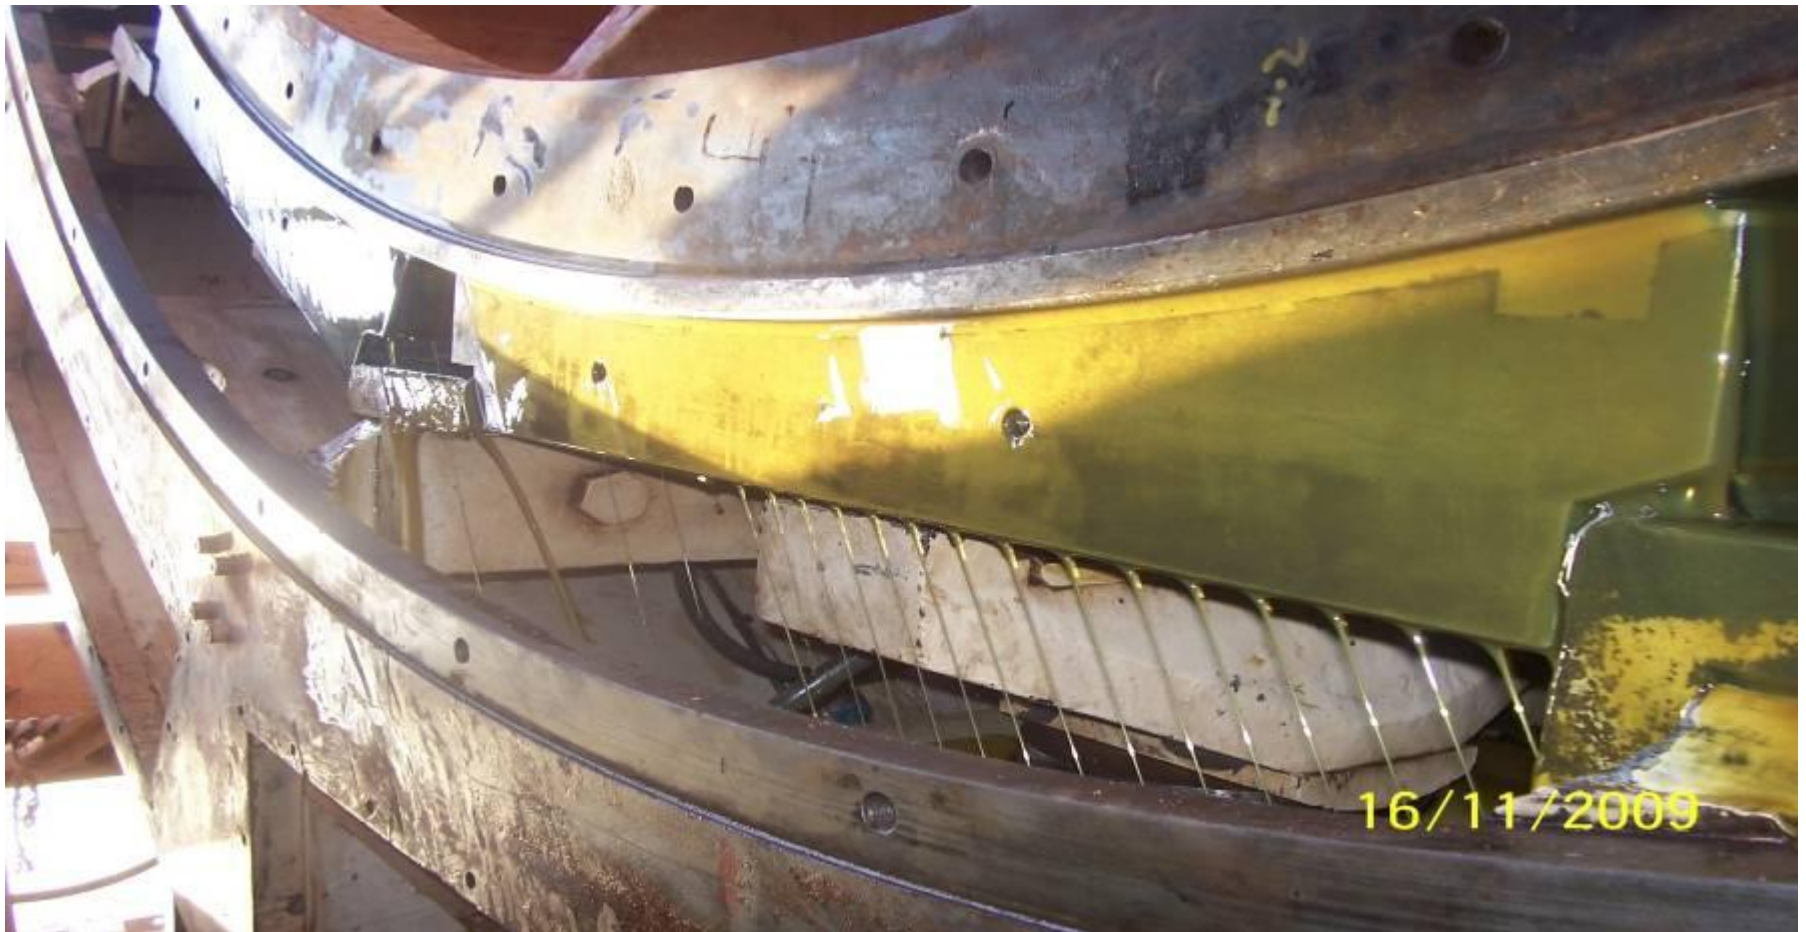
SAG Mill 2

New Bearing Pads after installation showing excellent oil coverage.

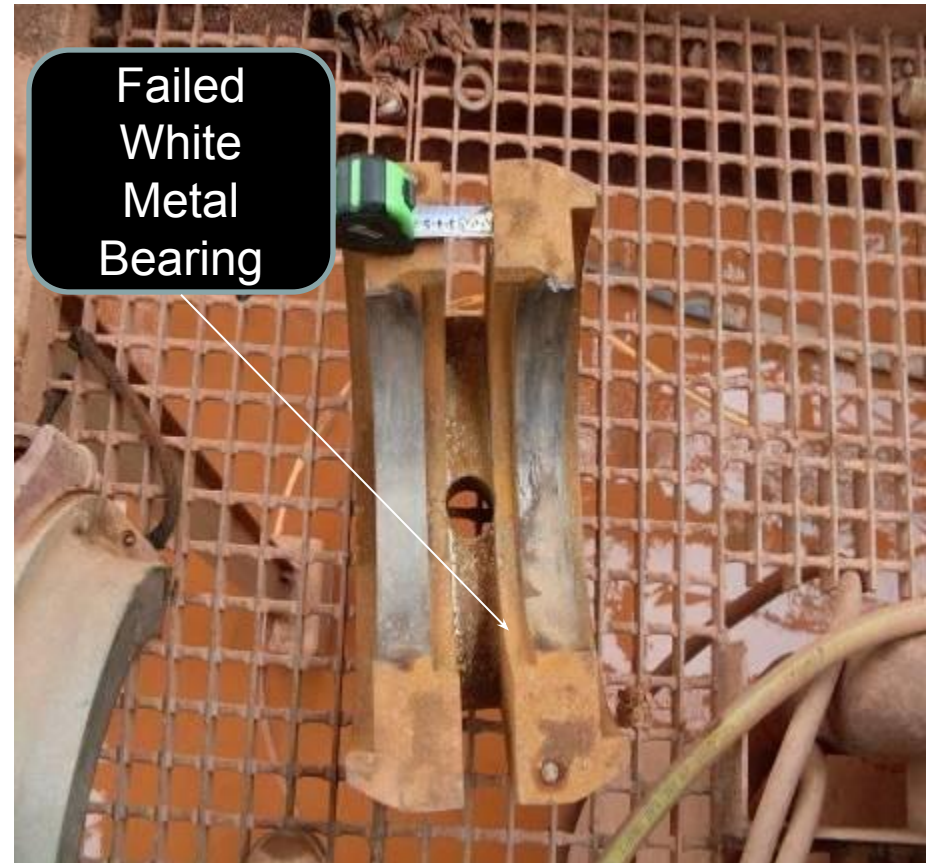
Ball Mill 1

The electric drive motor was recently completely overhauled and is expected to provide a fully serviceable life.
