LEFA Operations - Maintenance March 2010

Overview of Current Status

LEFA Operations - Process

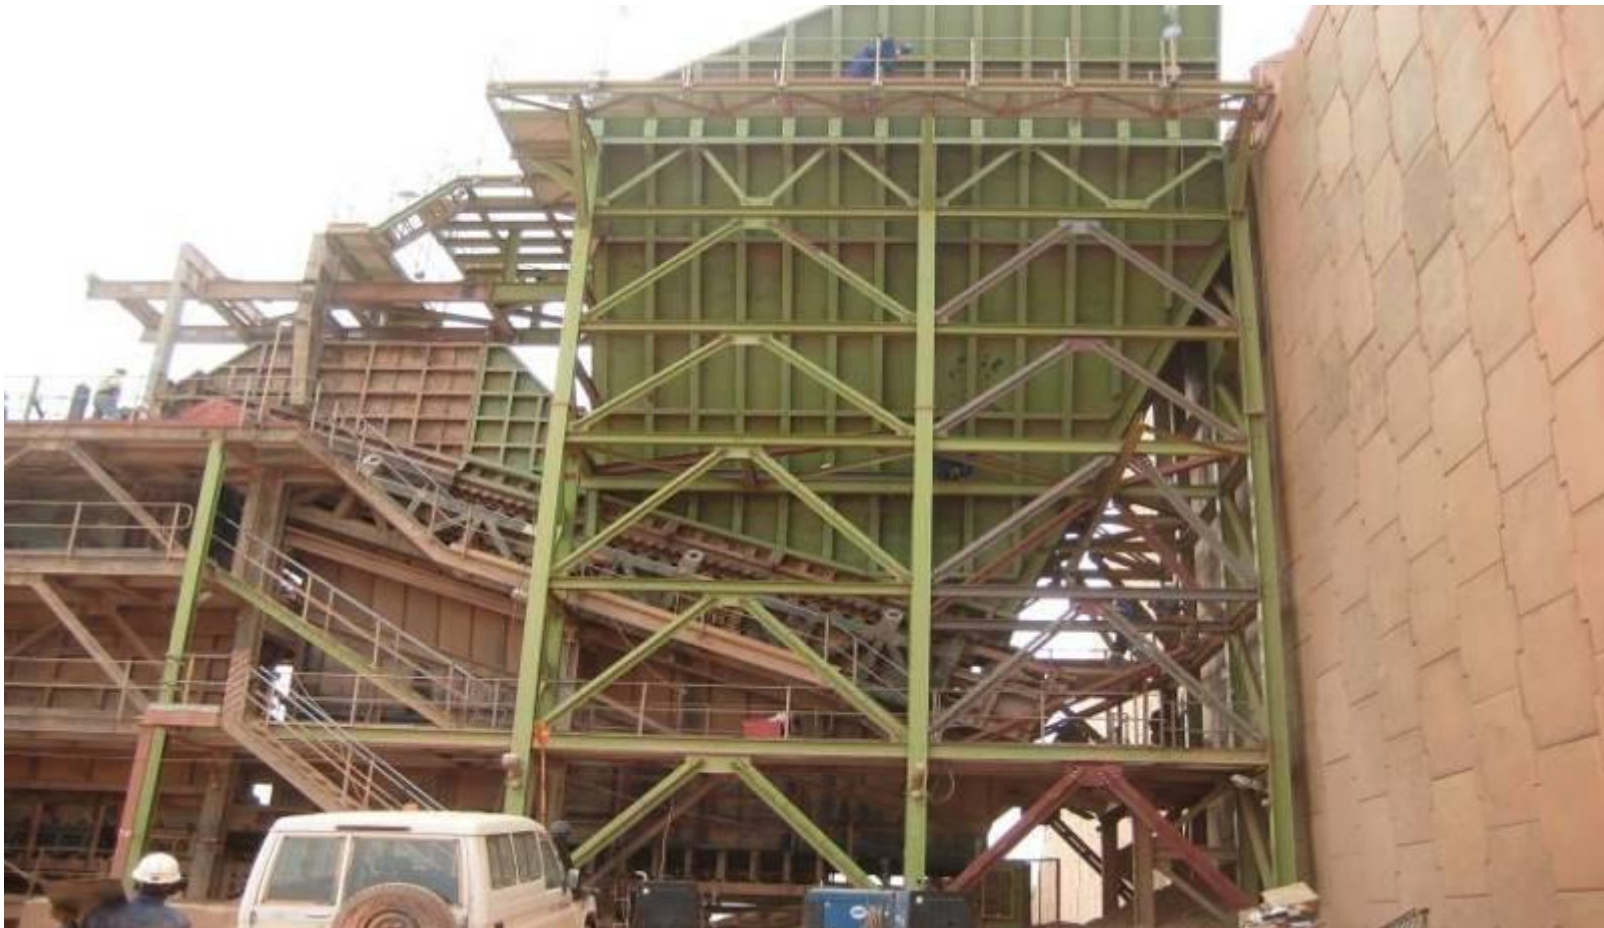
Lero & Fayalala Crushers

The ROM bin support structures were reinforced to stop movement.

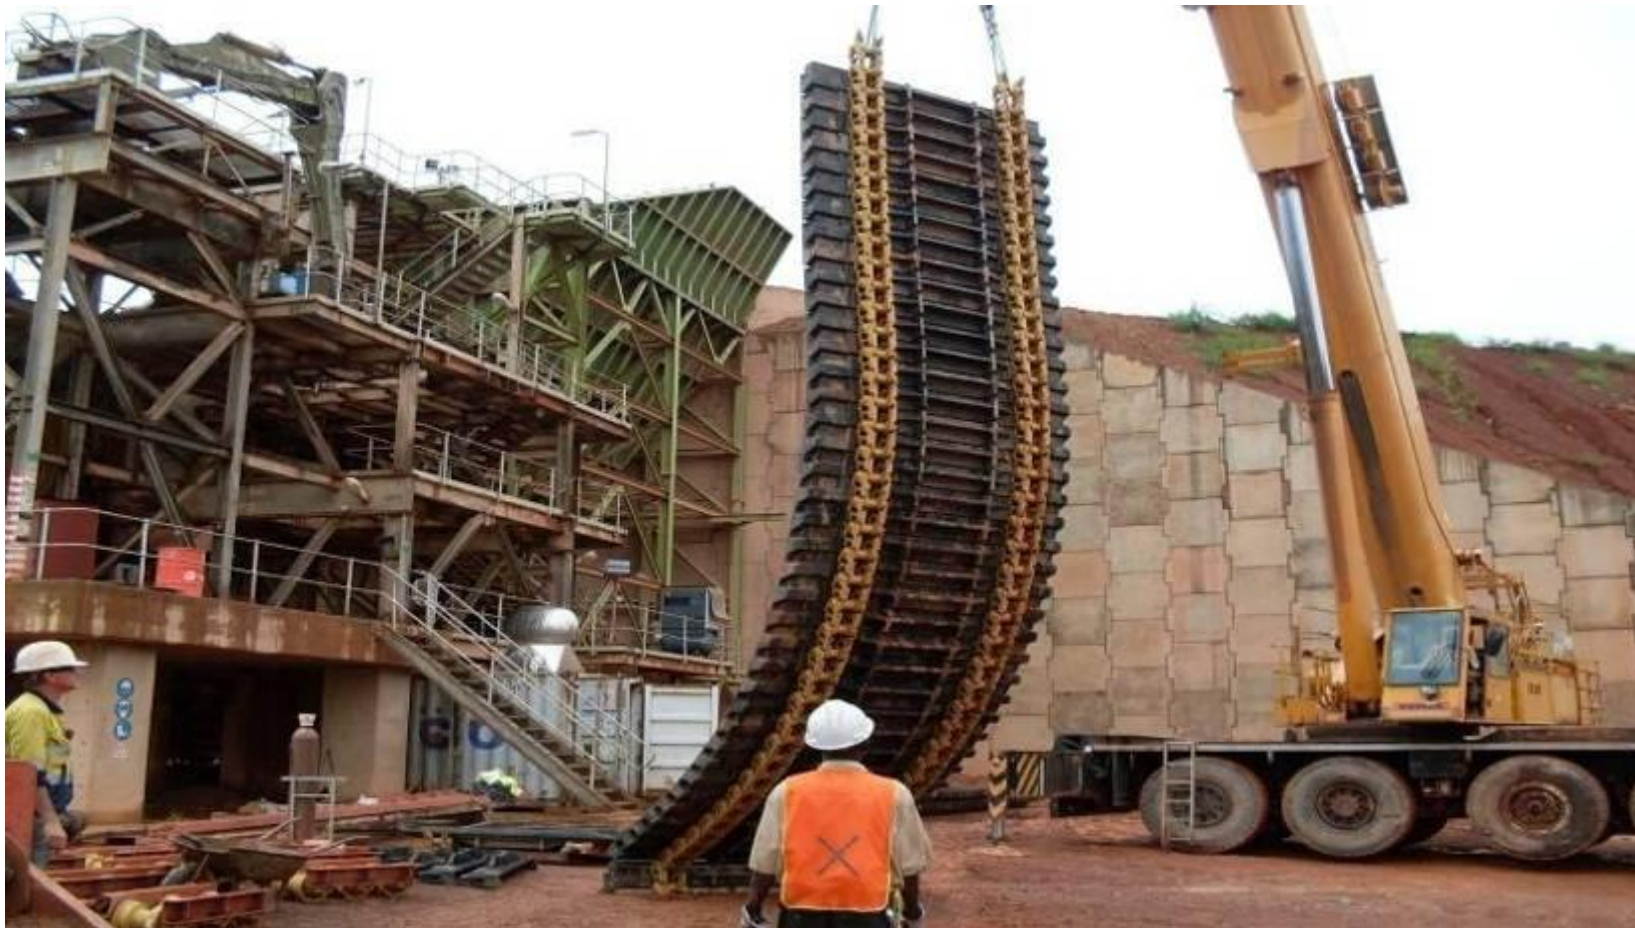
Lero & Fayalala Crushers

Apron feeder chains & pans have been replaced at the Lero crusher, pans and chains will be replaced in 2010 at the Fayalala crusher.

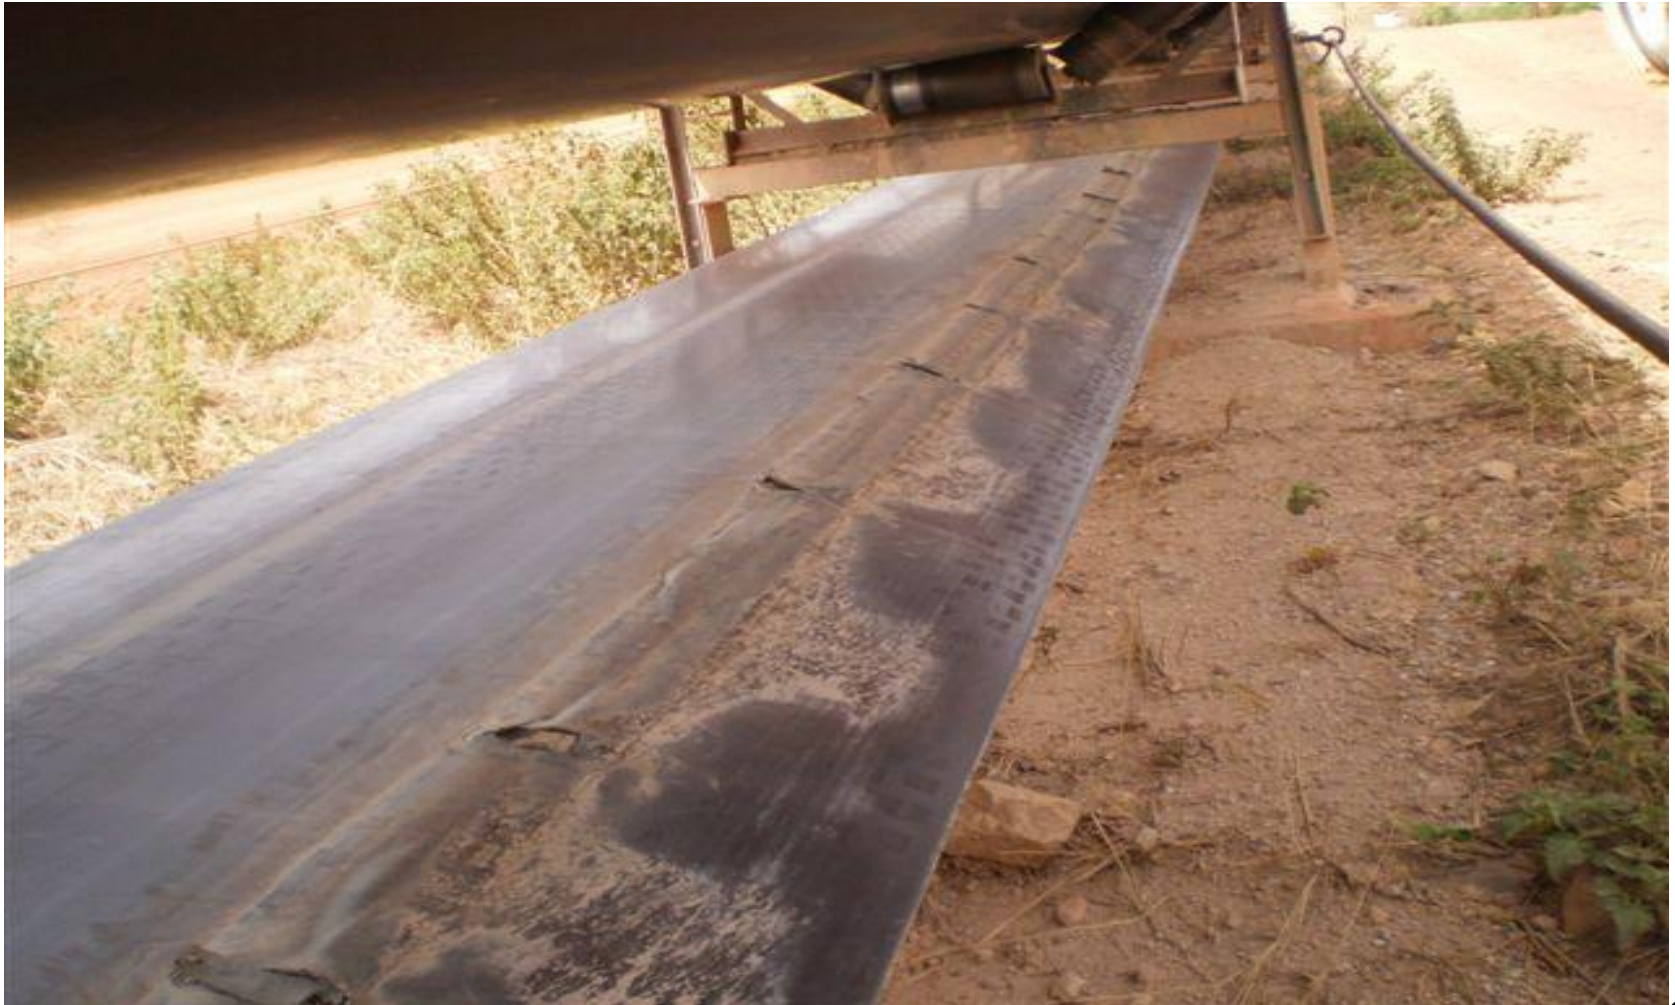
CV4 Overland Conveyor

CV04 clip repair

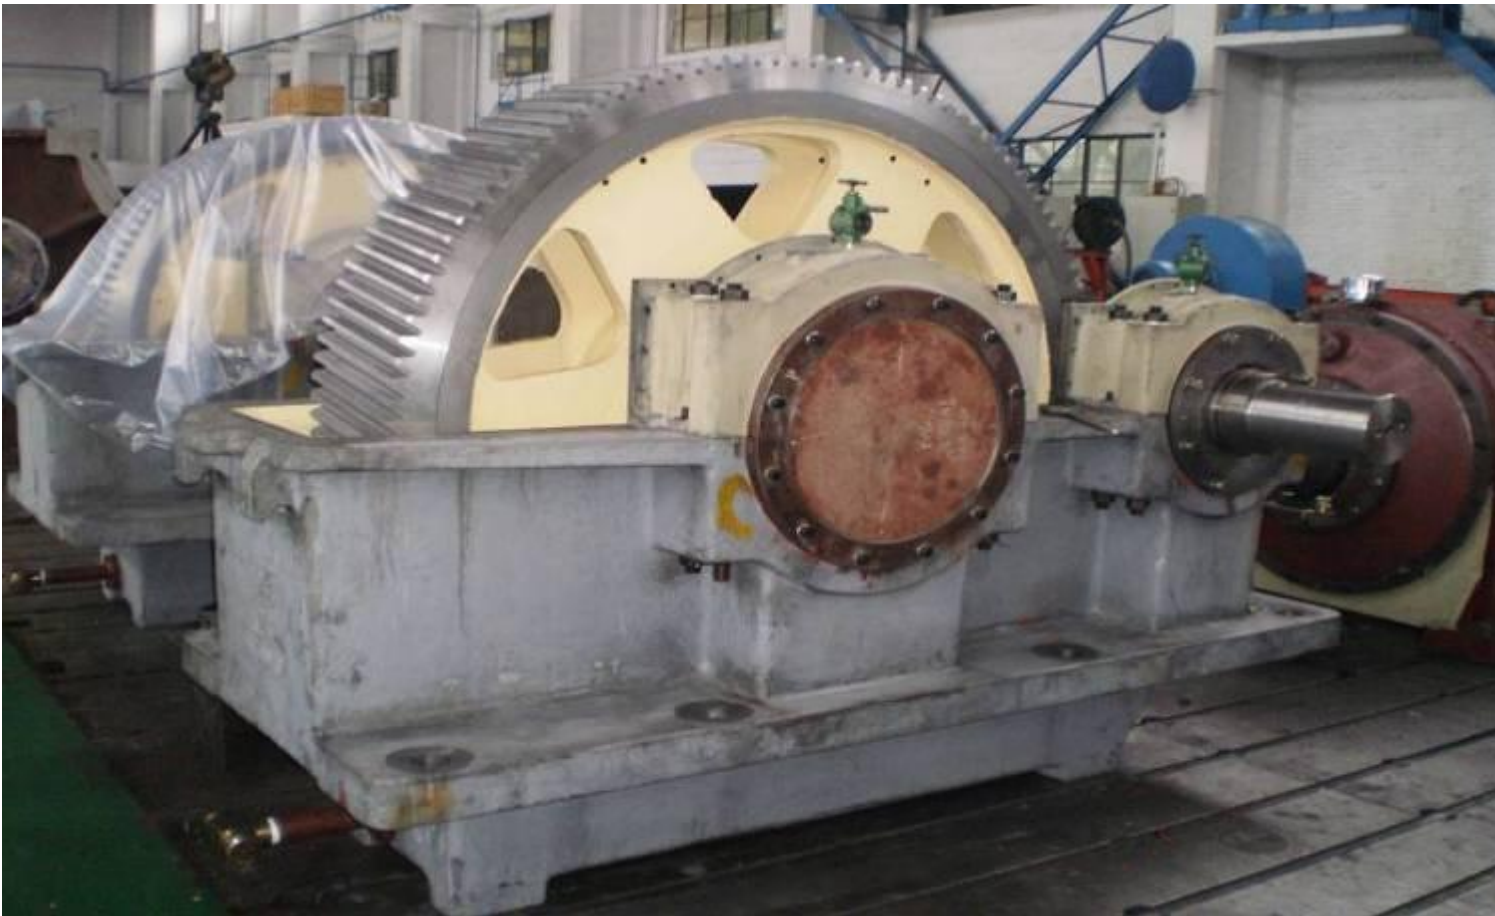
SAG Mill 1

- Two spare gearboxes (left and right) are on site.
- Scheduled to be installed on SAG 1 in July / August 2010.

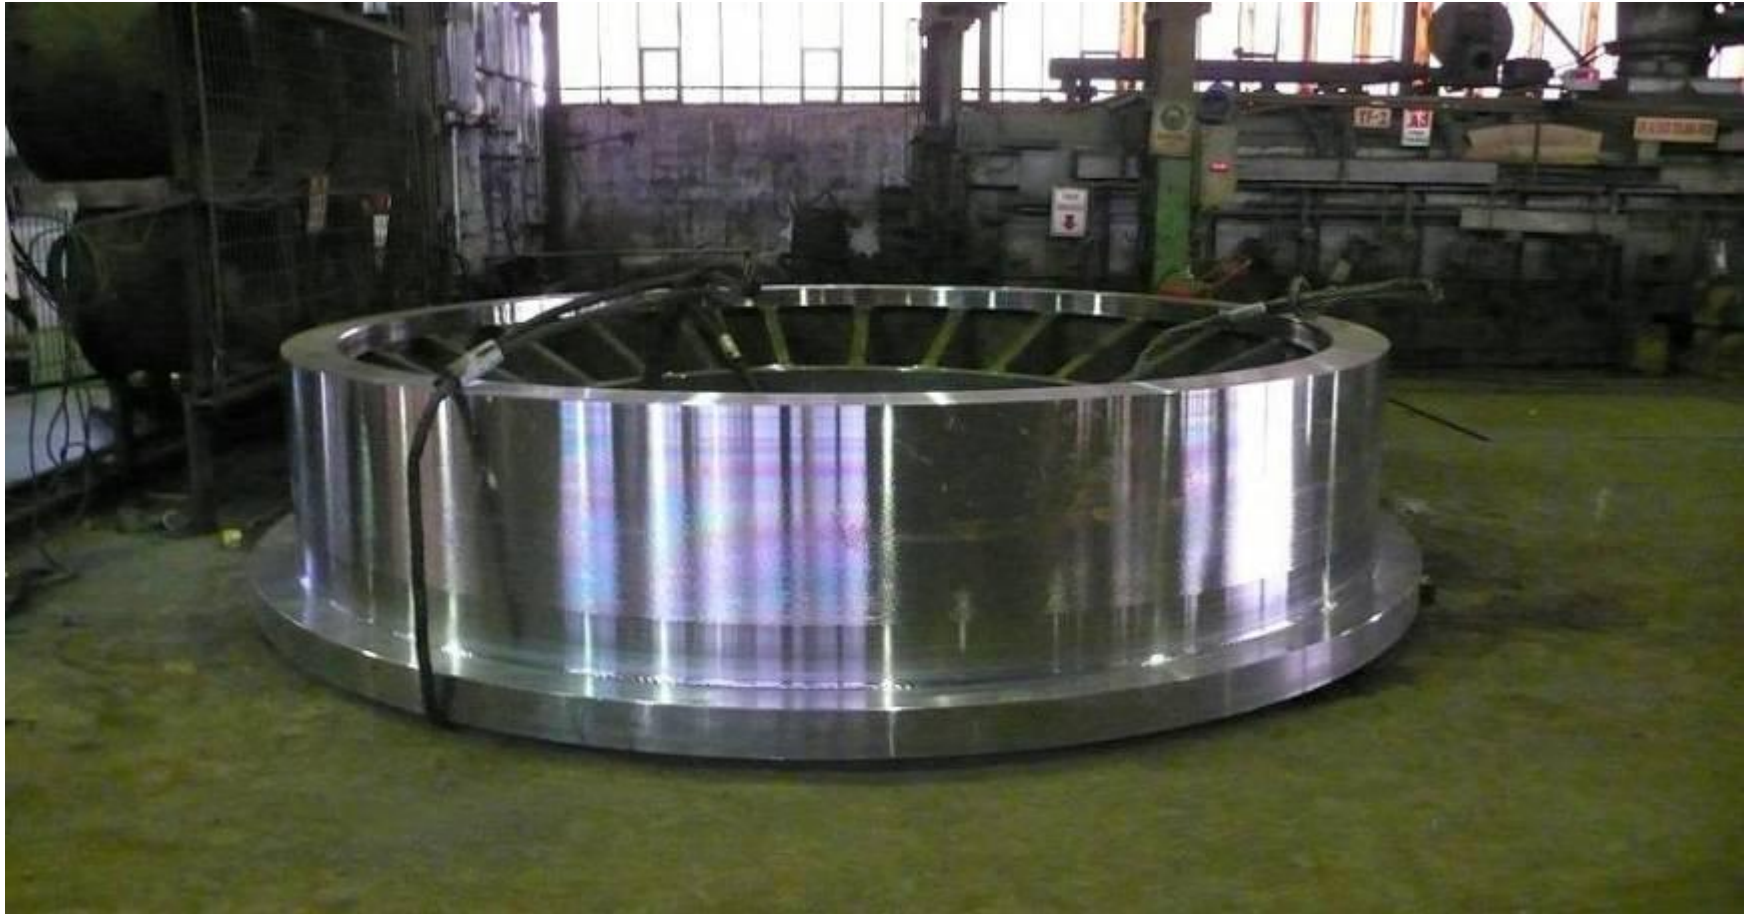
SAG Mill 1

Casting/forging of the SAG mill trunnions is completed in Turkey.

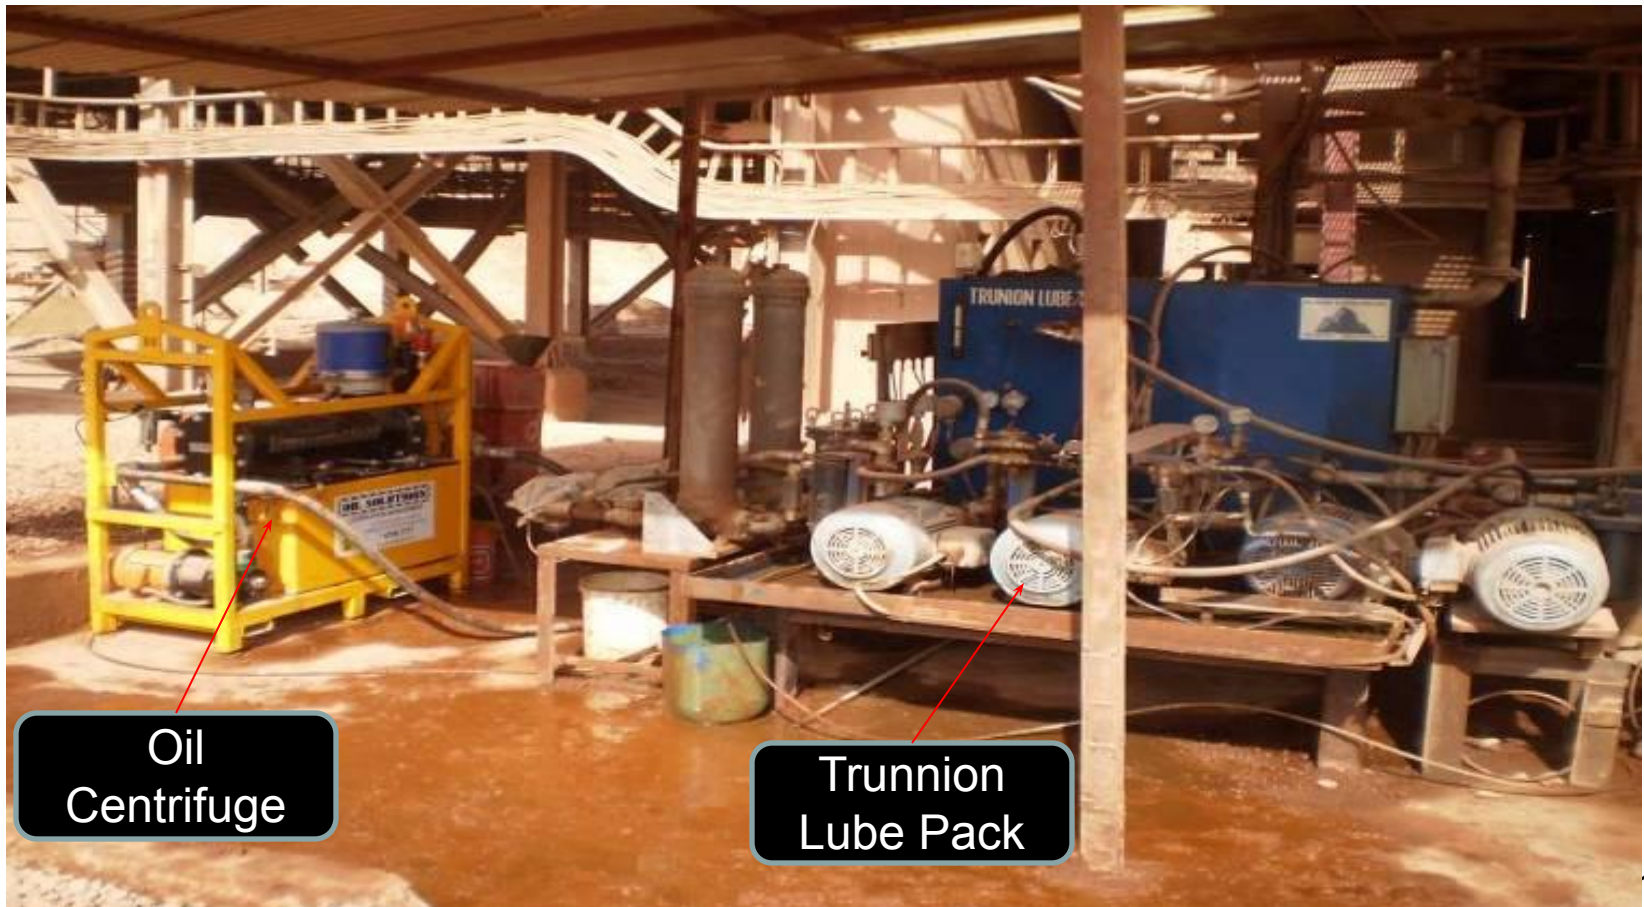
SAG Mill 1

LUBEMASTER Centrifuges have been installed on to both SAG Mill lube packs to assist in keeping the oil cleaner until a solution to the Trunnion sealing is sourced.

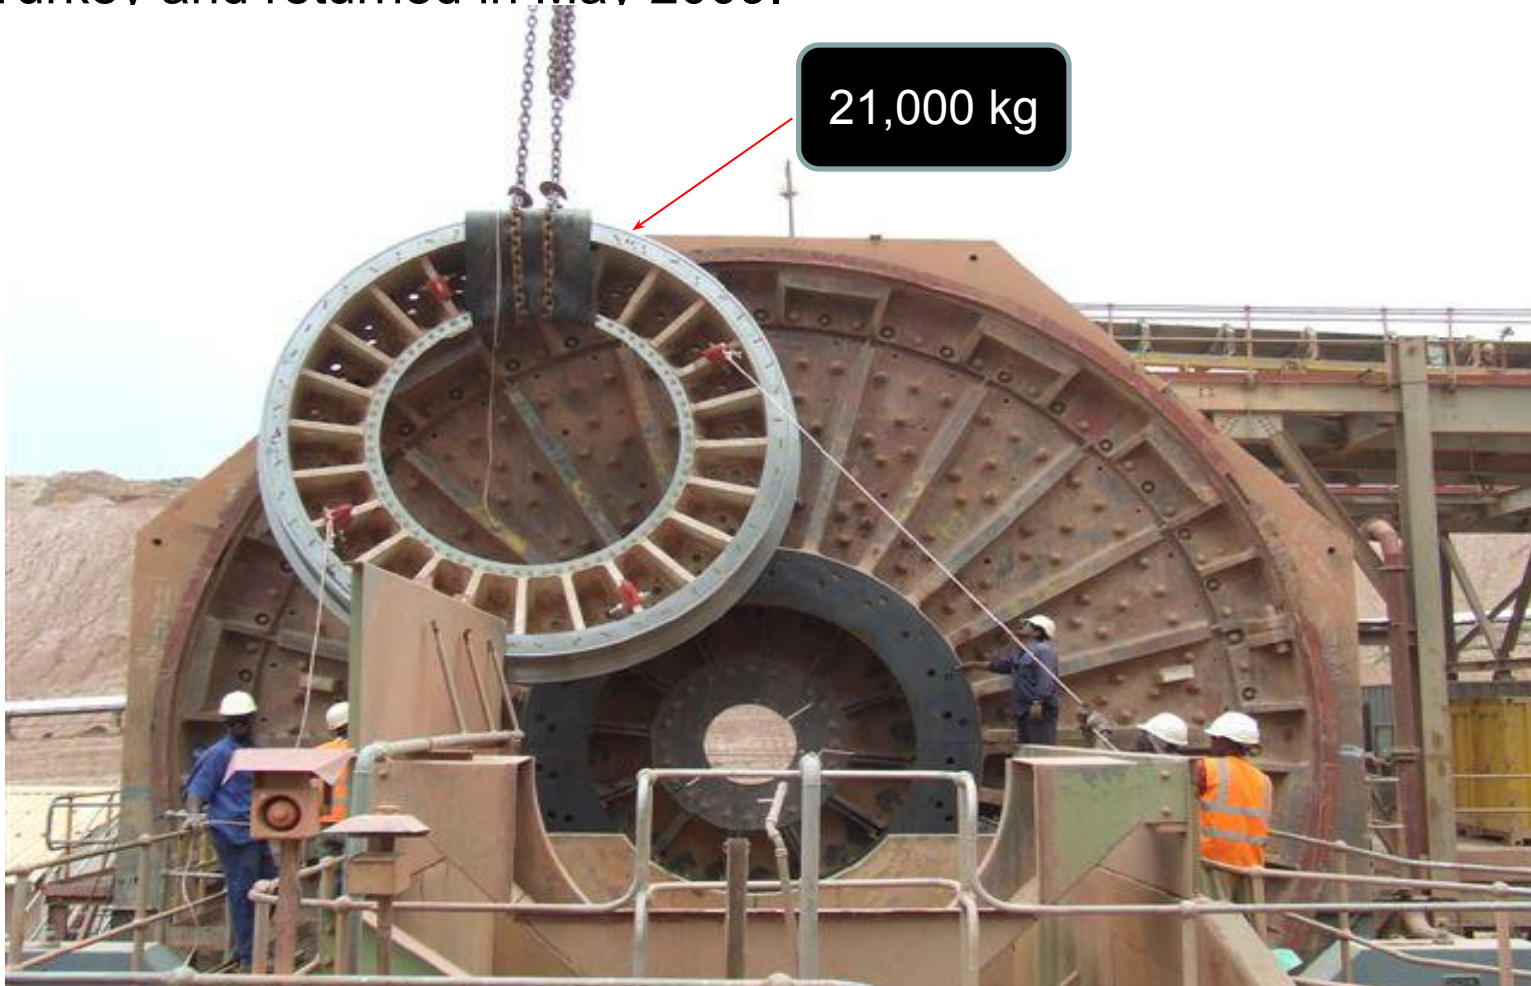
SAG Mill 2

The trunnion for this mill was removed for machining by REMAS in Turkey and returned in May 2009.

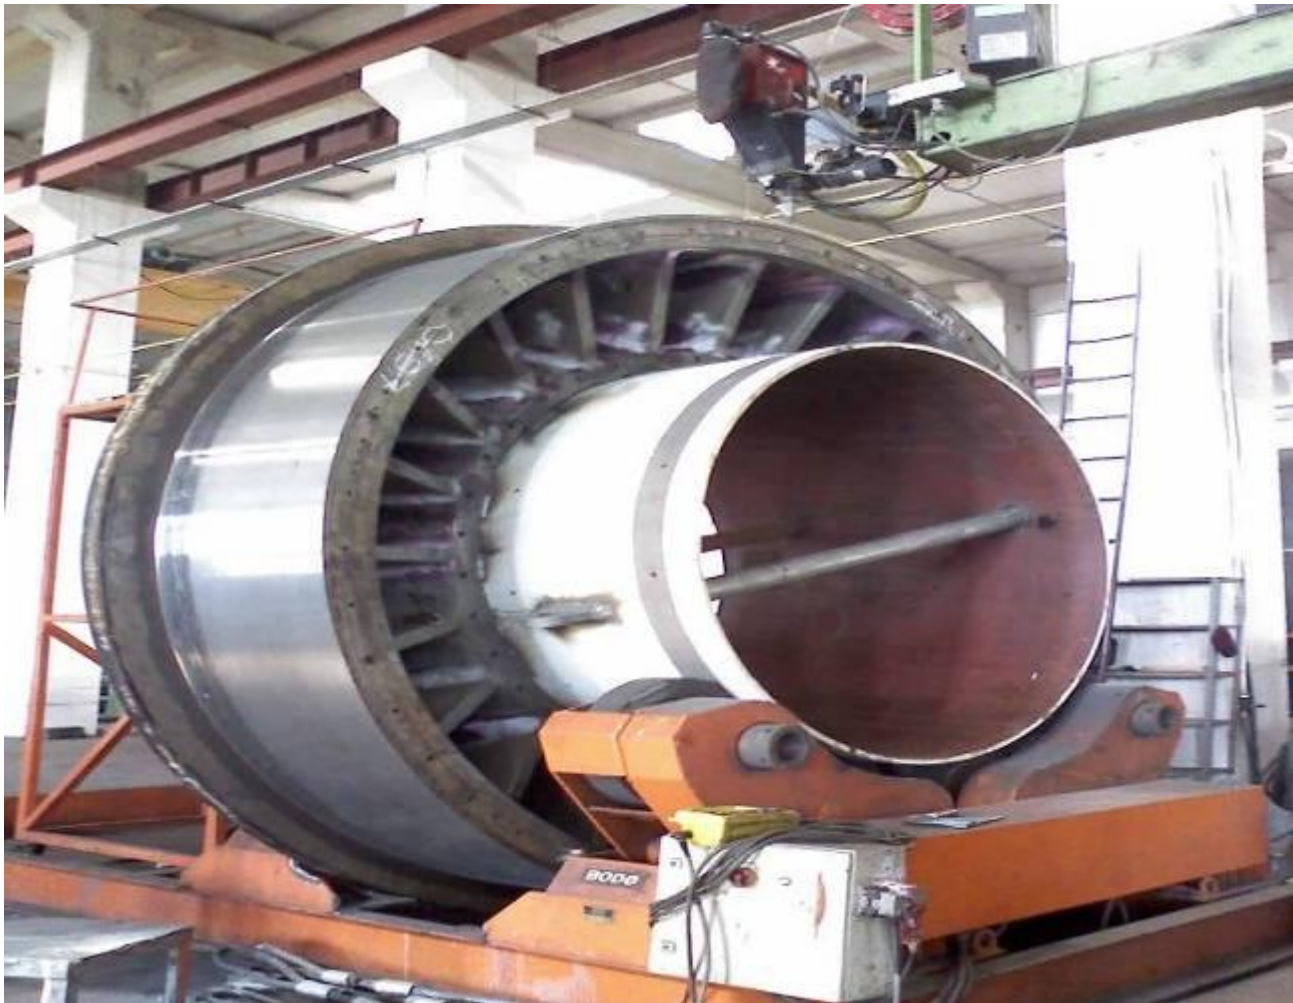
SAG Mill 2

SAG Mill 2, Trunnion being repaired by REMAS in Turkey. After machining, sub-arc welding to rebuild the surface.

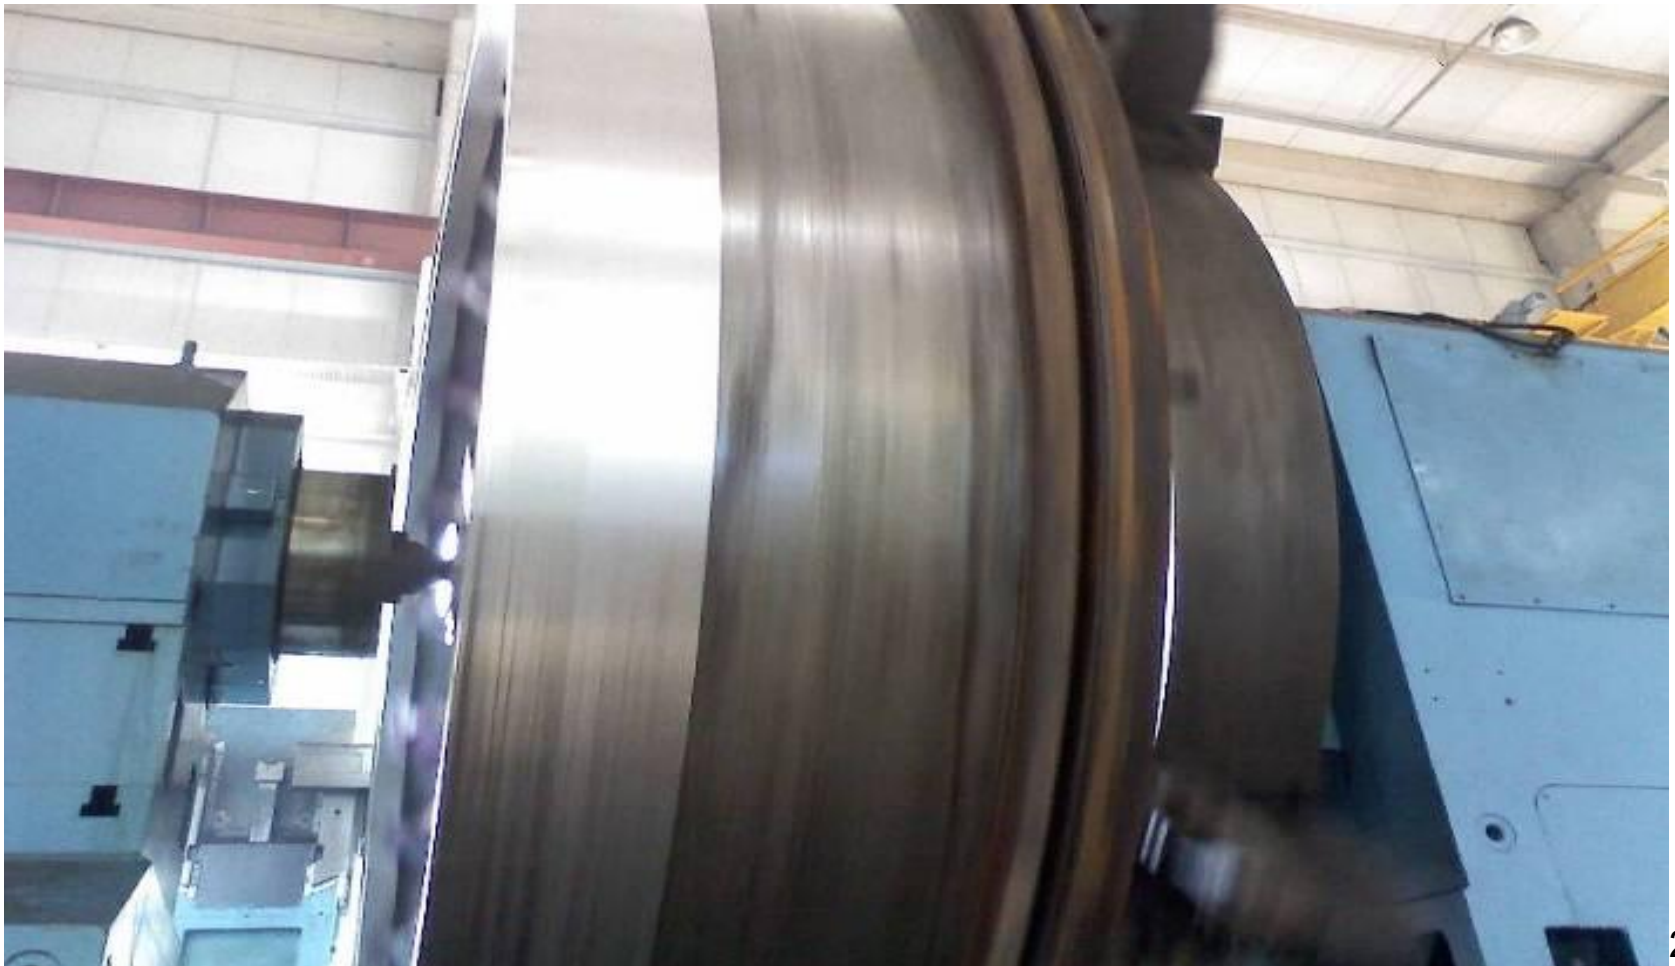
SAG Mill 2

SAG Mill 2, Trunnion being repaired by REMAS in Turkey
Machining back to OEM dimensions.

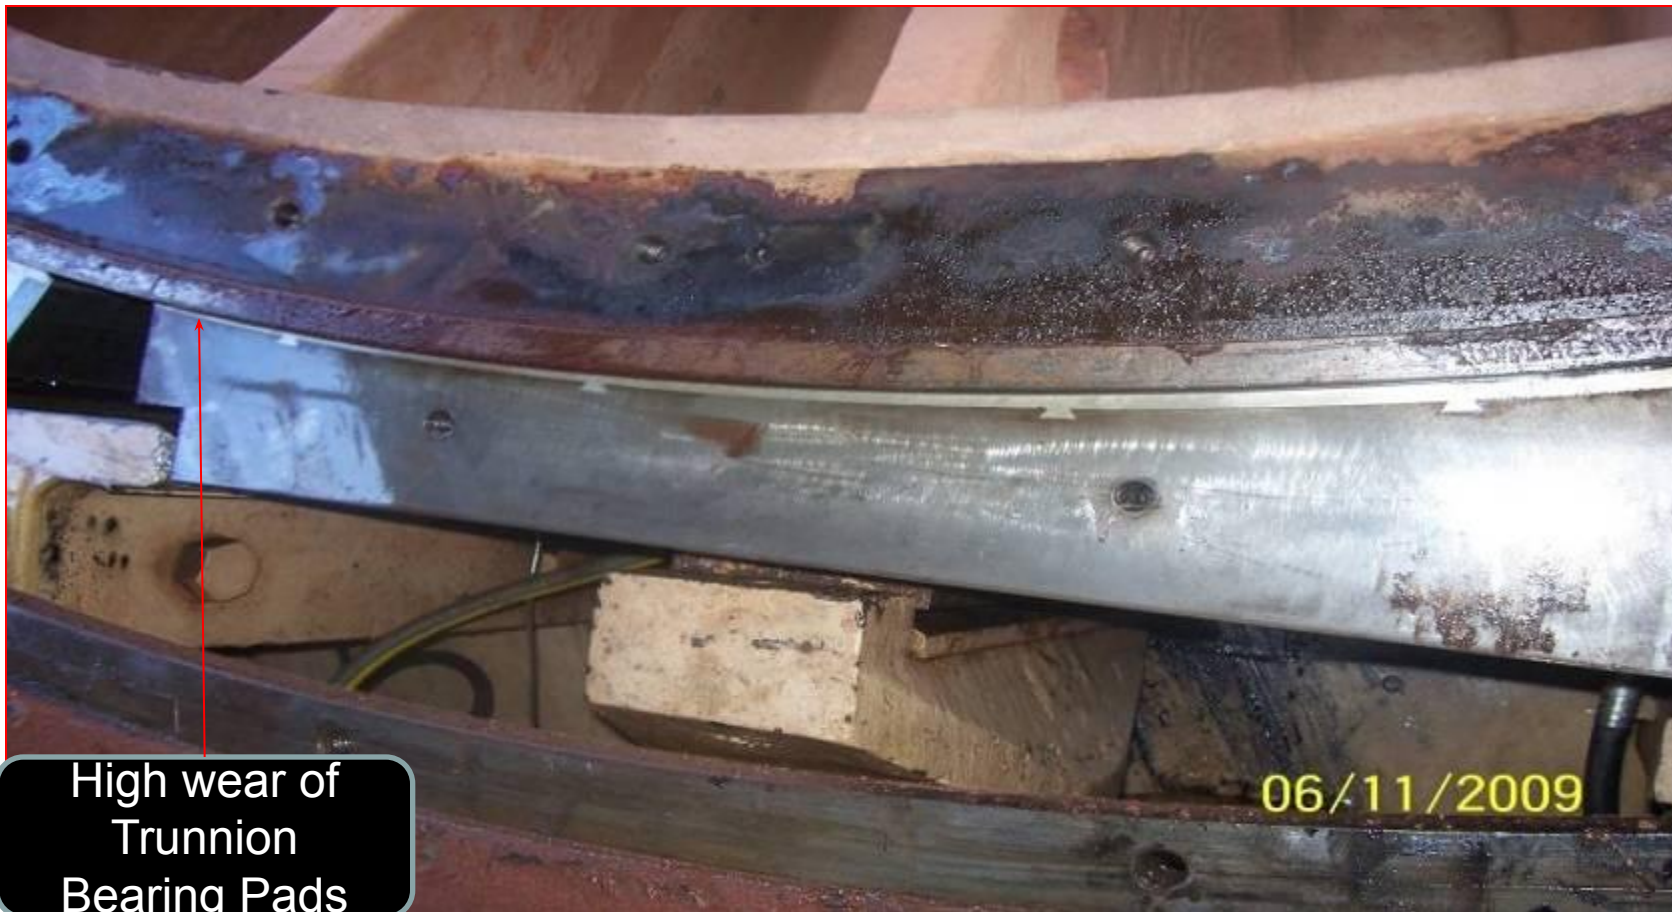
- SAG Mill discharge end trunnion bearings need to be replaced every 6 to 8 months due to excessive wear (normally last plus 10 years). The main reason for damage is thought to be loss of pressure to the oil separating the trunnion from the bearing during power outages and contamination of the oil due to poor design of the trunnion seals. A re-engineered seal and an accumulators will resolve these issues in 2010.

- Premature SAG Mill Trunnion Bearing failures remain a concern until new trunnion seals and accumulator for lubricating oil installed.
November 2009 SAG Mill 2 Discharge End.

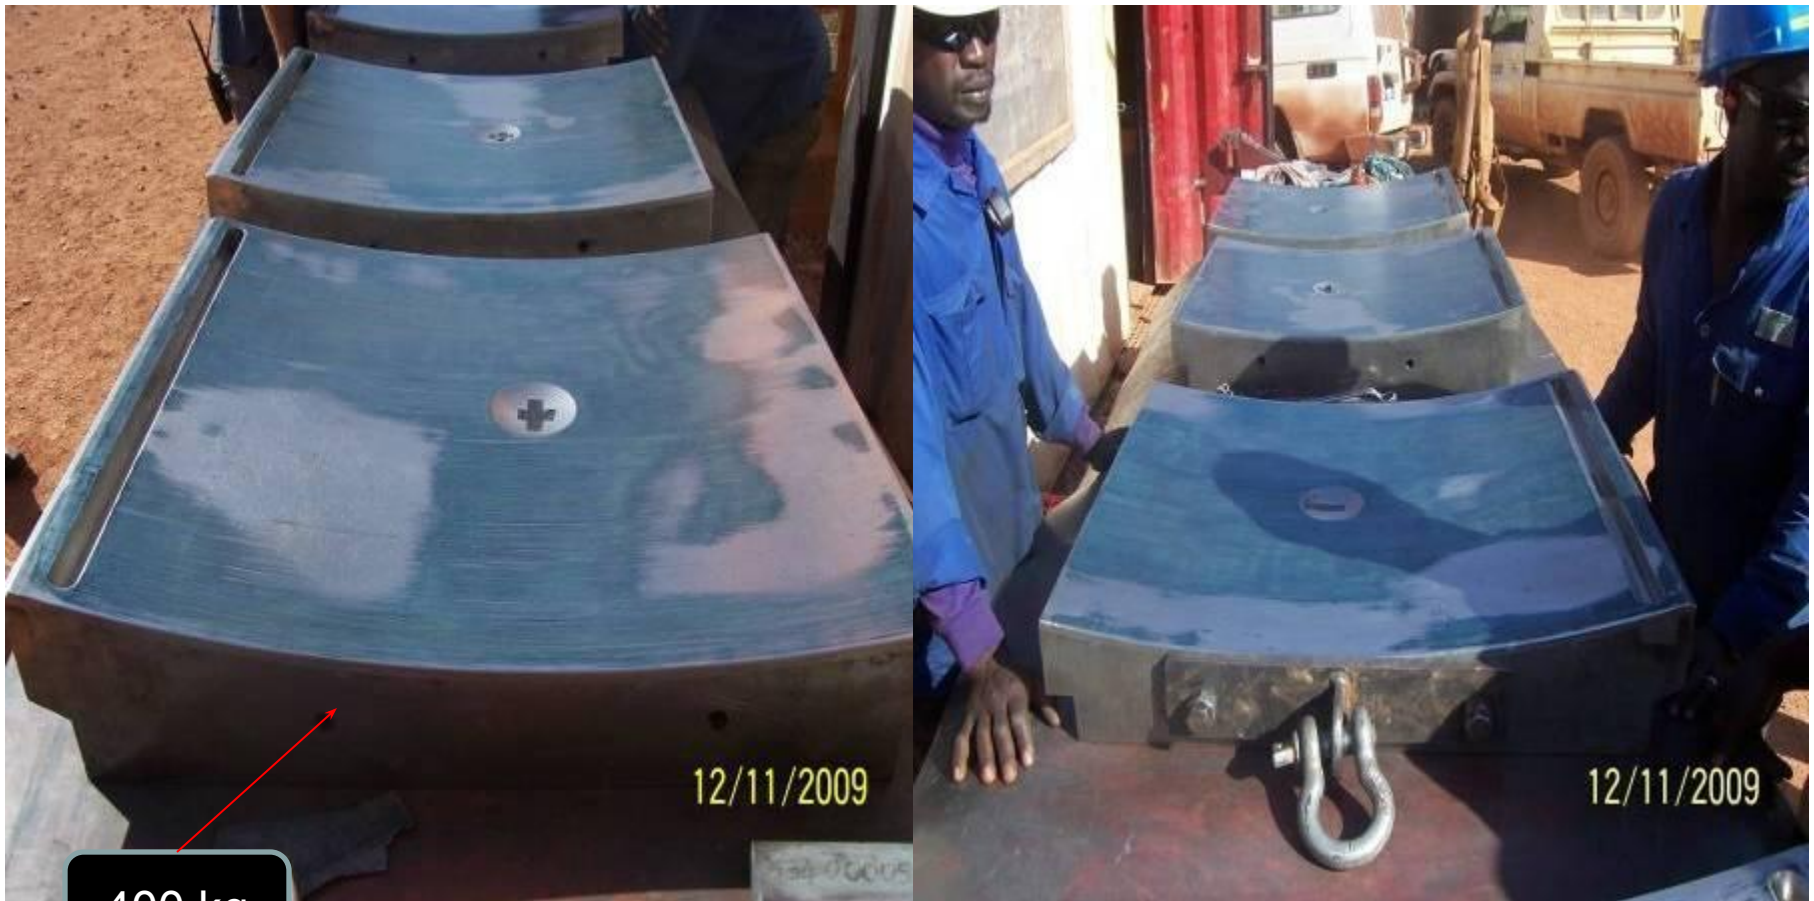
SAG Mill 2 bearings were hand scraped for the best possible contact with the trunnion Journal surface.

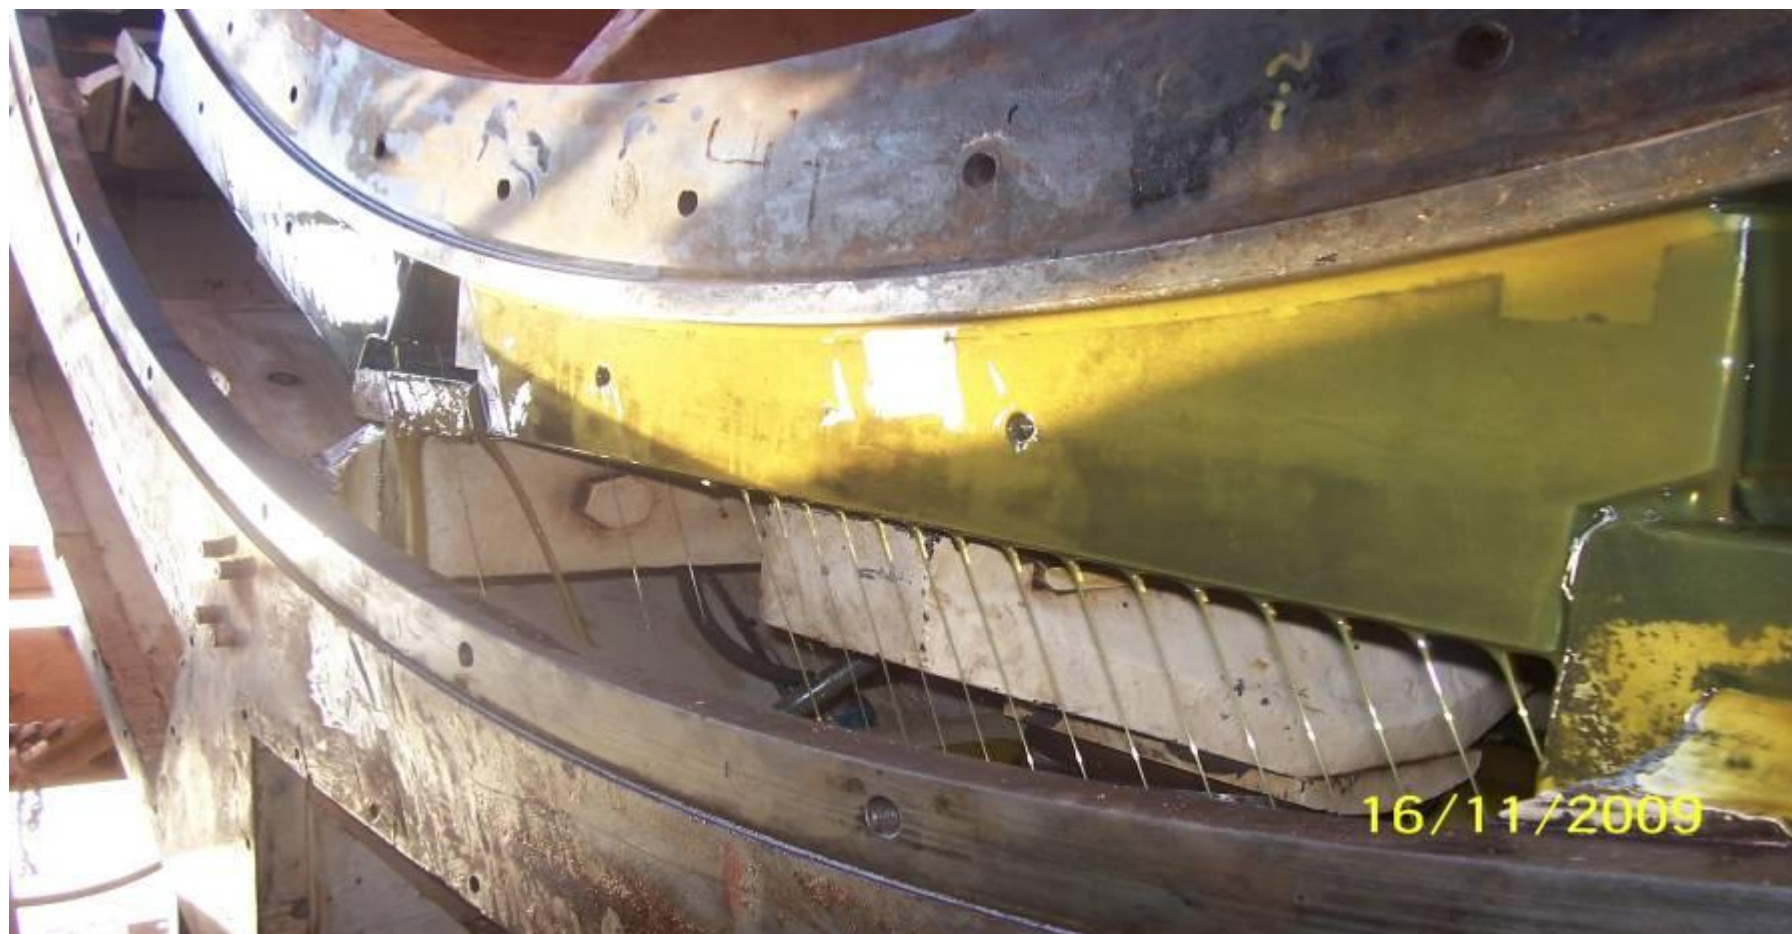
SAG Mill 2

New Bearing Pads after installation showing excellent oil coverage.

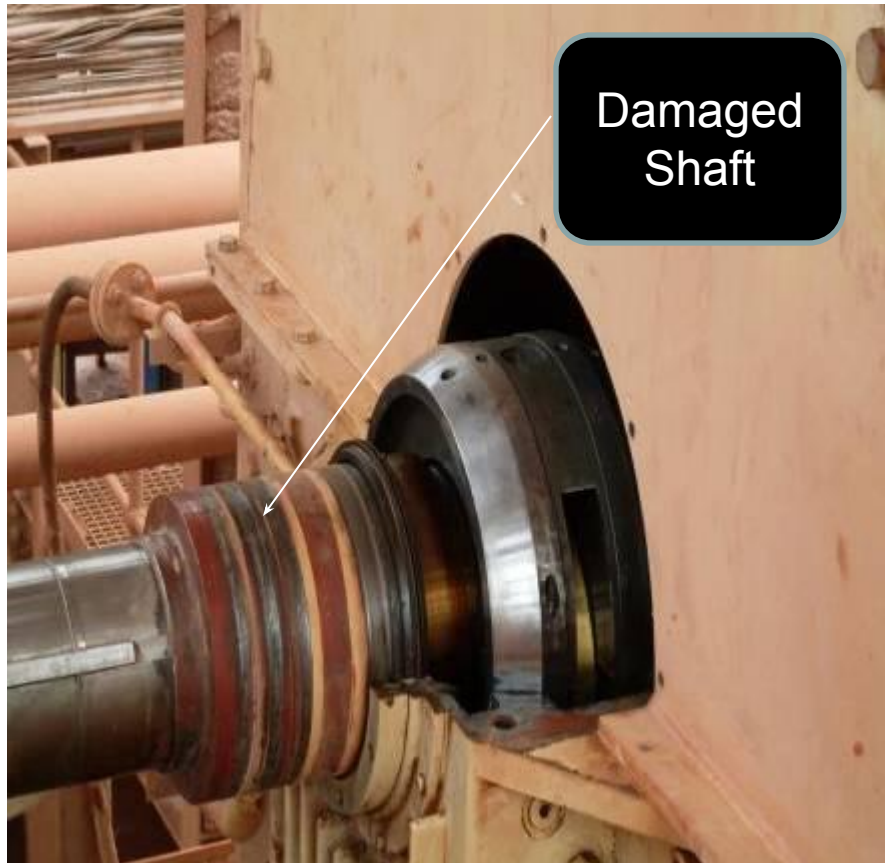
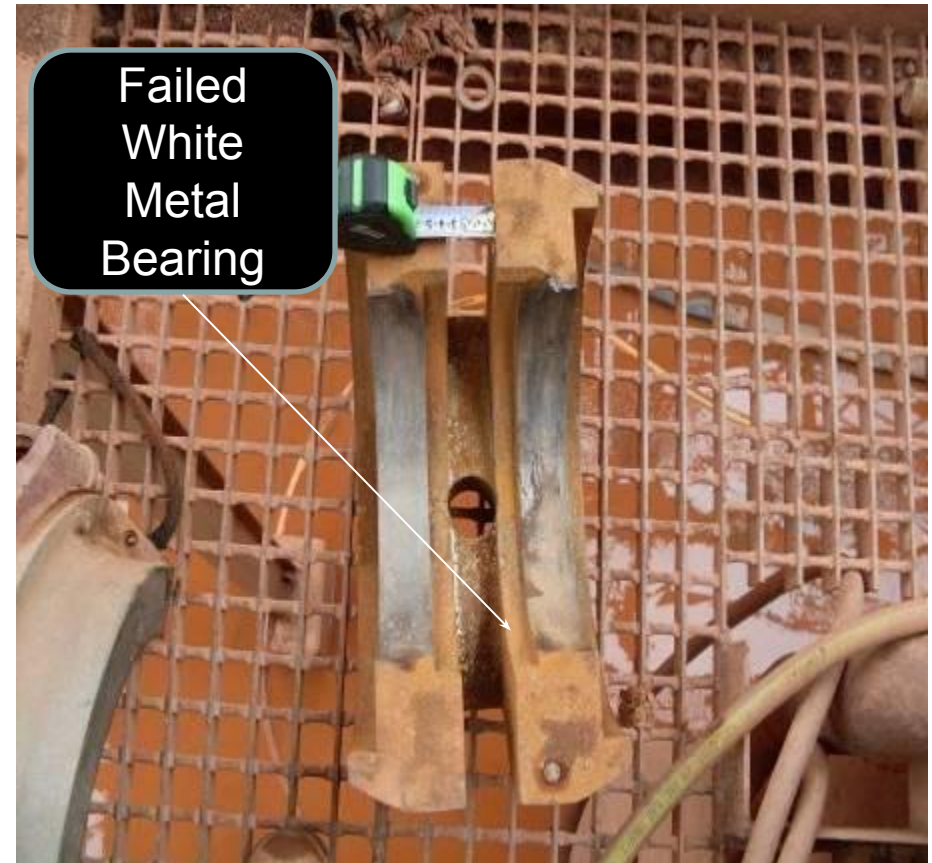
Ball Mill 1

The electric drive motor was recently completely overhauled and is expected to provide a fully serviceable life.

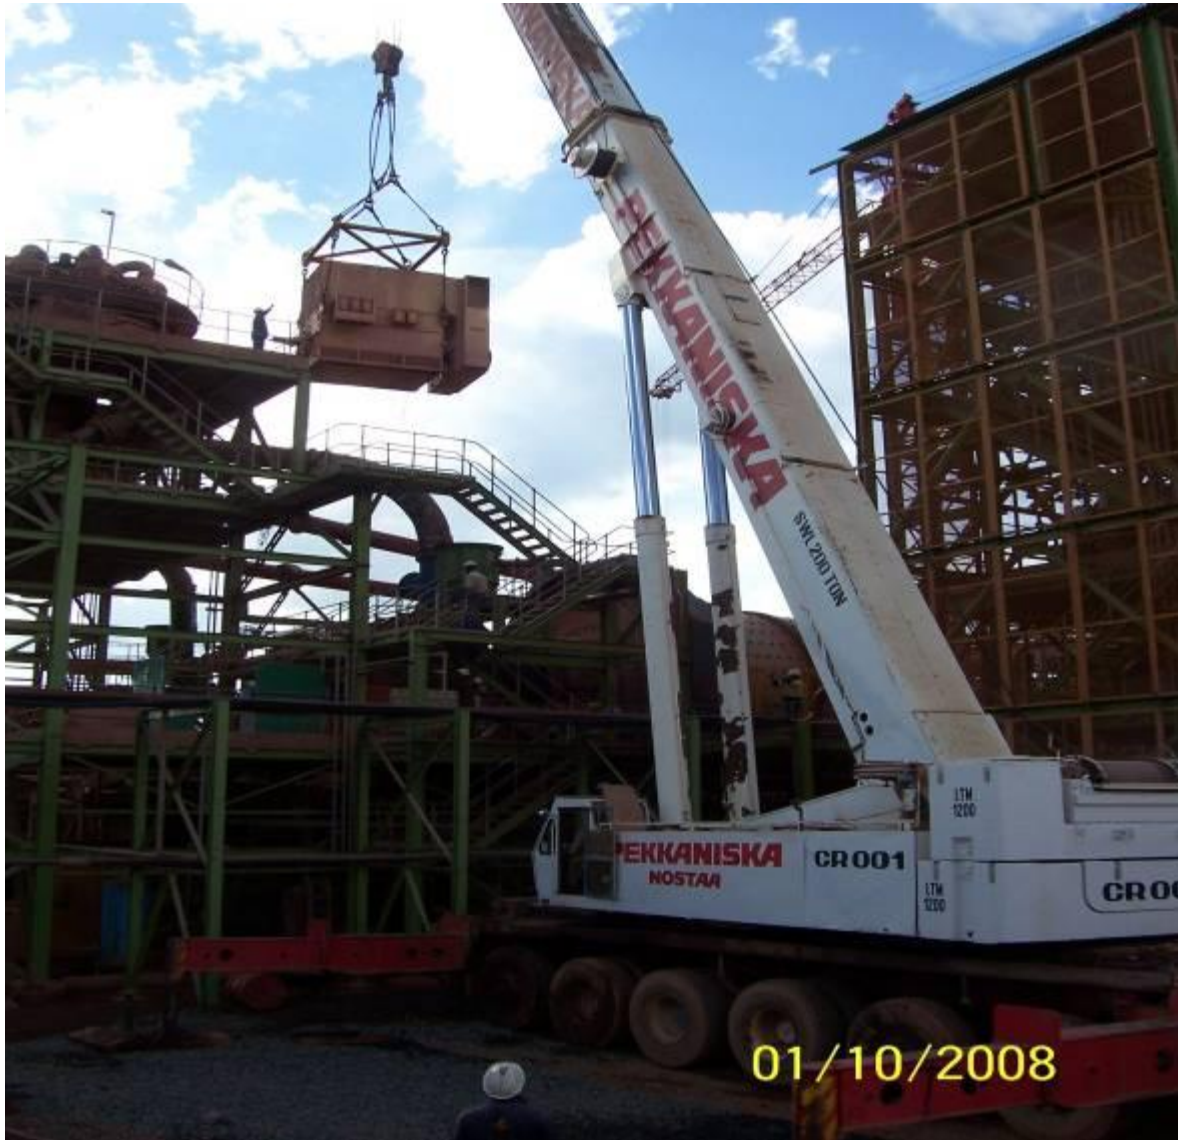
Ball Mill 1 motor
being lifted away
from the Mill.
Motor weighs 28T

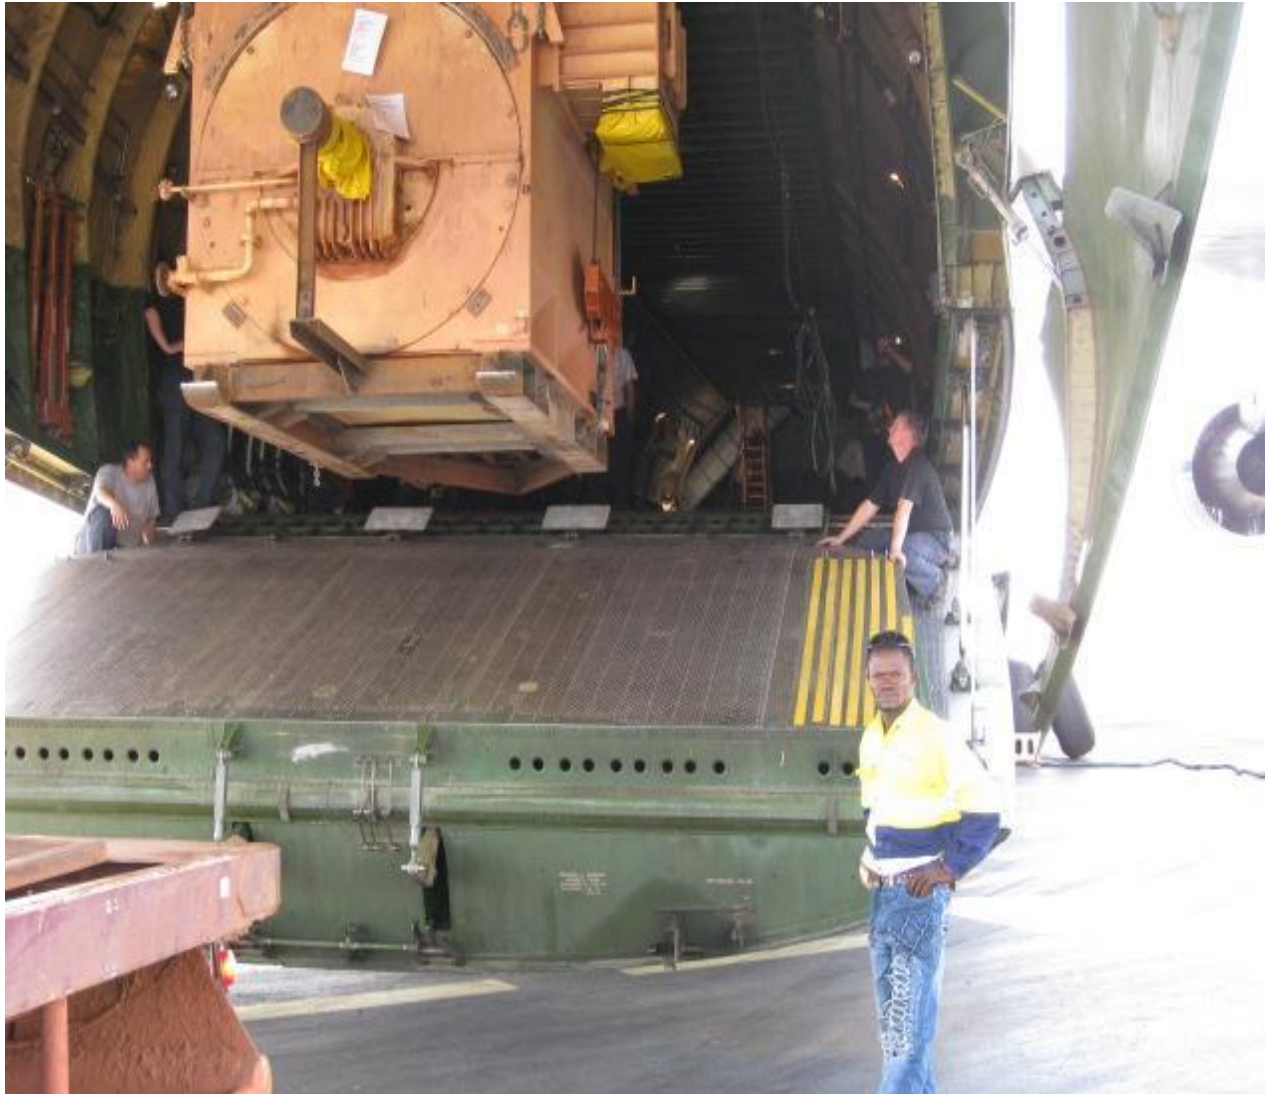
Ball Mill 1 Motor
being loaded onto
an Antonov
Aircraft bound for
Antwerp for
overhaul.
