LEFA Operations - Maintenance March 2010

Overview of Current Status

LEFA Operations - Process

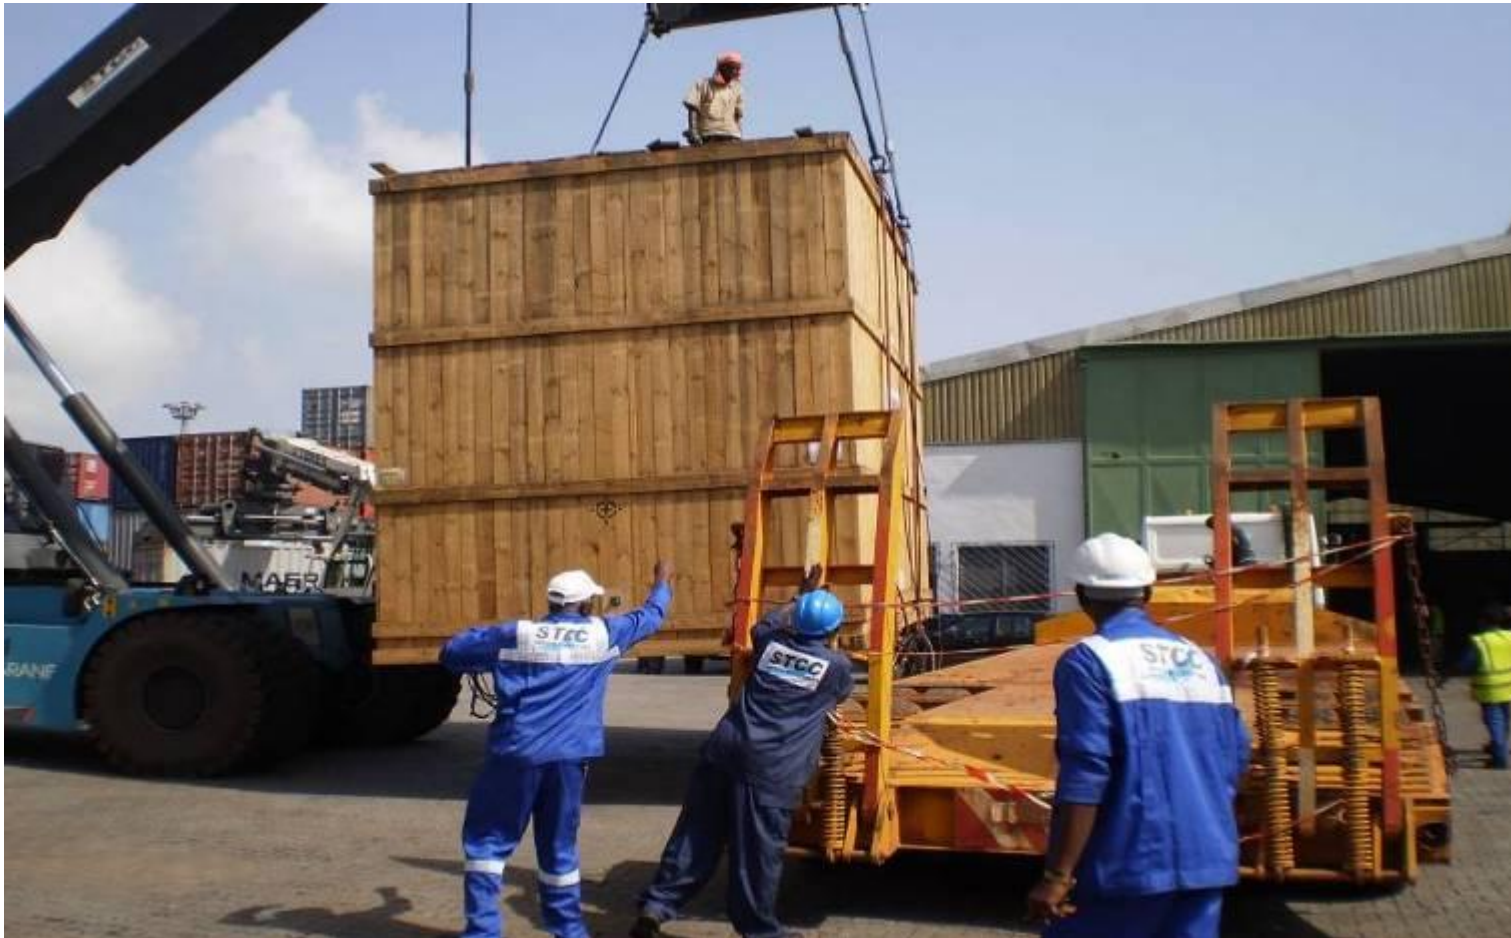
Ball Mill 2

New Ball Mill being loaded onto Truck for transporting to site.

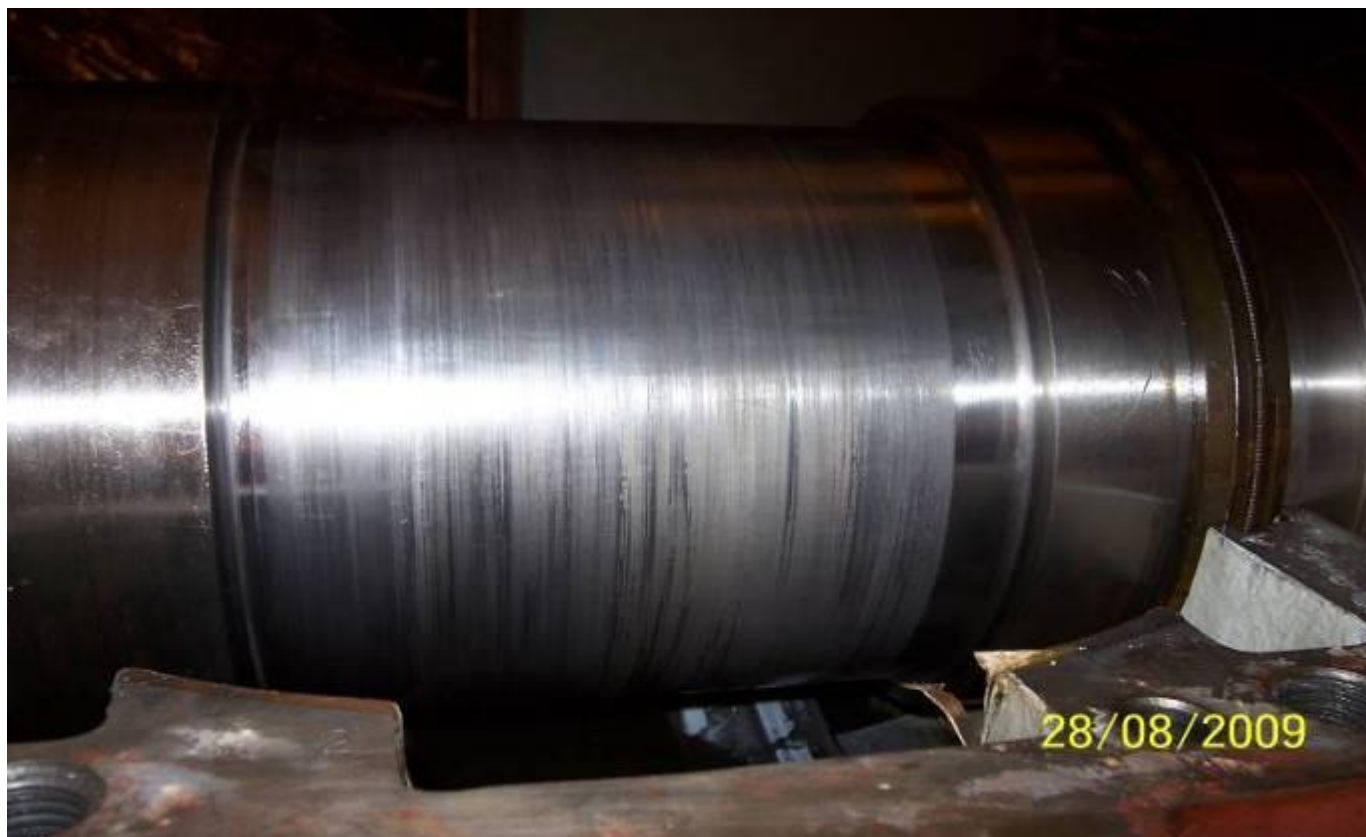
The motor on Ball Mill 2 went down in late August on high temperature on the non drive end. The shaft was inspected and deemed OK and with no evidence of problems with the windings.

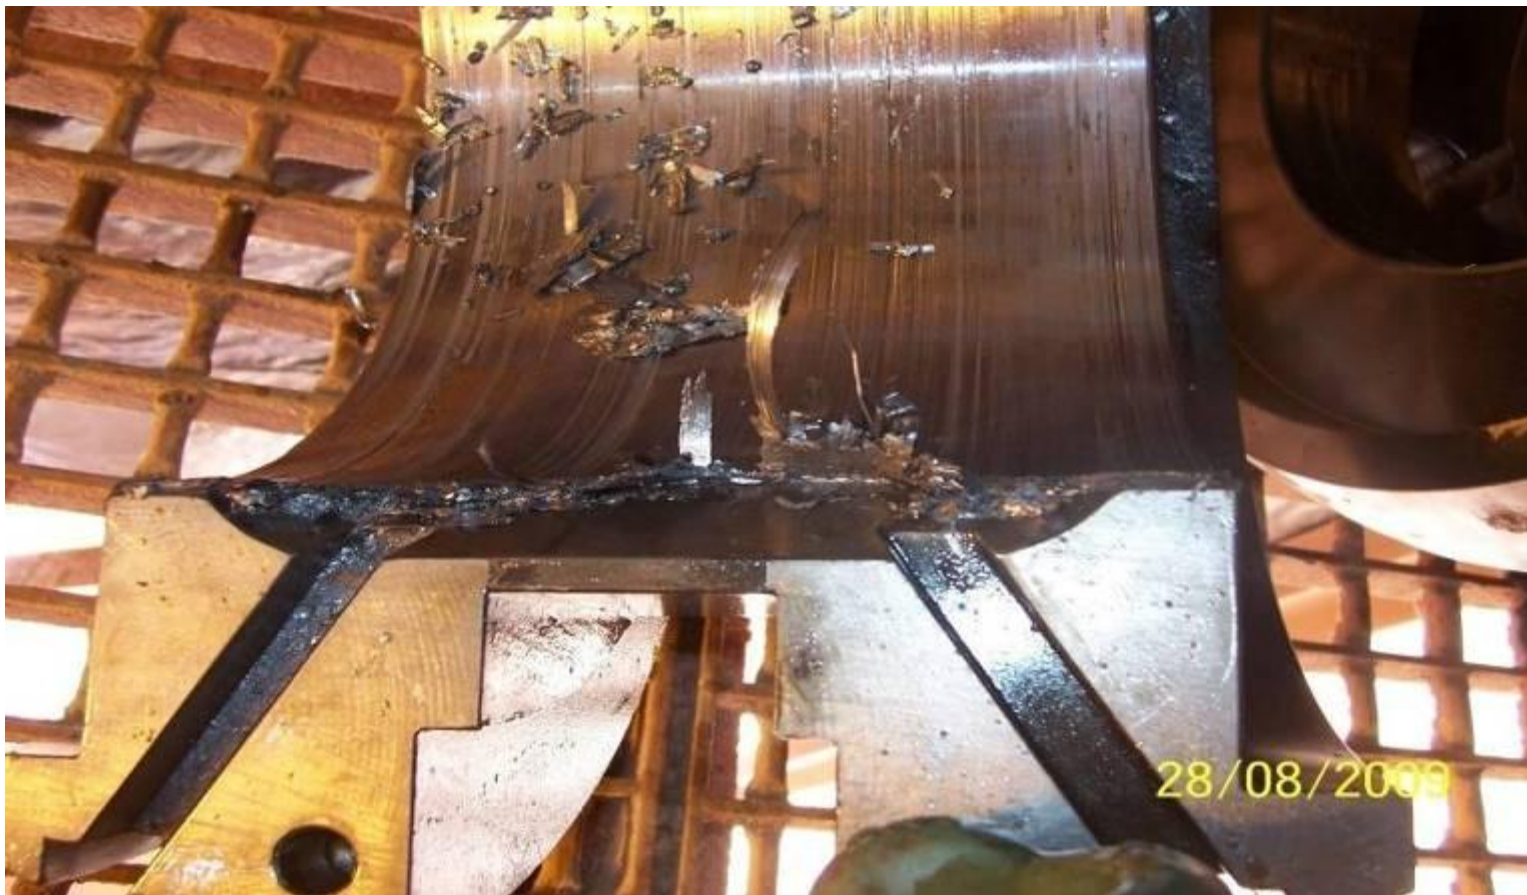
Ball Mill 2

Failed set of white metal bearings. A new set of bearings were installed and operating conditions monitored with no indications impending issues.

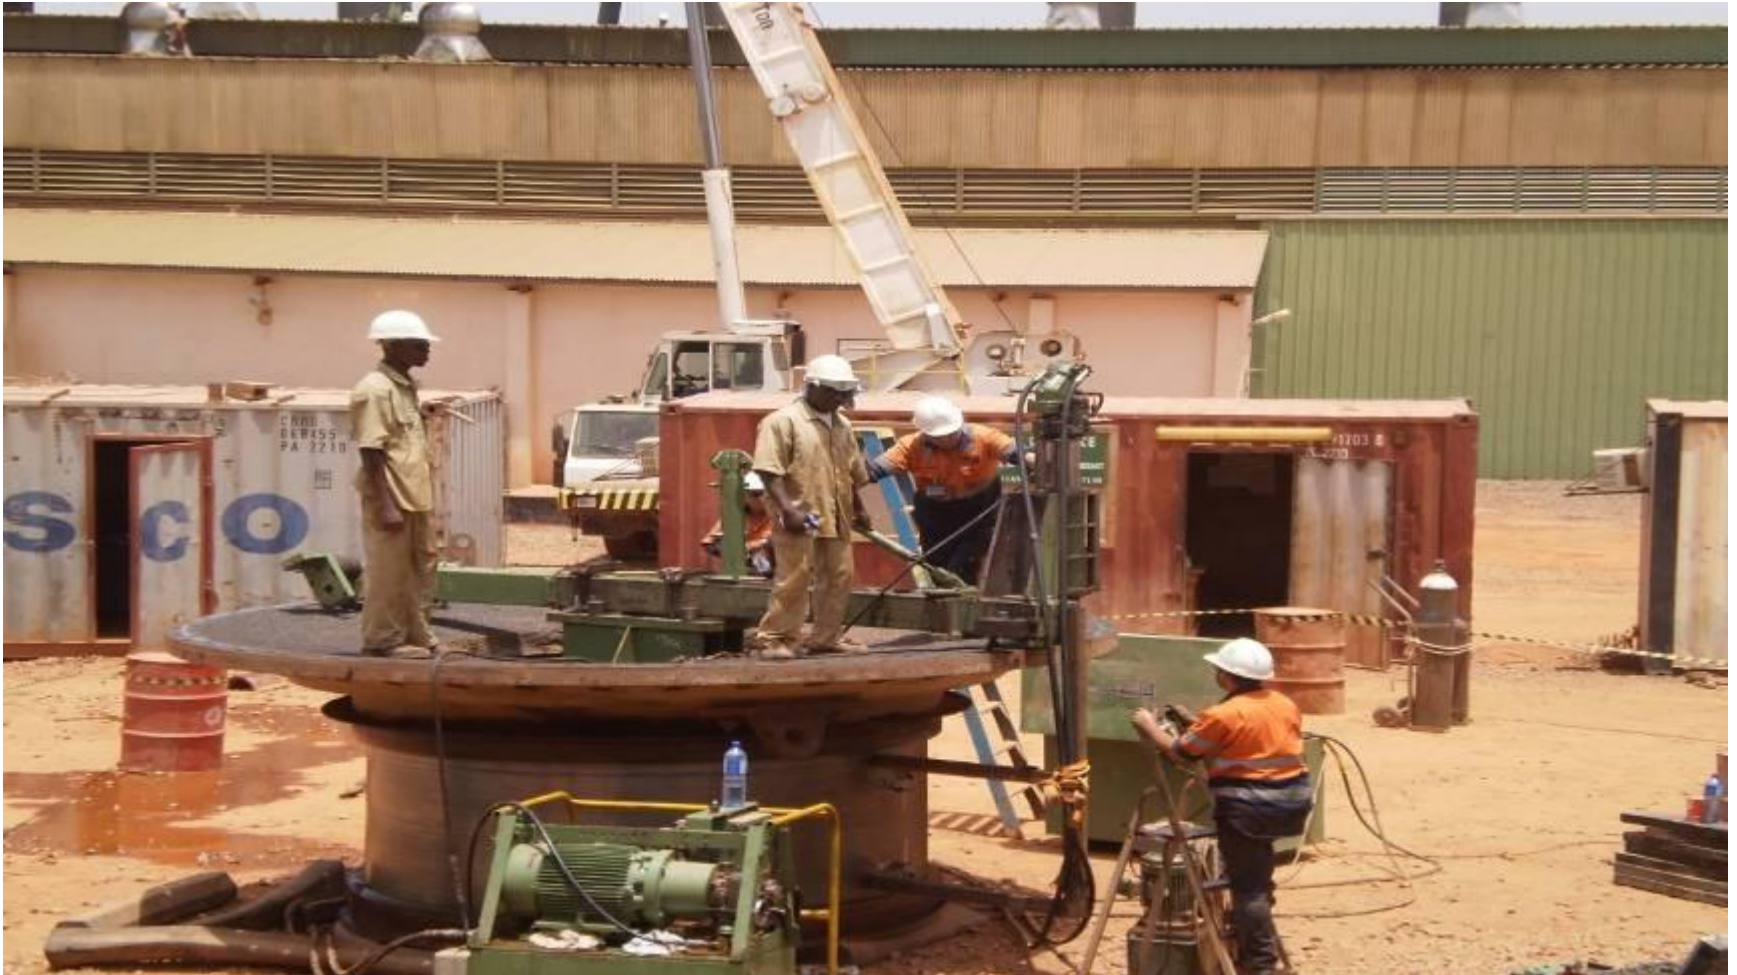
- Ball Mill 2 keeps breaking feed end flange bolts. This requires the mill to be shut down for a couple of days every two months. The end plate mating surfaces and trunnion require re-machining to reduce stress on the bolts. **This was done in May 2010 by Hofmann Engineering with good results.**

Ball Mill 2 was breaking feed end flange bolts. The end plate mating surfaces and trunnion **have been re-machined** to reduce stress on the bolts.

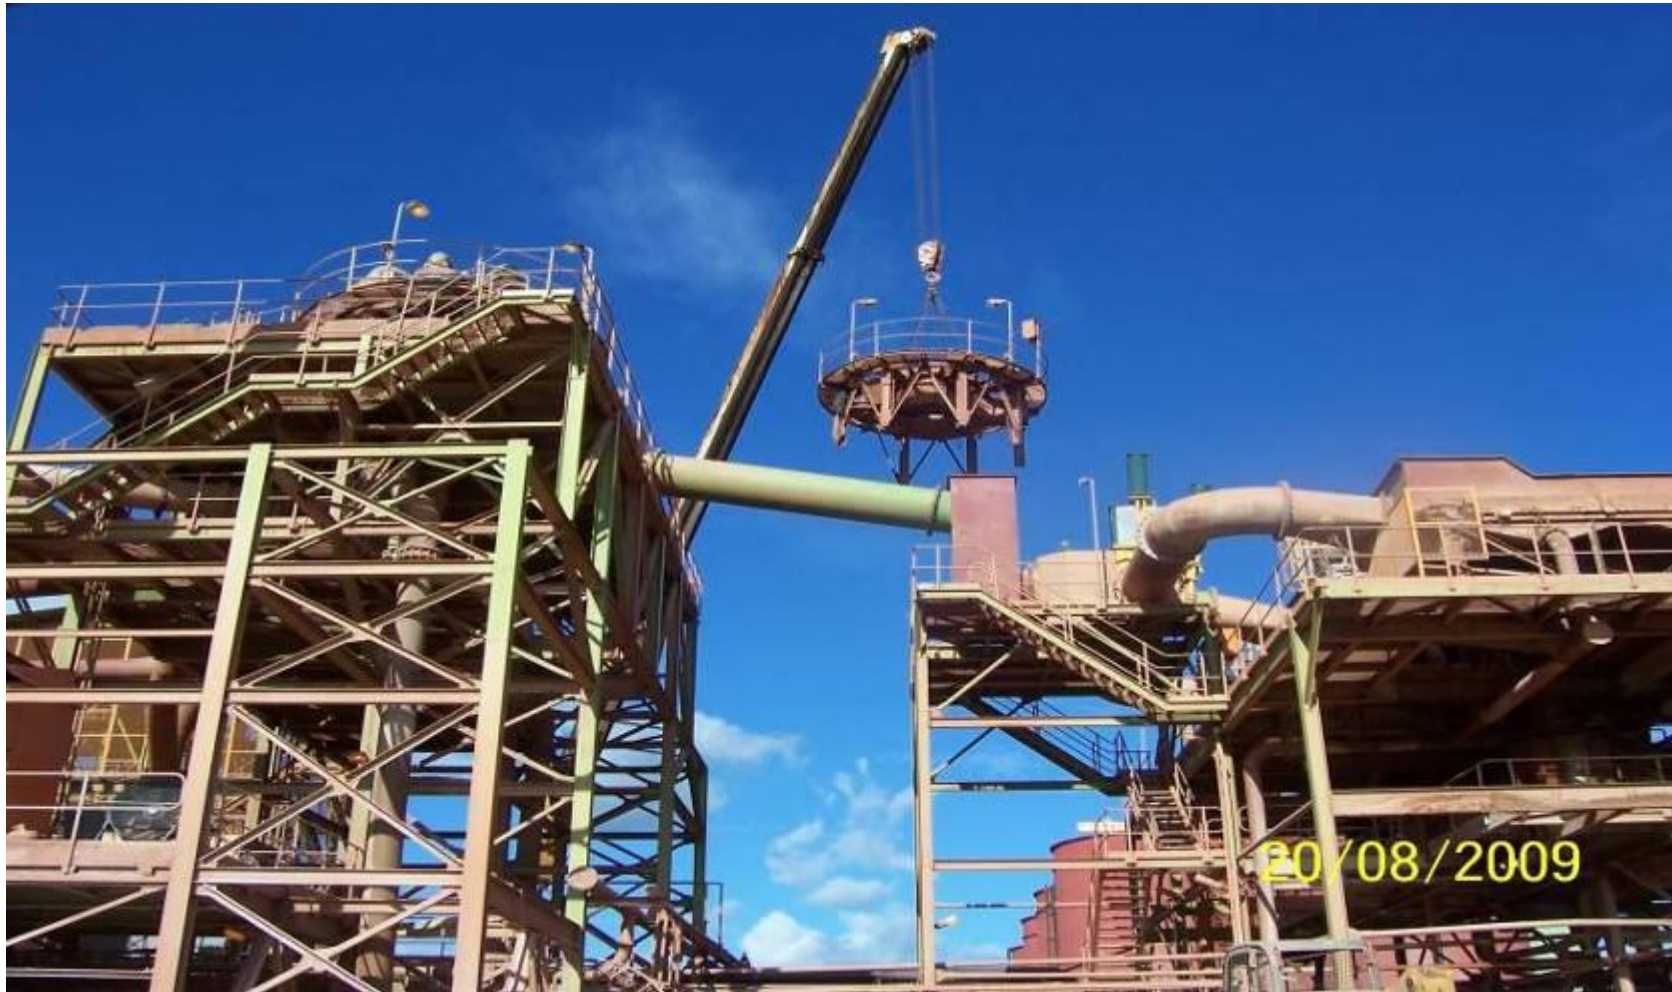
Cyclones

New cyclones cluster being installed in August 2009.

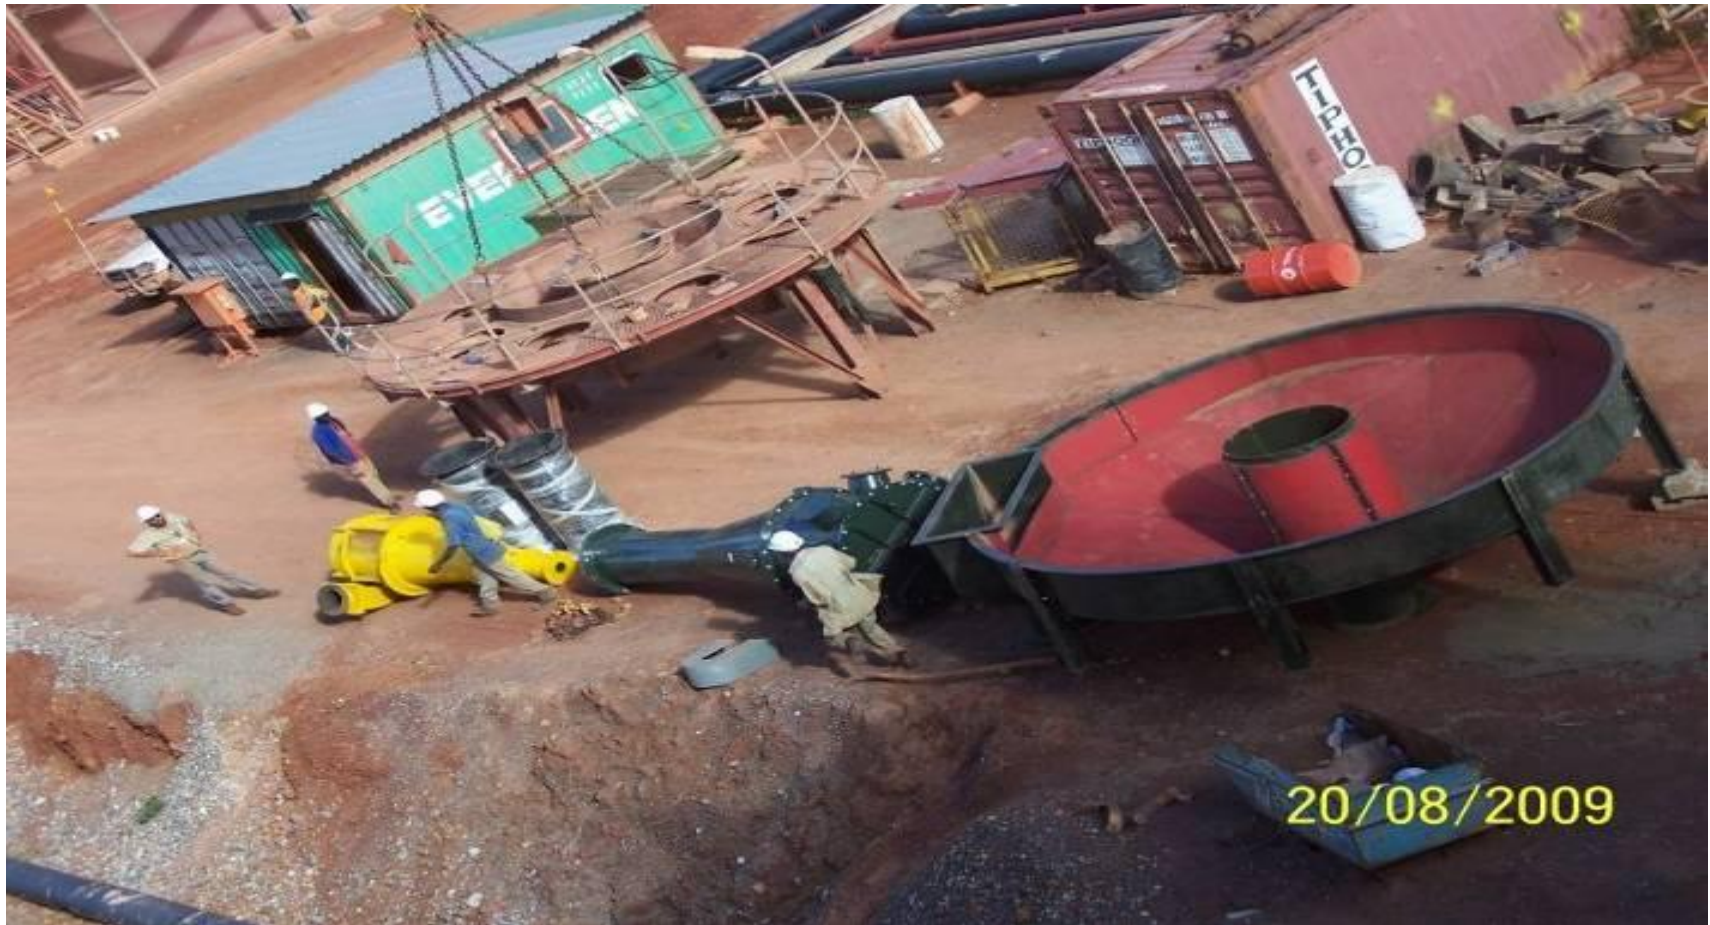
Cyclones

New cyclones cluster being installed in August 2009. New Cyclone Underflow pan before being lifted into position.

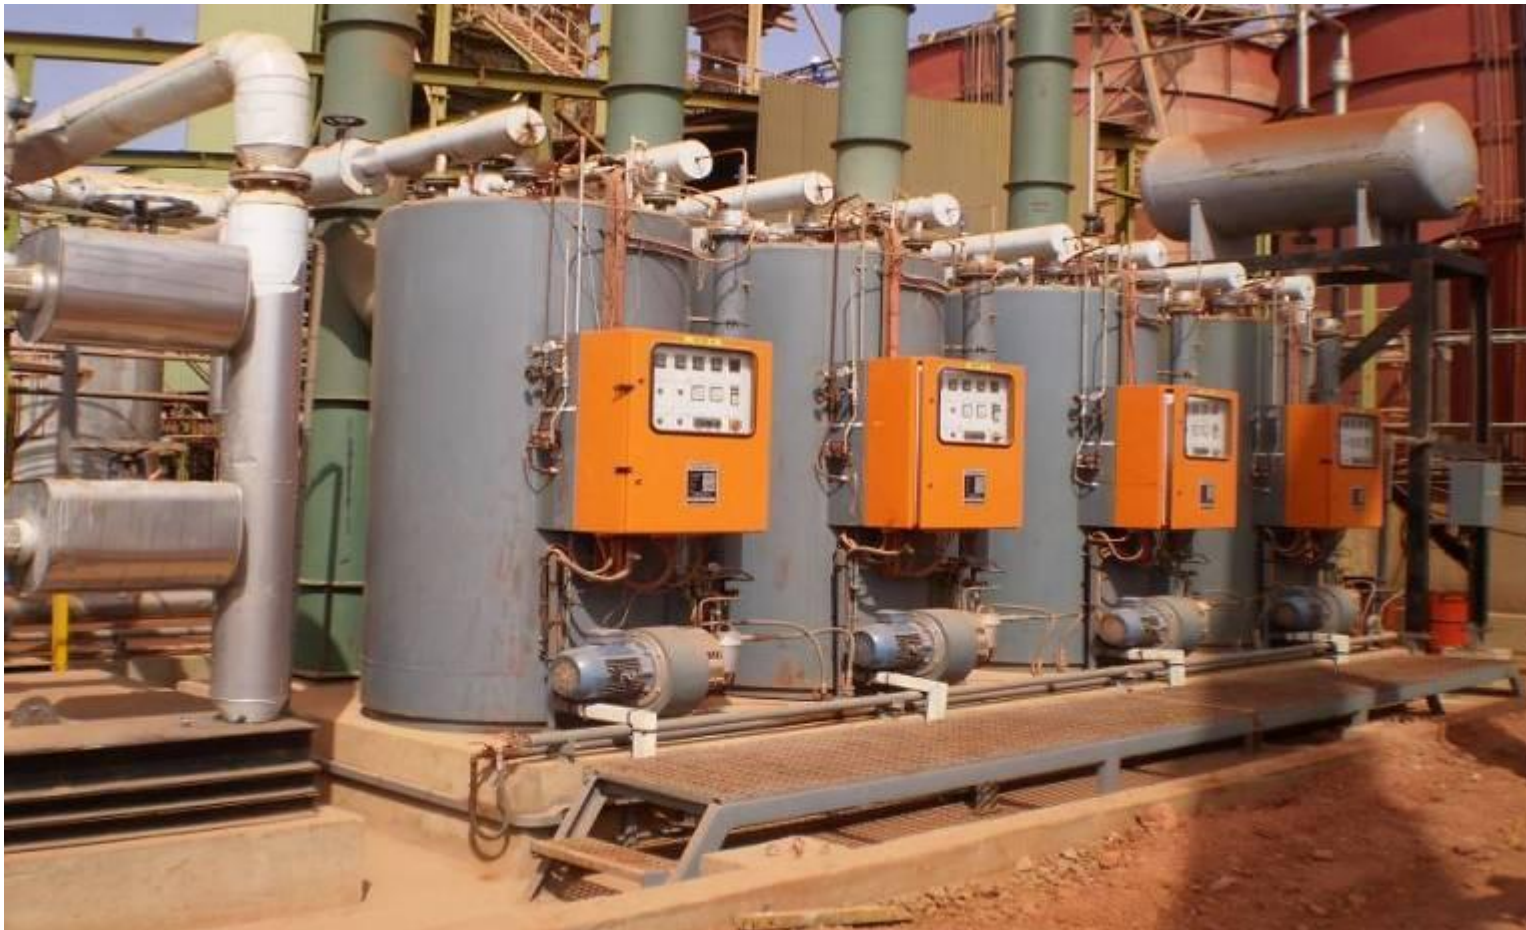
Elution, electrowinning and smelting.

New thermal heaters, associated pump packs, heat exchangers and prefabricated pipe work, to replace the Glycol boilers.

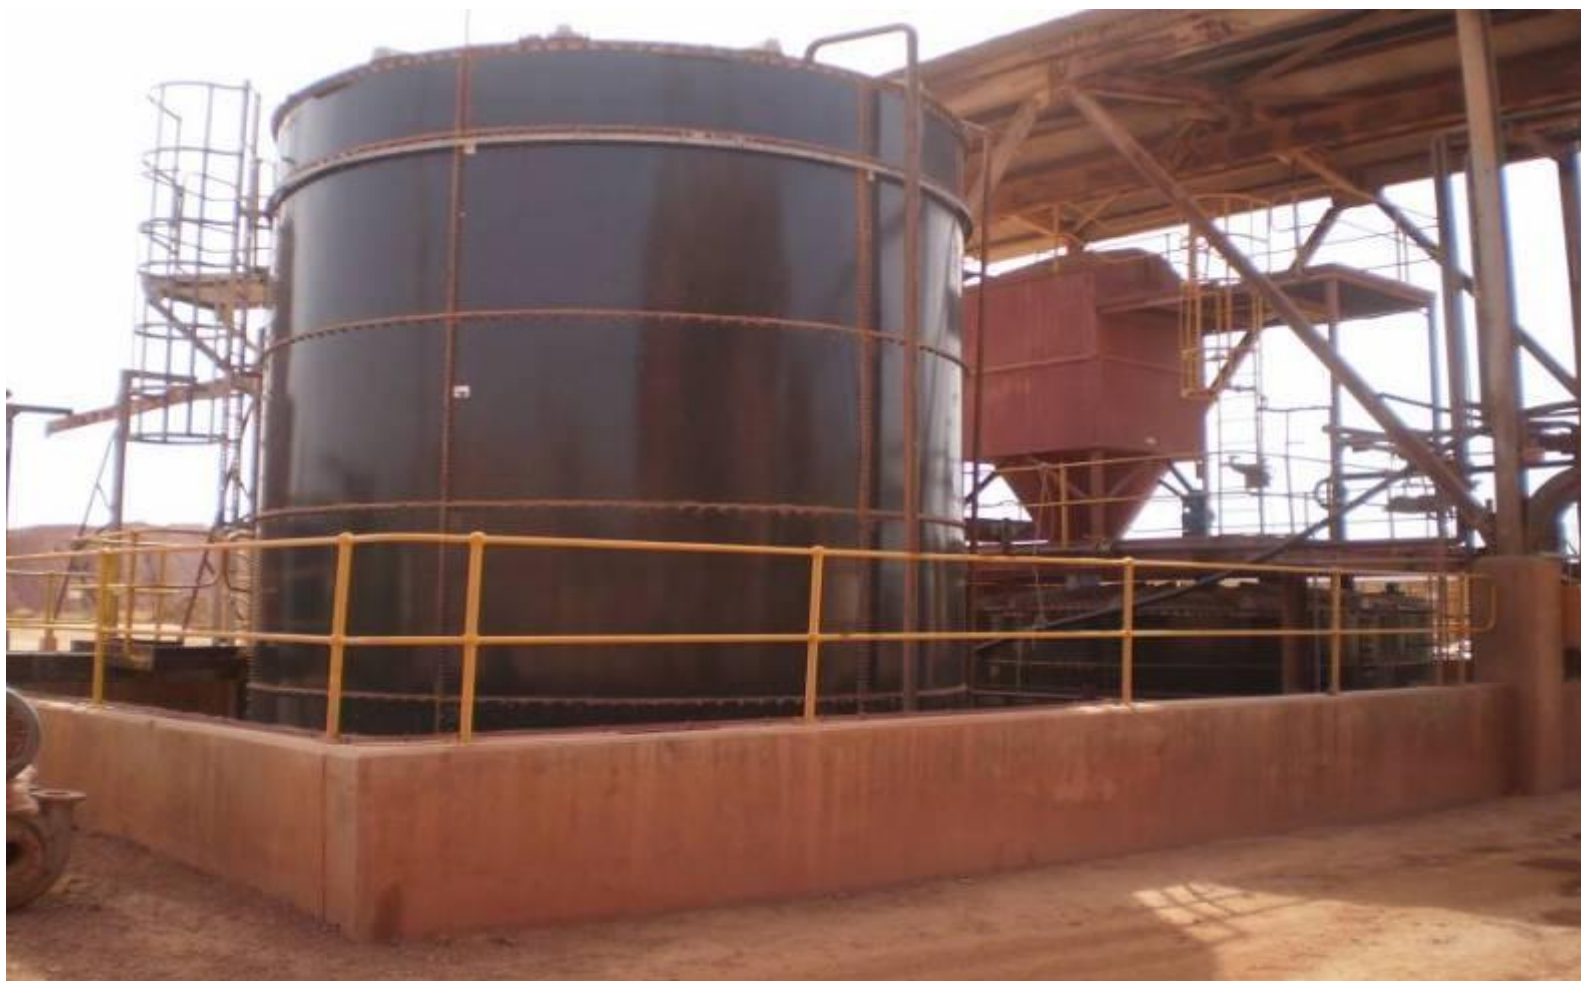
Reagent Mixing

New Cyanide mixing and storage tanks

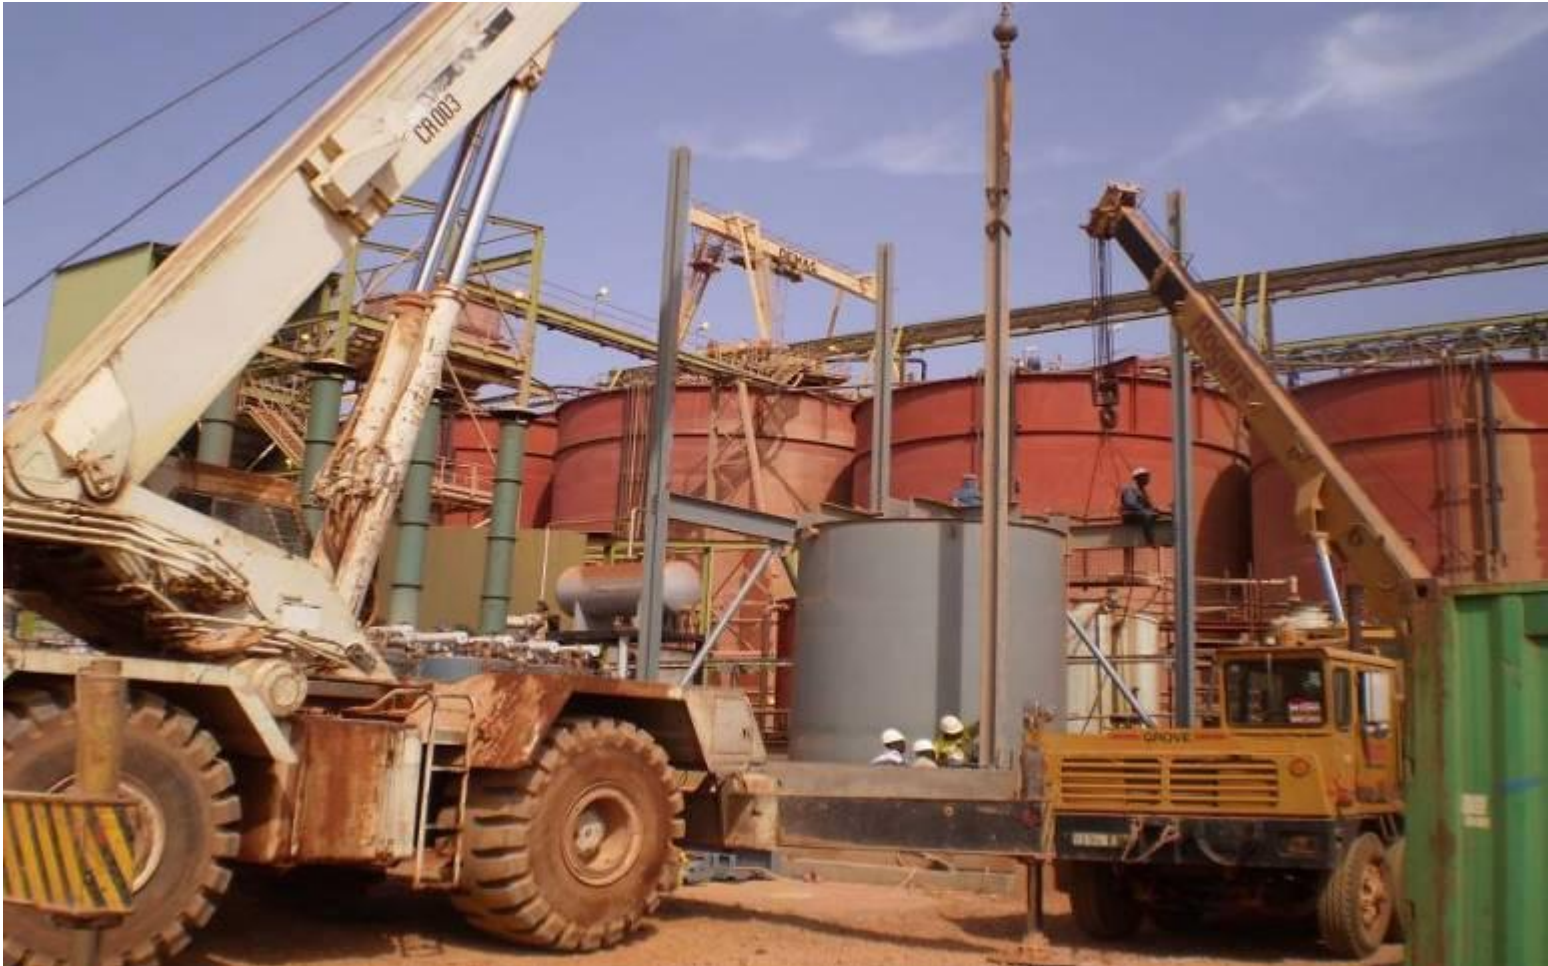
Reagent Mixing

New Caustic tank with Hopper structure being assembled.
