LEFA Operations - Maintenance March 2010

Overview of Current Status

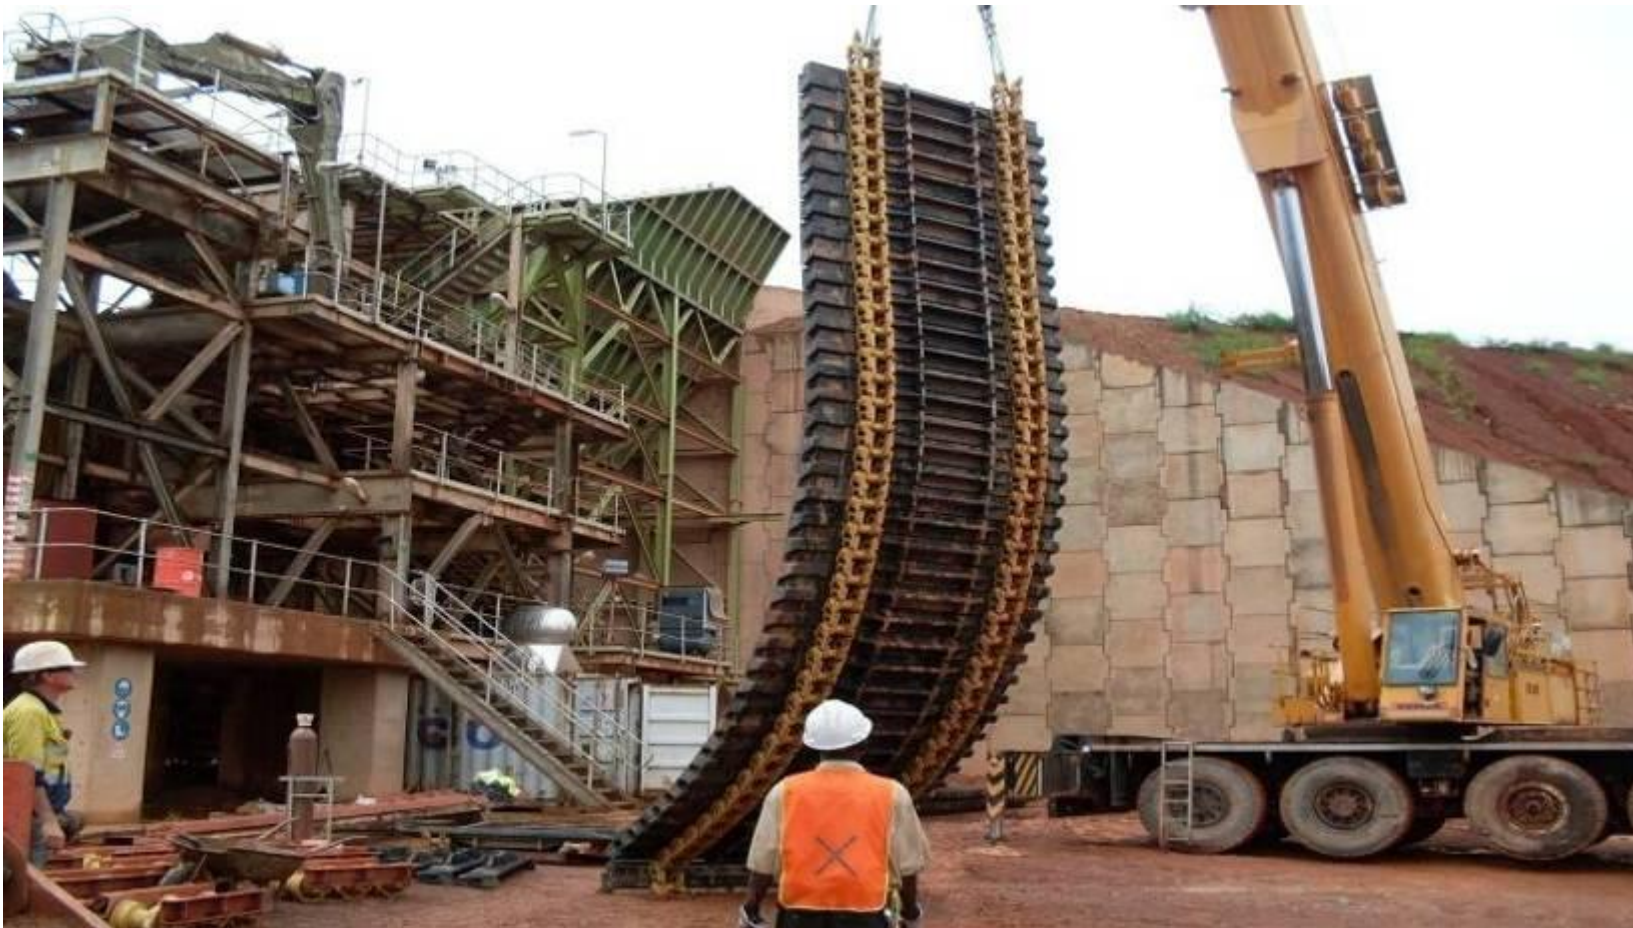
Lero & Fayalala Crushers

Apron feeder chains & pans have been replaced at the Lero crusher, pans and chains will be replaced in 2010 at the Fayalala crusher.

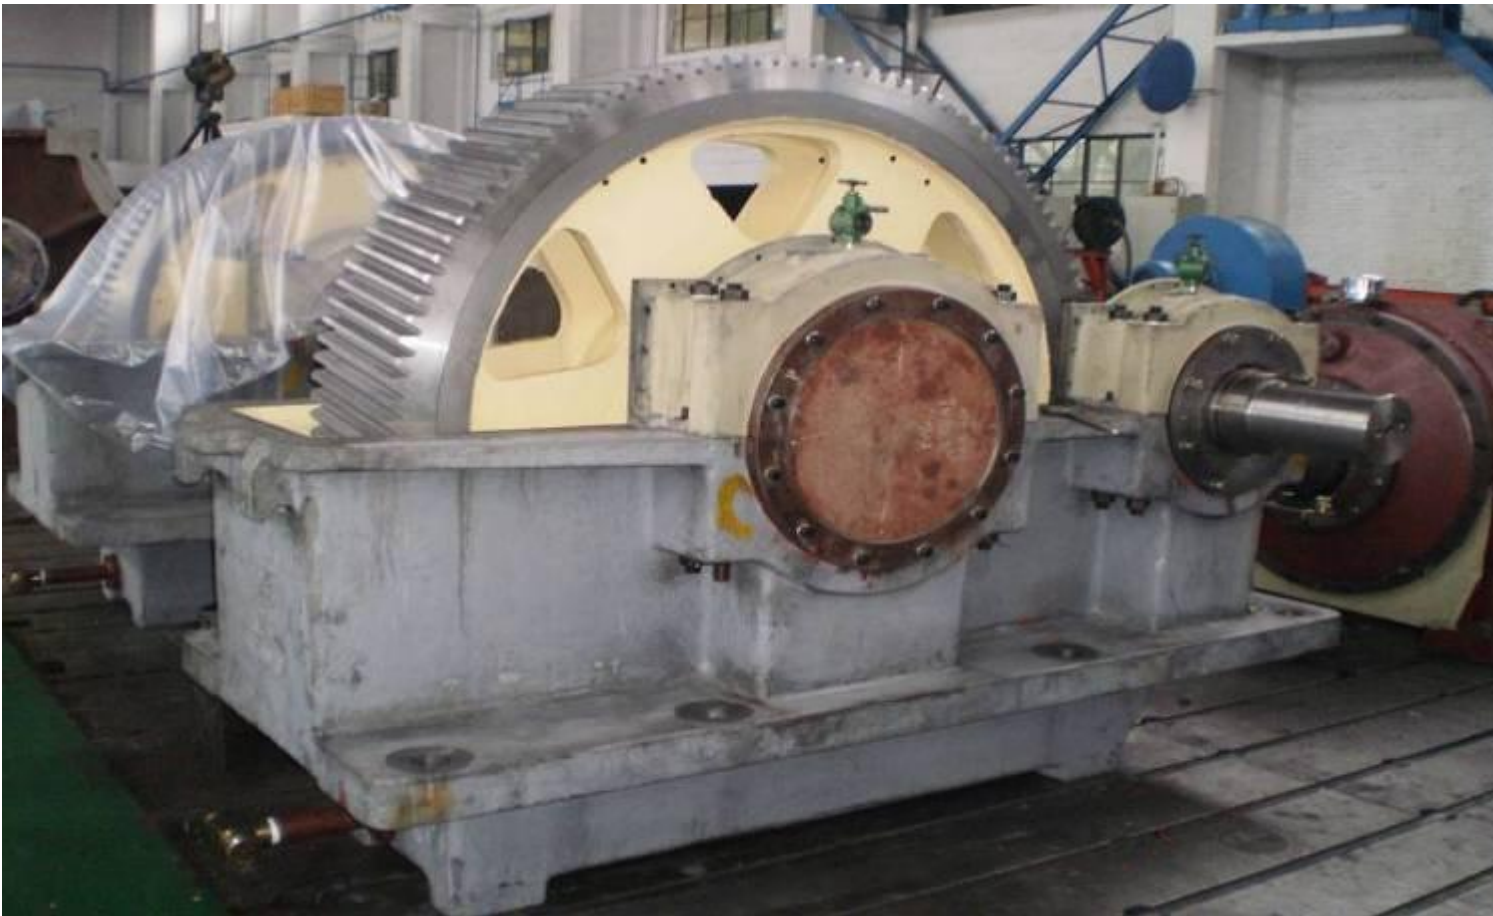
SAG Mill 1

- Two spare gearboxes (left and right) are on site.
- Scheduled to be installed on SAG 1 in July / August 2010.

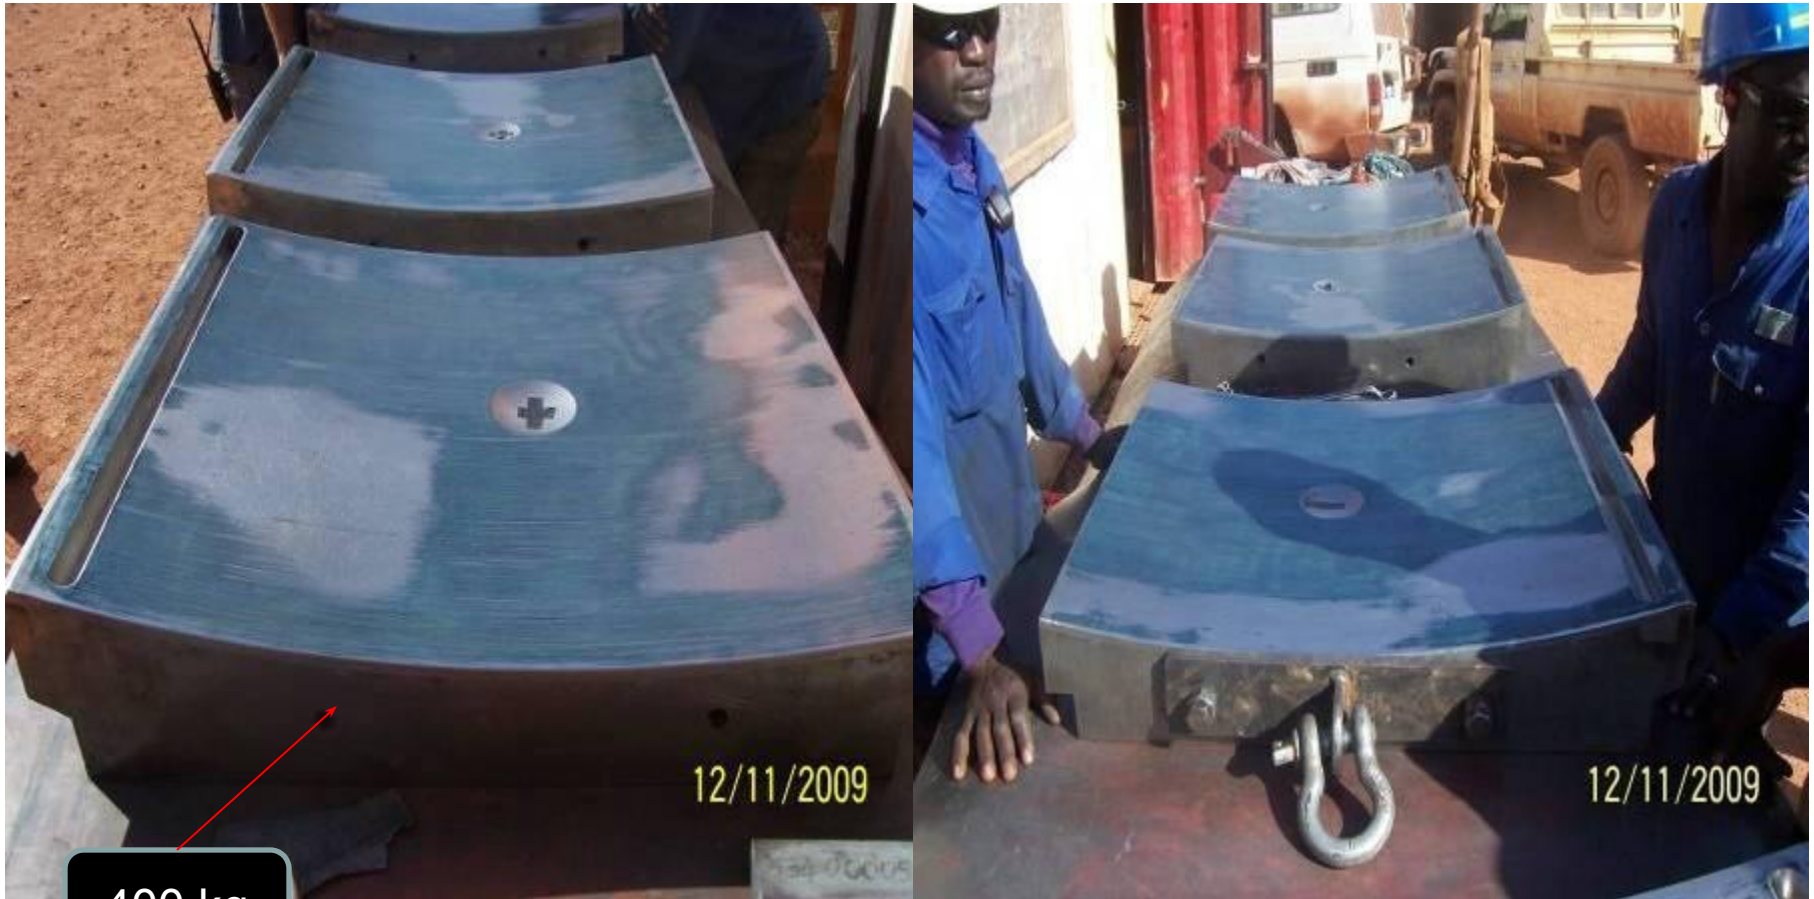
SAG Mill 2 bearings were hand scraped for the best possible contact with the trunnion Journal surface.

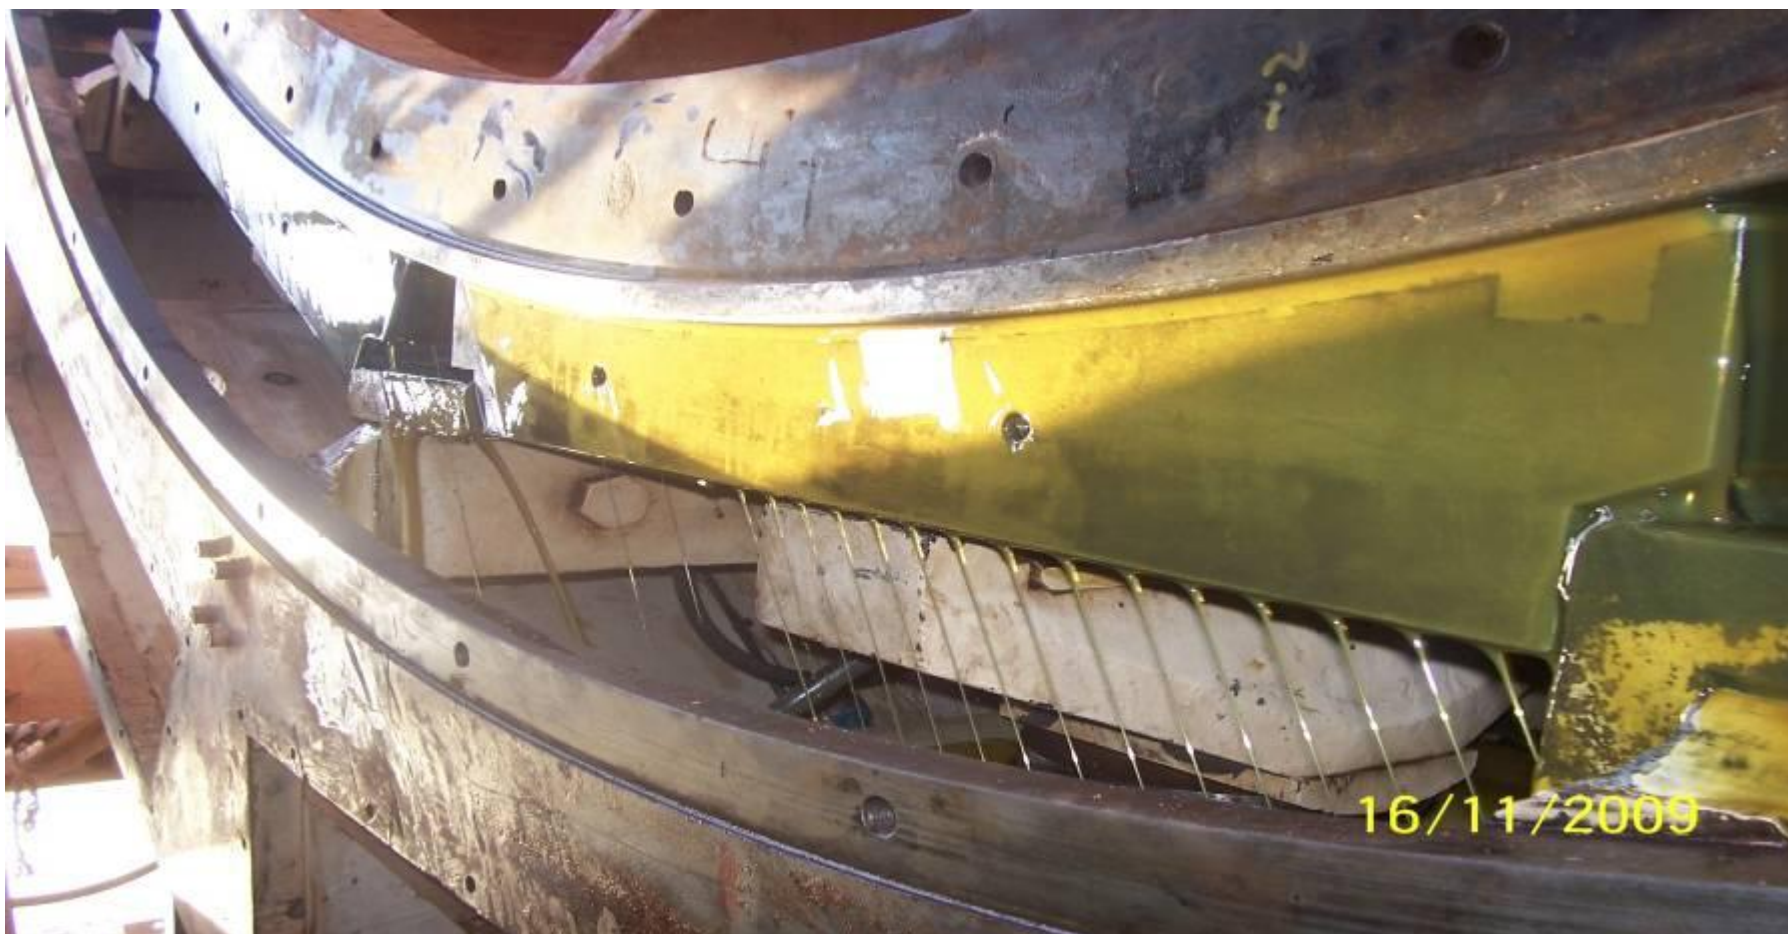
SAG Mill 2

New Bearing Pads after installation showing excellent oil coverage.

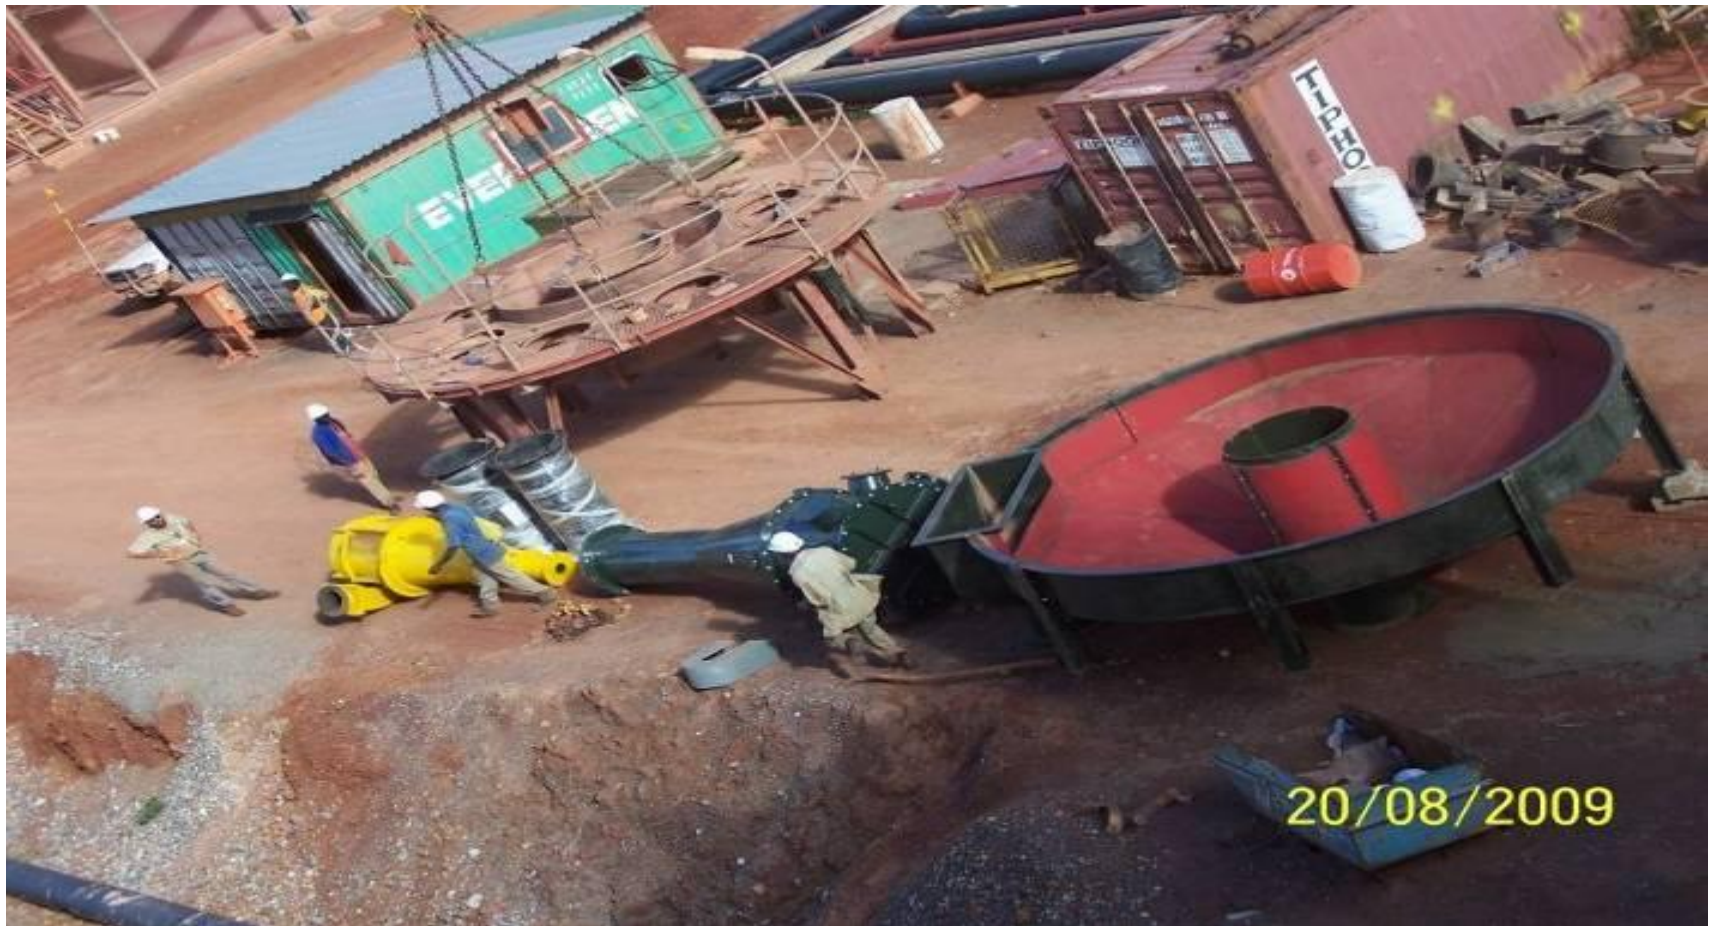
Cyclones

New cyclones cluster being installed in August 2009. New Cyclone Underflow pan before being lifted into position.
