Презентация на тему: «Катастрофа Superjet 100 в Шереметьево»

ПРЕЗЕНТАЦИЮ
ПОДГОТОВИЛ СТУДЕНТ
ГРУППЫ БТП 3-1
ЯХОНТОВ АЛЕКСАНДР

On May 5, 2019, an Aeroflot Superjet 100 crashed while landing at Sheremetyevo Airport. The liner was flying on the route Moscow - Murmansk. When returning to the departure airfield, the aircraft made several rough landings and as a result of the resulting fire received significant damage. 41 people died, 37 survived.

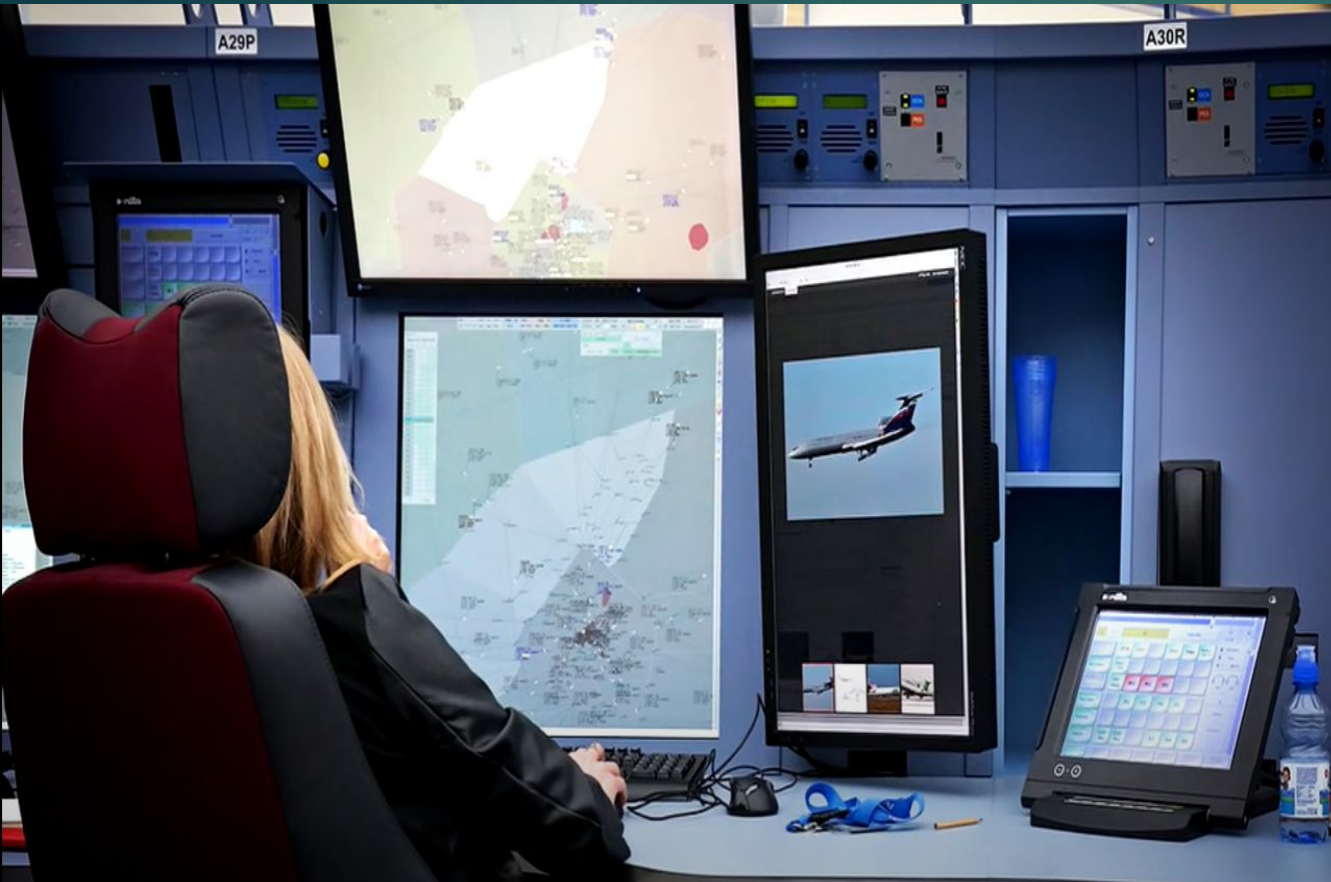
- ▶ After half a minute, lightning strikes the plane, the autopilot turns off and the plane switches to direct mode (direct control) - one of the three regular flight modes of the liner. In this mode, the aircraft can only be controlled by a joystick (sidestick).

- ▶ After a lightning strike, the plane can continue its flight and there is no urgent need to return back.
- ▶ However, Denis Evdokimov decides to return to the airport immediately.
- ▶ Meanwhile, the co-pilot is trying to report the incident to the dispatcher, but due to a lightning strike, the radio station does not work.
- ▶ As a result, the crew manages to get in touch with the help of an emergency radio station and the entire further flight is carried out using the instructions of the dispatcher.
- ▶ The plane begins to descend.

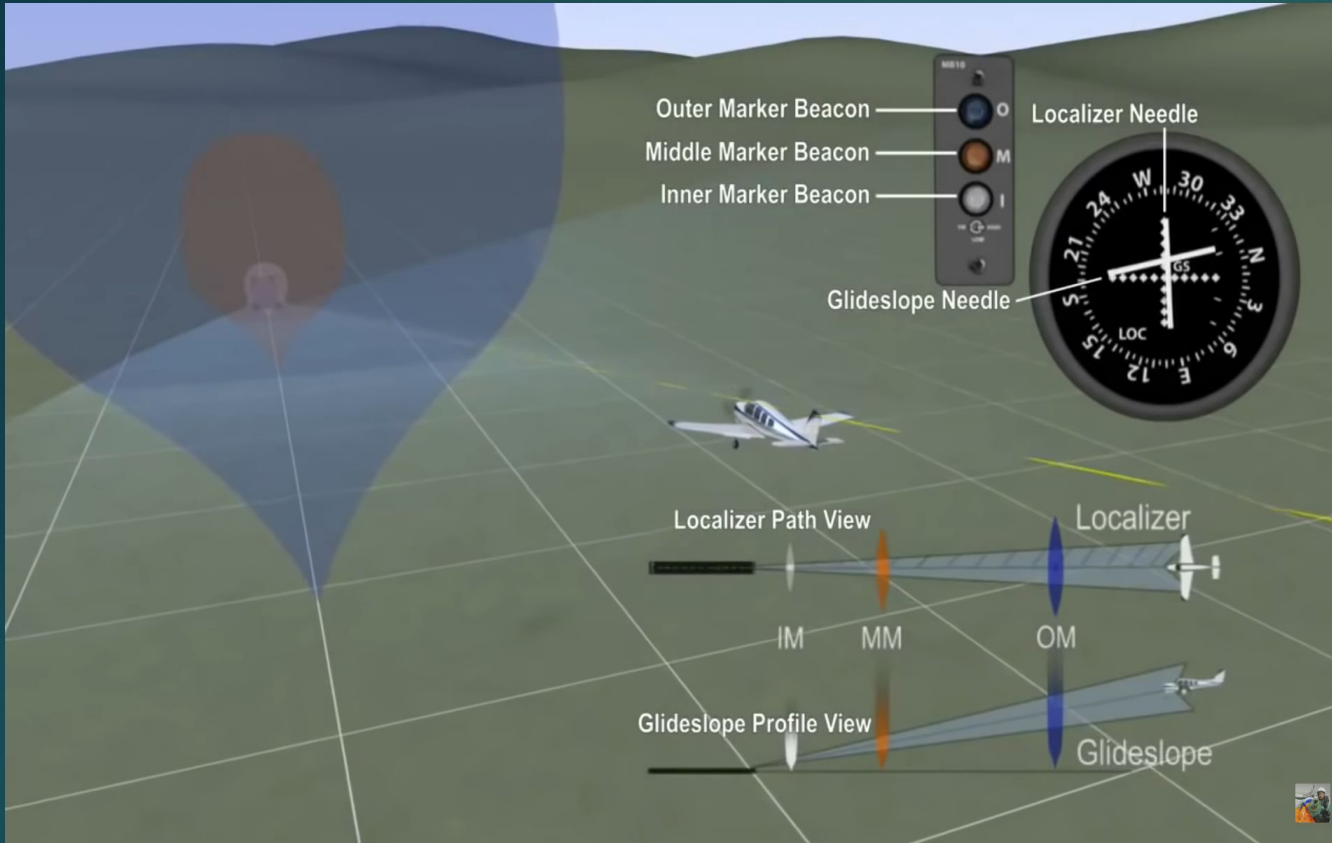
The only ILS view available with Directmode

- ▶ 20 km before the runway, the dispatchers take the plane on a landing course.
- ▶ After 11 km, the entry point to the glide path, it is from there that the final descent to the lane will begin.
- ▶ When asked by the dispatcher about the type of approach, the crew replies that they will enter by ILS (instrumental landing system)
- ▶ Pilots read the map of control checks "on landing", but before that the crew does not perform the map of control checks "on approach".
- ▶ And there was something to discuss, if the commander had done it, then the co-pilot would have understood better what to do and how to help, in fact the crew is not ready to land.

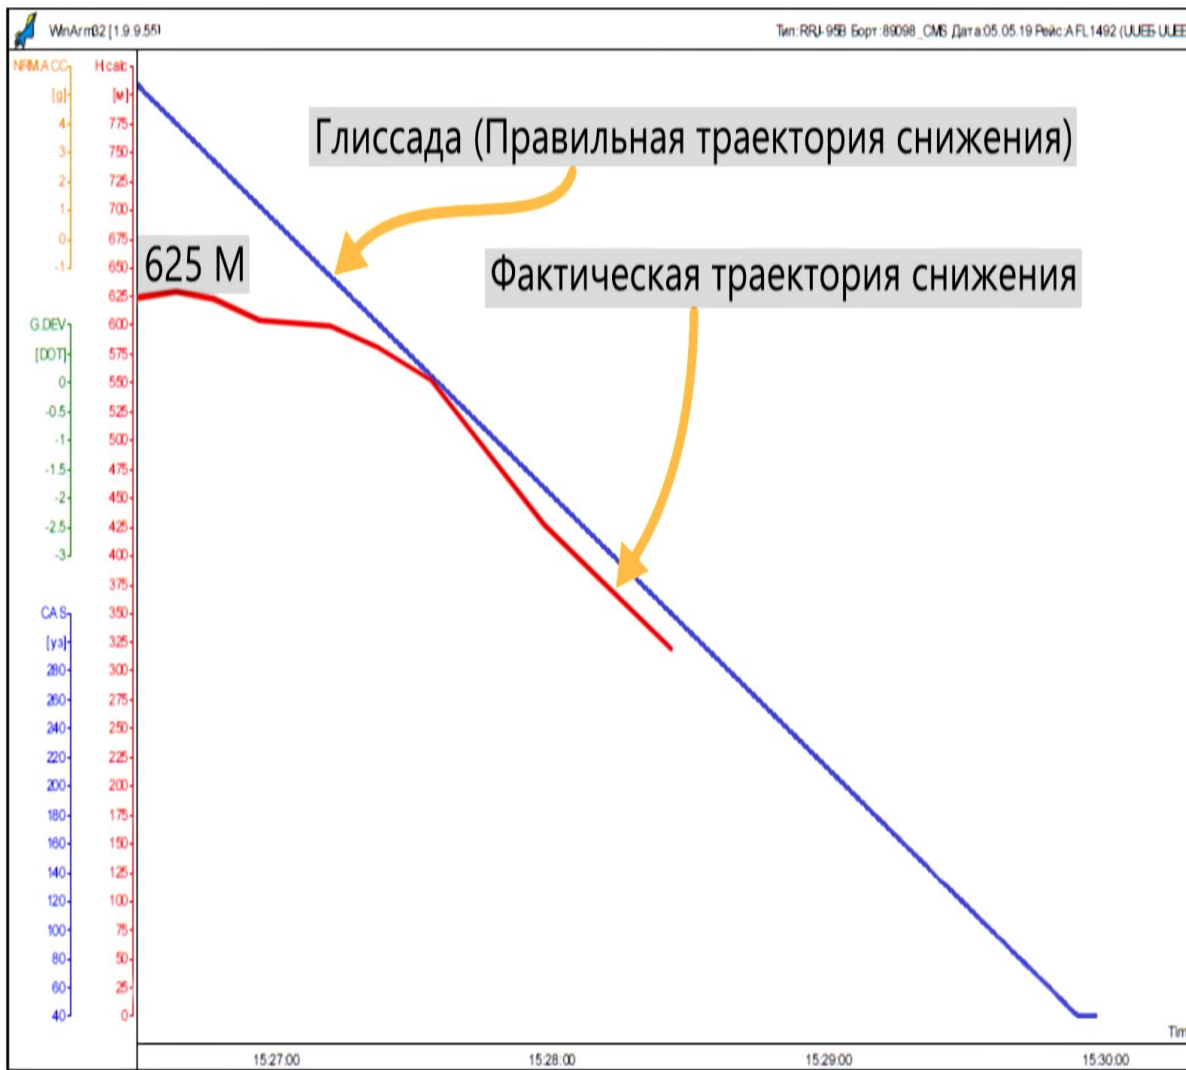
- ▶ 9 km to the runway, the plane is descending, while the commander is deliberately going below the glide path.
- ▶ On the left, a strong side wind blows almost at an angle of 90 degrees with gusts up to 15 meters per second, which complicates the situation.
- ▶ The height is 335 meters, the wind shear alarm is working (go around, wind shear ahead), according to the instructions it is necessary to go for a second round, but if the commander is sure that there is actually no threat of wind shear, you can continue the approach. The commander ignores this alarm.

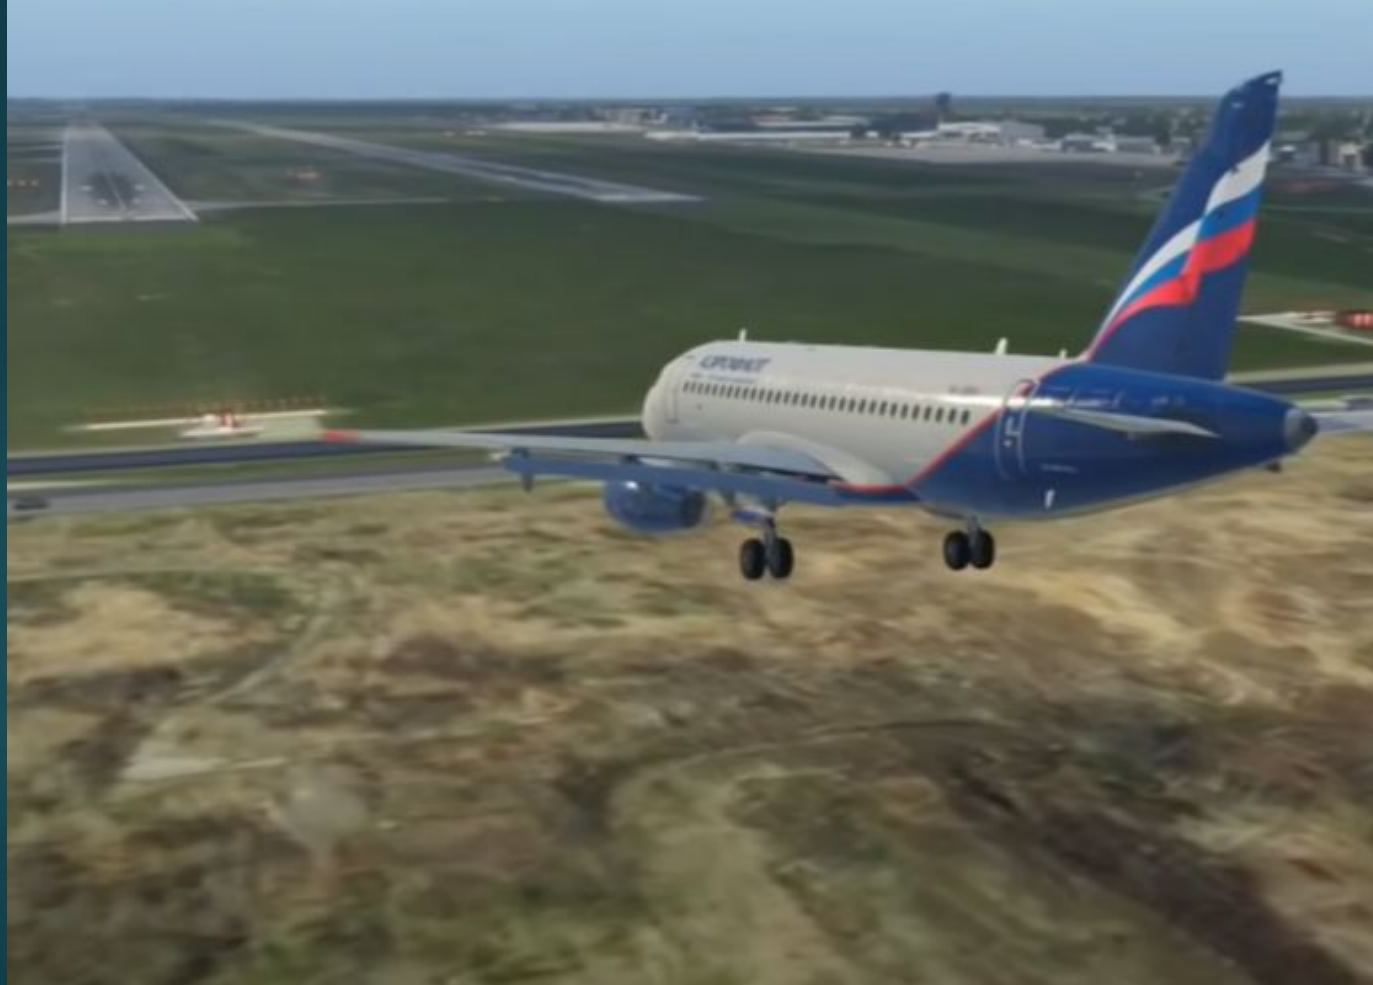
- ▶ The height is 80 meters, we urgently need to make a decision. At this moment, as the system warned, the wind changes dramatically, and the plane quickly falls under the glide path and begins to go below the set trajectory.
- ▶ In order to catch up with the glide path, the commander adds thrust, the engines accelerate, but not immediately, they need time for this. The speed is increasing.
- ▶ They pass the end of the strip at a height of 12 meters, which is much lower than the prescribed value.
- ▶ The speed is 305 km per hour and continues to grow.

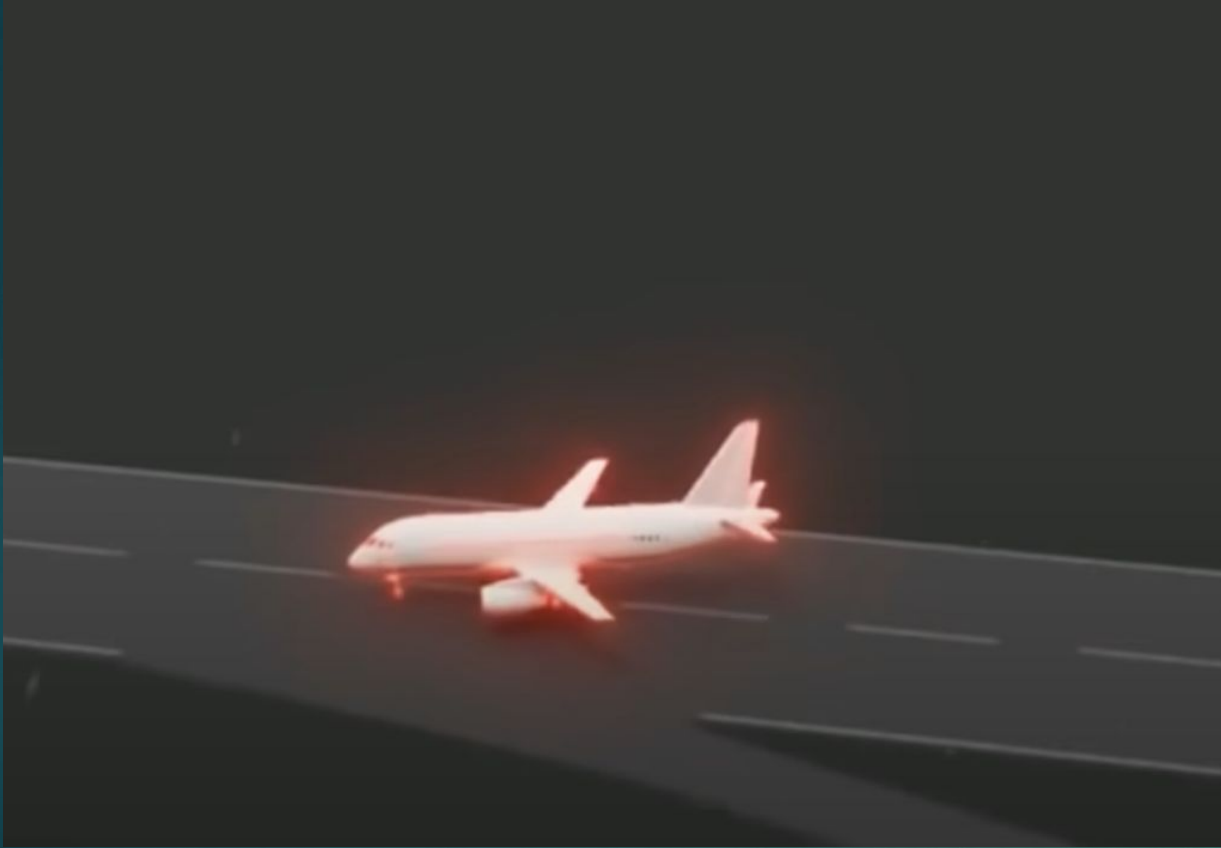
- ▶ The pilot controls the joystick excessively sharply in extreme positions and because of this landing occurs with an overload of 2.55G - this is very rude.
- ▶ The air brakes themselves are not released due to the direct mode mode, so the plane does not press against the runway and jumps to a height of 1.5 meters, hitting the ground with an overload of 5.85G.
- ▶ According to international standards, the landing gear must withstand a maximum load of 3.75G, so they begin to collapse, but the fuel tanks are still intact, the liner again lifts off the ground already at a height of 5 meters, the reverse turns on, and the aircraft at a speed of 258 km per hour falls to the ground with an overload of 5G for the last time.

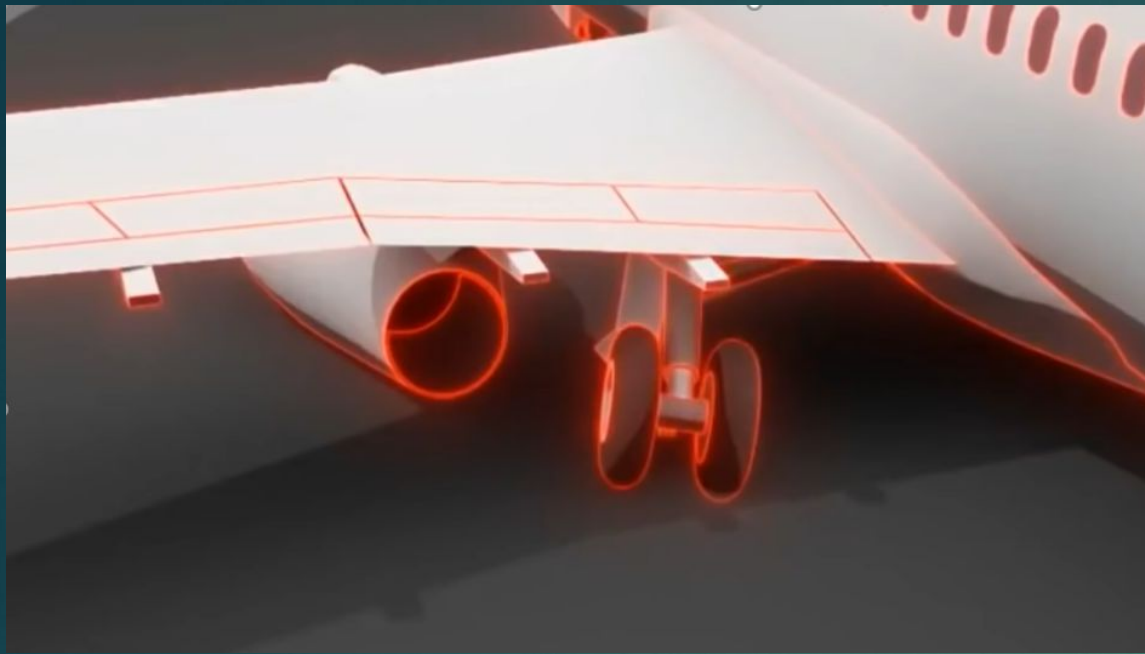
- ▶ The partially destroyed chassis finally breaks down and breaks through the fuel tanks, fuel spills and a fire starts. The dispatcher's command "emergency services to the lane" sounds.
- ▶ The plane turns to the left and stops, evacuation begins and after a minute the engines stop...
