Презентация на тему: «Катастрофа Superjet 100 в Шереметьево»

ПРЕЗЕНТАЦИЮ
ПОДГОТОВИЛ СТУДЕНТ
ГРУППЫ БТП 3-1
ЯХОНТОВ АЛЕКСАНДР

On May 5, 2019, an Aeroflot Superjet 100 crashed while landing at Sheremetyevo Airport. The liner was flying on the route Moscow - Murmansk. When returning to the departure airfield, the aircraft made several rough landings and as a result of the resulting fire received significant damage. 41 people died, 37 survived.

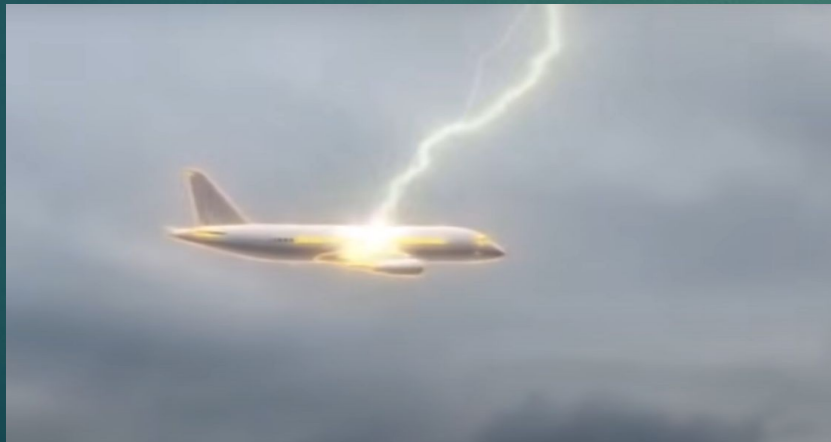
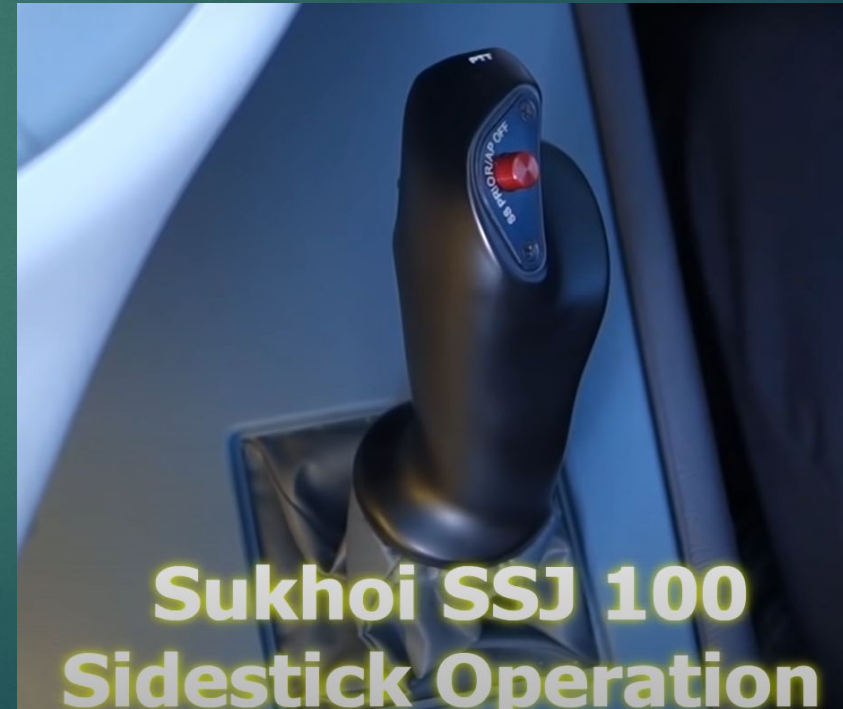
- ▶ After half a minute, lightning strikes the plane, the autopilot turns off and the plane switches to direct mode (direct control) - one of the three regular flight modes of the liner. In this mode, the aircraft can only be controlled by a joystick (sidestick).

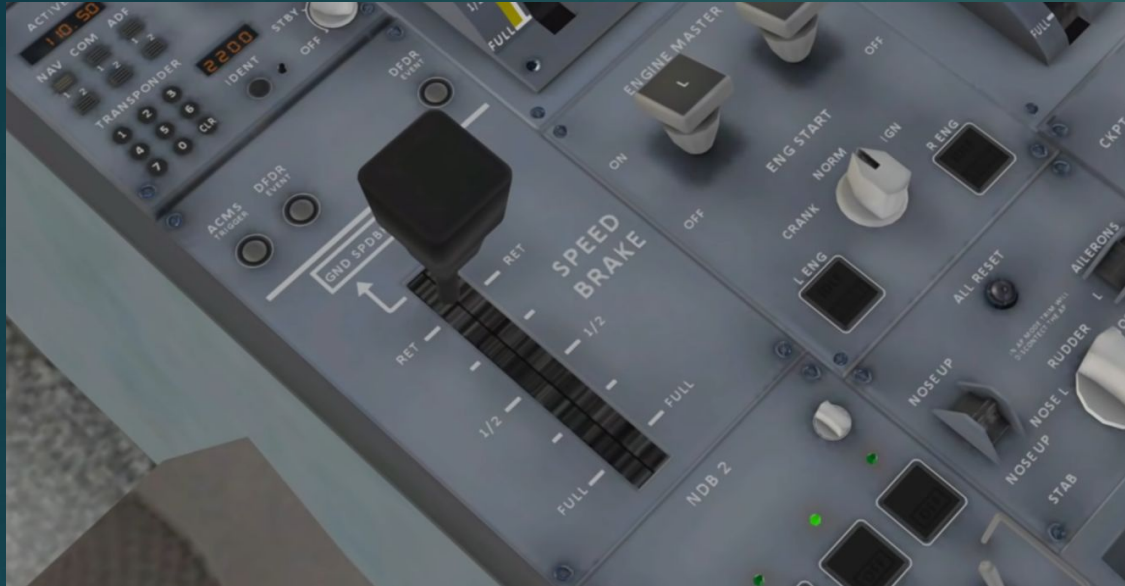
- ▶ The crew reinforces the air brakes (these are flaps on the wing that rise up).
- ▶ In reinforcement mode, when the landing gear touches the ground, they should automatically go up and thereby press the aircraft to the runway, but they are not automatically released in direct mode, and this is what the co-pilot said 9 minutes ago when reading the checklist.

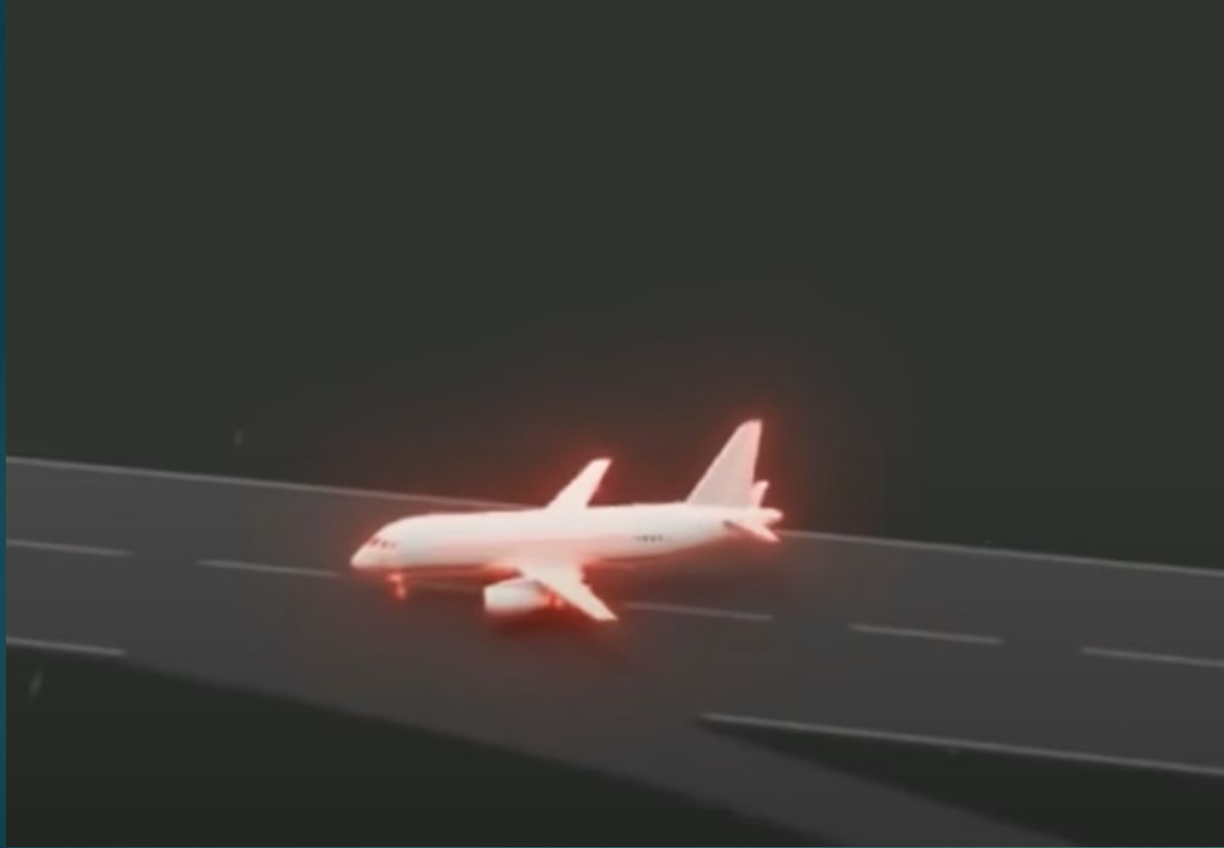
- ▶ The pilot controls the joystick excessively sharply in extreme positions and because of this landing occurs with an overload of 2.55G - this is very rude.
- ▶ The air brakes themselves are not released due to the direct mode mode, so the plane does not press against the runway and jumps to a height of 1.5 meters, hitting the ground with an overload of 5.85G.
- ▶ According to international standards, the landing gear must withstand a maximum load of 3.75G, so they begin to collapse, but the fuel tanks are still intact, the liner again lifts off the ground already at a height of 5 meters, the reverse turns on, and the aircraft at a speed of 258 km per hour falls to the ground with an overload of 5G for the last time.
