Презентация на тему:
«Катастрофа Superjet 100 в
Шереметьево»

ПРЕЗЕНТАЦИЮ
ПОДГОТОВИЛ СТУДЕНТ
ГРУППЫ БТП 3-1
ЯХОНТОВ АЛЕКСАНДР

On May 5, 2019, an Aeroflot Superjet 100 crashed while landing at Sheremetyevo Airport. The liner was flying on the route Moscow - Murmansk. When returning to the departure airfield, the aircraft made several rough landings and as a result of the resulting fire received significant damage. 41 people died, 37 survived.

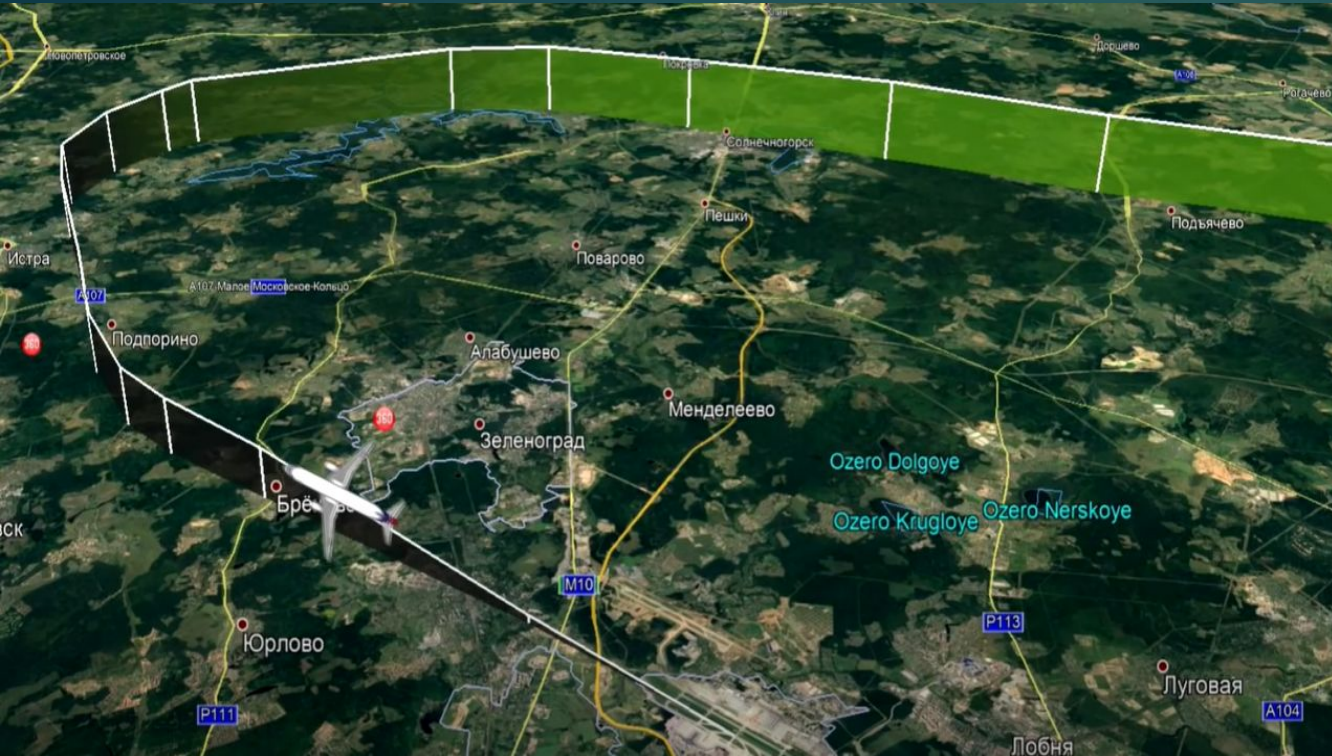
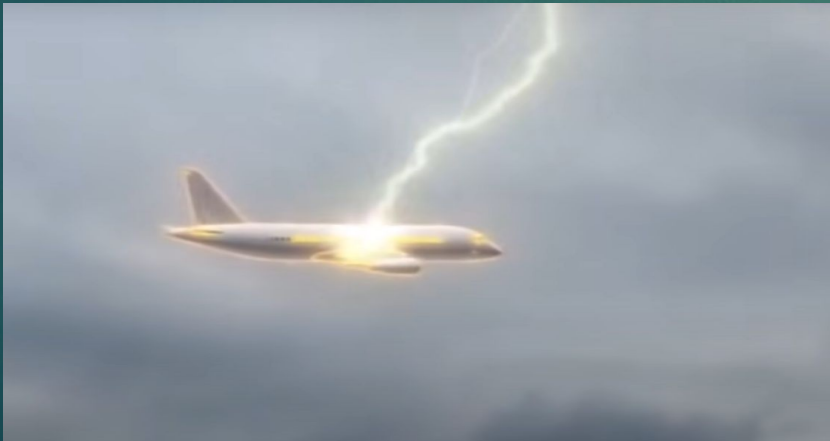
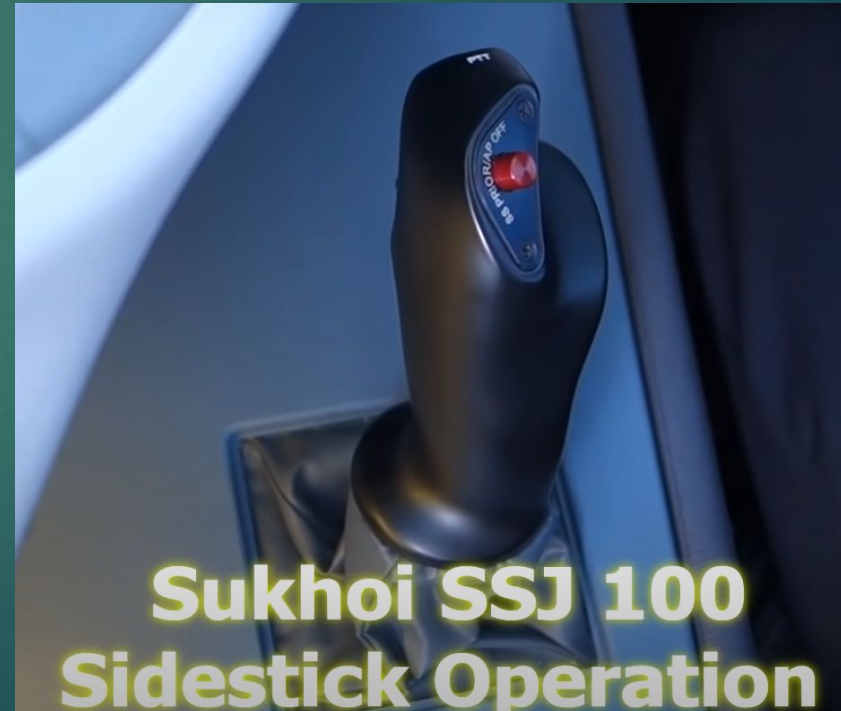
- ▶ After half a minute, lightning strikes the plane, the autopilot turns off and the plane switches to direct mode (direct control) - one of the three regular flight modes of the liner. In this mode, the aircraft can only be controlled by a joystick (sidestick).

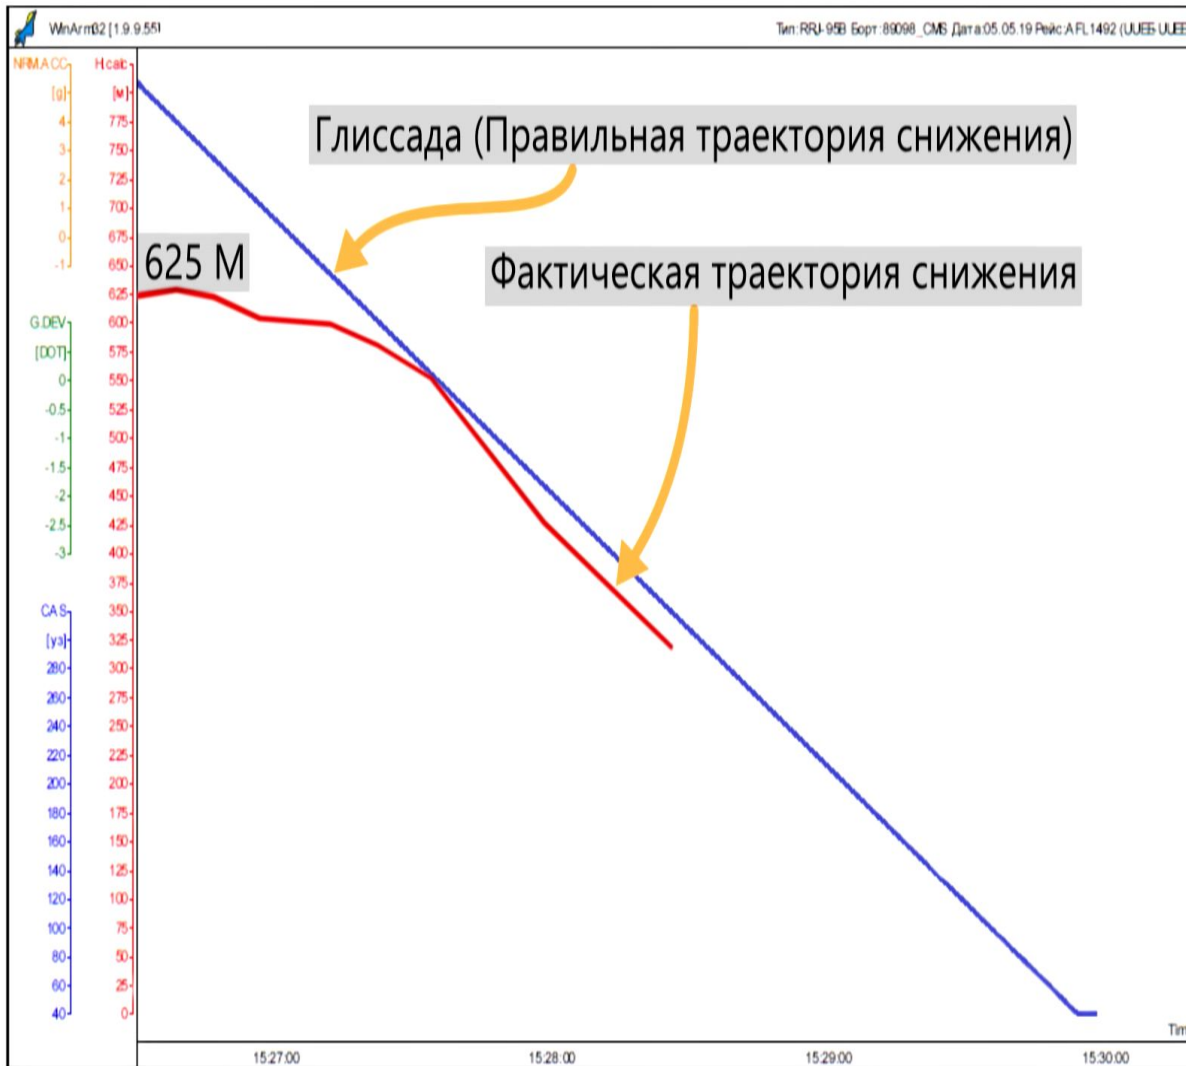
The only ILS view available with Directmode

- ▶ 20 km before the runway, the dispatchers take the plane on a landing course.
- ▶ After 11 km, the entry point to the glide path, it is from there that the final descent to the lane will begin.
- ▶ When asked by the dispatcher about the type of approach, the crew replies that they will enter by ILS (instrumental landing system)
- ▶ Pilots read the map of control checks "on landing", but before that the crew does not perform the map of control checks "on approach".
- ▶ And there was something to discuss, if the commander had done it, then the co-pilot would have understood better what to do and how to help, in fact the crew is not ready to land.

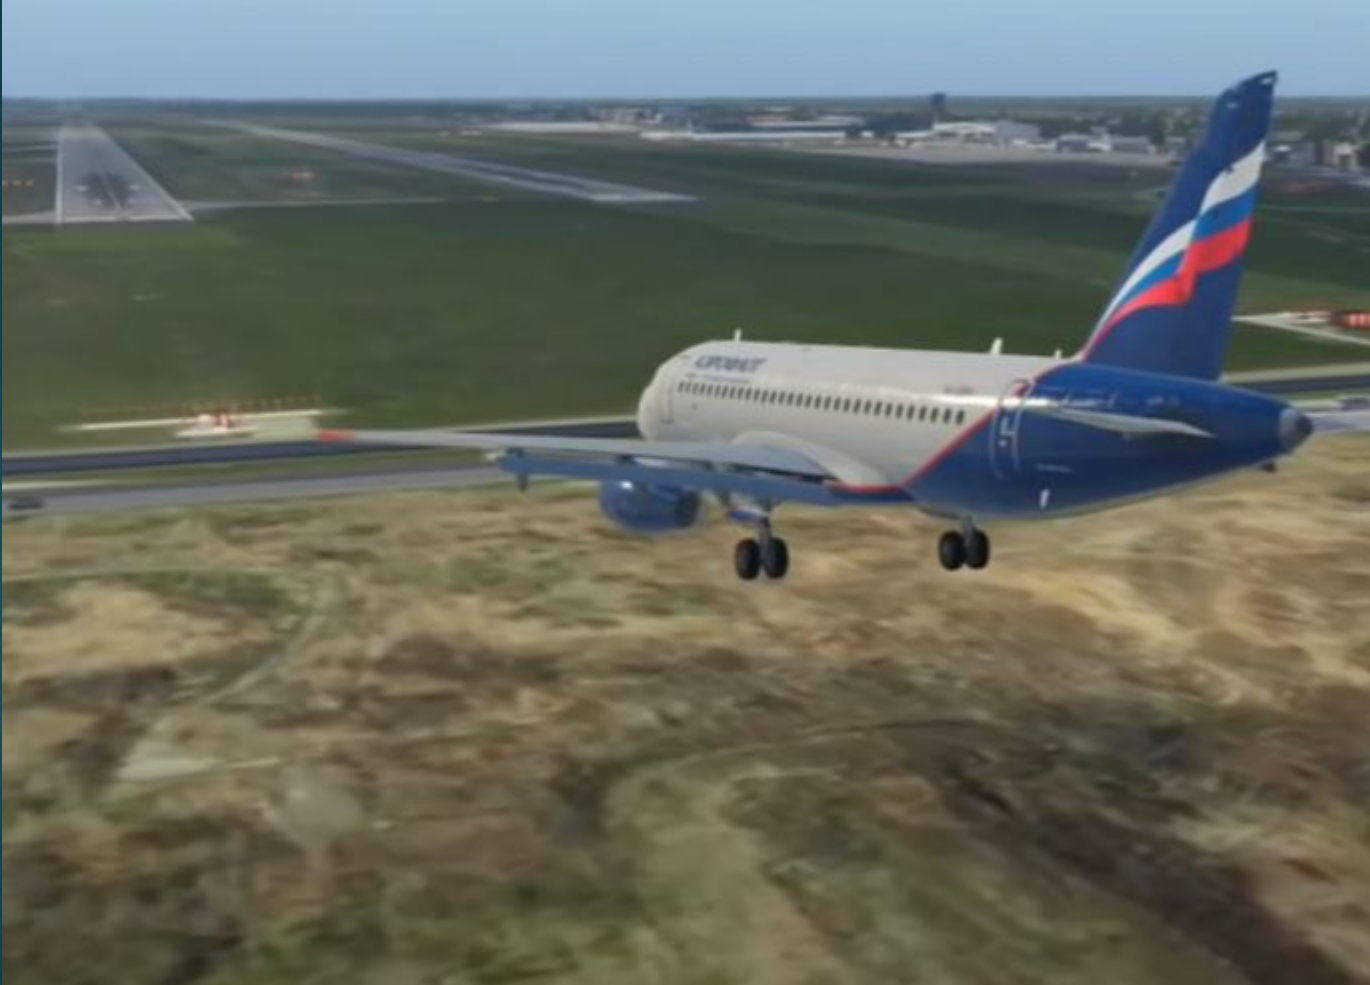
- ▶ 9 km to the runway, the plane is descending, while the commander is deliberately going below the glide path.
- ▶ On the left, a strong side wind blows almost at an angle of 90 degrees with gusts up to 15 meters per second, which complicates the situation.
- ▶ The height is 335 meters, the wind shear alarm is working (go around, wind shear ahead), according to the instructions it is necessary to go for a second round, but if the commander is sure that there is actually no threat of wind shear, you can continue the approach. The commander ignores this alarm.

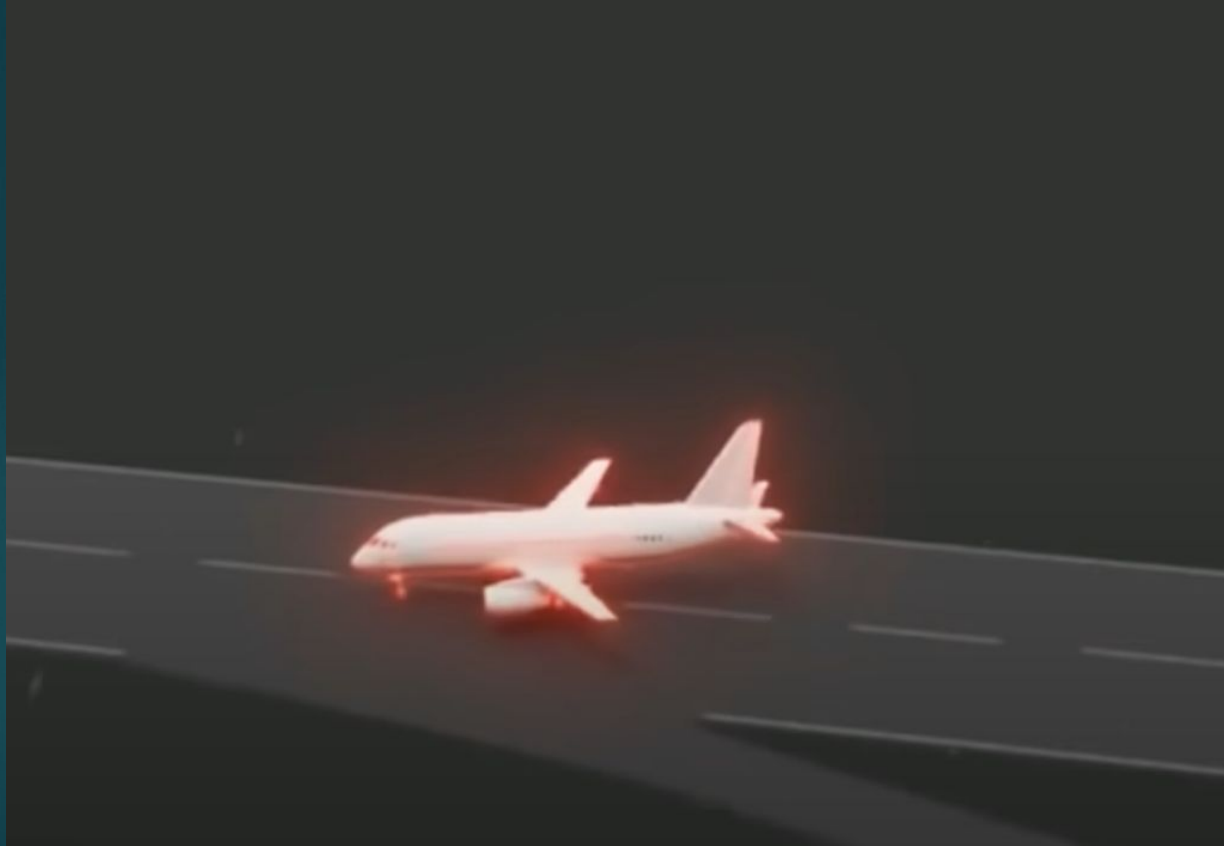
- ▶ The height is 80 meters, we urgently need to make a decision. At this moment, as the system warned, the wind changes dramatically, and the plane quickly falls under the glide path and begins to go below the set trajectory.
- ▶ In order to catch up with the glide path, the commander adds thrust, the engines accelerate, but not immediately, they need time for this. The speed is increasing.
- ▶ They pass the end of the strip at a height of 12 meters, which is much lower than the prescribed value.
- ▶ The speed is 305 km per hour and continues to grow.

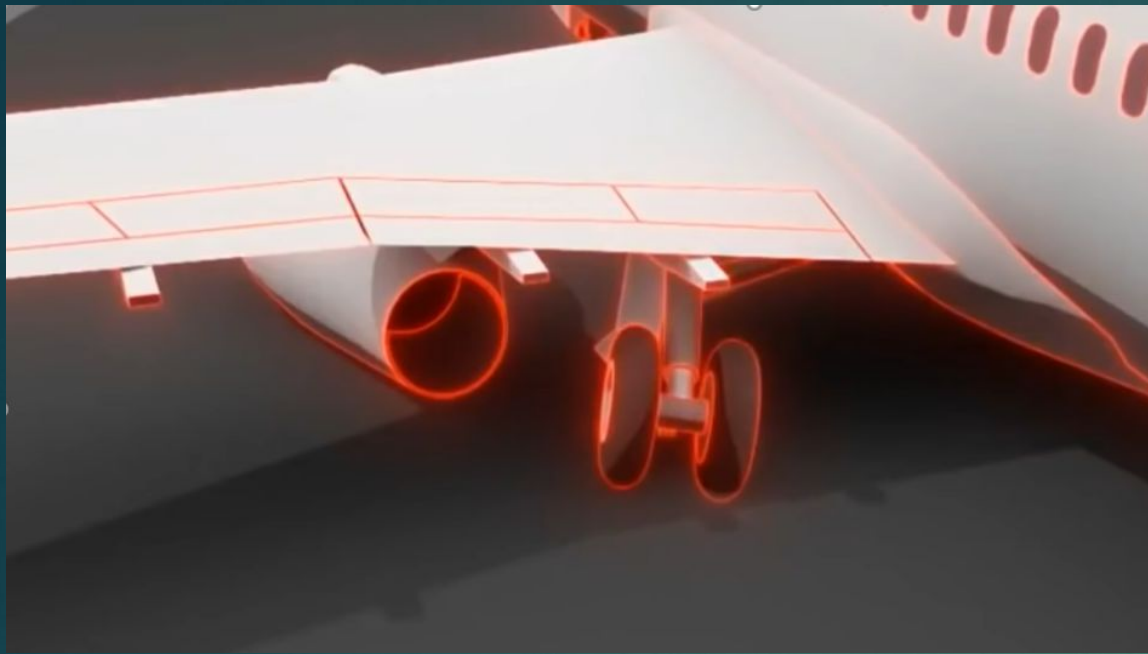
- ▶ The pilot controls the joystick excessively sharply in extreme positions and because of this landing occurs with an overload of 2.55G - this is very rude.
- ▶ The air brakes themselves are not released due to the direct mode mode, so the plane does not press against the runway and jumps to a height of 1.5 meters, hitting the ground with an overload of 5.85G.
- ▶ According to international standards, the landing gear must withstand a maximum load of 3.75G, so they begin to collapse, but the fuel tanks are still intact, the liner again lifts off the ground already at a height of 5 meters, the reverse turns on, and the aircraft at a speed of 258 km per hour falls to the ground with an overload of 5G for the last time.

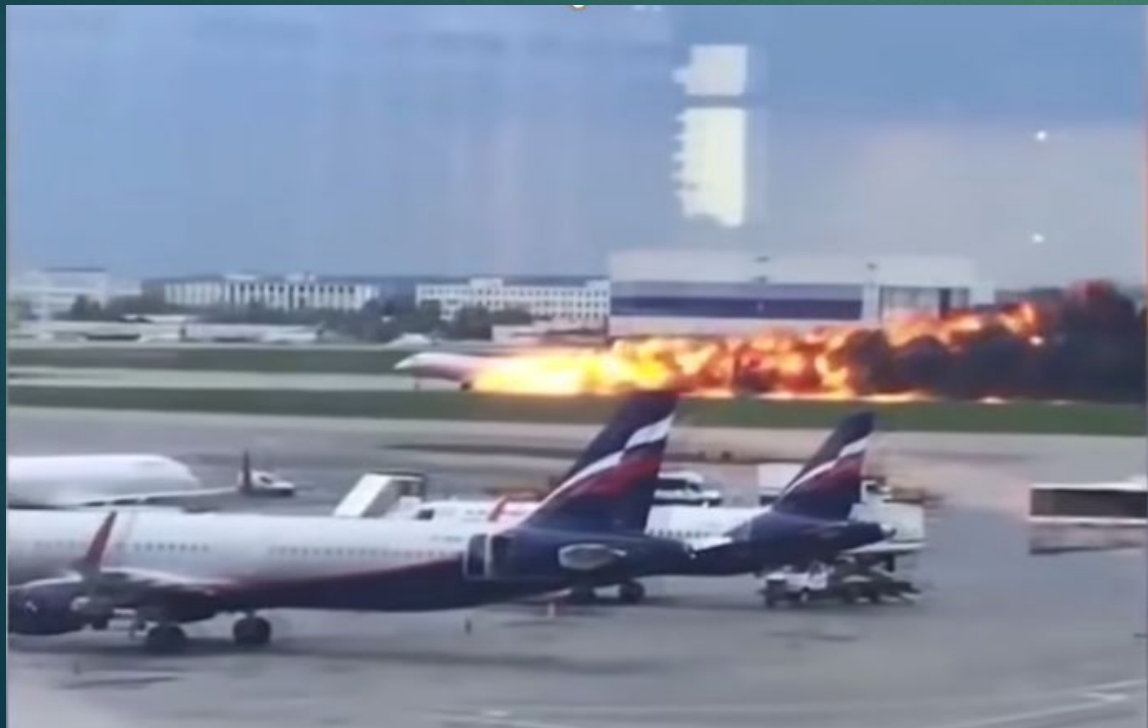
- ▶ The partially destroyed chassis finally breaks down and breaks through the fuel tanks, fuel spills and a fire starts. The dispatcher's command "emergency services to the lane" sounds.
- ▶ The plane turns to the left and stops, evacuation begins and after a minute the engines stop...
