Презентация на тему:
«Катастрофа Superjet 100 в
Шереметьево»

ПРЕЗЕНТАЦИЮ
ПОДГОТОВИЛ СТУДЕНТ
ГРУППЫ БТП 3-1
ЯХОНТОВ АЛЕКСАНДР

On May 5, 2019, an Aeroflot Superjet 100 crashed while landing at Sheremetyevo Airport. The liner was flying on the route Moscow - Murmansk. When returning to the departure airfield, the aircraft made several rough landings and as a result of the resulting fire received significant damage. 41 people died, 37 survived.

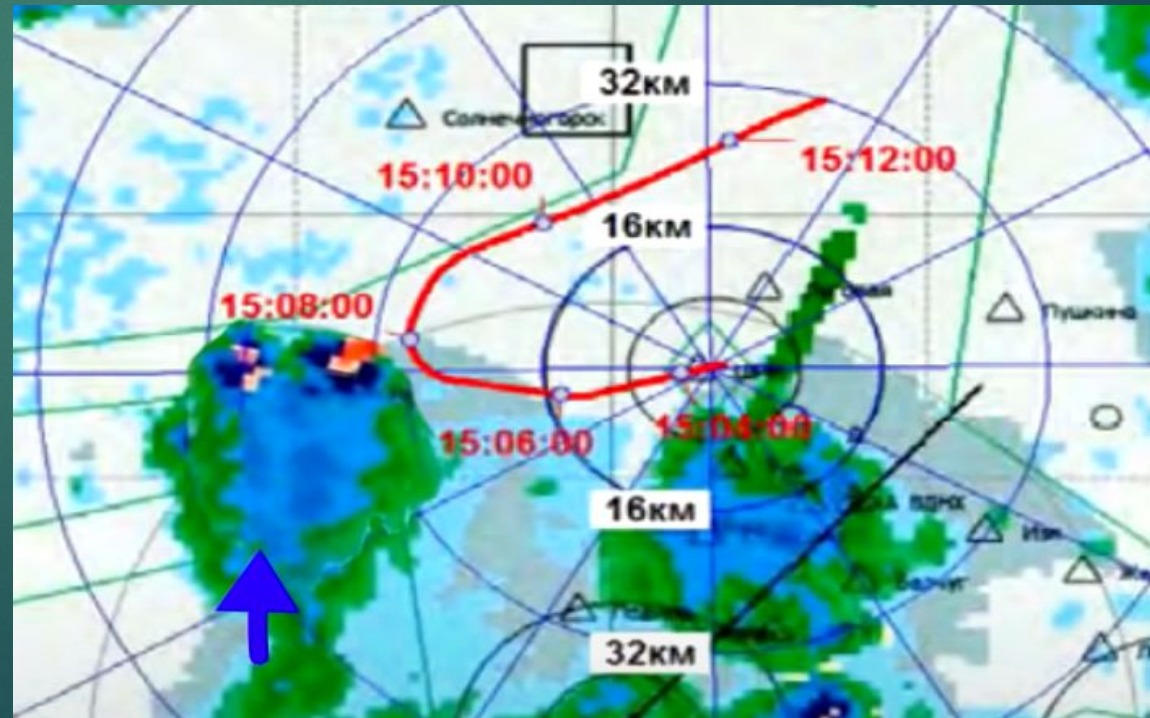
▶ After half a minute, lightning strikes the plane, the autopilot turns off and the plane switches to direct mode (direct control) - one of the three regular flight modes of the liner. In this mode, the aircraft can only be controlled by a joystick (sidestick).
