## CH 3. Five Types of Equipment Map

### 3.1.1 LEAK DETECTOR M/C

## Article 2. Defect Map

## 3.2.1 LEAK DETECTOR

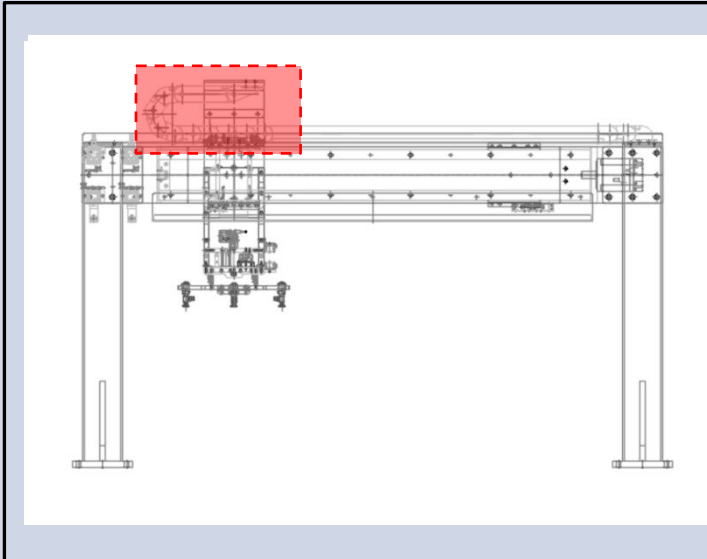
No	Process	Equip. Name	Unit Name	Part Name	Defective Spot	Defective Spot Details	Material	Expected Problem	Cause of Defect	Impact	Estimated Time for Replacement	Points	Level of Significance	Improvements	Completion Y/N	Frequency of Inspection	Periodical Inspection
1	LGCWA #5	LEAK DETECTOR	CELL IN P&P	CABLEVEYOR	1	Cableveyor & Guide Rail Contact Part	Nylon Frame	Operation in the instrument part is not working smoothly because of the defect in the Cableveyor.	friction	L	3		L	Visual Maintenance after Eye-Mark	Y	1 day	friction

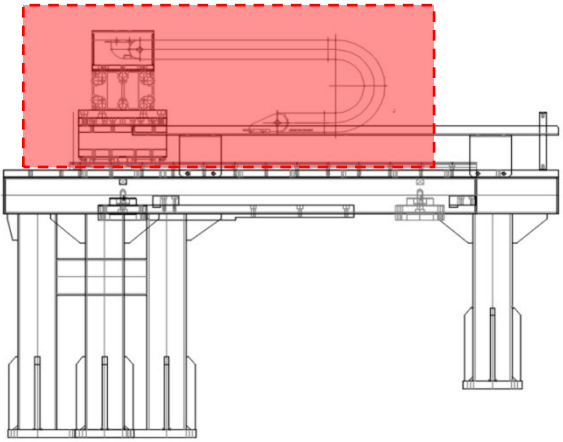
No	Process	Equip. Name	Unit Name	Part Name	Defective Spot	Defective Spot Details	Material	Expected Problem	Cause of Defect	Impact	Estimated Time for Replacement	Points	Level of Significance	Improvements	Completion Y/N	Frequency of Inspection	Period of Inspection
1	LGCWA #5	LEAK DETECTOR	CELL IN TRANSFER	CABLEVEYOR	1	Cableveyor & Guide Rail Contact Part	Nylon Frame	Operation in the instrument part is not working smoothly because of the defect in the Cableveyor.	friction	L	3		L	Visual Maintenance after Eye-Mark	Y	1 day	friction

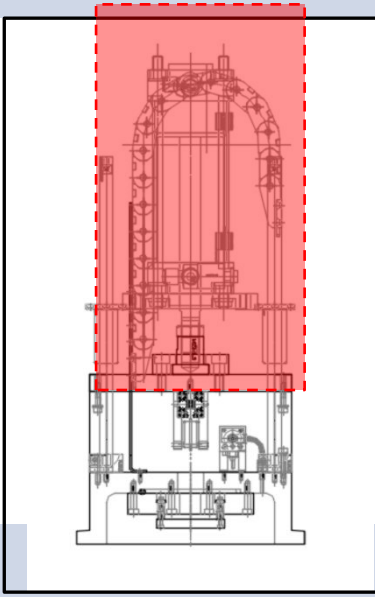
No	Process	Equip. Name	Unit Name	Part Name	Defective Spot	Defective Spot Details	Material	Expected Problem	Cause of Defect	Impact	Estimated Time for Replacement	Points	Level of Significance	Improvements	Completion Y/N	Frequency of Inspection	Periodical Inspection
1	LGCWA #5	LEAK DETECTOR	LEAK DETECTOR (Upper Part)	CABLEVEYOR	1	Cableveyor & Guide Rail Contact Part	Nylon Frame	Operation in the instrument part is not working smoothly because of the defect in the Cableveyor.	friction	L	3		L	Visual Maintenance after Eye-Mark	Y	1 day	friction

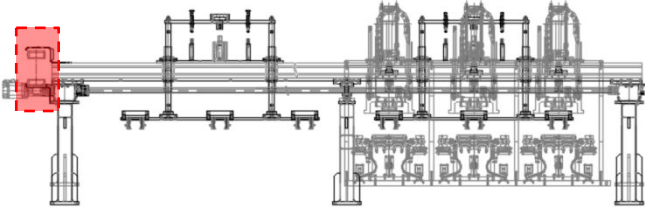
No	Process	Equip. Name	Unit Name	Part Name	Defective Spot	Defective Spot Details	Material	Expected Problem	Cause of Defect	Impact	Estimated Time for Replacement	Points	Level of Significance	Improvements	Completion Y/N	Frequency of Inspection	Periodical Inspection
1	LGCWA #5	LEAK DETECTOR	CELL OUT TRANSFER	CABLEVEYOR	1	Cableveyor & Guide Rail Contact Part	Nylon Frame	Operation in the instrument part is not working smoothly because of the defect in the Cableveyor.	friction	L	3		L	Visual Maintenance after Eye-Mark	Y	1 day	friction

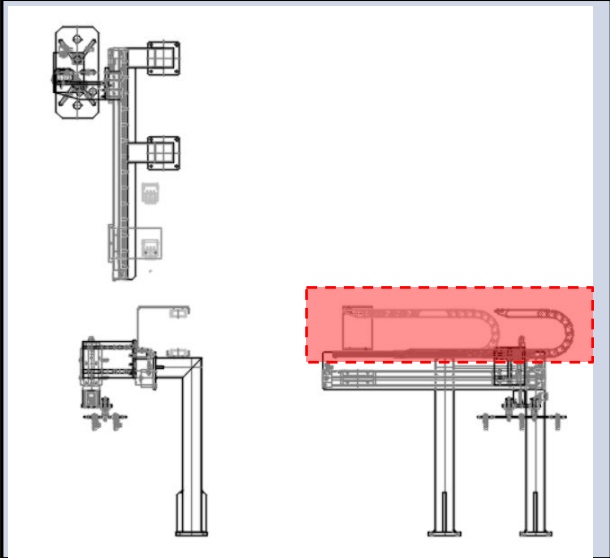
No	Process	Equip. Name	Unit Name	Part Name	Defective Spot	Defective Spot Details	Material	Expected Problem	Cause of Defect	Impact	Estimated Time for Replacement	Points	Level of Significance	Improvements	Completion Y/N	Frequency of Inspection	Periodical Inspection
1	LGCWA #5	LEAK DETECTOR	NG Ejection	CABLEVEYOR	1	Cableveyor & Guide Rail Contact Part	Nylon Frame	Operation in the instrument part is not working smoothly because of the defect in the Cableveyor.	friction	L	3		L	Visual Maintenance after Eye-Mark	Y	1 day	friction

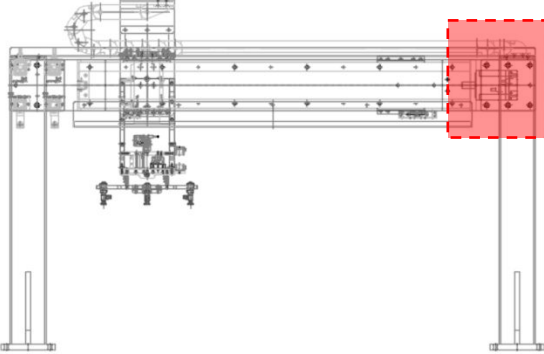
No	Process	Equip. Name	Unit Name	Part Name	Vibration Source Section	Vibration Source Section Details	Expected Problem	Cause of Vibration Source	Impact	Estimated Time for Replacement	Points	Level of Significance	Improvements	Completion Y/N	Frequency Inspection	Periodical Inspection
1	LGCWA #5	LEAK DETECTOR	CELL IN P&P	Driving MOTOR	1	Driving MOTOR (SERVO MOTOR)	Unable to transfer CELL because of the defect in the MOTOR.	MOTOR Driving	Equipment Defect	10 min.		M	Visual Maintenance after Eye-Mark	Y	Once/6M	Once/6M

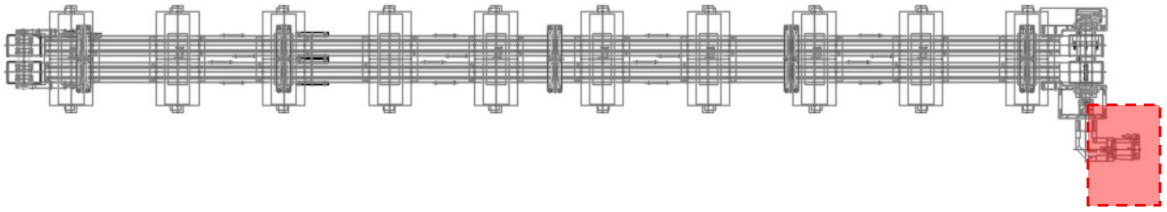
No	Process	Equip. Name	Unit Name	Part Name	Vibration Source Section	Vibration Source Section Details	Expected Problem	Cause of Vibration Source	Impact	Estimated Time for Replacement	Points	Level of Significance	Improvements	Completion Y/N	Frequency Inspection	Periodical Inspection
1	LGCWA #5	LEAK DETECTOR	CELL IN CONVEYOR	Driving MOTOR	1	Driving MOTOR (SERVO MOTOR)	Unable to transfer CELL because of the defect in the MOTOR.	MOTOR Driving	Equipment Defect	10 min.		M	Visual Maintenance after Eye-Mark	Y	Once/6M	Once/6M

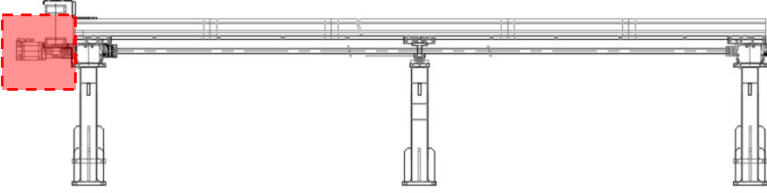
No	Process	Equip. Name	Unit Name	Part Name	Vibration Source Section	Vibration Source Section Details	Expected Problem	Cause of Vibration Source	Impact	Estimated Time for Replacement	Points	Level of Significance	Improvements	Completion Y/N	Frequency Inspection	Periodical Inspection
1	LGCWA #5	LEAK DETECTOR	CELL IN TRANSFER	Driving MOTOR	1	Driving MOTOR (SERVO MOTOR)	Unable to transfer CELL because of the defect in the MOTOR.	MOTOR Driving	Equipment Defect	10 min.		M	Visual Maintenance after Eye-Mark	Y	Once/6M	Once/6M

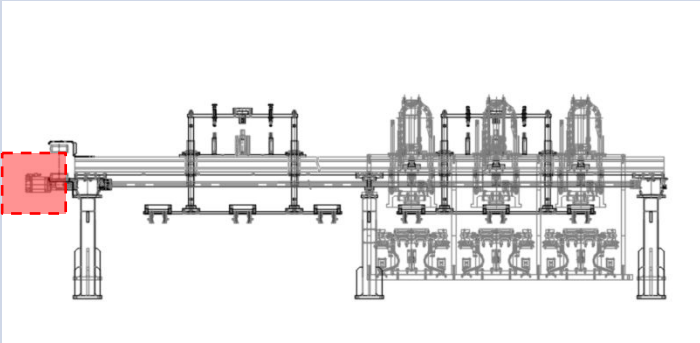
No	Process	Equip. Name	Unit Name	Part Name	Vibration Source Section	Vibration Source Section Details	Expected Problem	Cause of Vibration Source	Impact	Estimated Time for Replacement	Points	Level of Significance	Improvements	Completion Y/N	Frequency Inspection	Periodical Inspection
1	LGCWA #5	LEAK DETECTOR	CELL OUT TRANSFER	Driving MOTOR	1	Driving MOTOR (SERVO MOTOR)	Unable to transfer CELL because of the defect in the MOTOR.	MOTOR Driving	Equipment Defect	10 min.		M	Visual Maintenance after Eye-Mark	Y	Once/6M	Once/6M

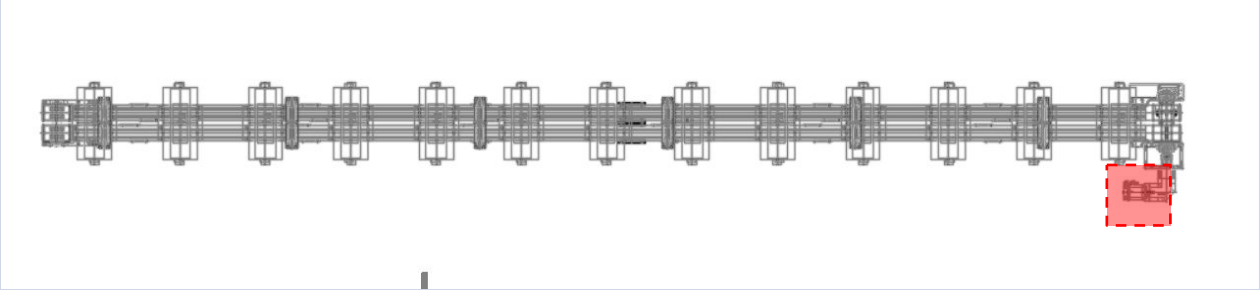
No	Process	Equip. Name	Unit Name	Part Name	Vibration Source Section	Vibration Source Section Details	Expected Problem	Cause of Vibration Source	Impact	Estimated Time for Replacement	Points	Level of Significance	Improvements	Completion Y/N	Frequency Inspection	Periodical Inspection
1	LGCWA #5	LEAK DETECTOR	CELL OUT CONVEYOR	Driving MOTOR	1	Driving MOTOR (SERVO MOTOR)	Unable to transfer CELL because of the defect in the MOTOR.	MOTOR Driving	Equipment Defect	10 min.		M	Visual Maintenance after Eye-Mark	Y	Once/6M	Once/6M

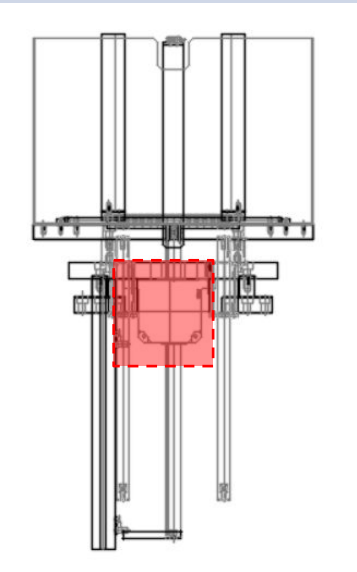
No	Process	Equip. Name	Unit Name	Part Name	Vibration Source Section	Vibration Source Section Details	Expected Problem	Cause of Vibration Source	Impact	Estimated Time for Replacement	Points	Level of Significance	Improvements	Completion Y/N	Frequency Inspection	Periodical Inspection
1	LGCWA #5	LEAK DETECTOR	NG Ejection	Driving MOTOR	1	Driving MOTOR (SERVO MOTOR)	Unable to transfer CELL because of the defect in the MOTOR.	MOTOR Driving	Equipment Defect	10 min.		M	Visual Maintenance after Eye-Mark	Y	Once/6M	Once/6M
