**Furnaces corrosion / prevention to
improve the longevity of campaigns
Th Roustan 2016/10**

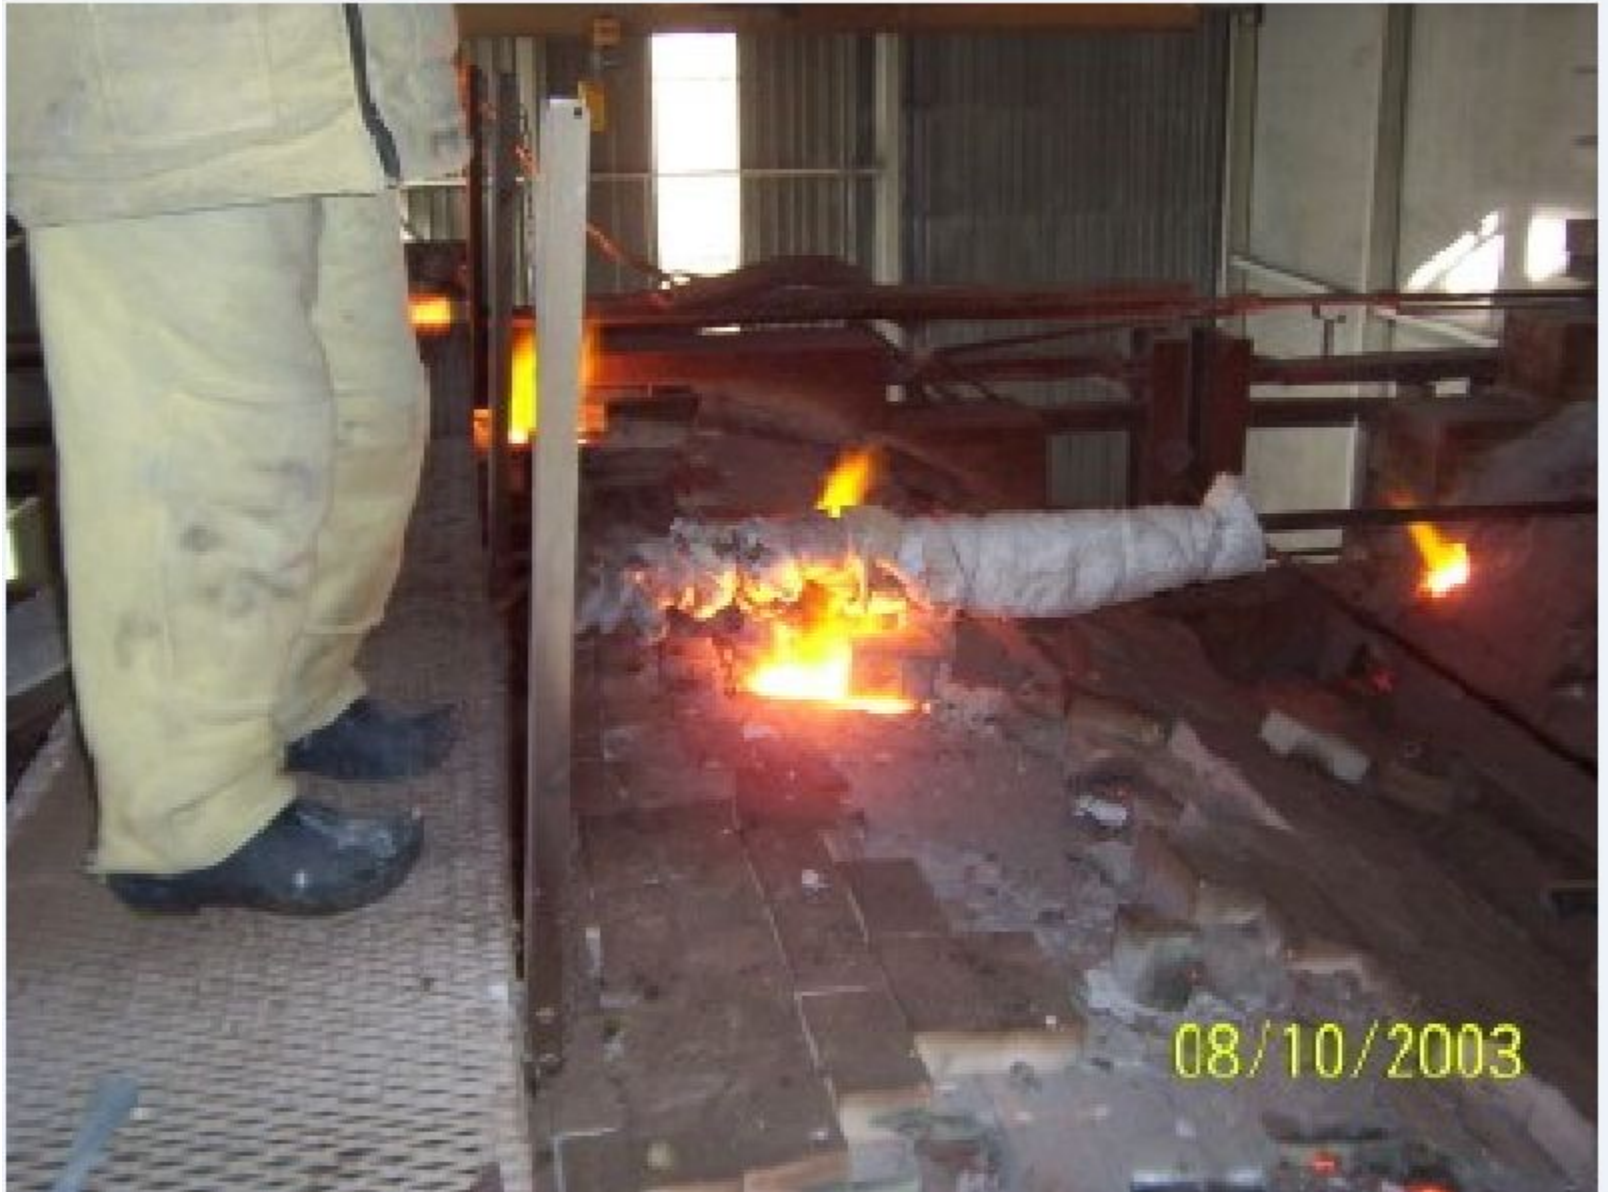
Crown flames passages

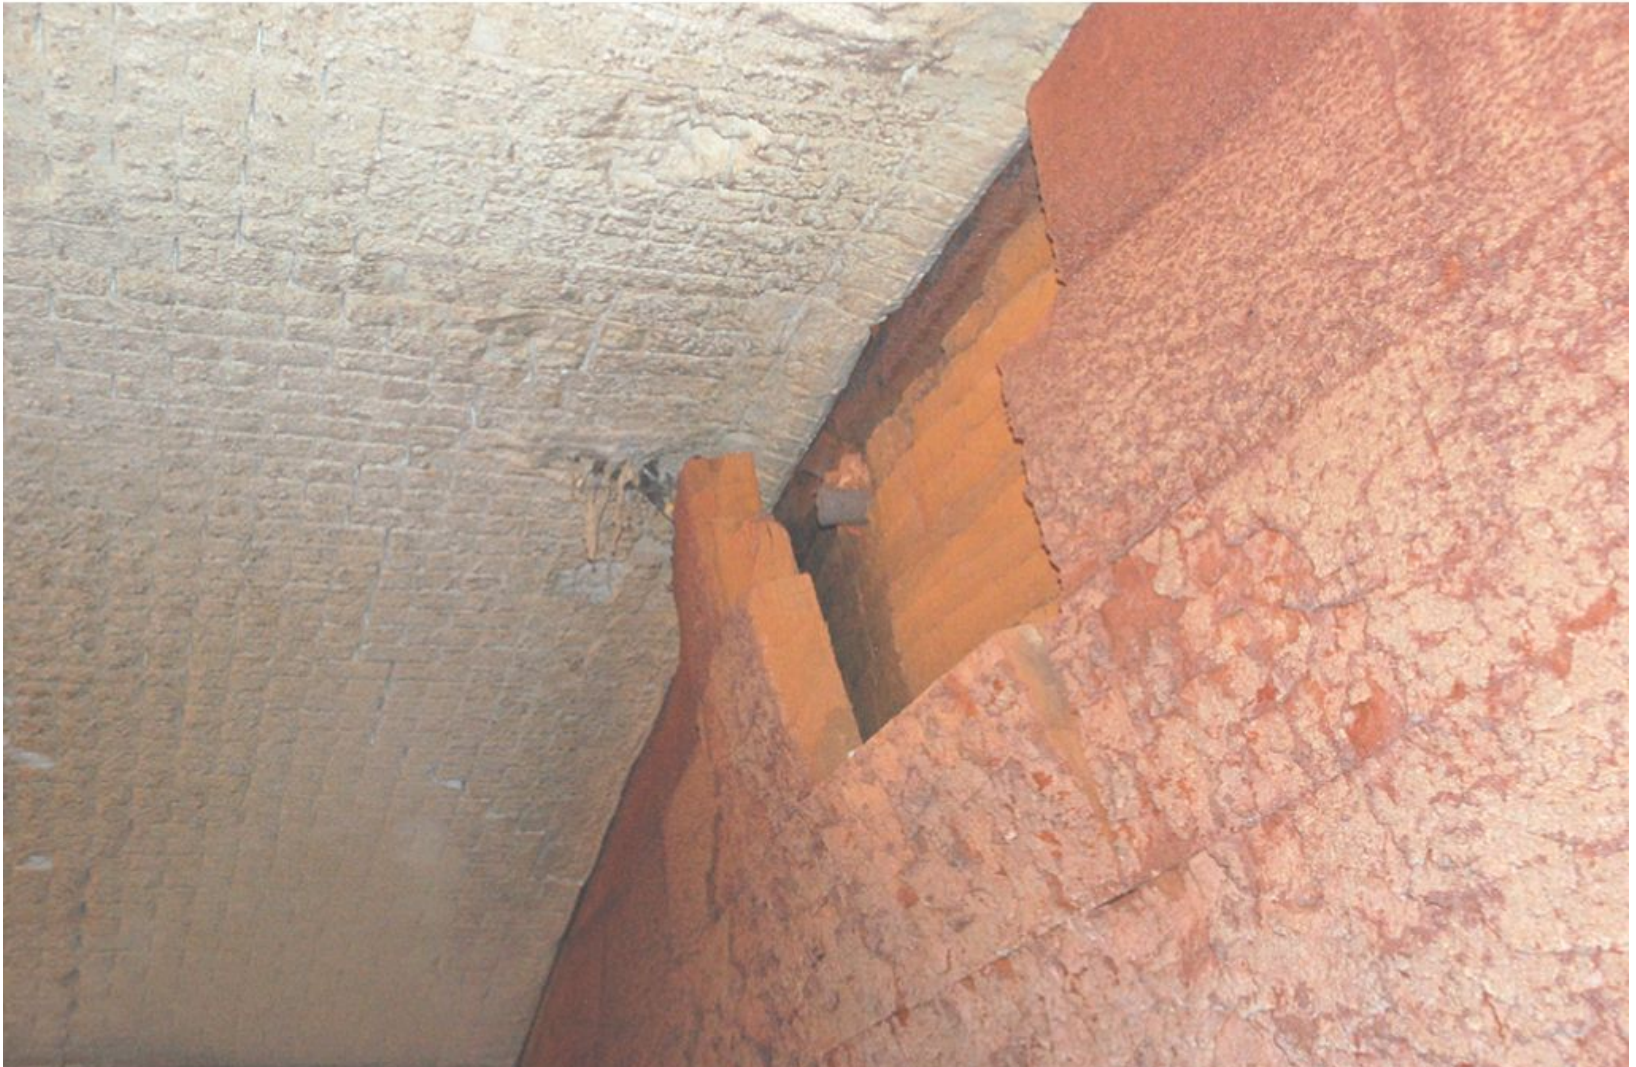
Lagnieu F2 front wall / concrete wall protection

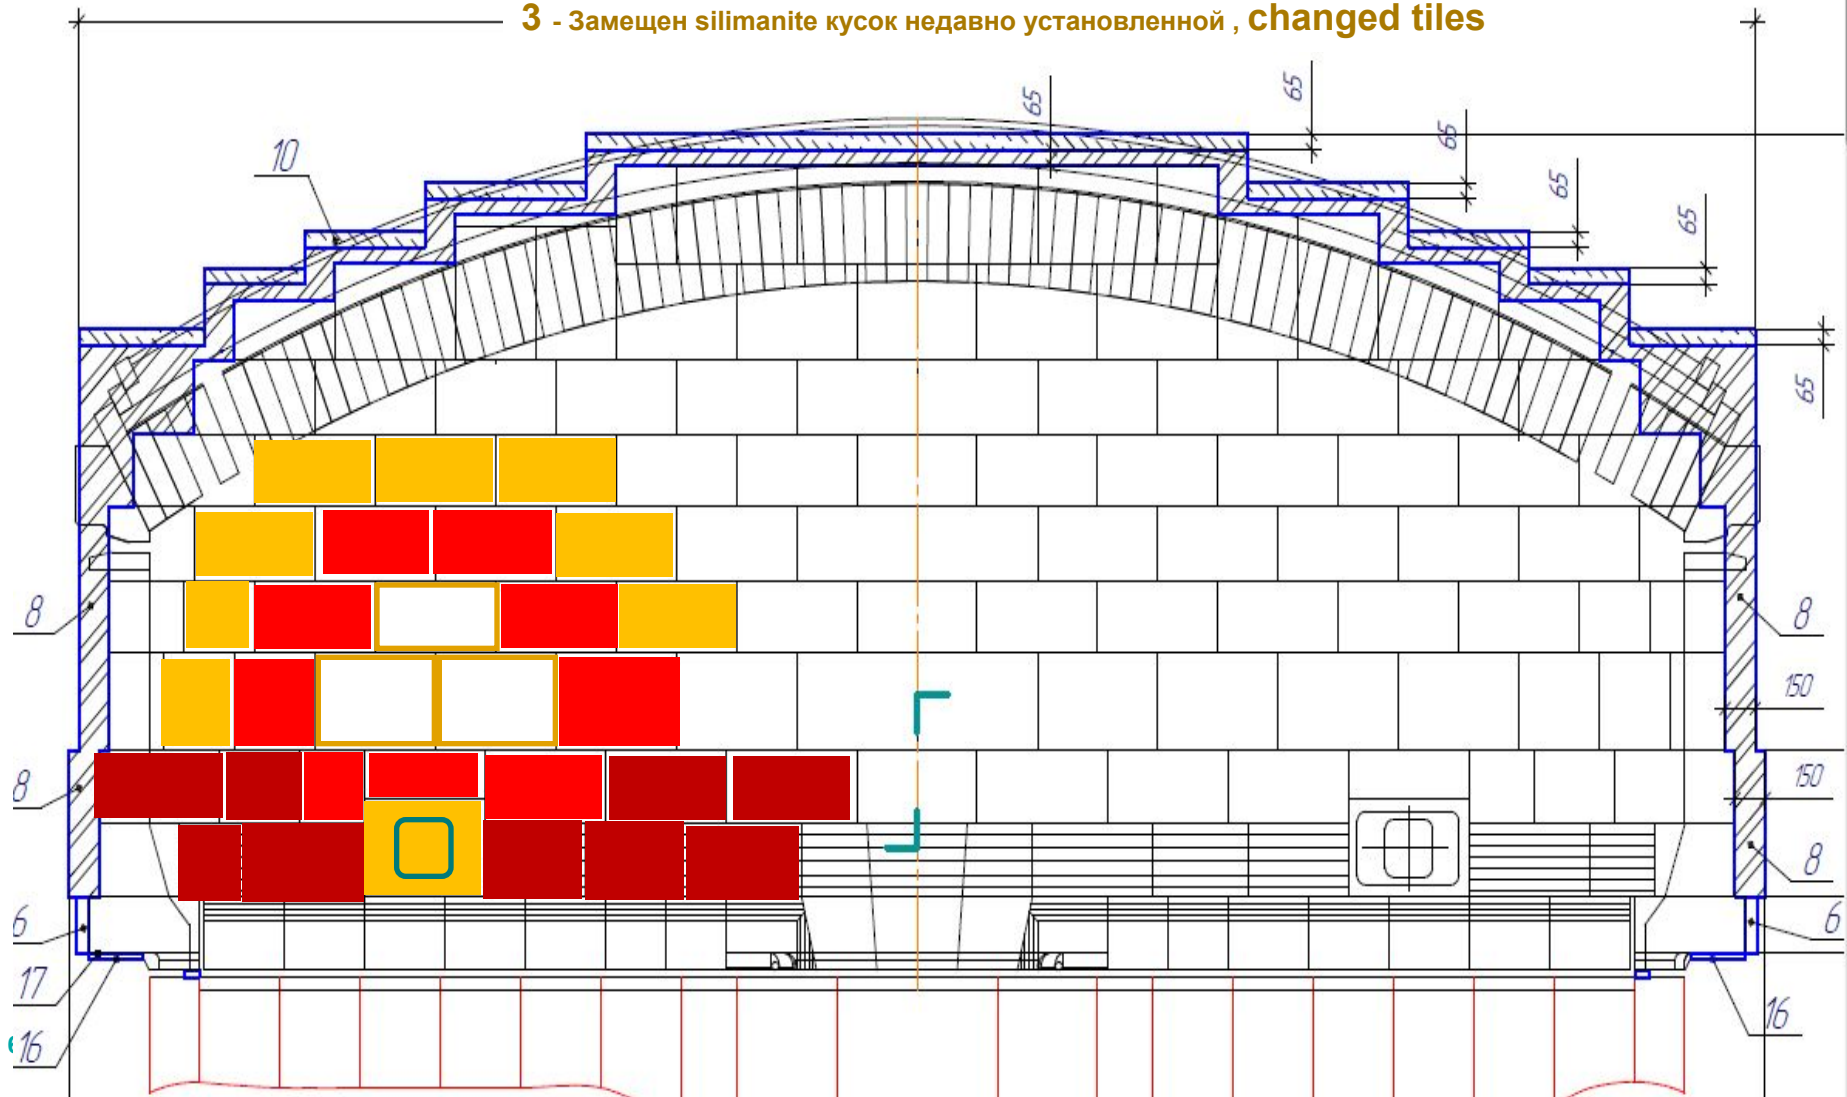
Kamyshin F1 front wall repair

Визуальный
осмотр со стороны
горелочных блоков

0 - Уже упал, следующий слой видим ,

already felt down

1 - Коррозия или частично нарушена, но в положении, part

heavy attack wit missed

2 - Нестабильный готов упасть.,

attacked

3 - Замещен silimanite кусок недавно установленной , changed tiles

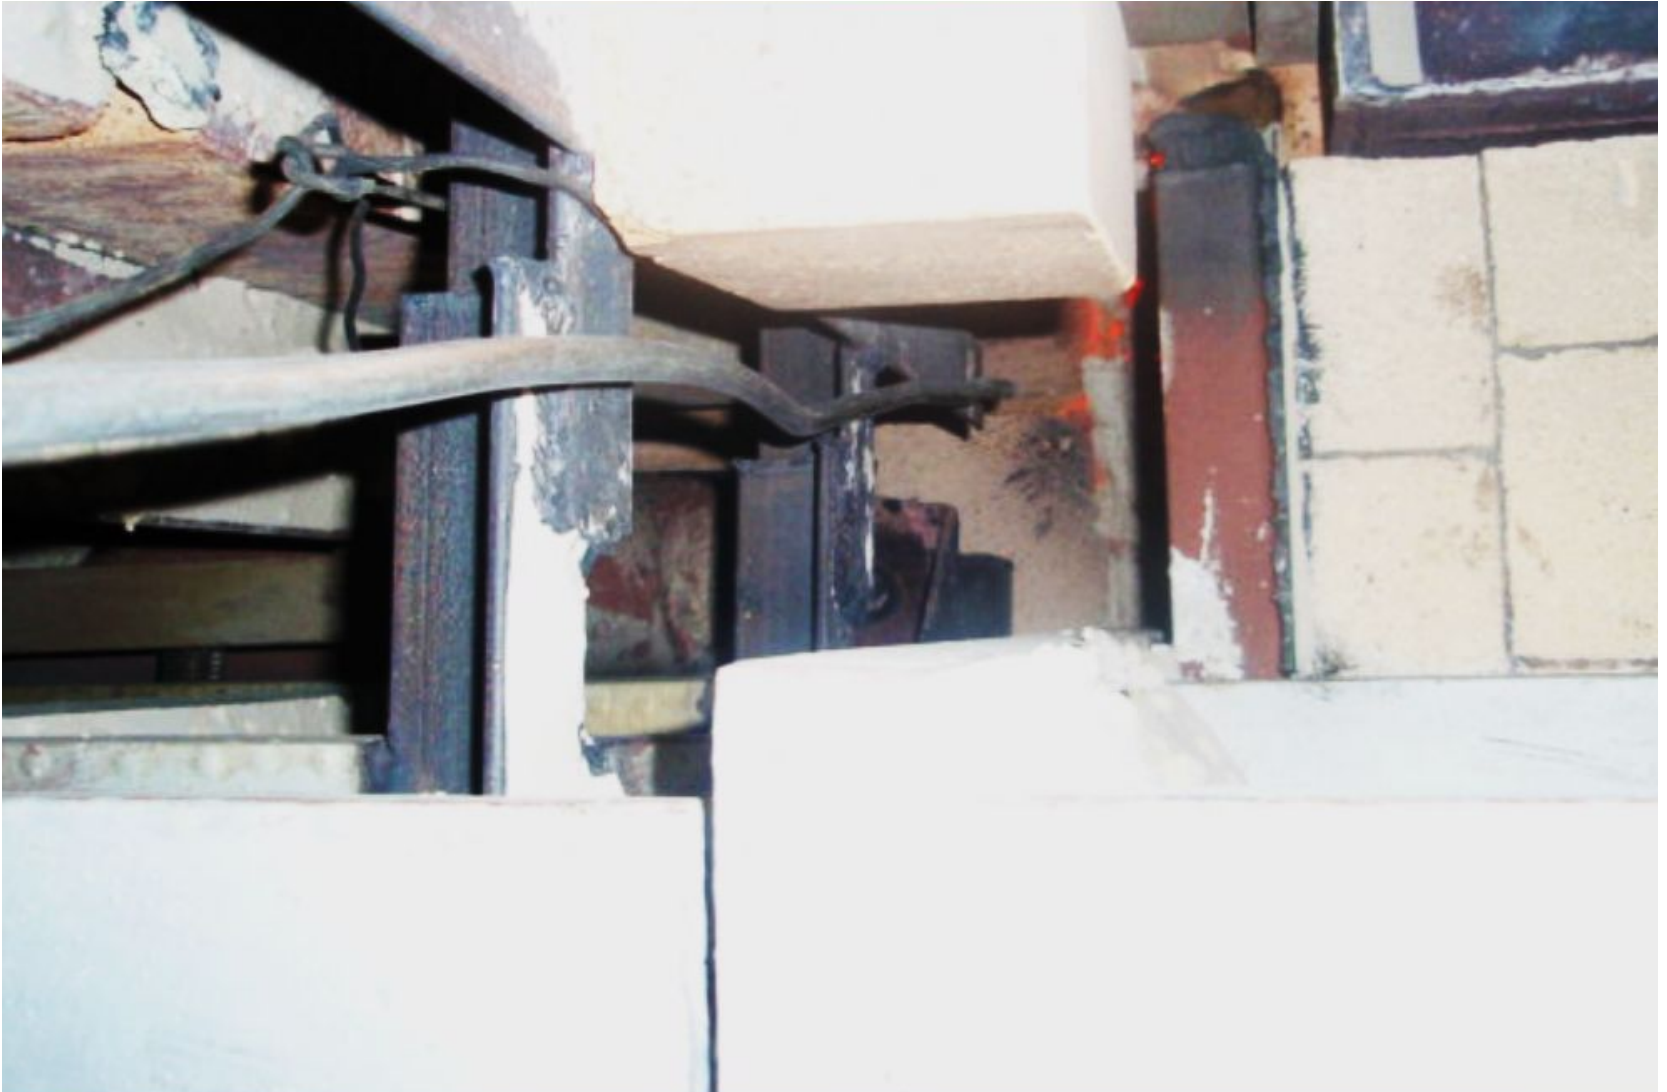
Dog house angle bloc not enough air cooling

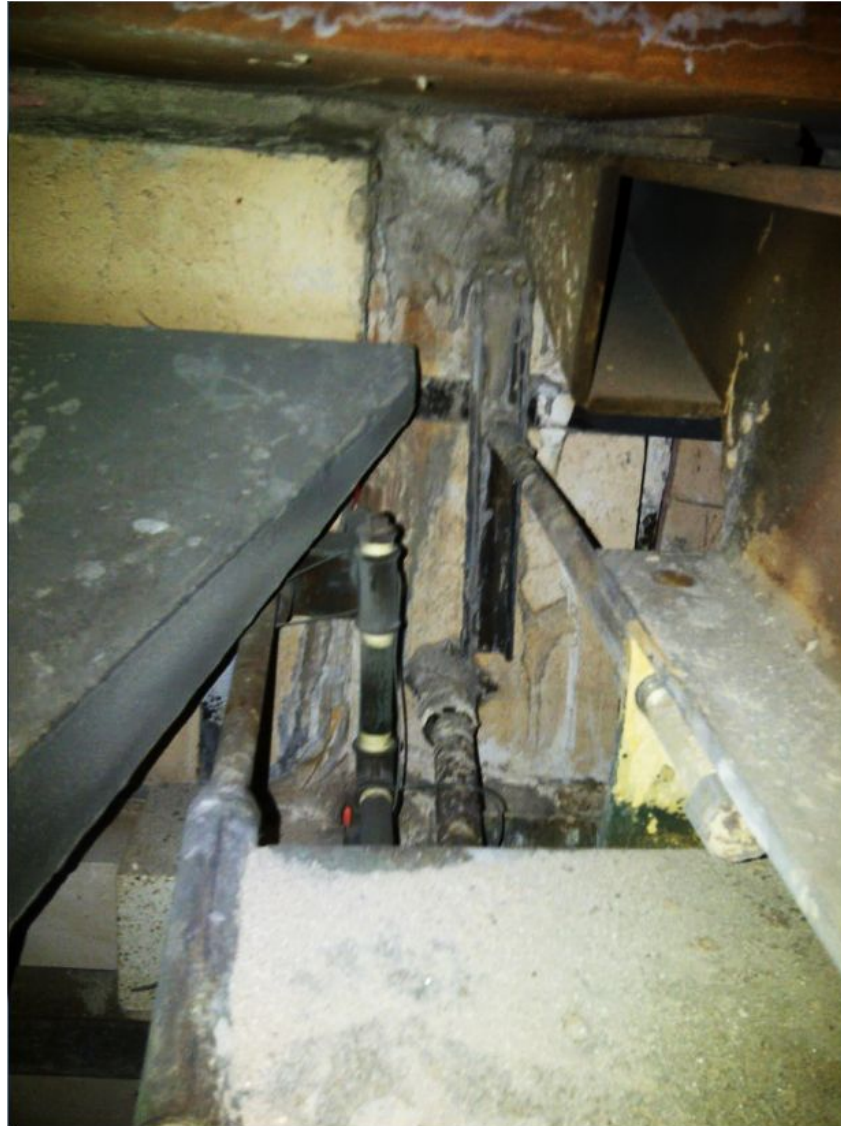
Extremity angle tank joint glass infiltration

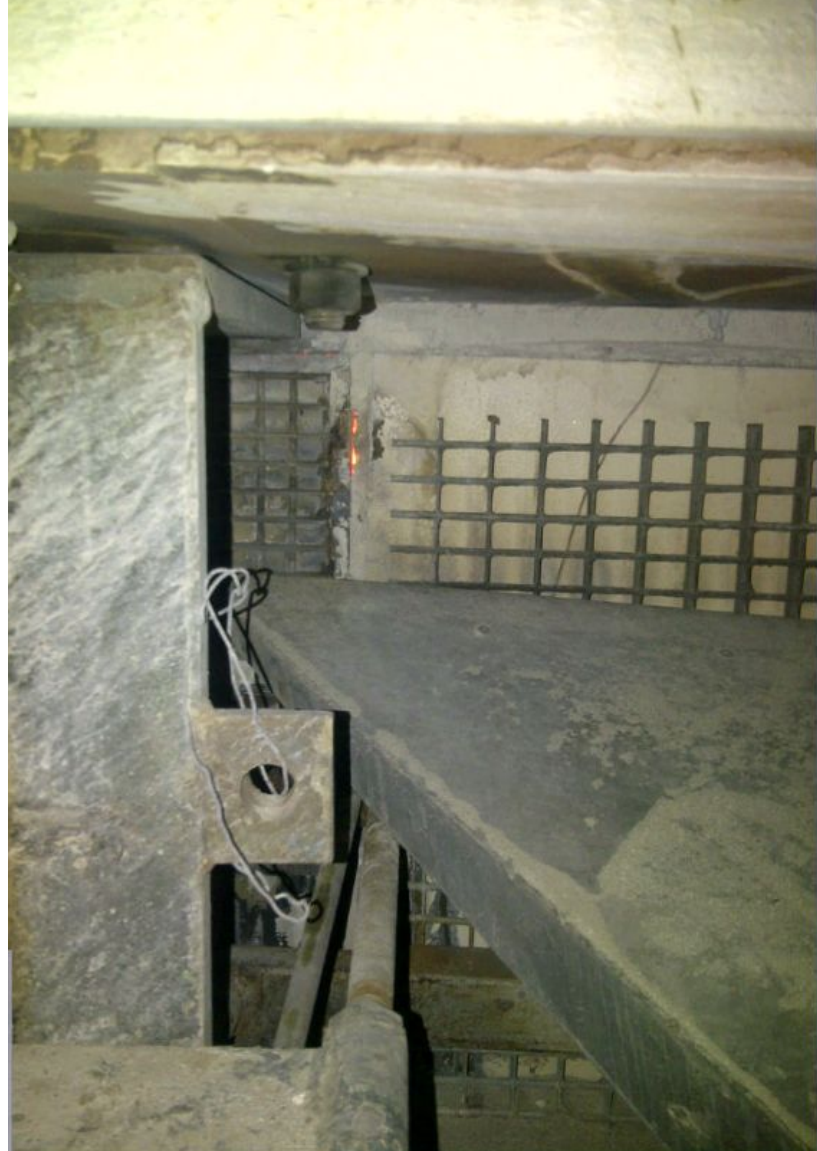
**Glass level corrosion,
leakage potential ricks
After 6 months in case of
air cooling breackdownwn**

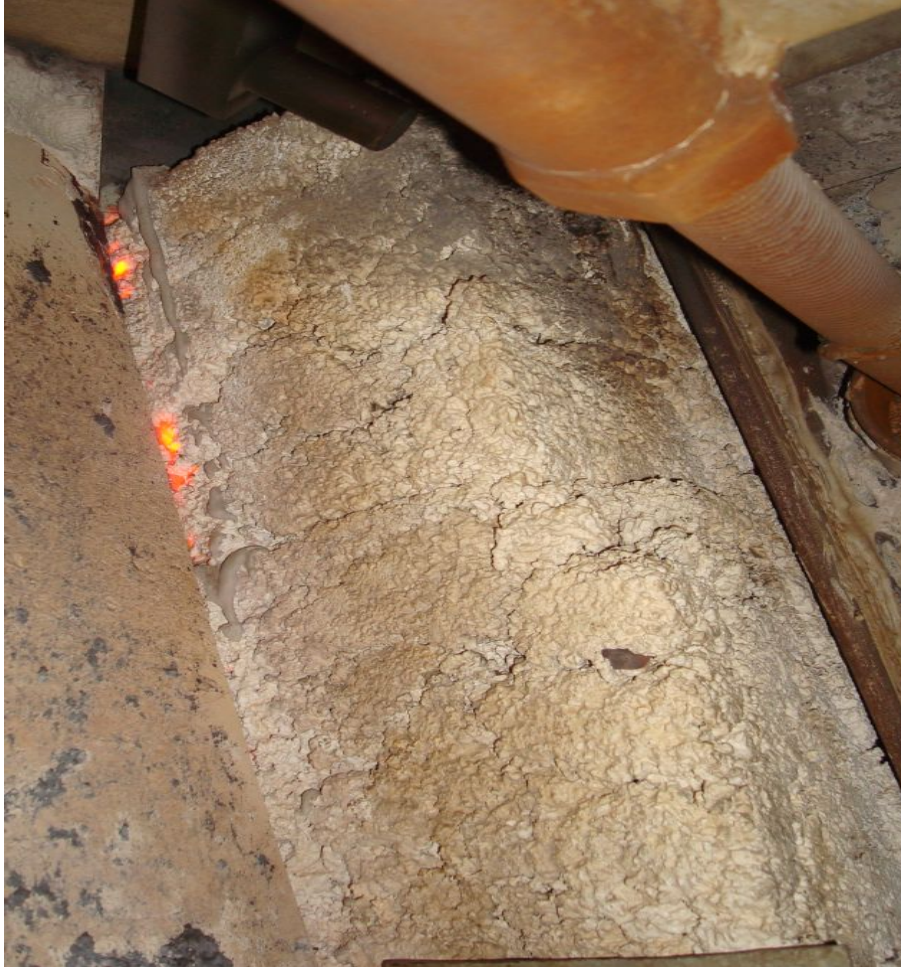
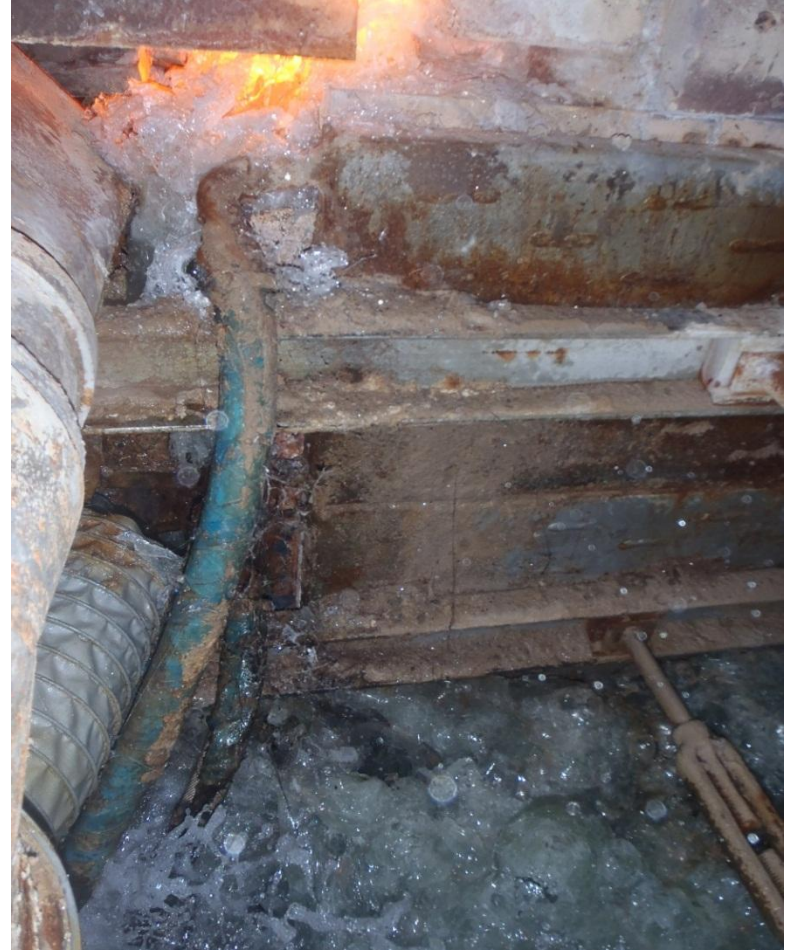
Throat angle block corrosion with bad air cooling..... And glass leakage

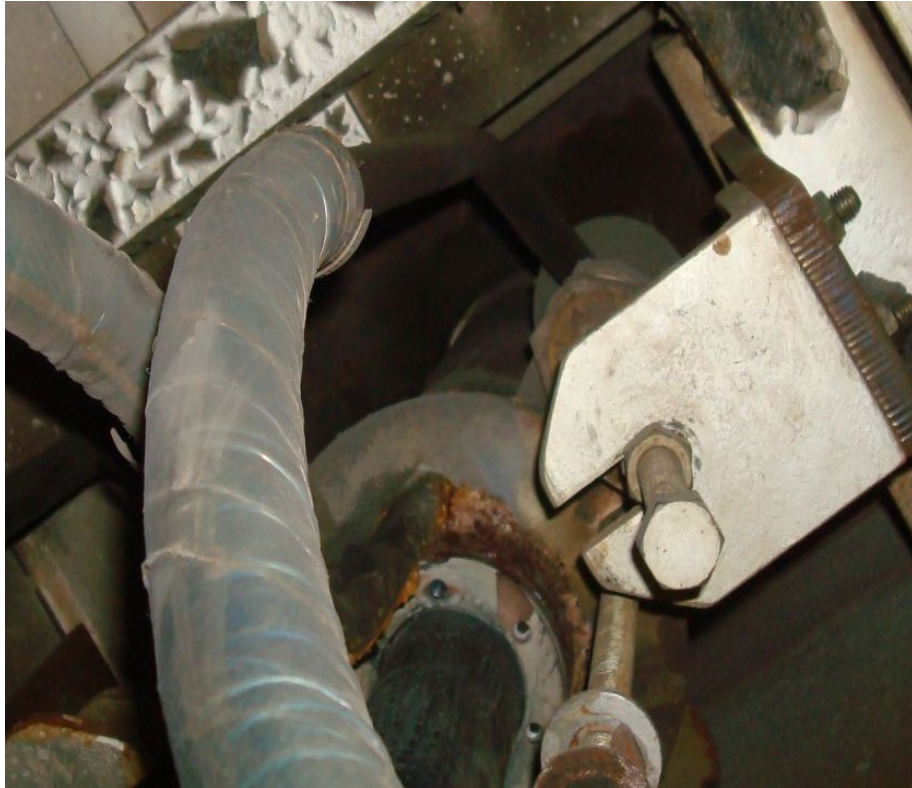
Water leak on electrode water jacket during 2 years without repair

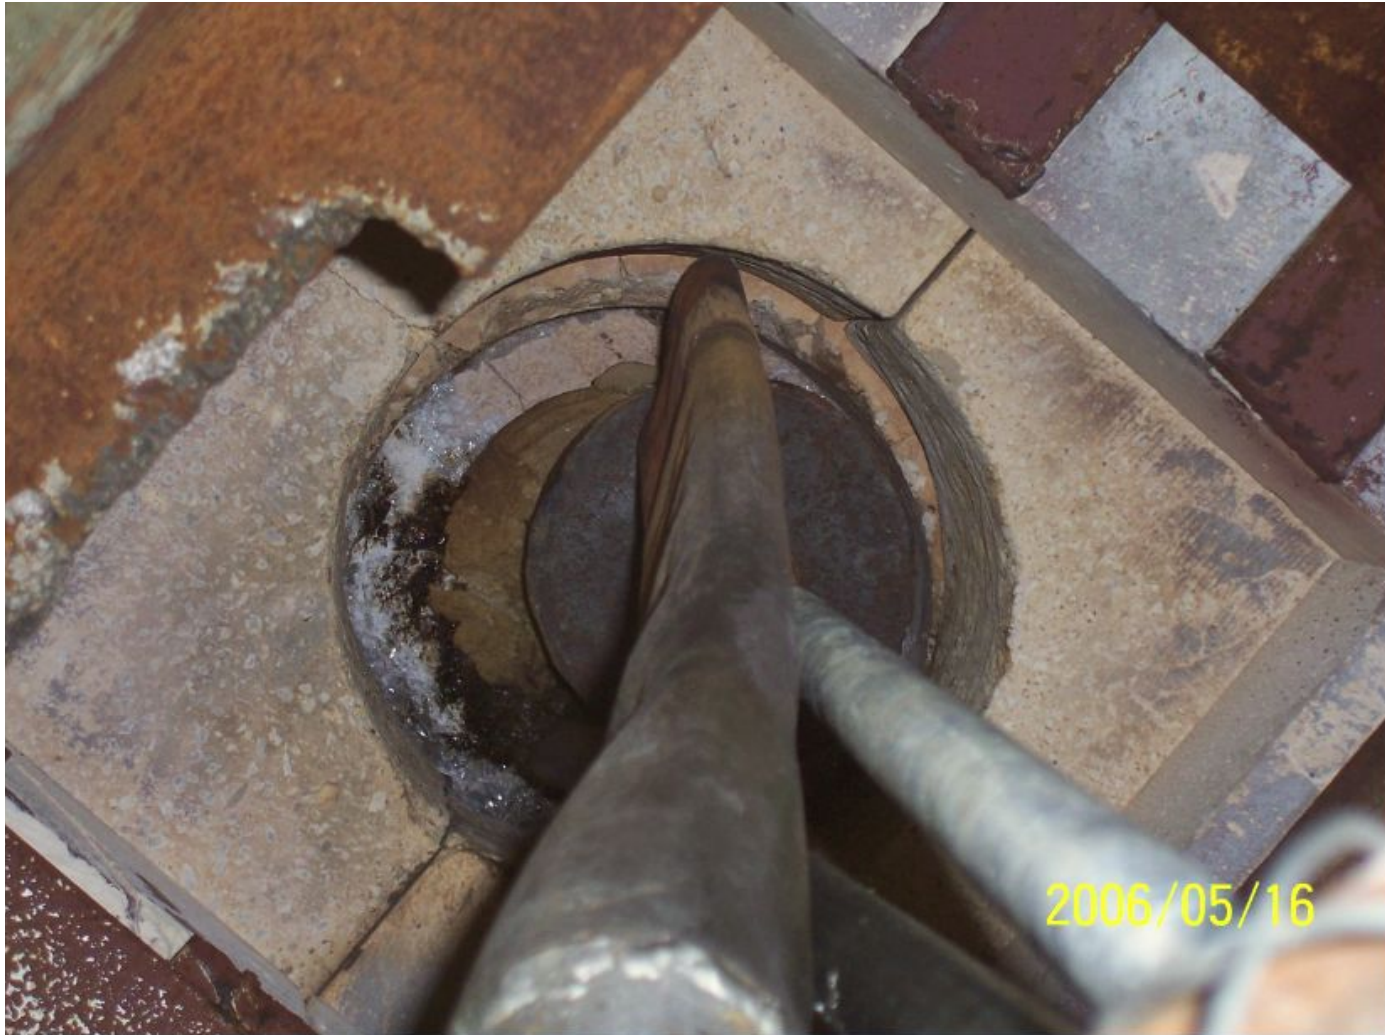
Bubbler block corroded, important glass infiltration

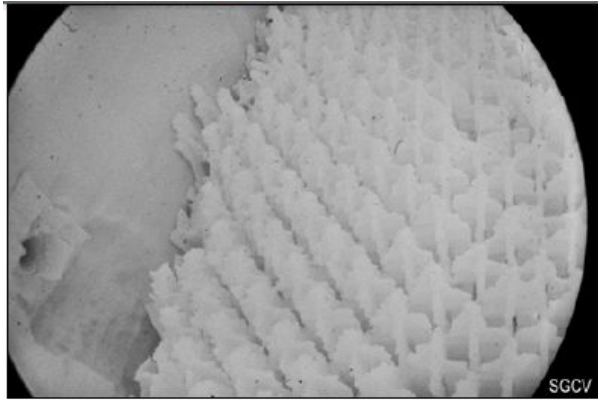
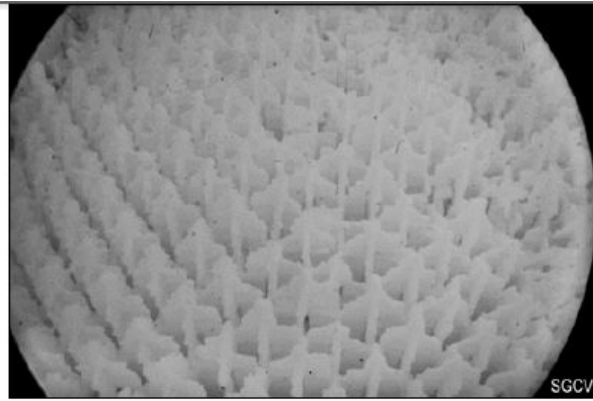
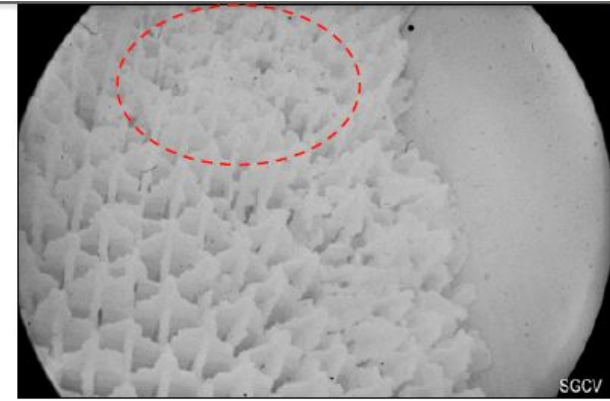
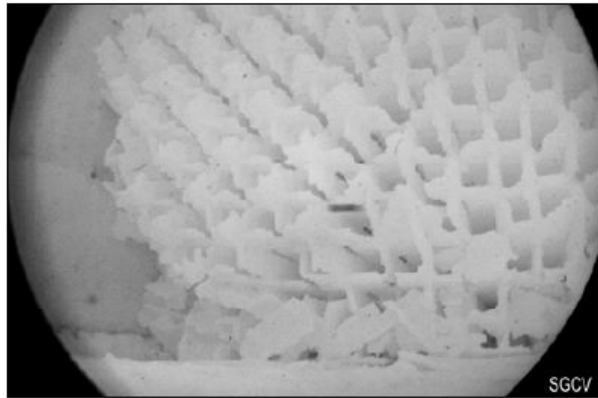
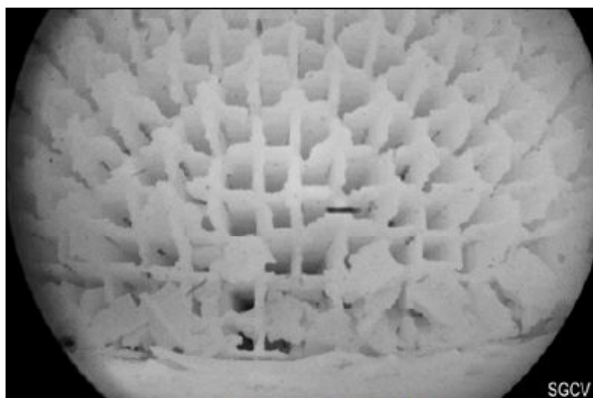
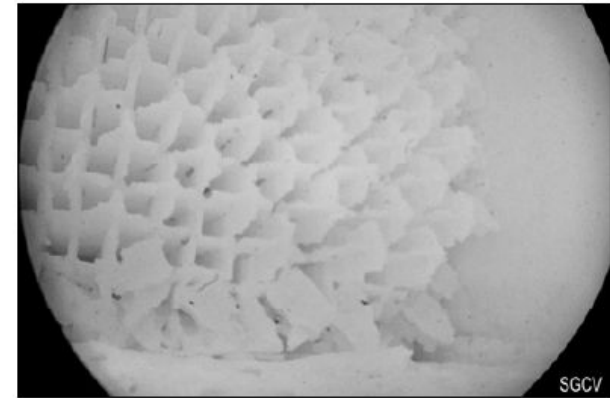
Checkers corrosion.....

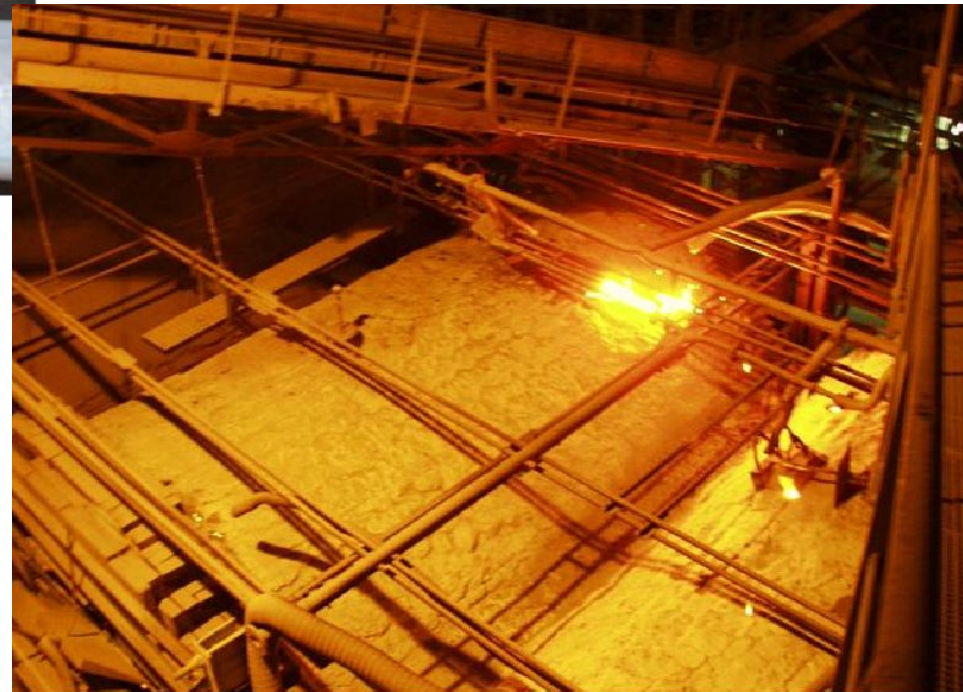
**Flames passage on
regenerator's crowns
(checkers frequently locked)**

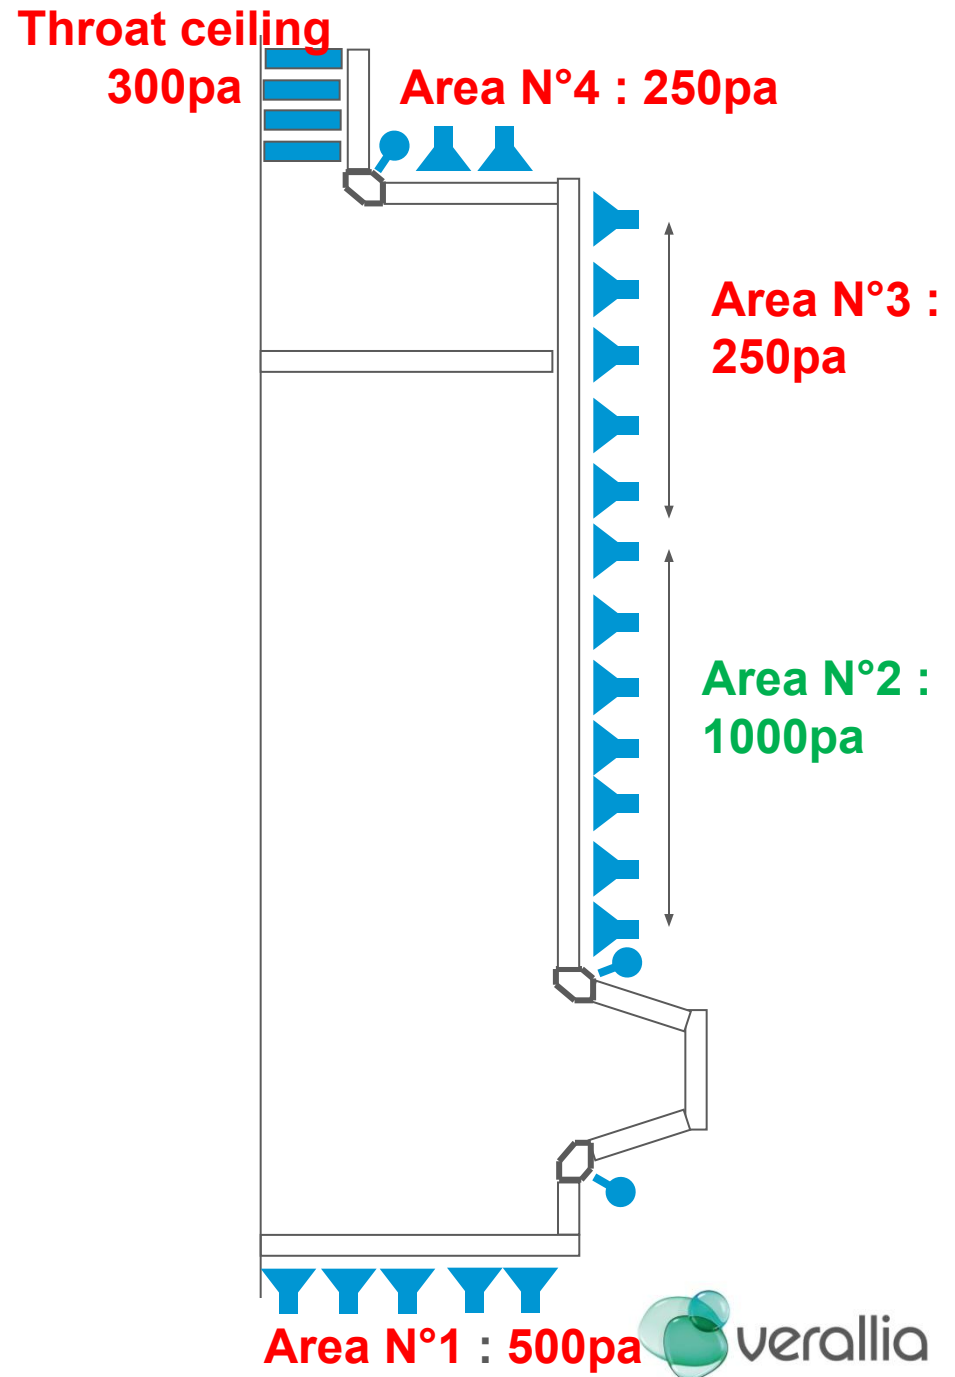
Air cooling
pressure measurement
on nozzles example
In red color insufficient
air cooling quantity
(≥ 700 Pa)

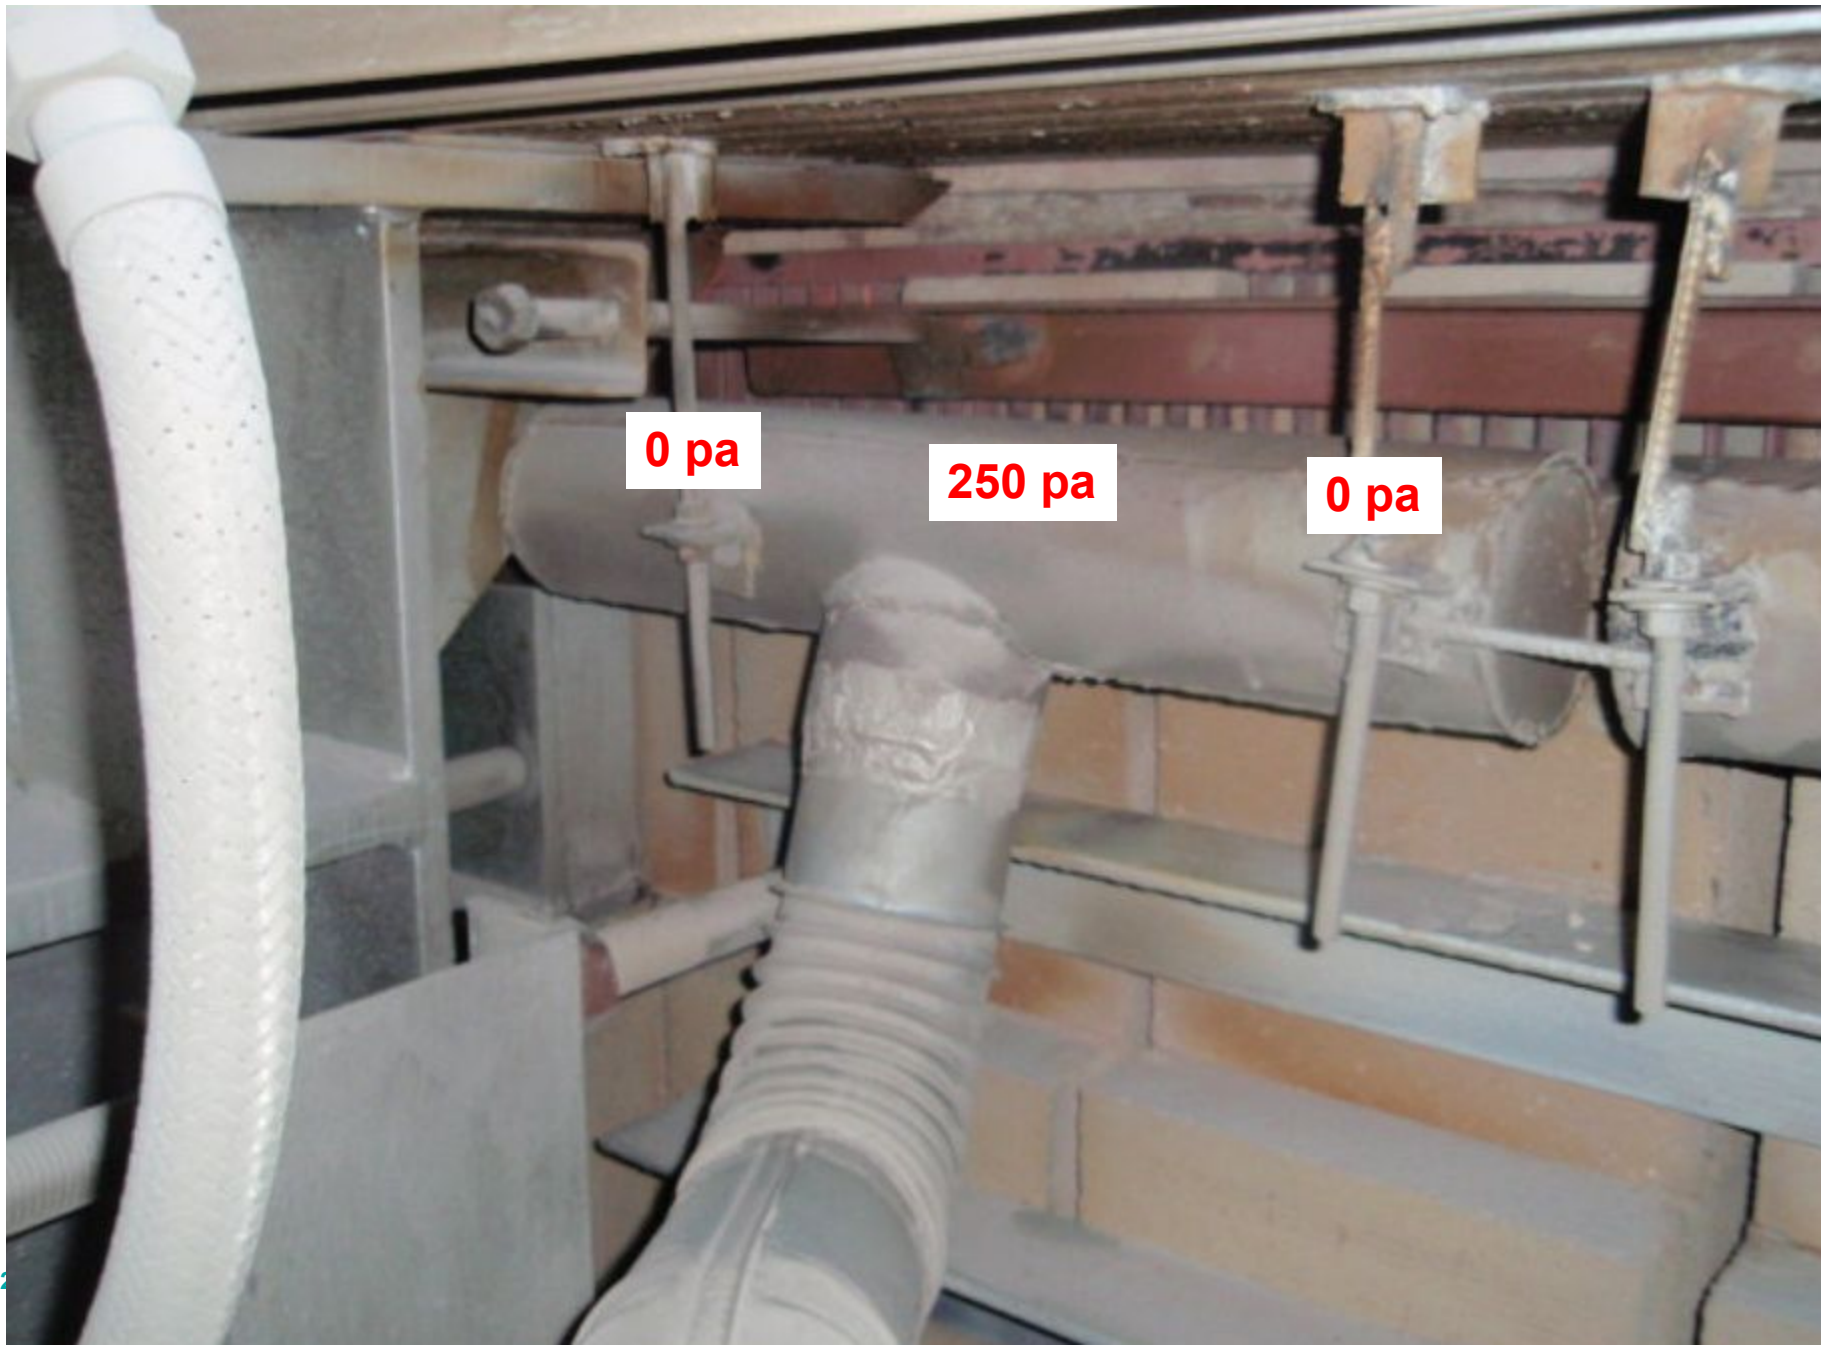
Bad nozzles shape

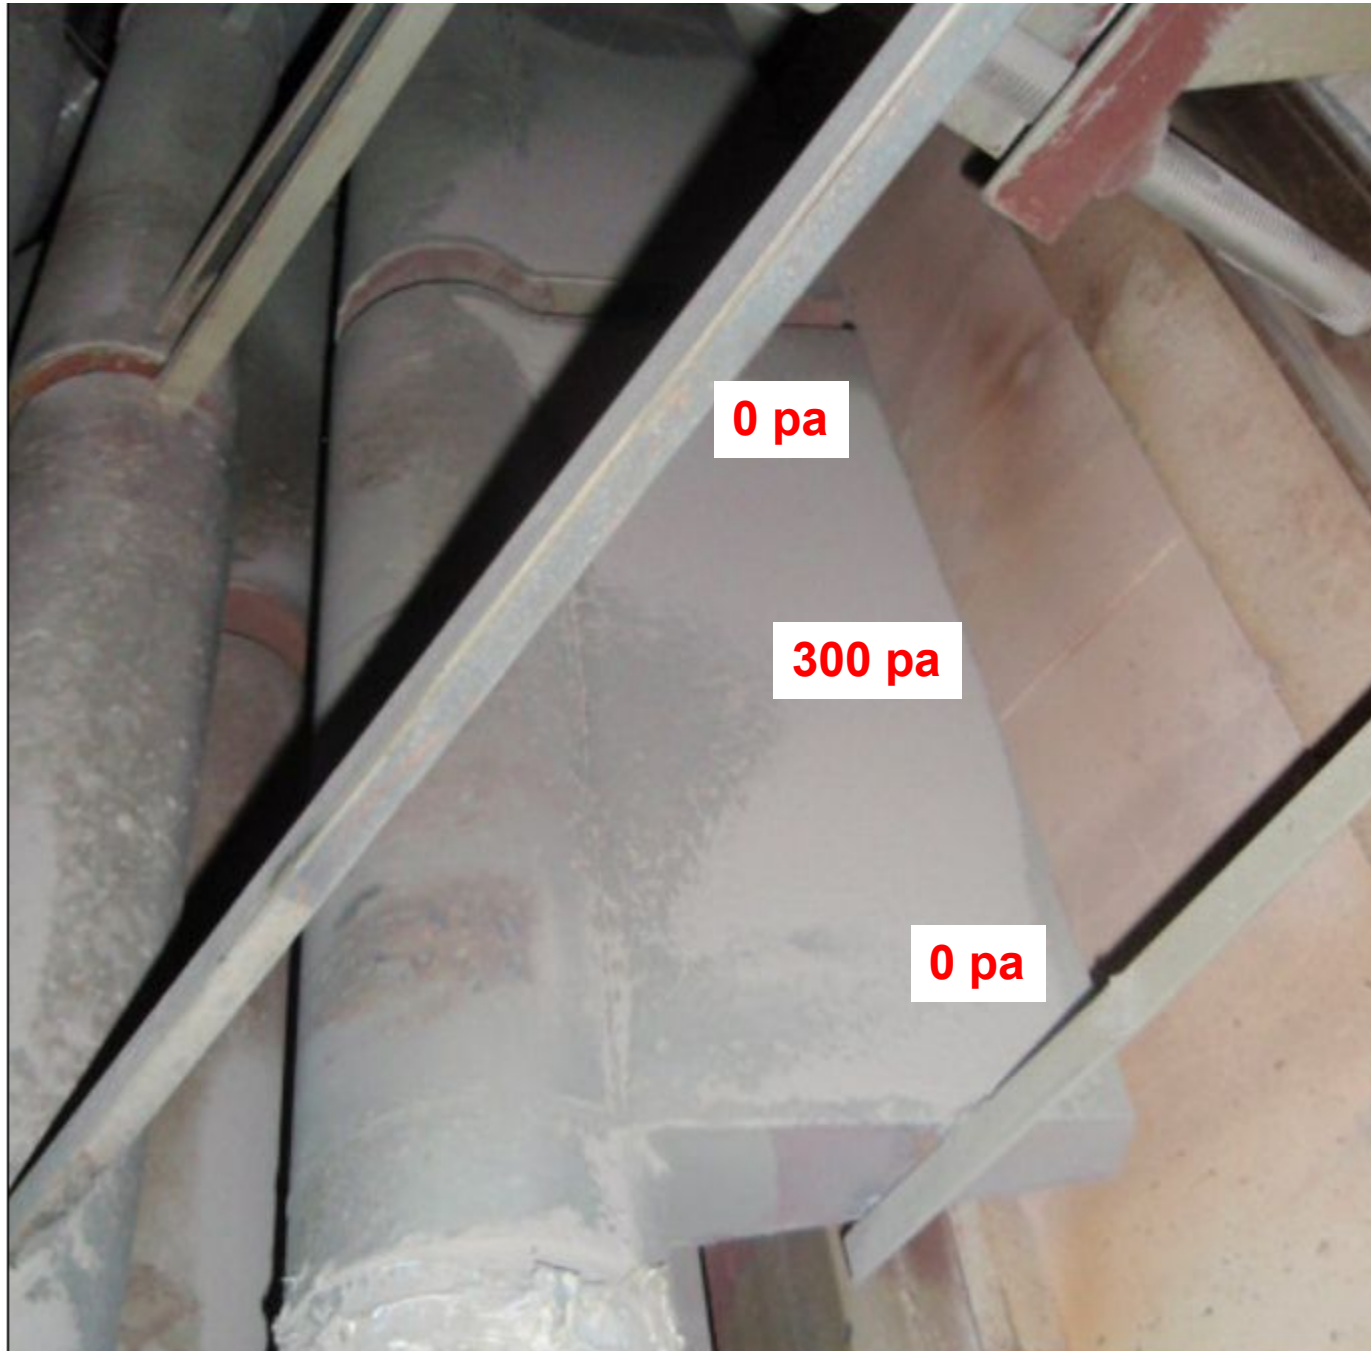
Bad nozzles shape in throat
