**Furnaces corrosion / prevention to
improve the longevity of campaigns
Th Roustan 2016/10**

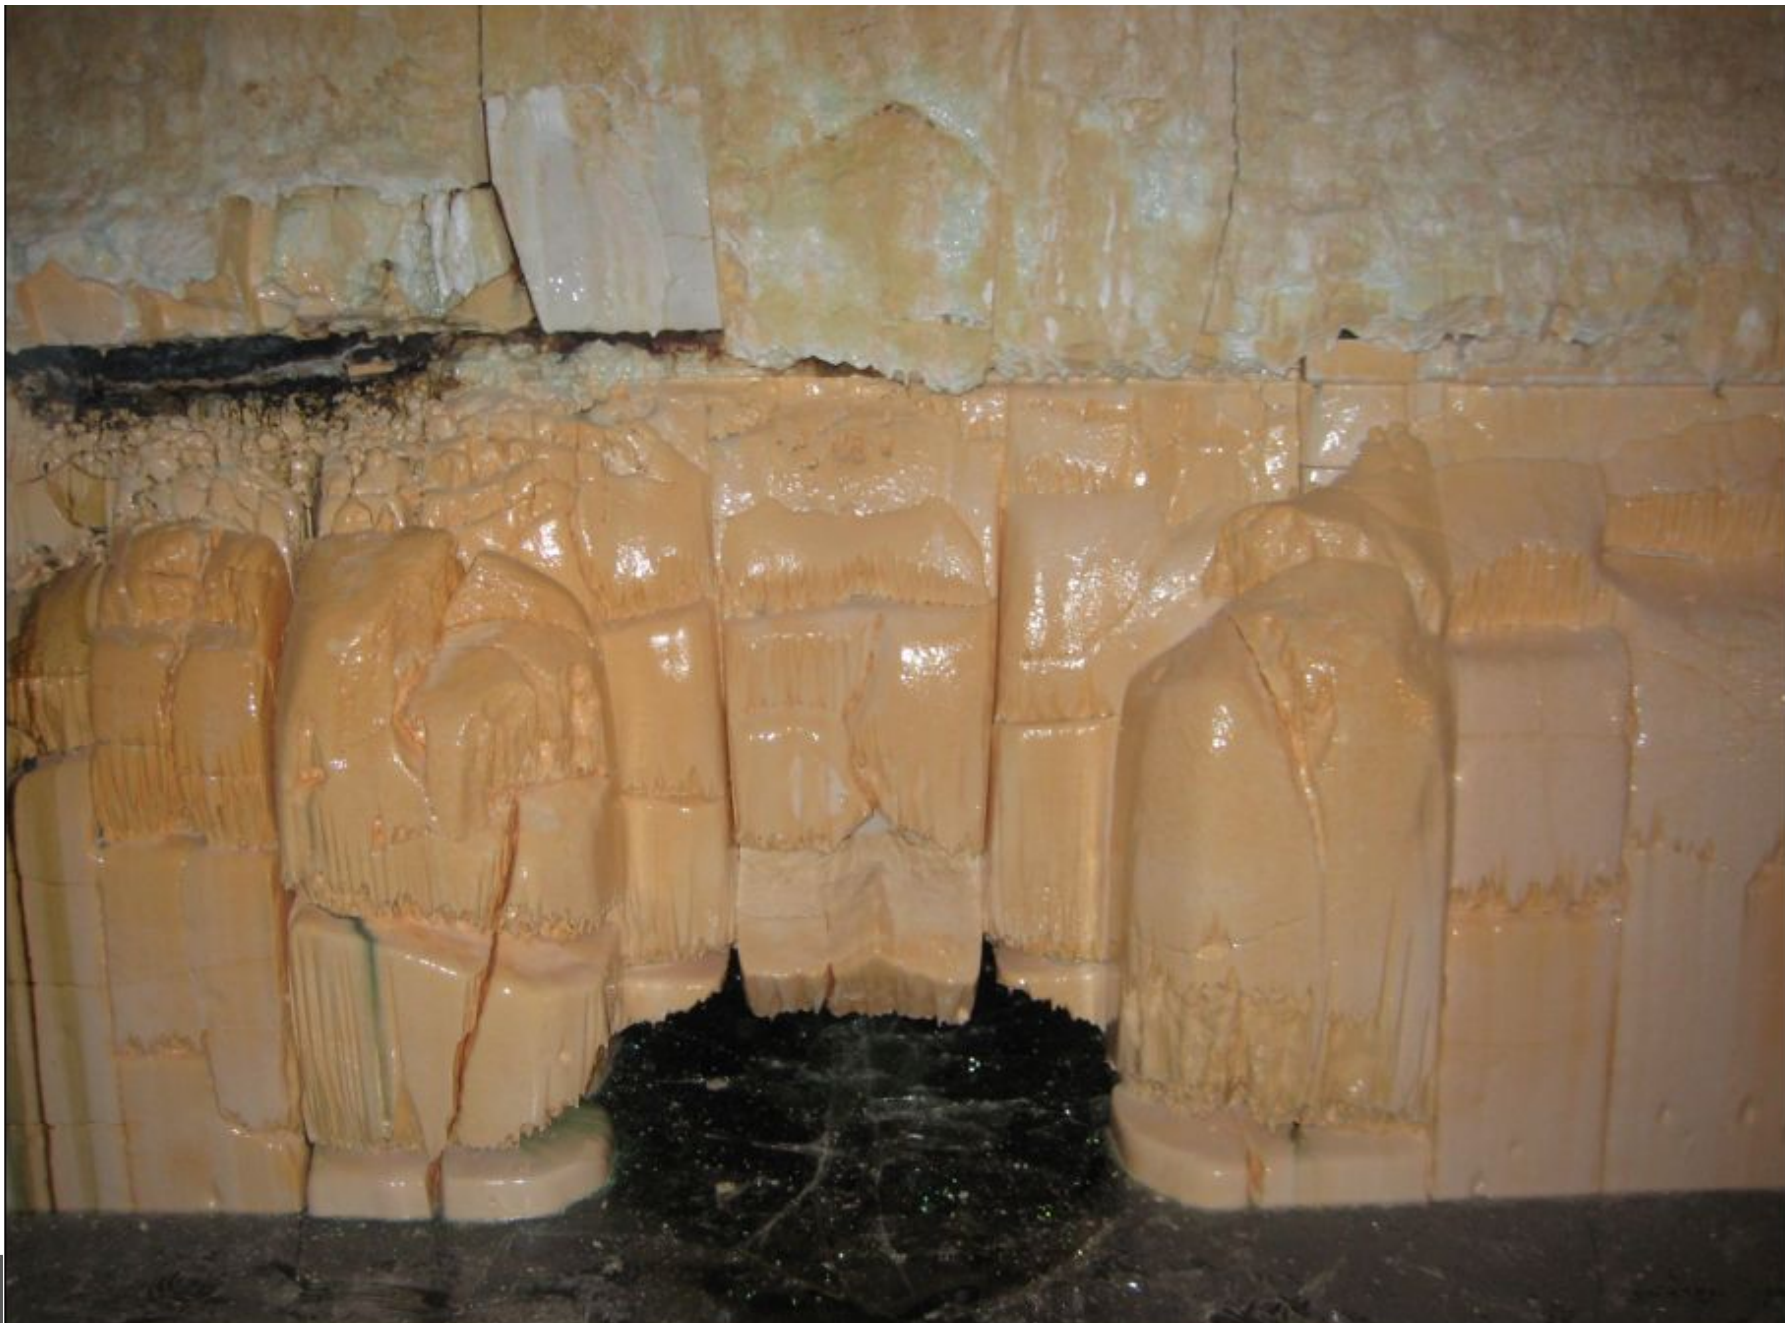
Throat angle blocks after 5 years campaign with insufficient air cooling

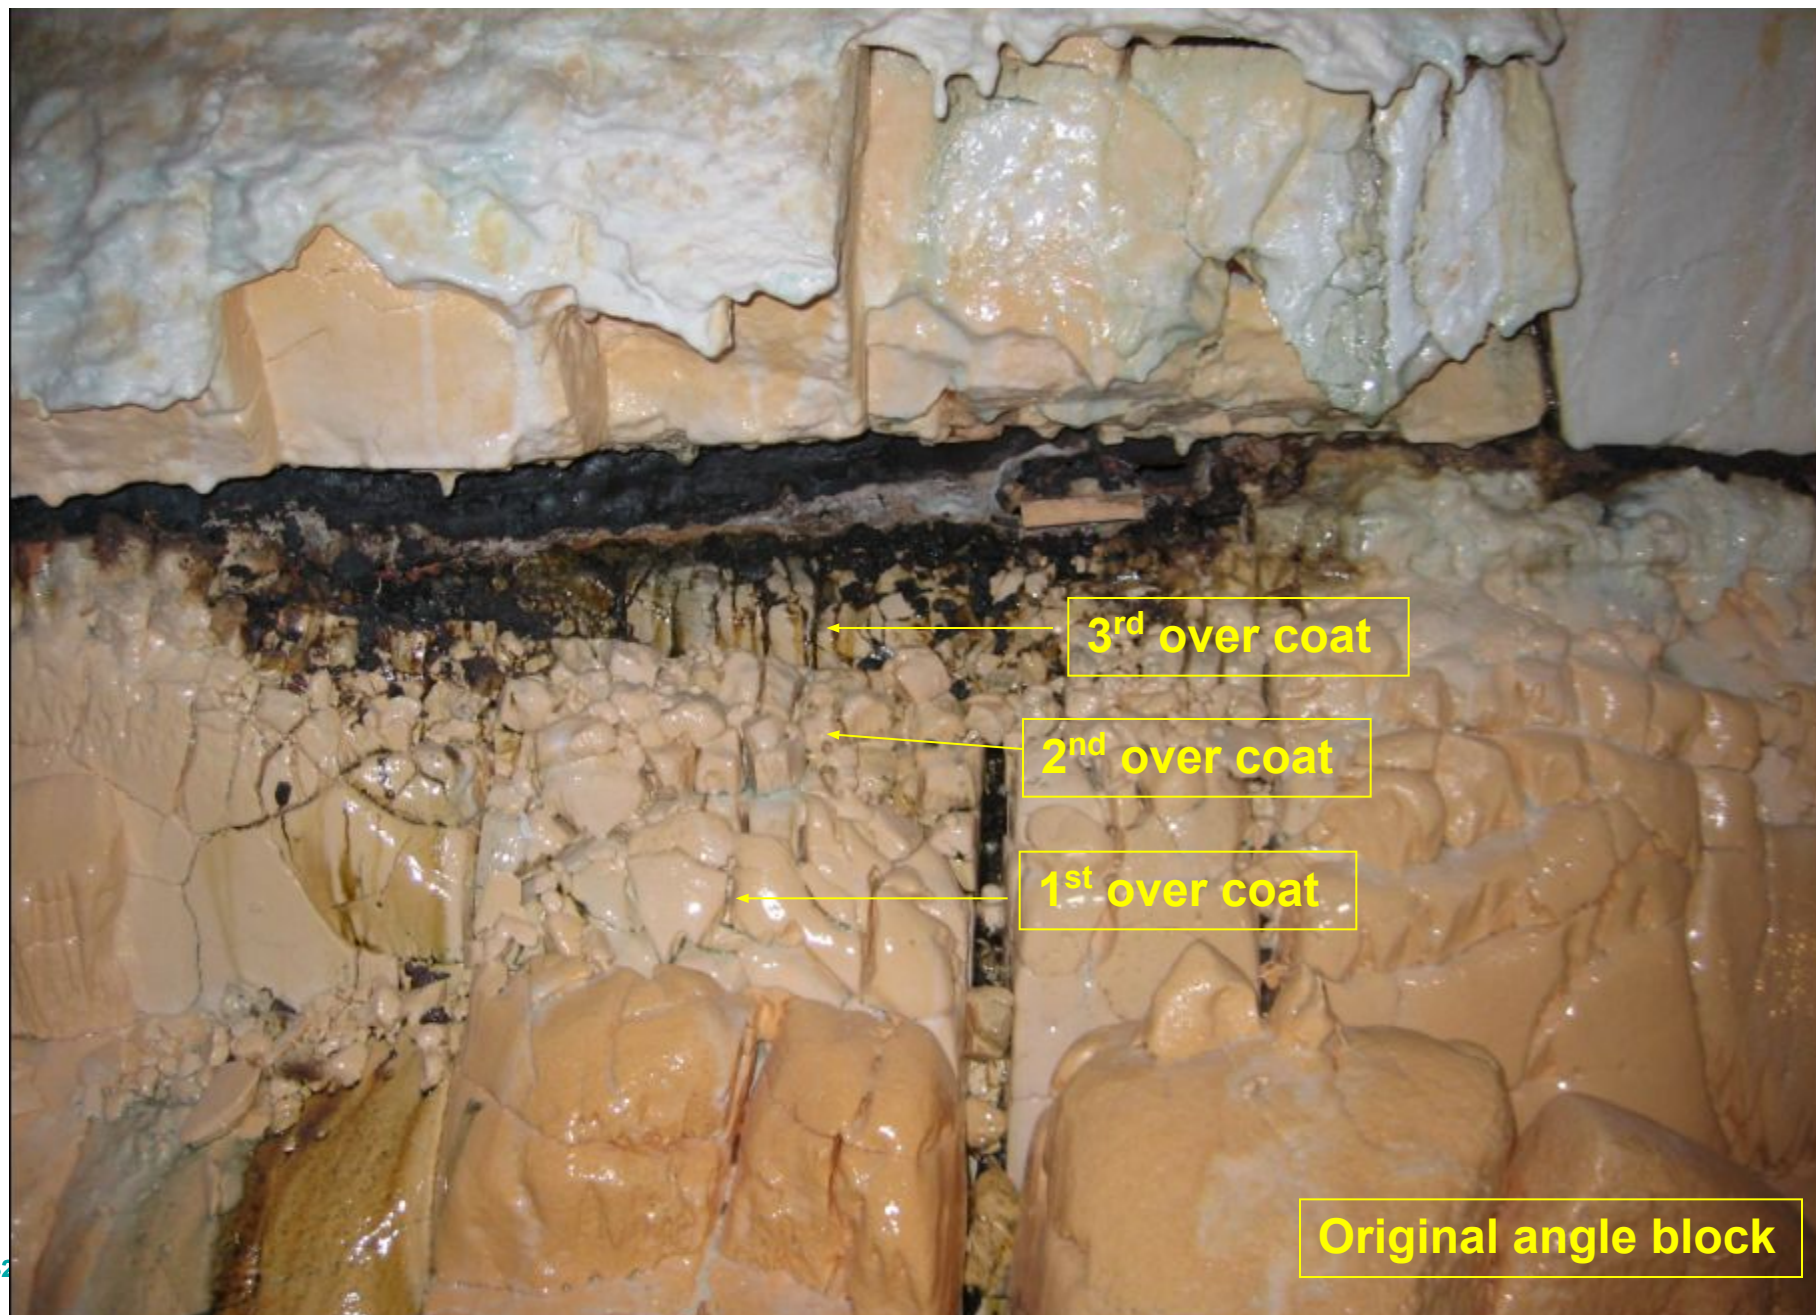
Throat angle blocks after 5 years campaign with insufficient air cooling
