# Furnaces corrosion / prevention to improve the longevity of campaigns

## Th Roustan 2016/10

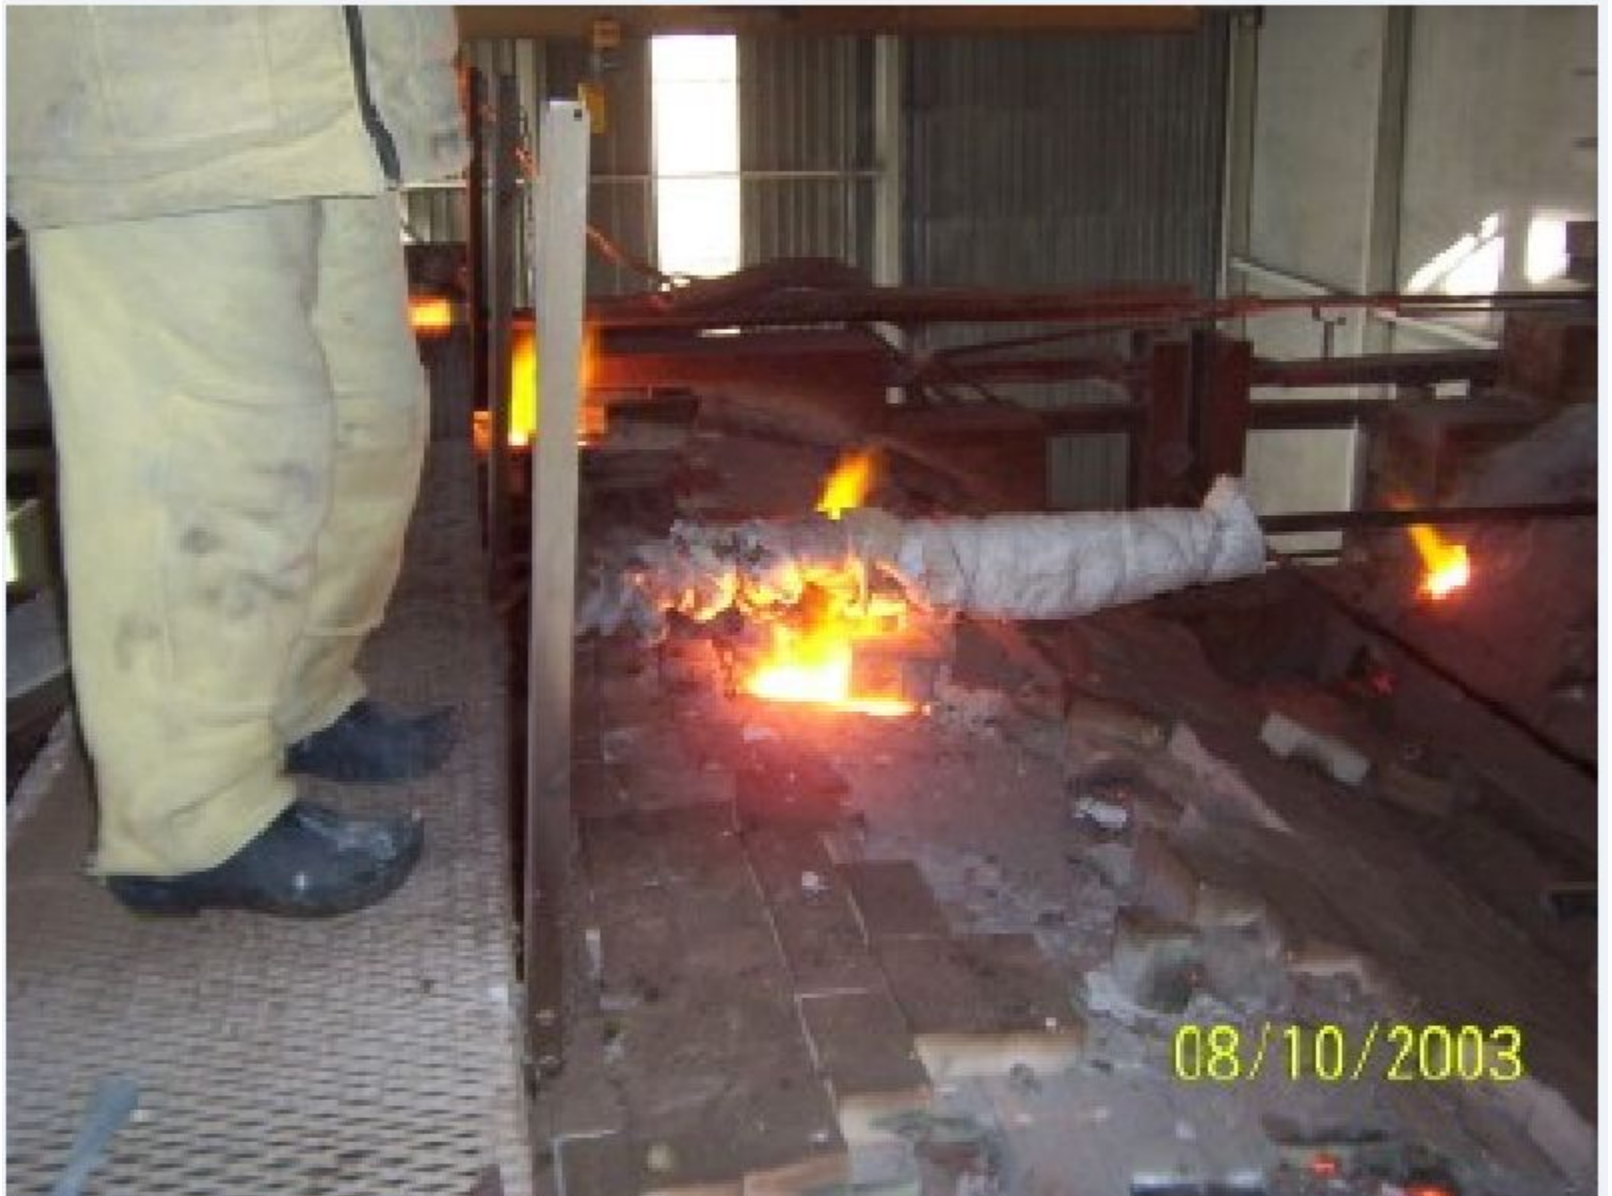
# Crown flames passages

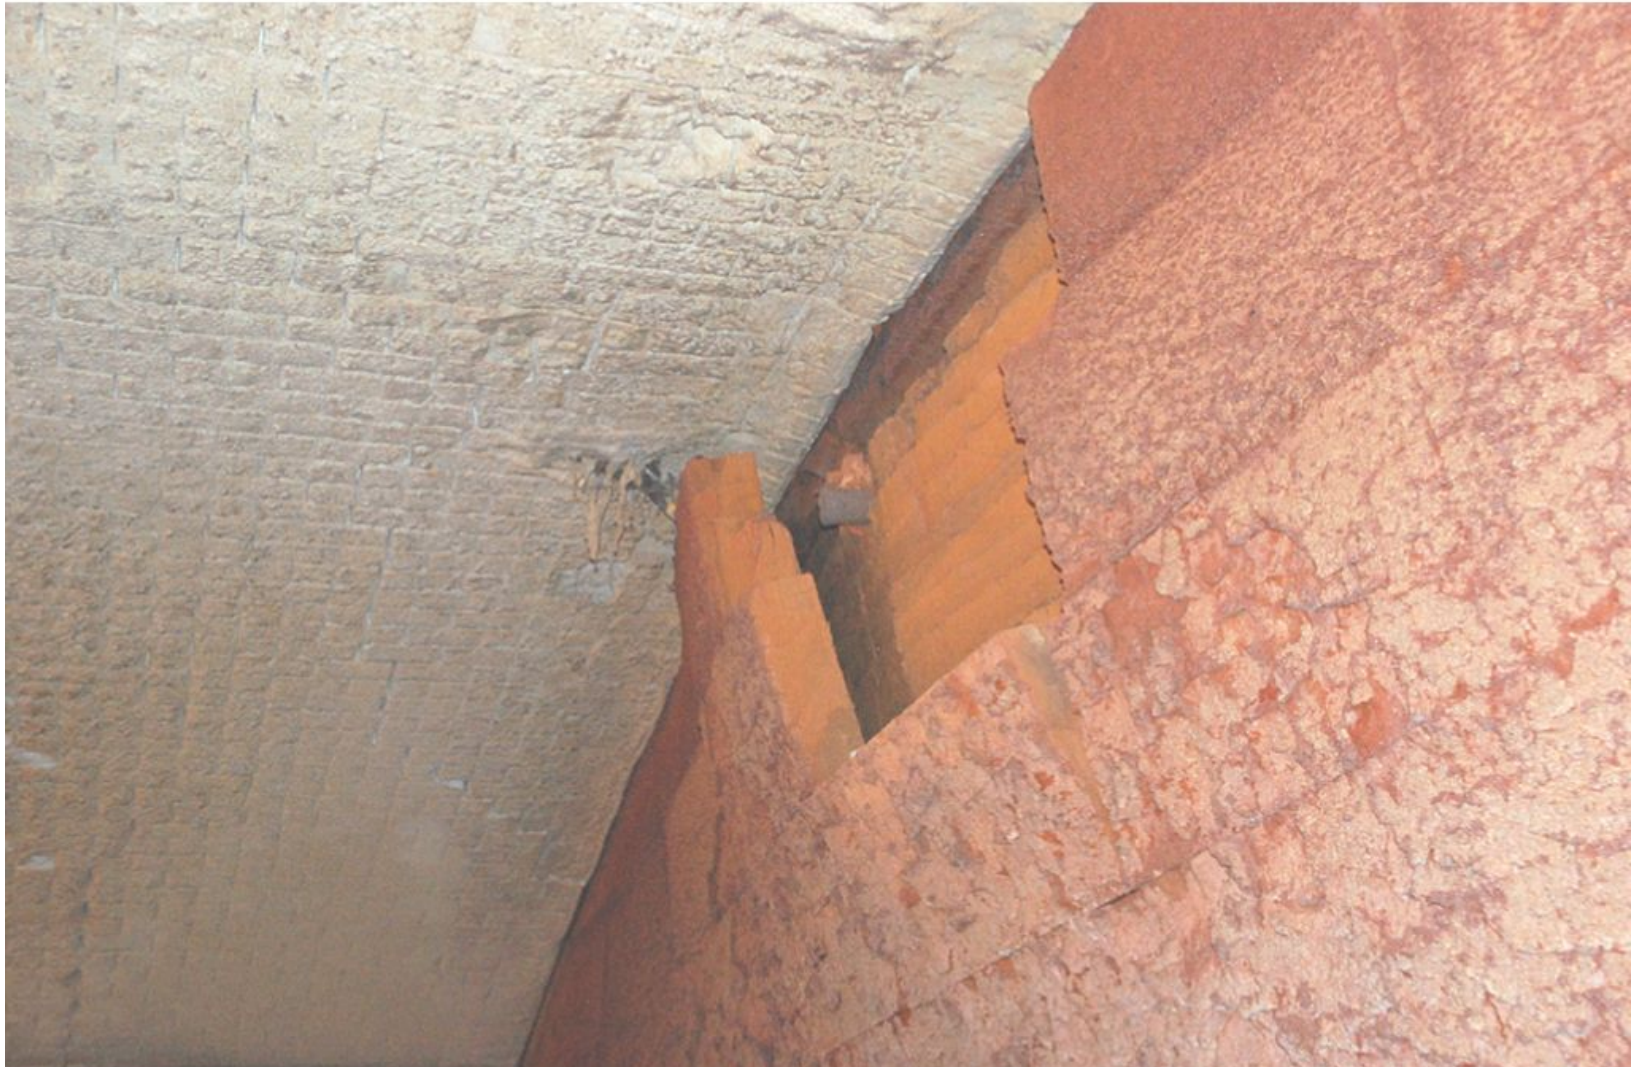
# Lagnieu F2 front wall / concrete wall protection

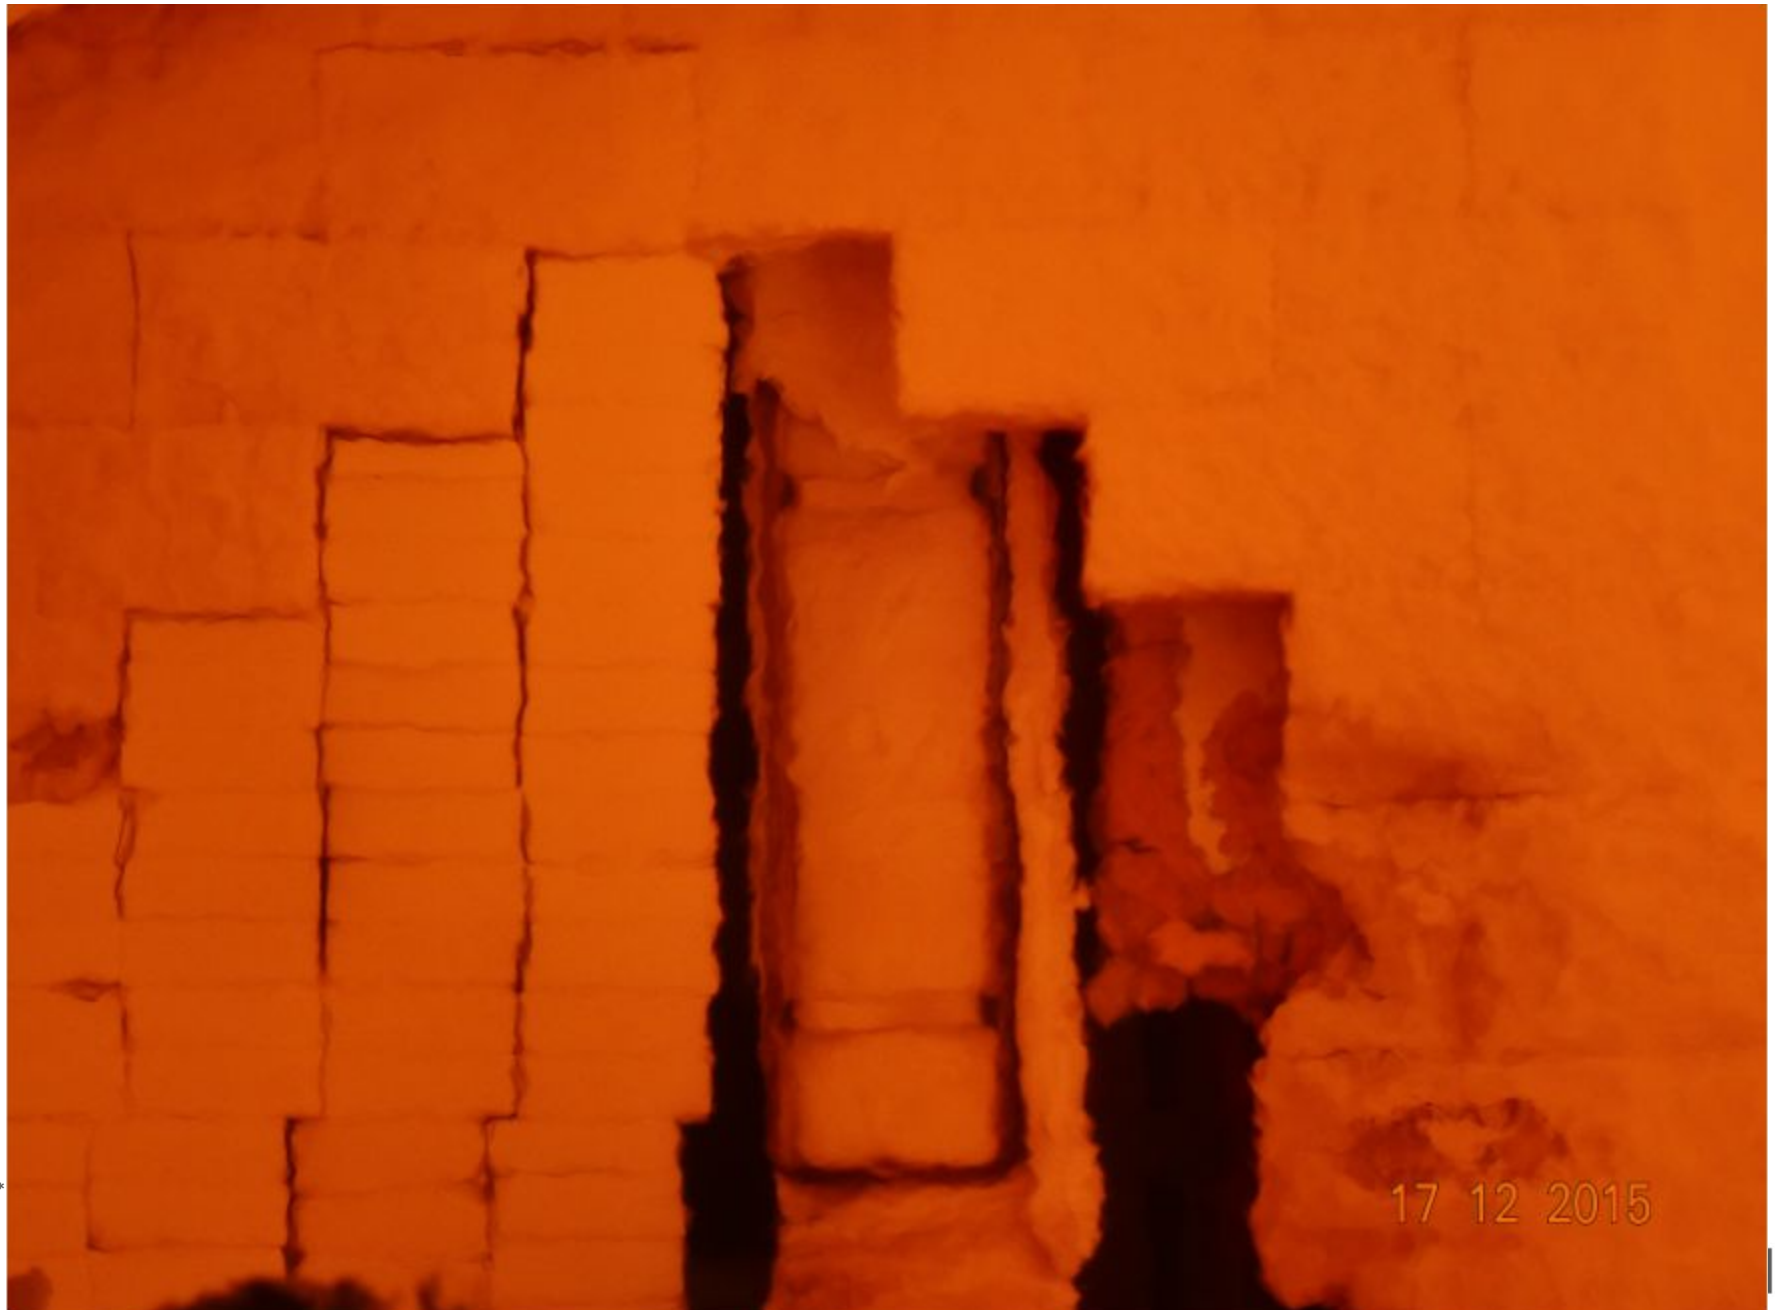
# Kamyshin F1 front wall repair with concrete blocks

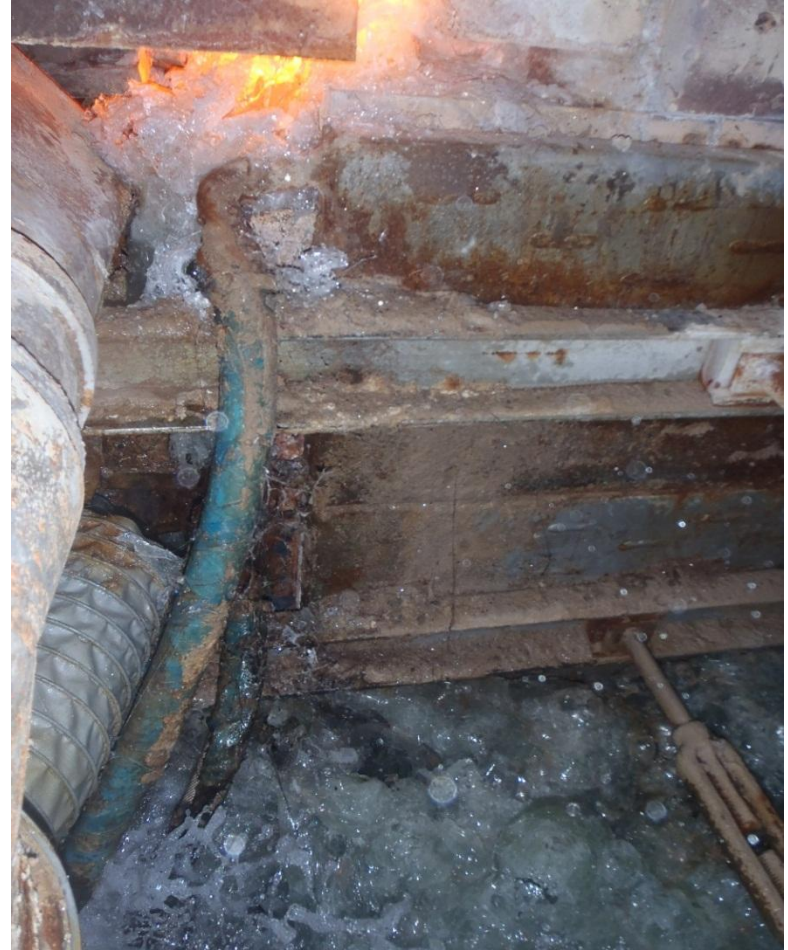
# Throat angle block corrosion with bad air cooling..... And glass leakage

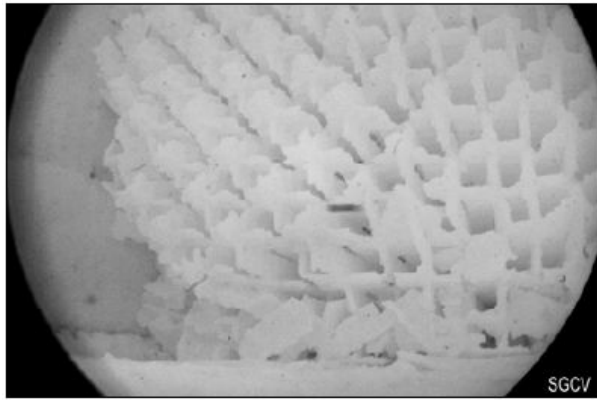
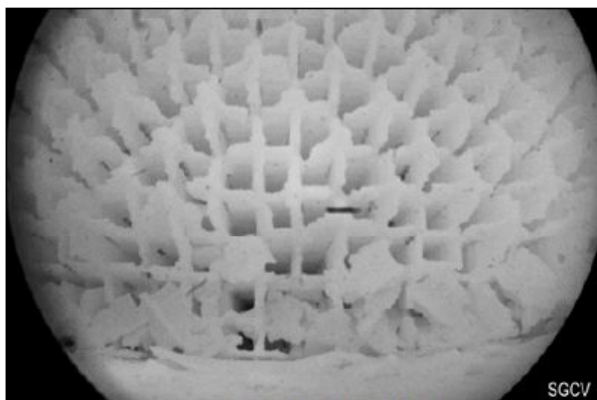
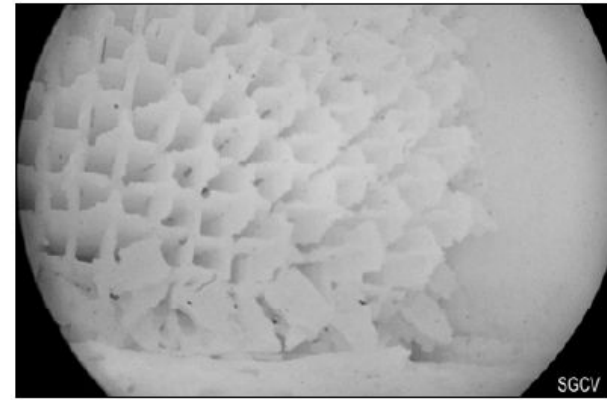
# Checkers corrosion.....

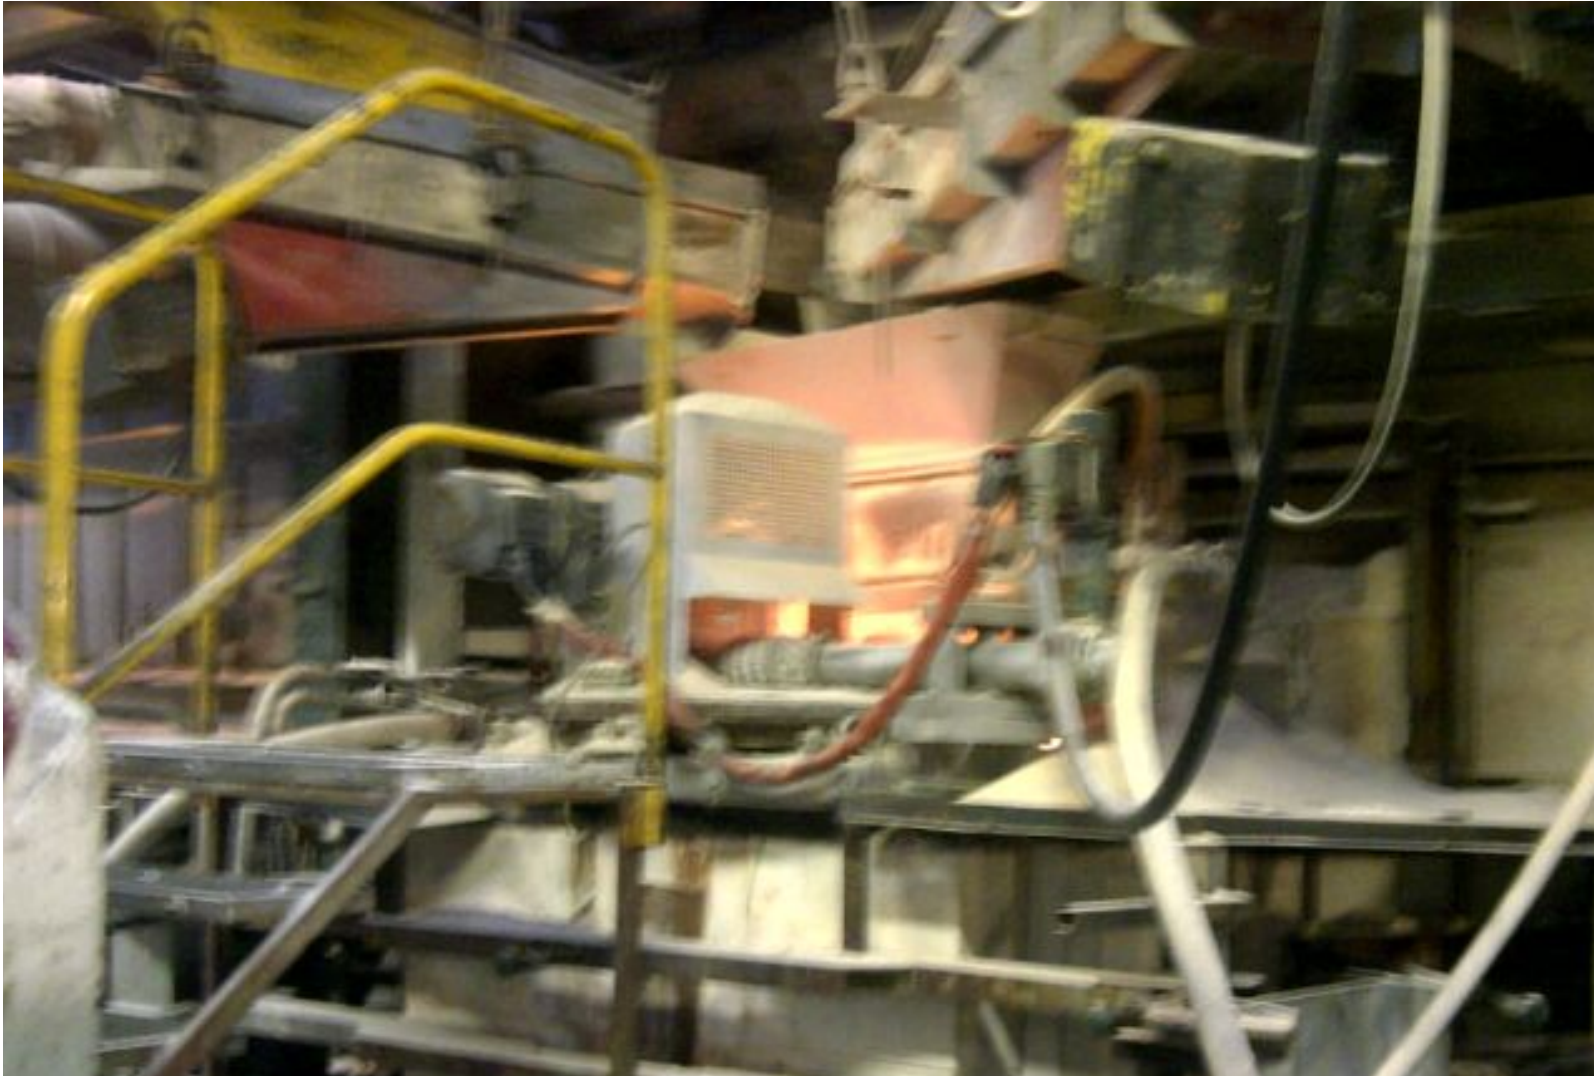
# Important raw materials deposits..... batch charger

## Mechanic problems

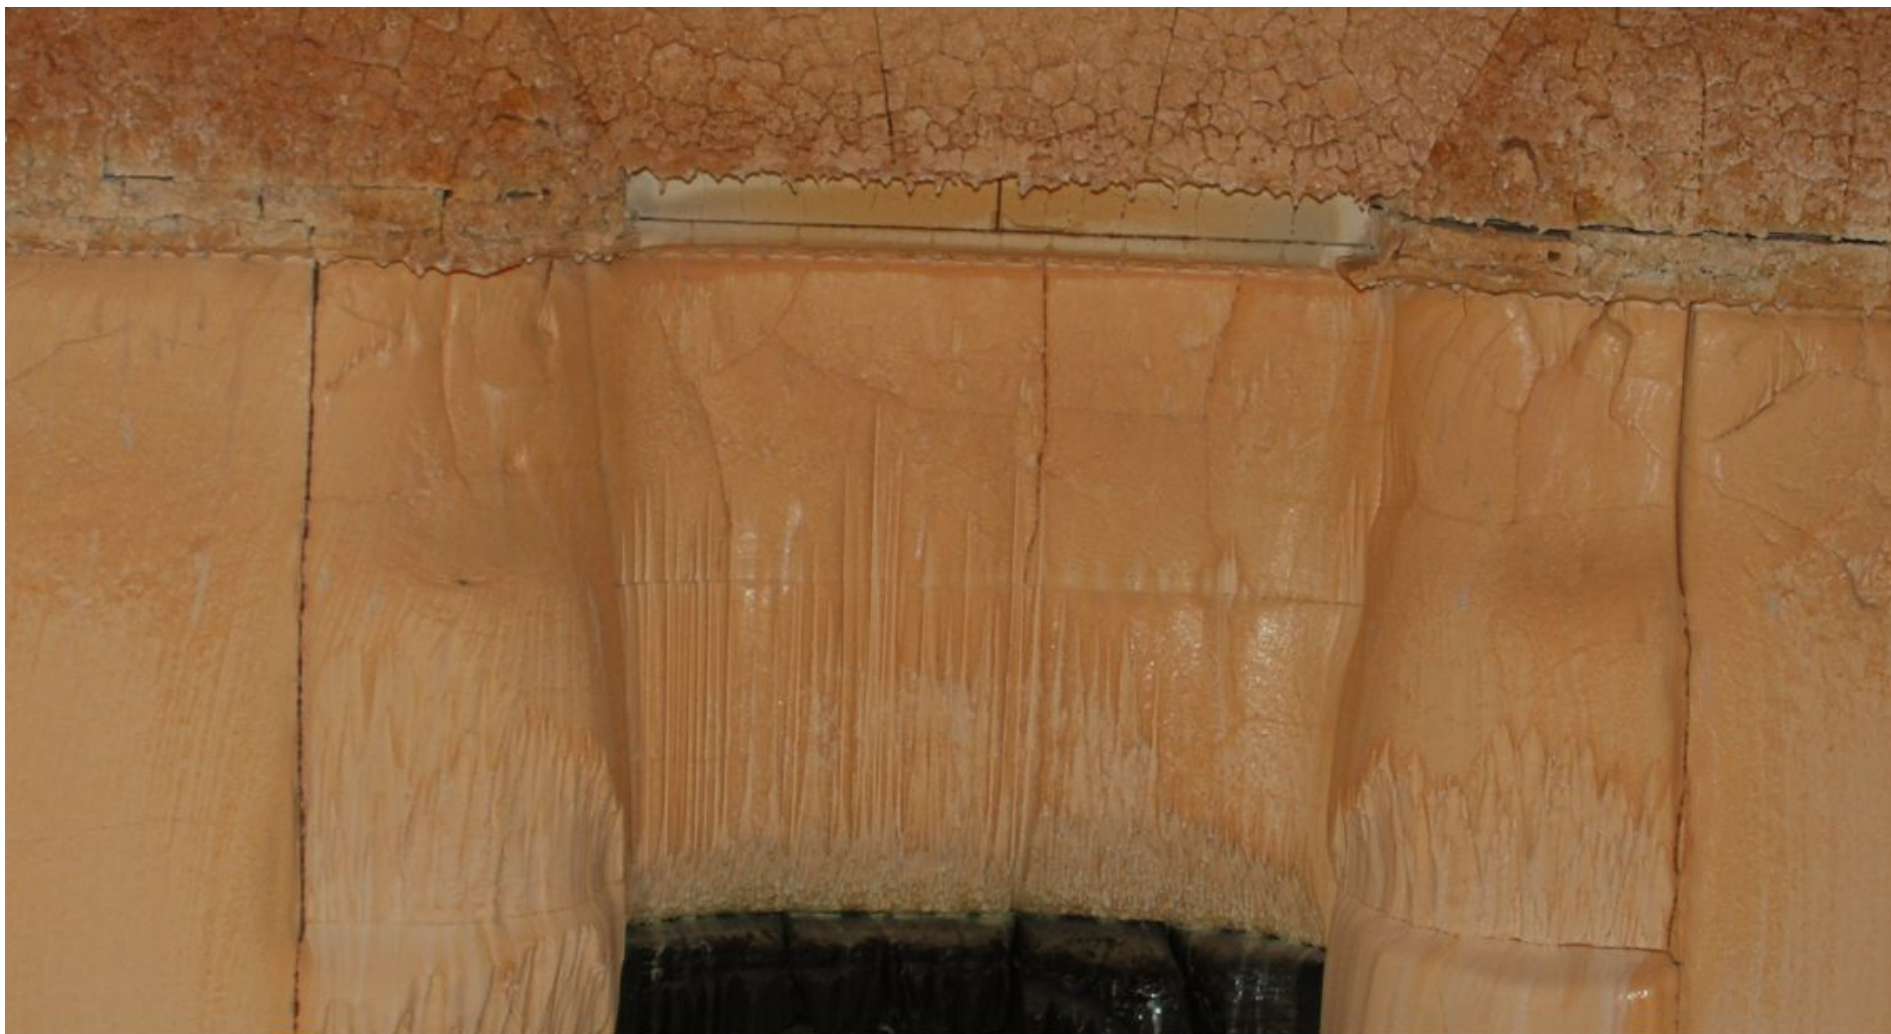
## Throat angle blocks after 11 years campaign with efficient air cooling (average air pressure nozzles : 1000 Pa)

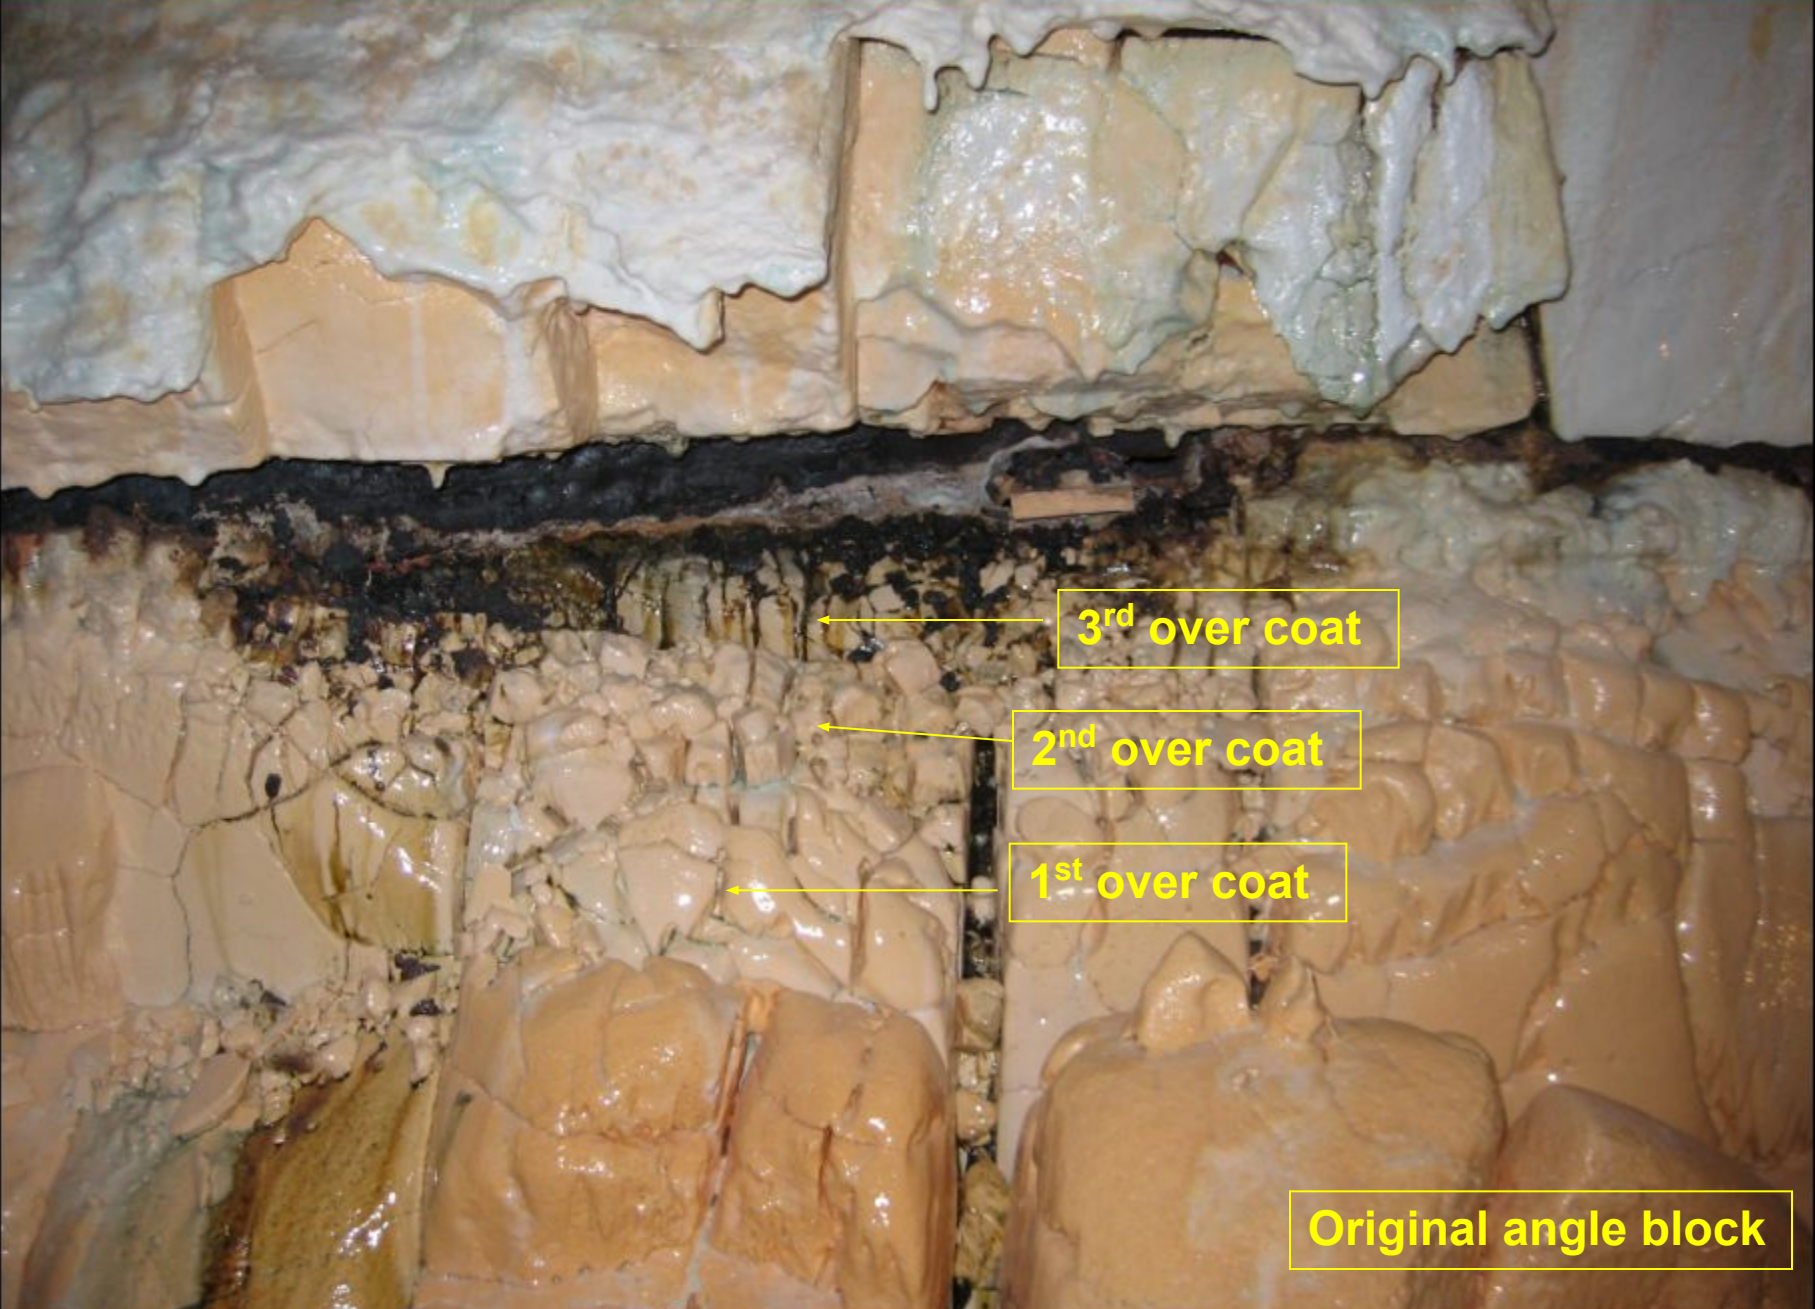
**Throat angle blocks after 5 years campaign with insufficient air cooling**
