Change 1 from NIC's new file 20220301:
The position for SD is longer
----- OK ,no problem from Hasion 3.1

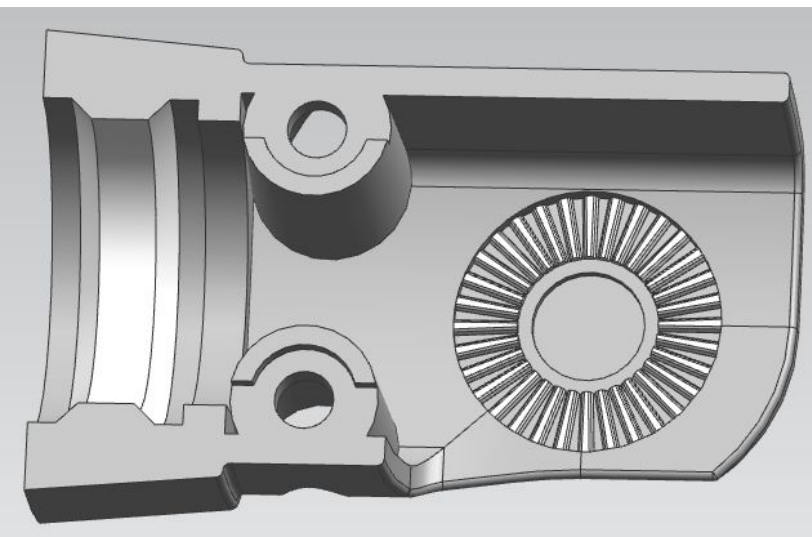
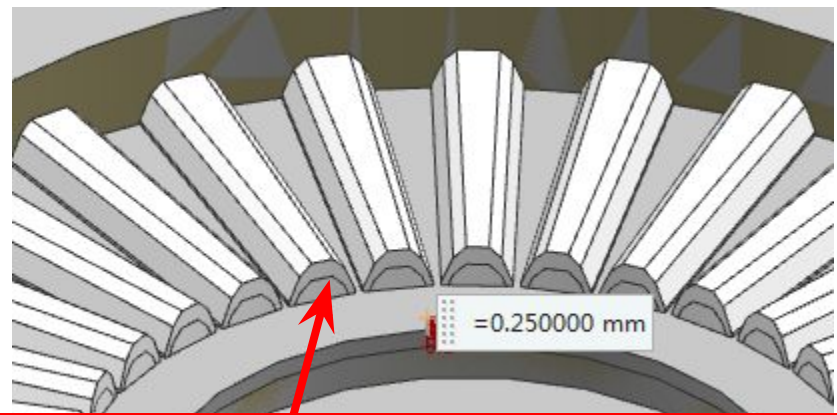
Change 2 from NIC's new file 20220301:
The position for gear
----- OK ,no problem from Hasion 3.1

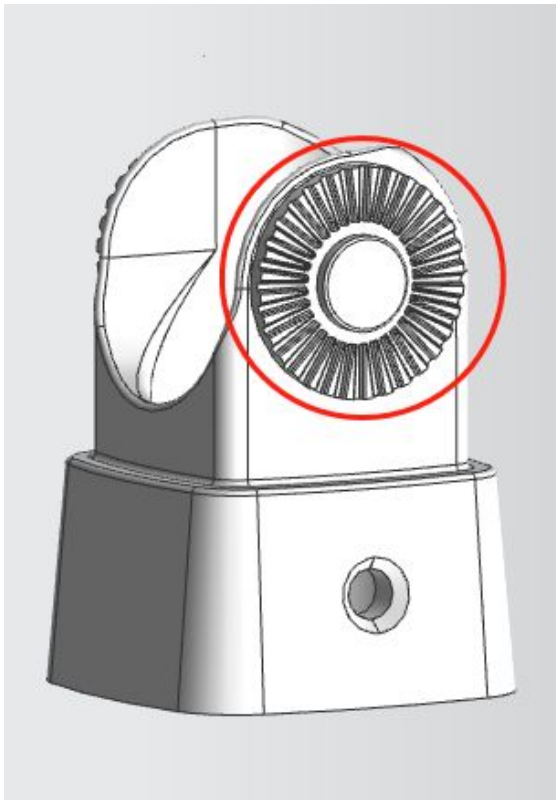
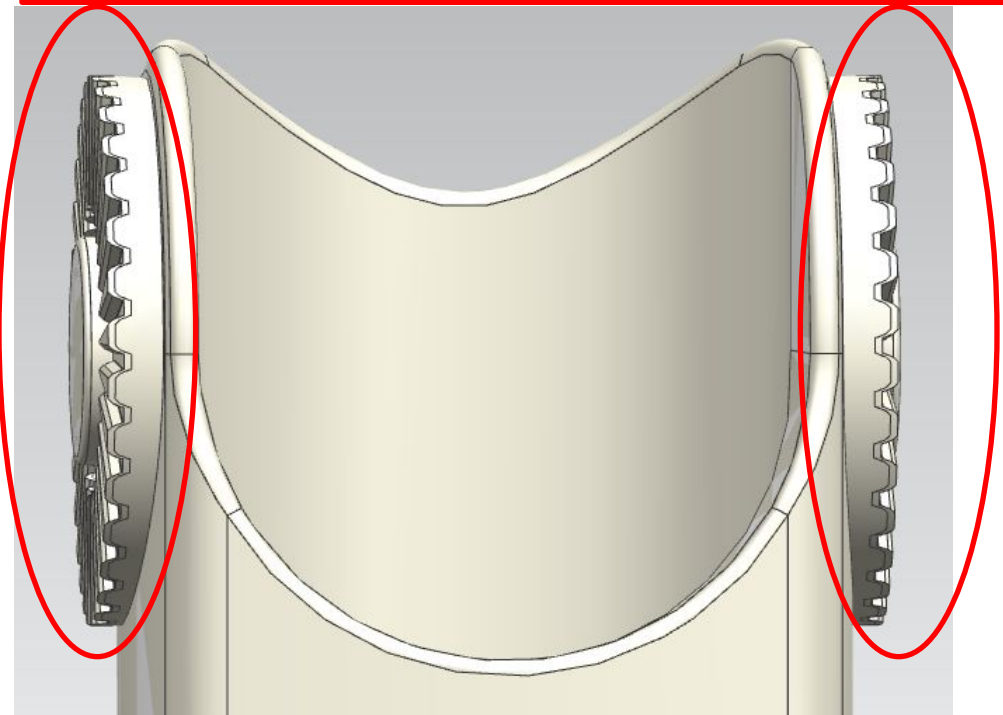
Change 3 from NIC's new file 20220301:

The thickness for here position

----- 0.6mm not OK , It at least 1.2mm--Hasion.3.1

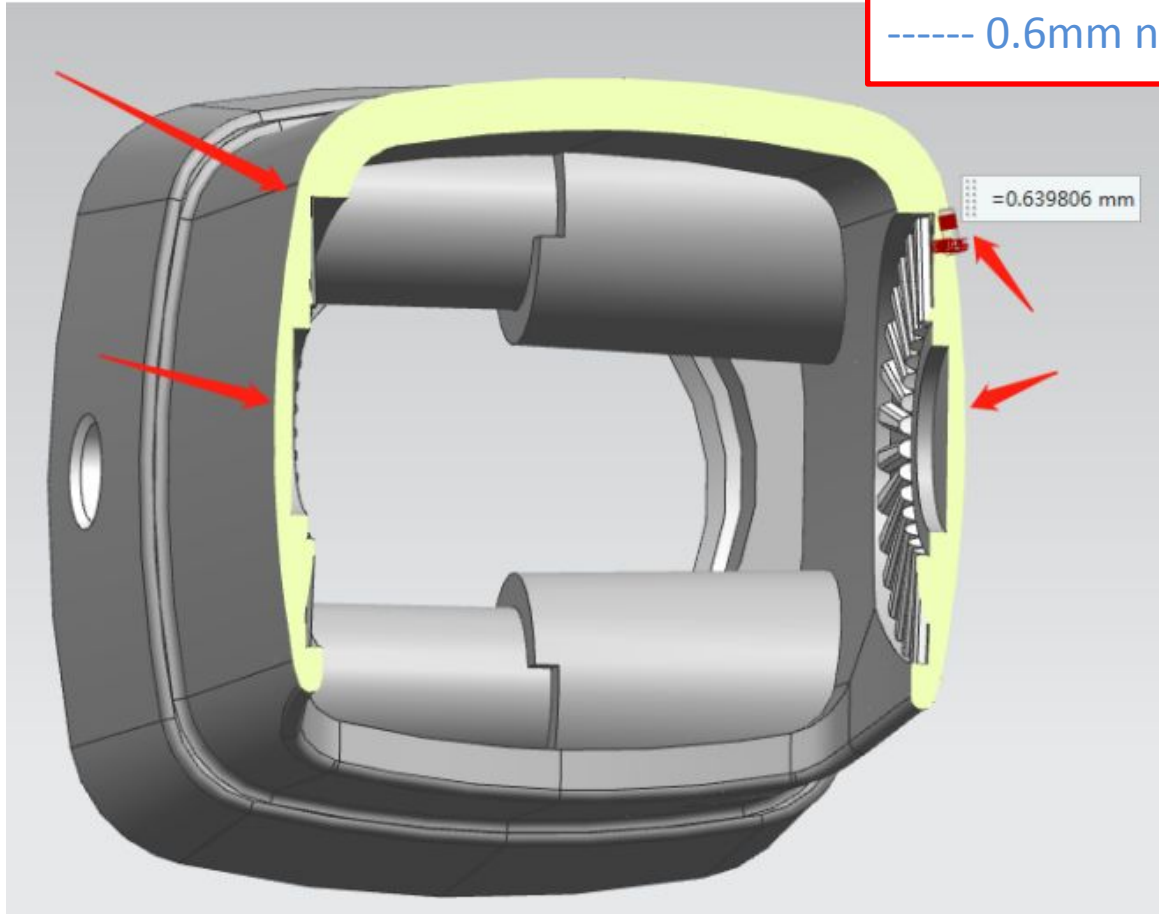
because only 0.6mm thickness ,
too thin , easy to be broken

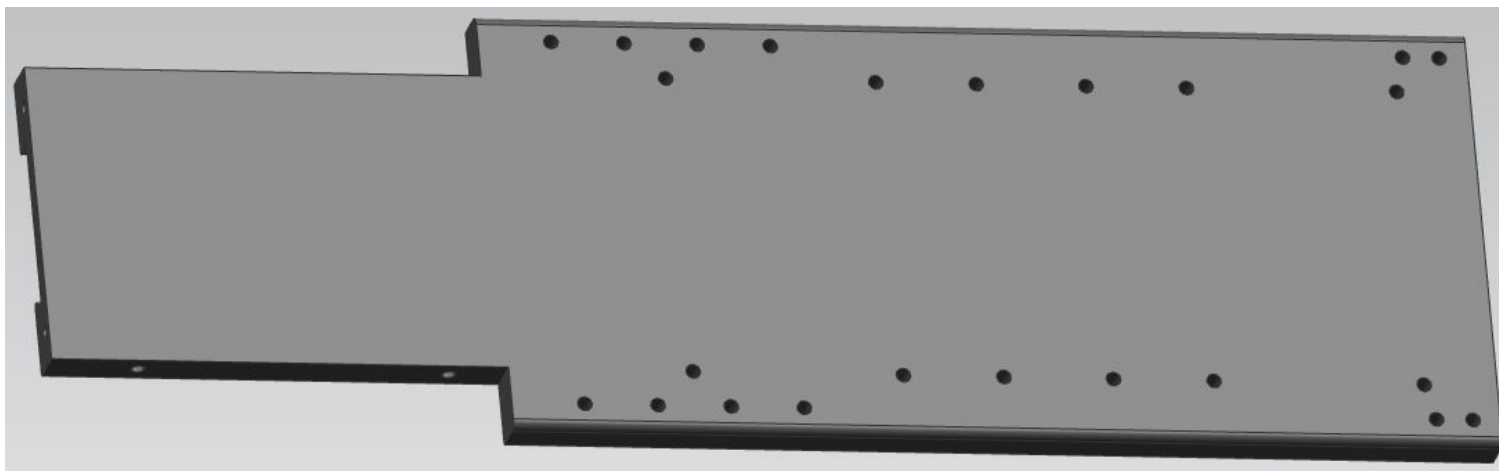
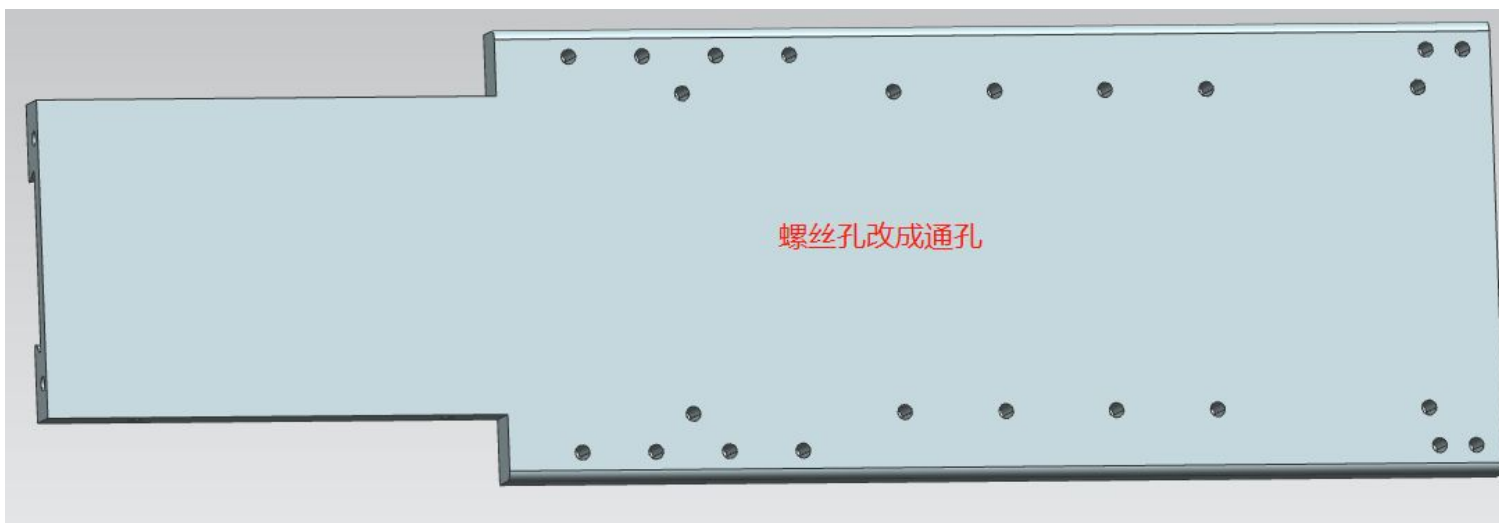
Change 4 from NIC's new file 20220301:
the hole is through hole type

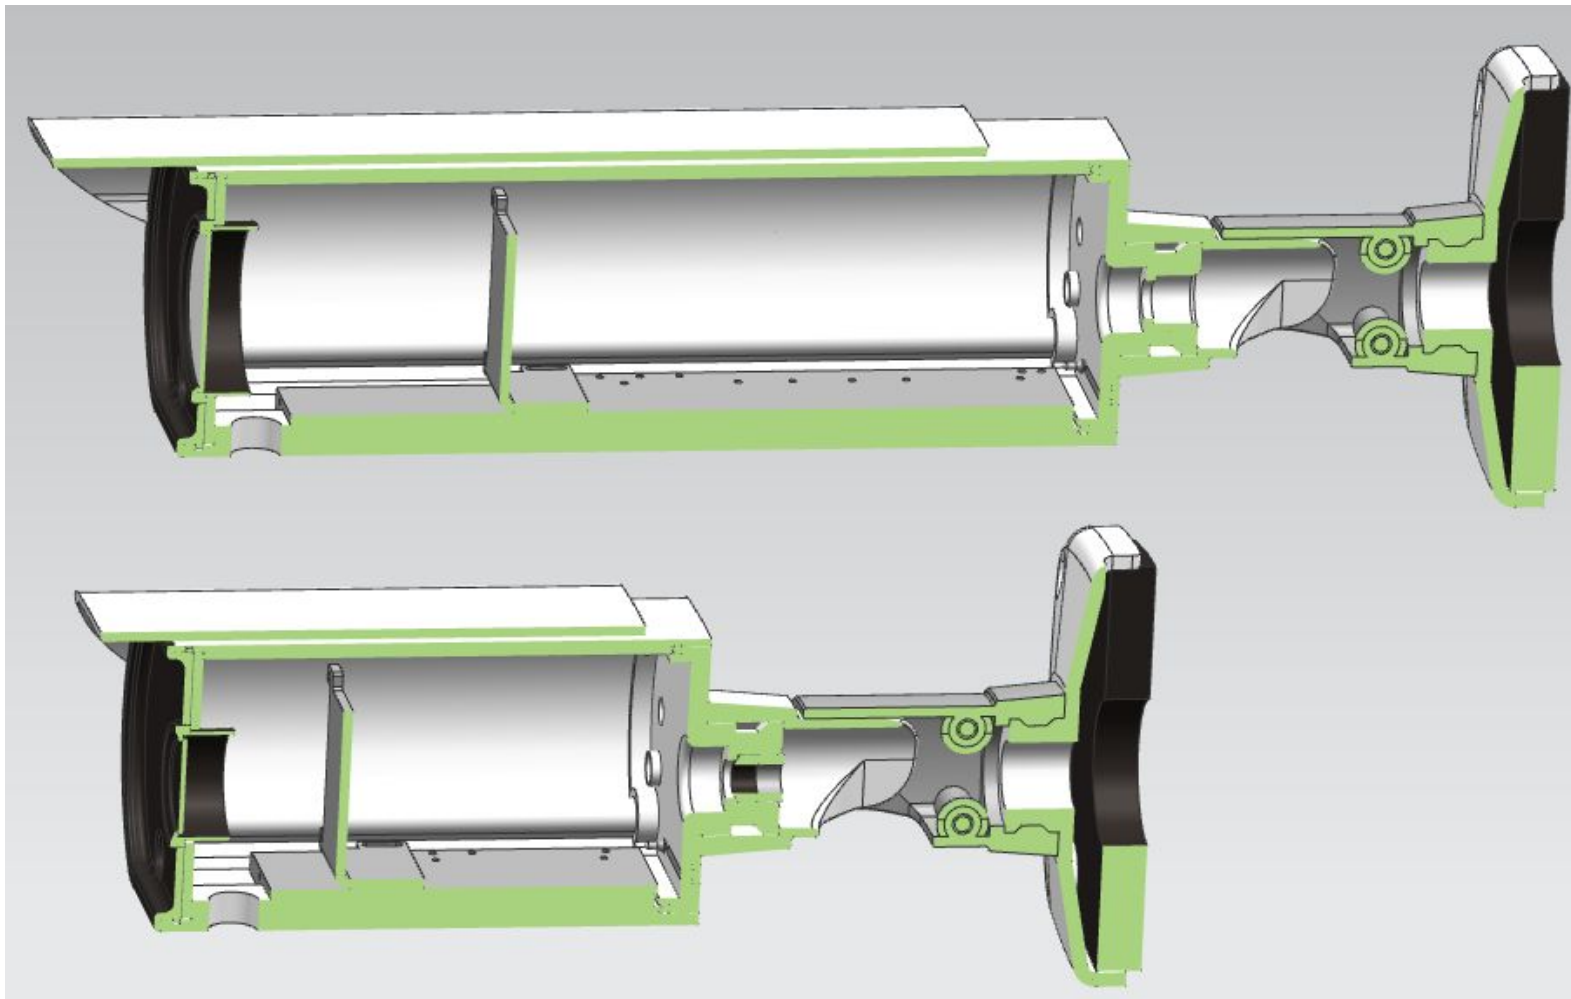
Problem 5 from NIC's new file 20220301:
fixing way of the bracket board

-----the fixing way is not unreasonable, it doesn't improve the fixing --
Hasion 3.1
