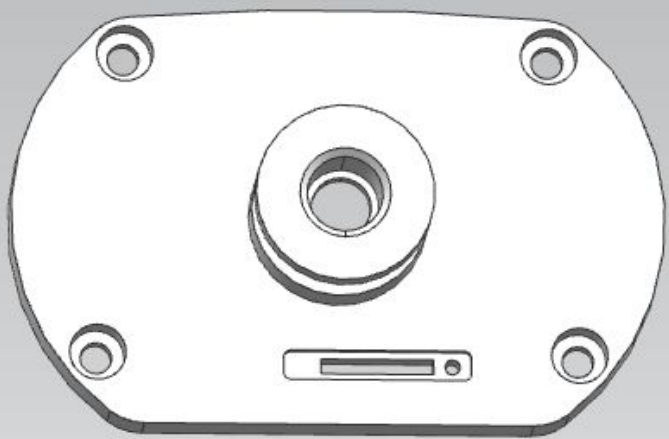
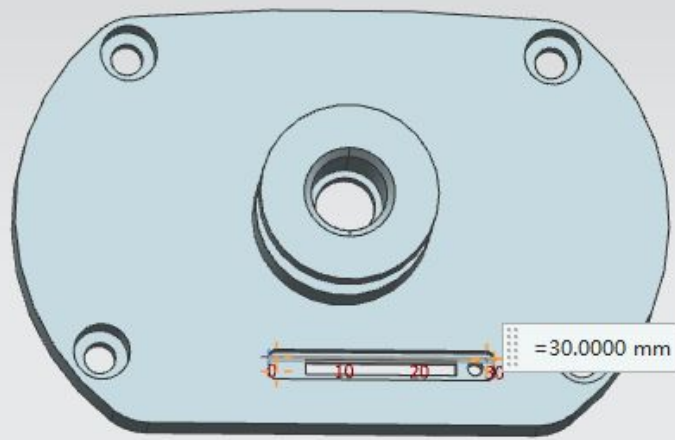
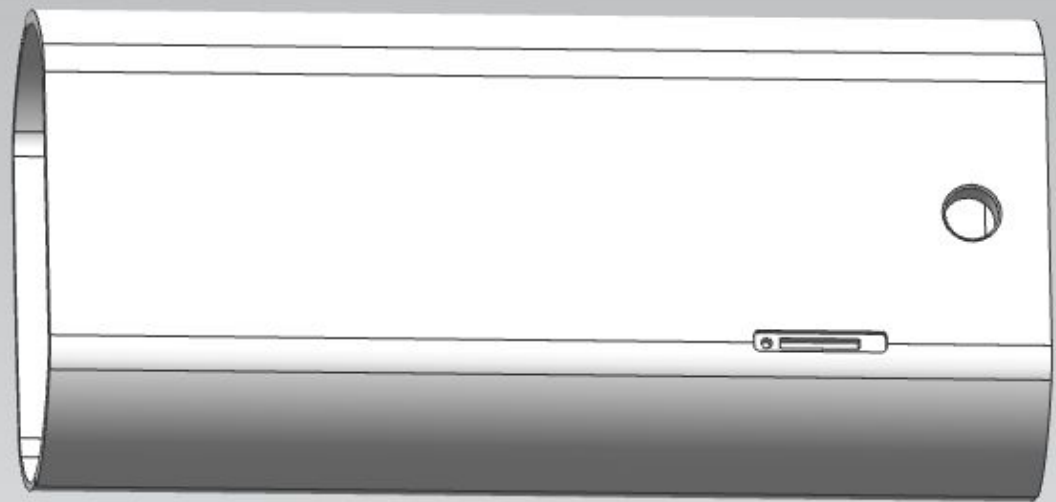
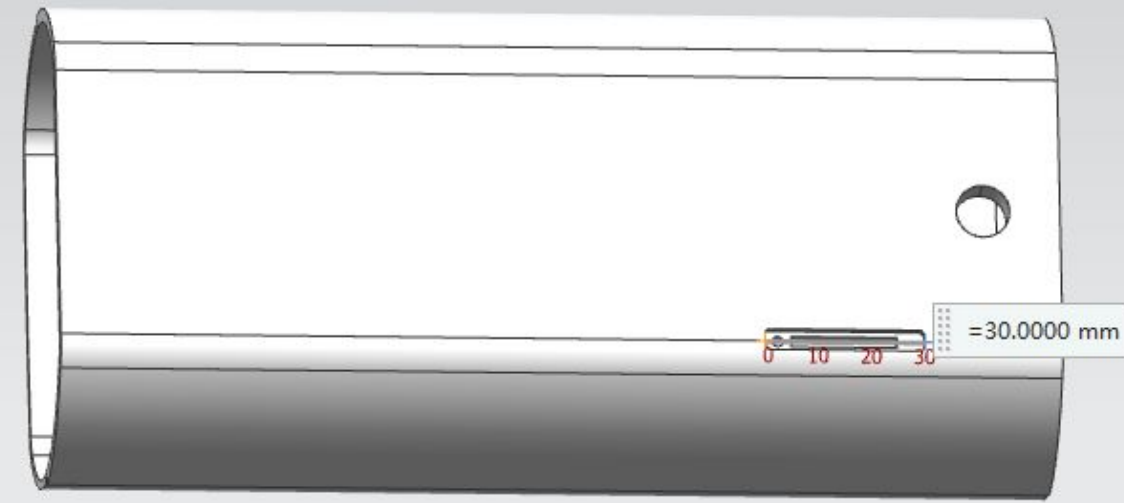
Change 1 from NIC's new file 20220301:
The position for SD is longer
----- OK ,no problem from Hasion 3.1

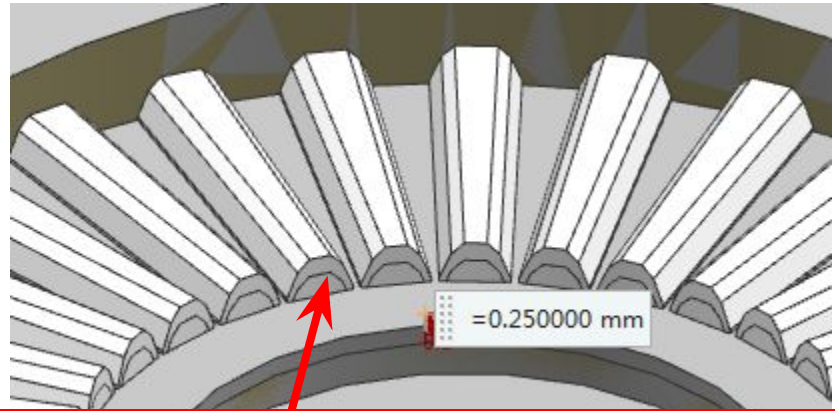
Change 2 from NIC's new file 20220301:
The position for gear
----- OK ,no problem from Hasion 3.1

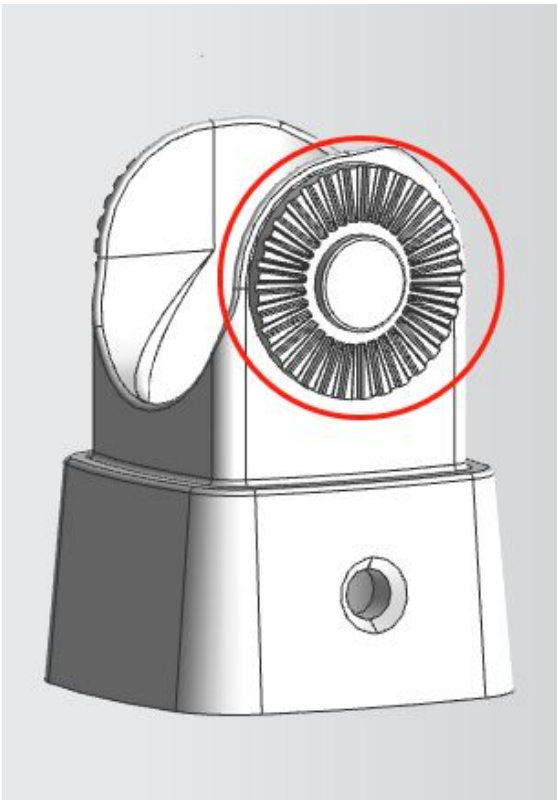
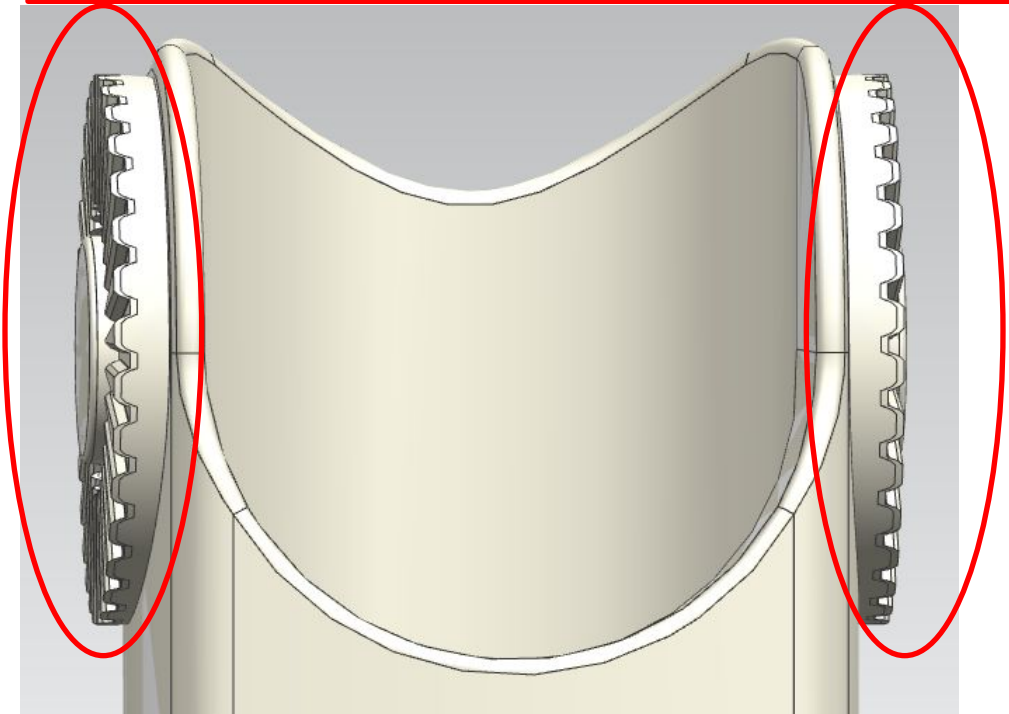
Change 3 from NIC's new file 20220301:

The thickness for here position

----- 0.6mm not OK , It at least 1.2mm--Hasion.3.1

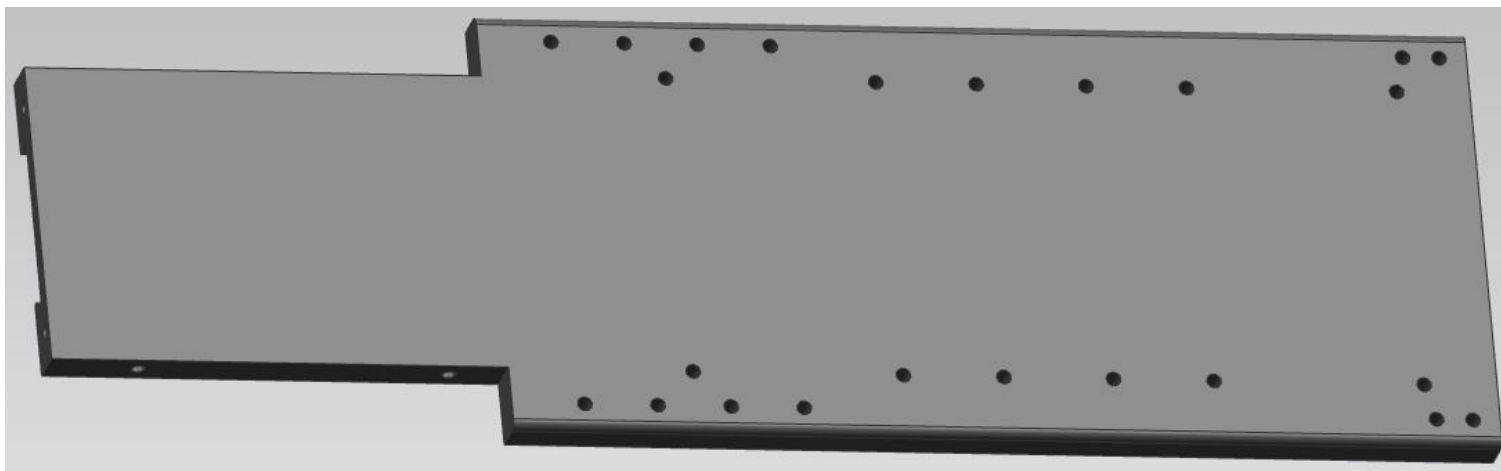
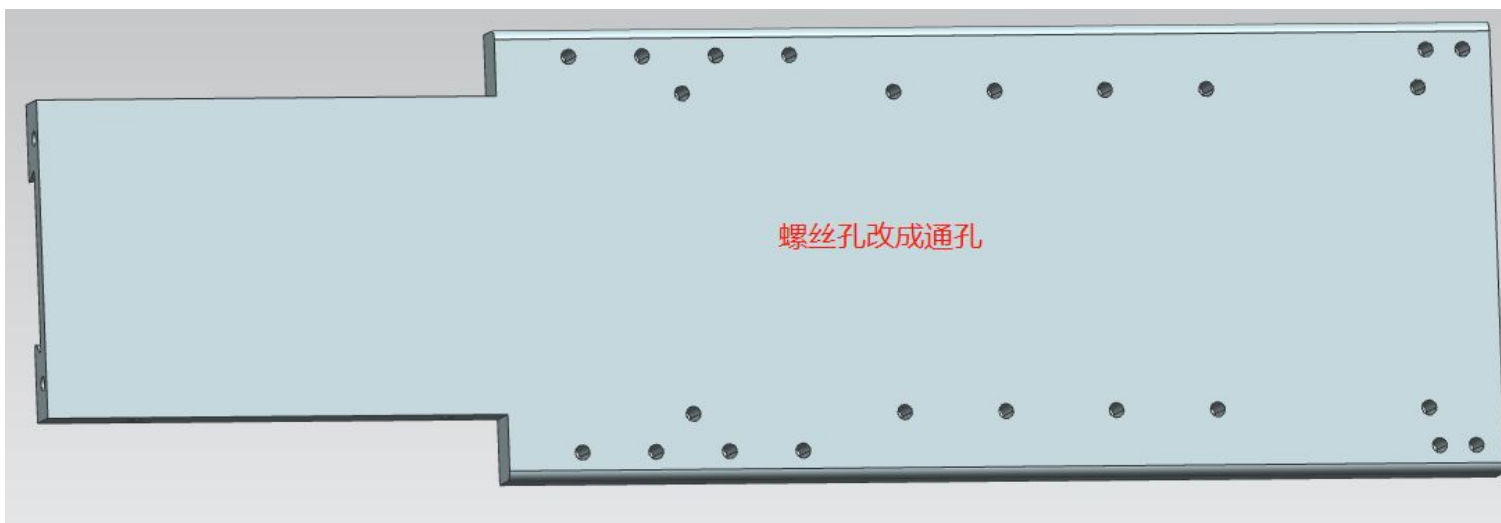
Change 4 from NIC's new file 20220301:
the hole is through hole type
