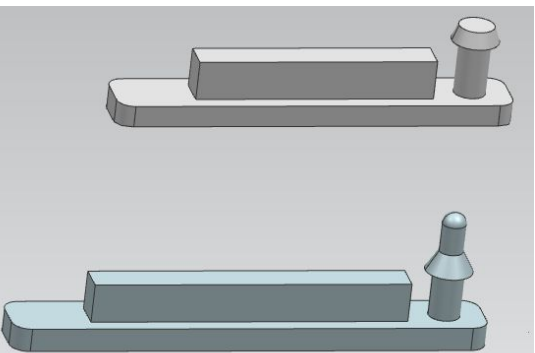
Change 1 from NIC's new file 20220301:  
The position for SD is longer  
----- OK ,no problem from Hasion 3.1

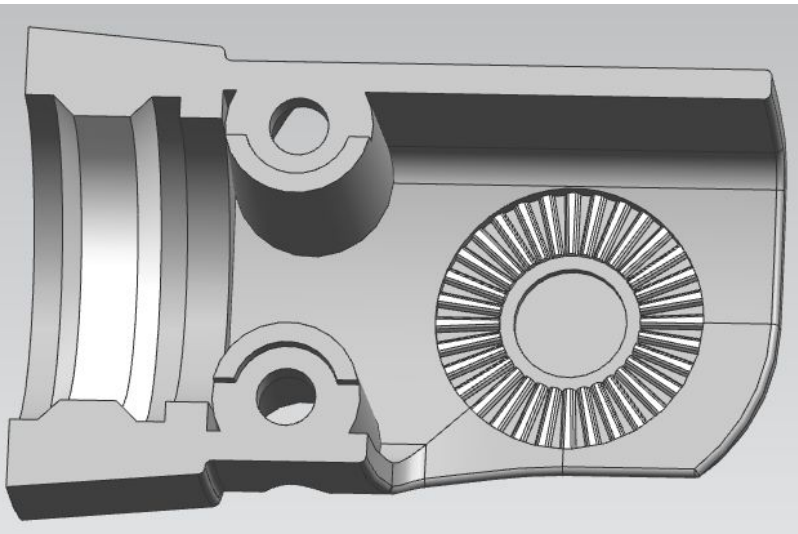
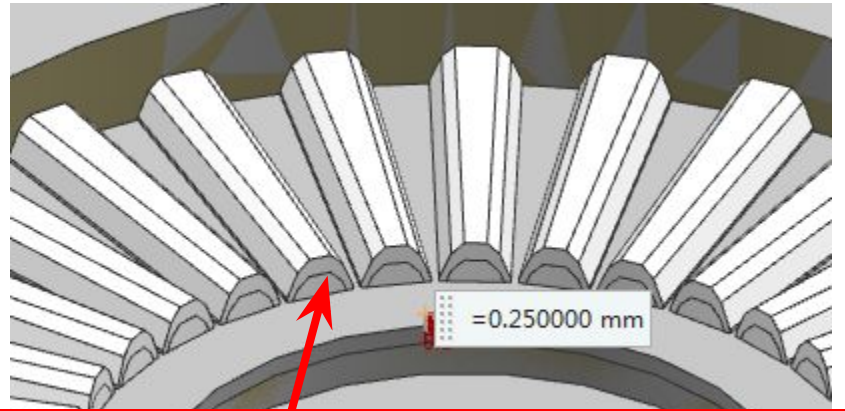
Change 2 from NIC's new file 20220301:  
The position for gear  
----- OK ,no problem from Hasion 3.1

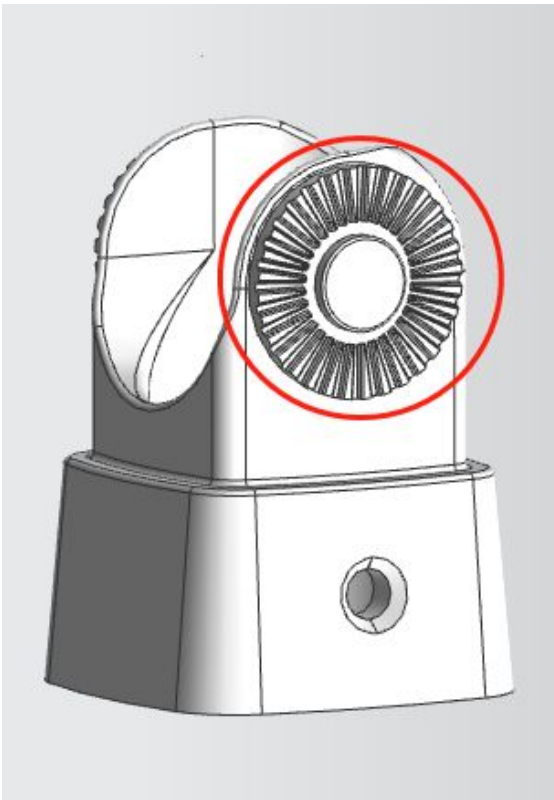
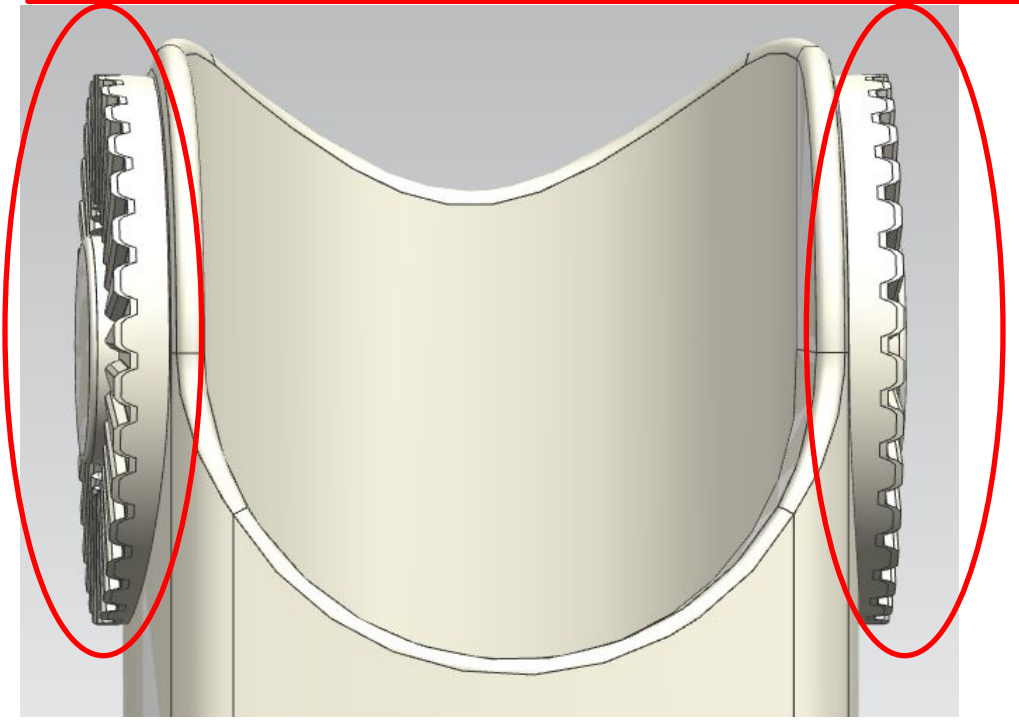
Change 3 from NIC's new file 20220301:

The thickness for here position

----- 0.6mm not OK , It at least 1.2mm--Hasion.3.1

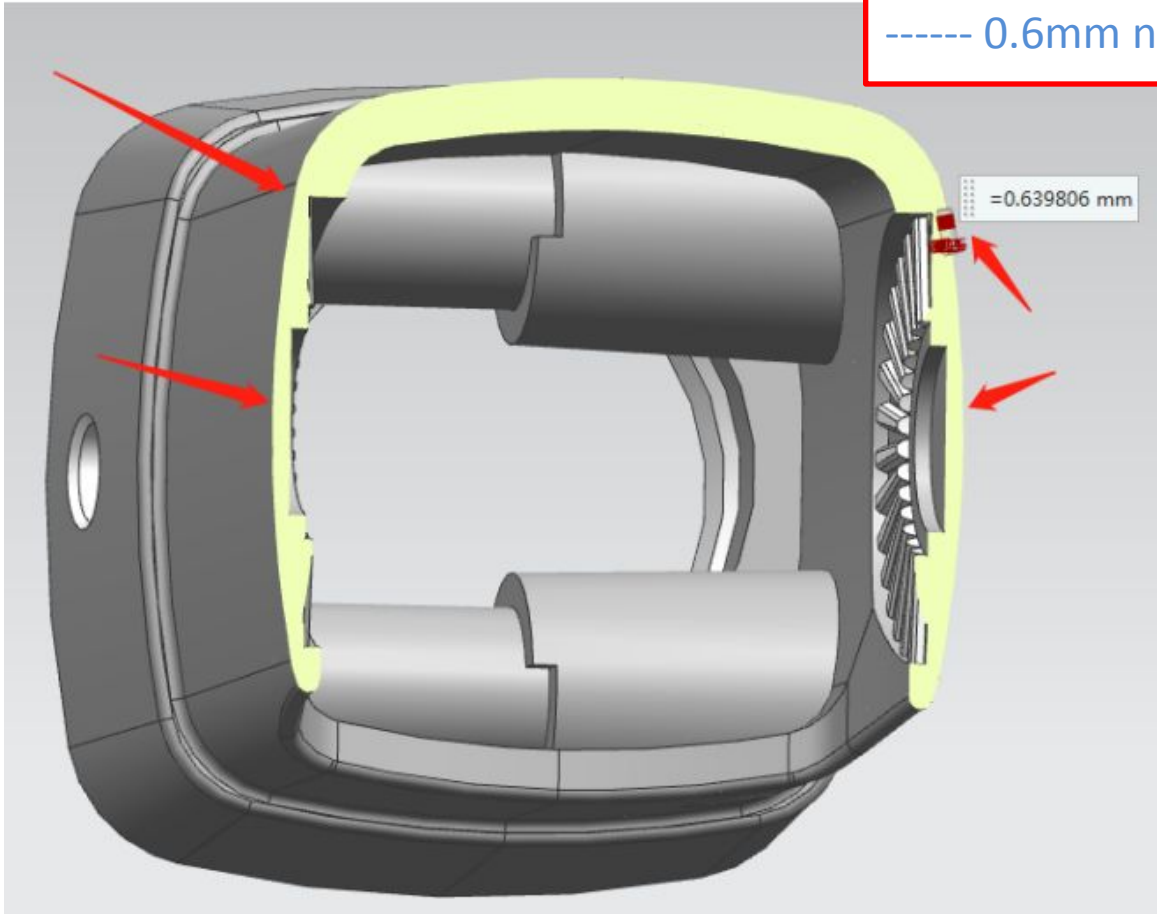
because only 0.6mm thickness ,  
too thin , easy to be broken

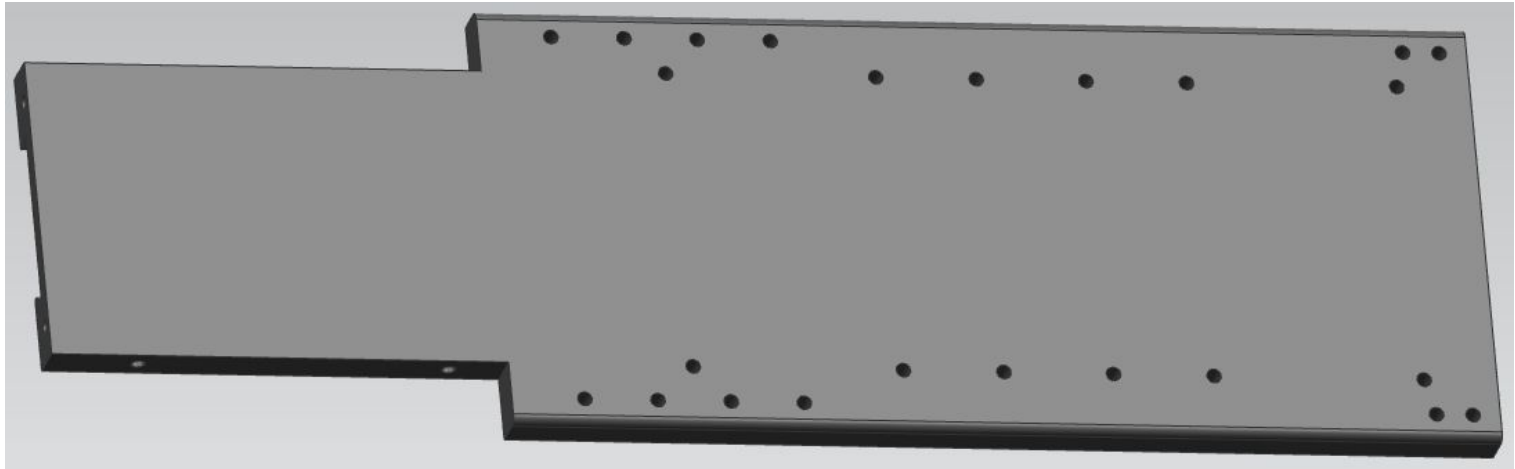
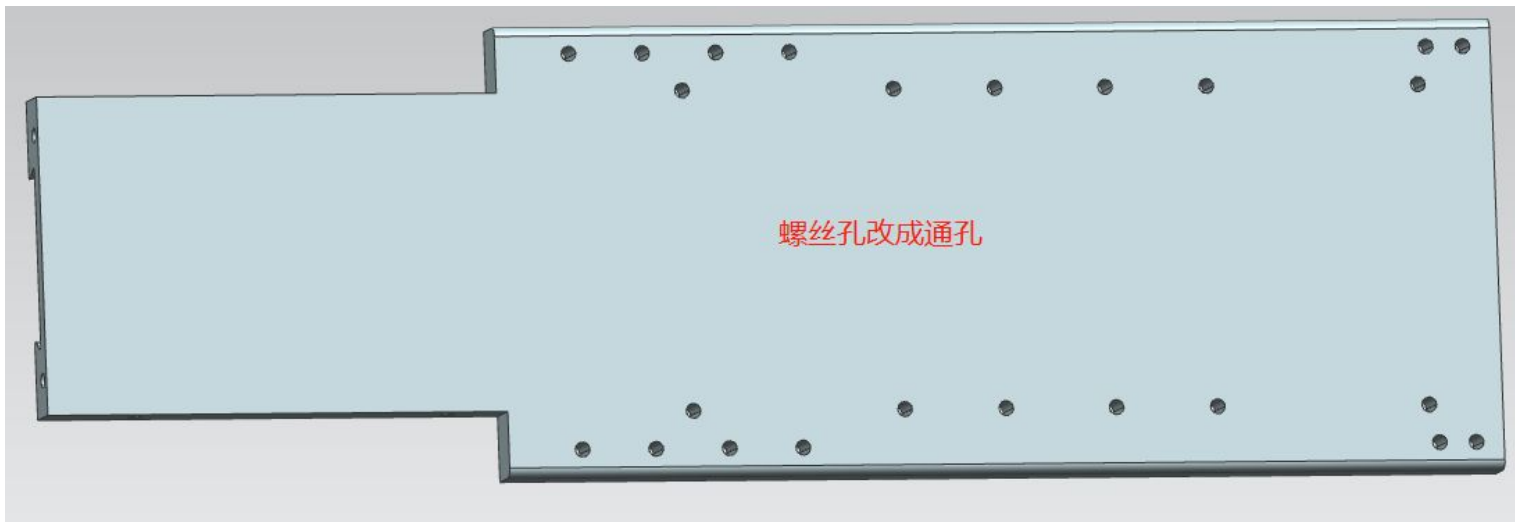
Change 4 from NIC's new file 20220301:  
the hole is through hole type

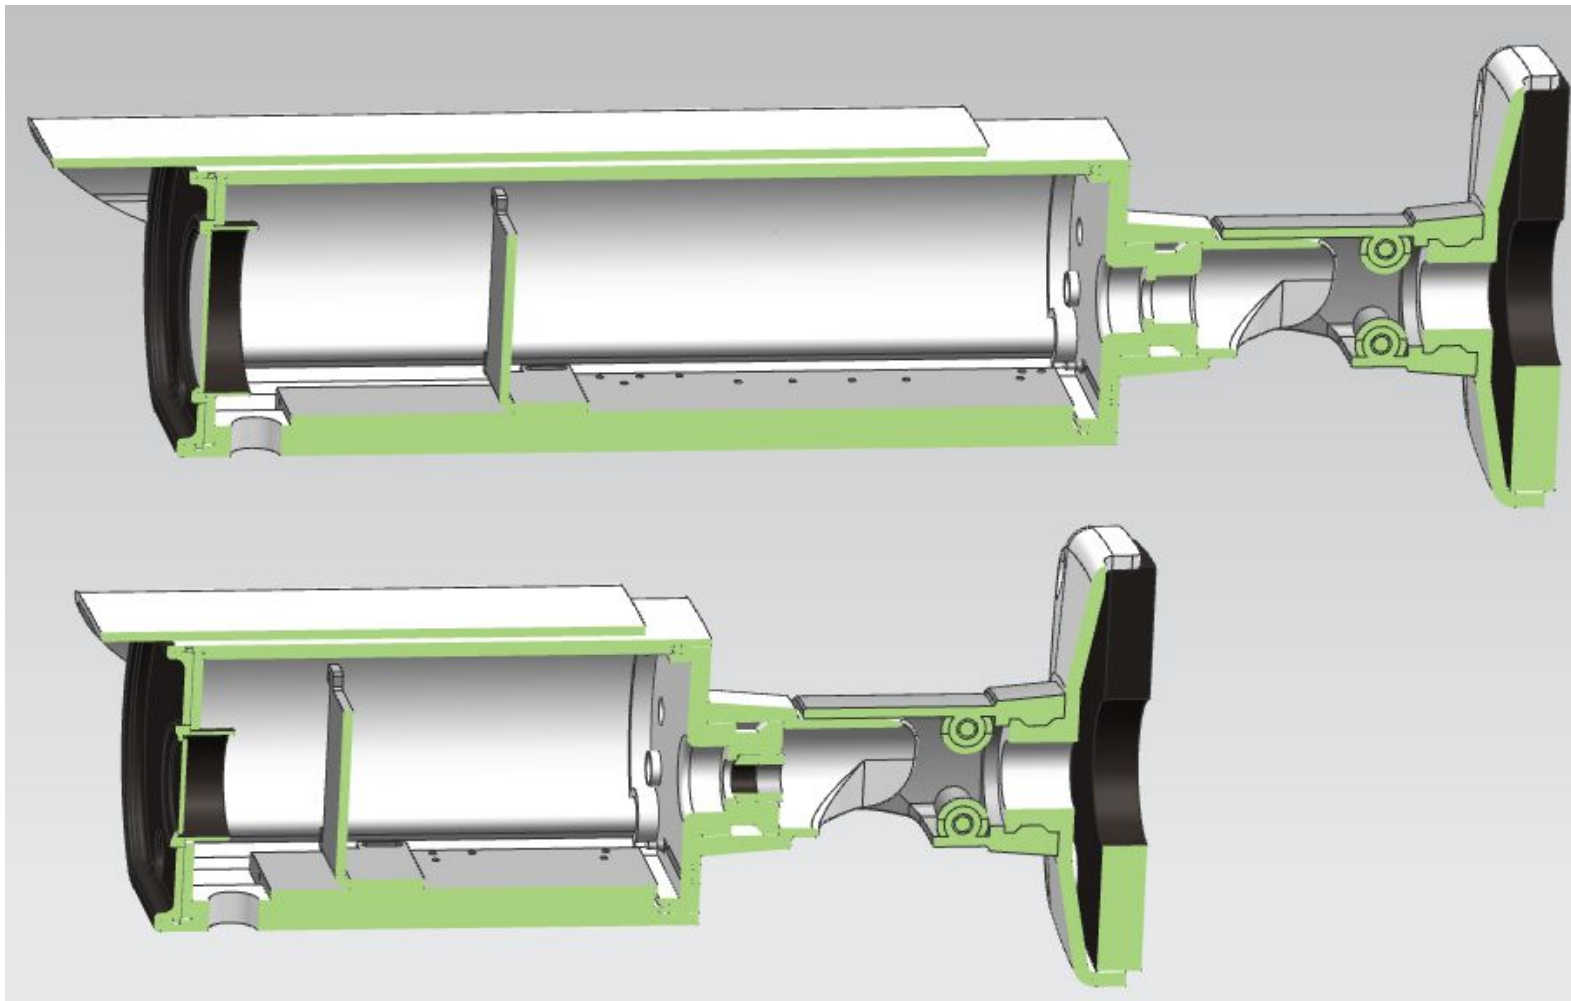
Problem 5 from NIC's new file 20220301:  
fixing way of the bracket board

-----the fixing way is not unreasonable, it doesn't improve the fixing --  
Hasion 3.1
