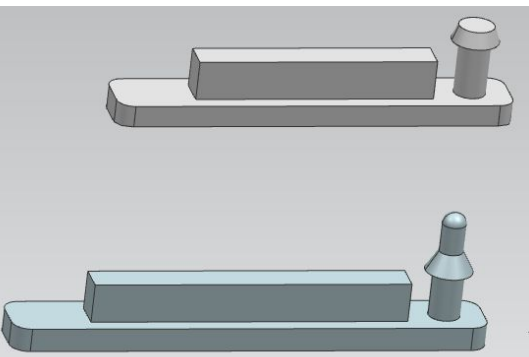
Change 1 from NIC's new file 20220301:
The position for SD is longer
----- OK ,no problem from Hasion 3.1

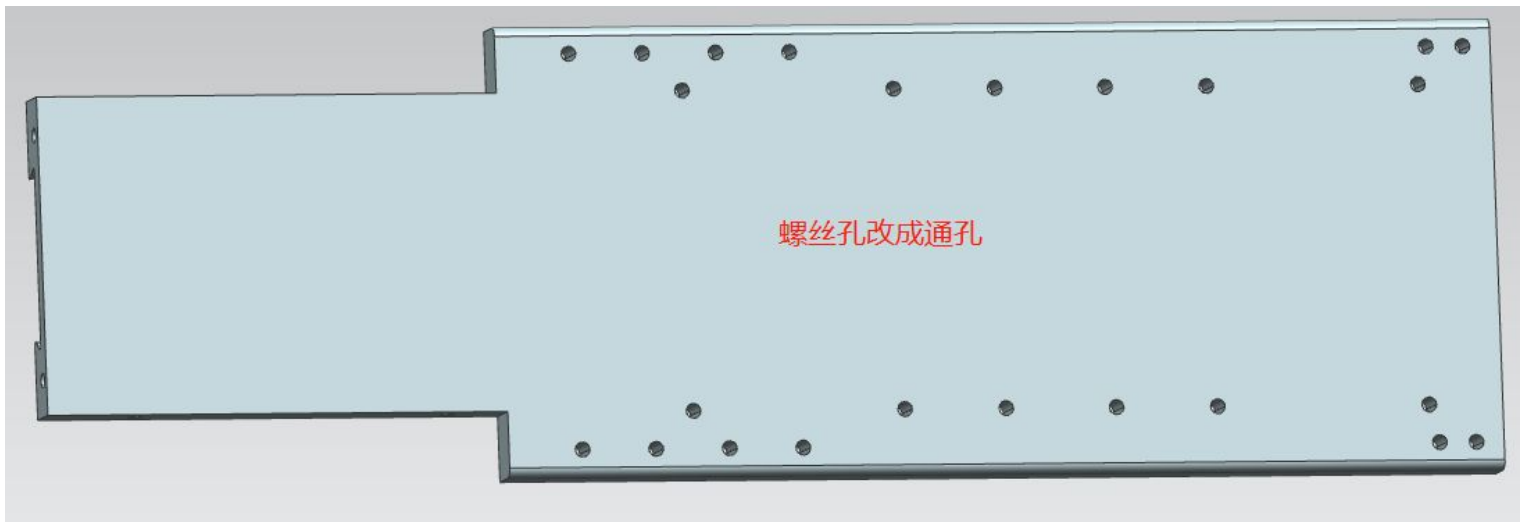
Change 4 from NIC's new file 20220301:
the hole is through hole type
