### LEFA Operations - Maintenance March 2010

### **Overview of Current Status**

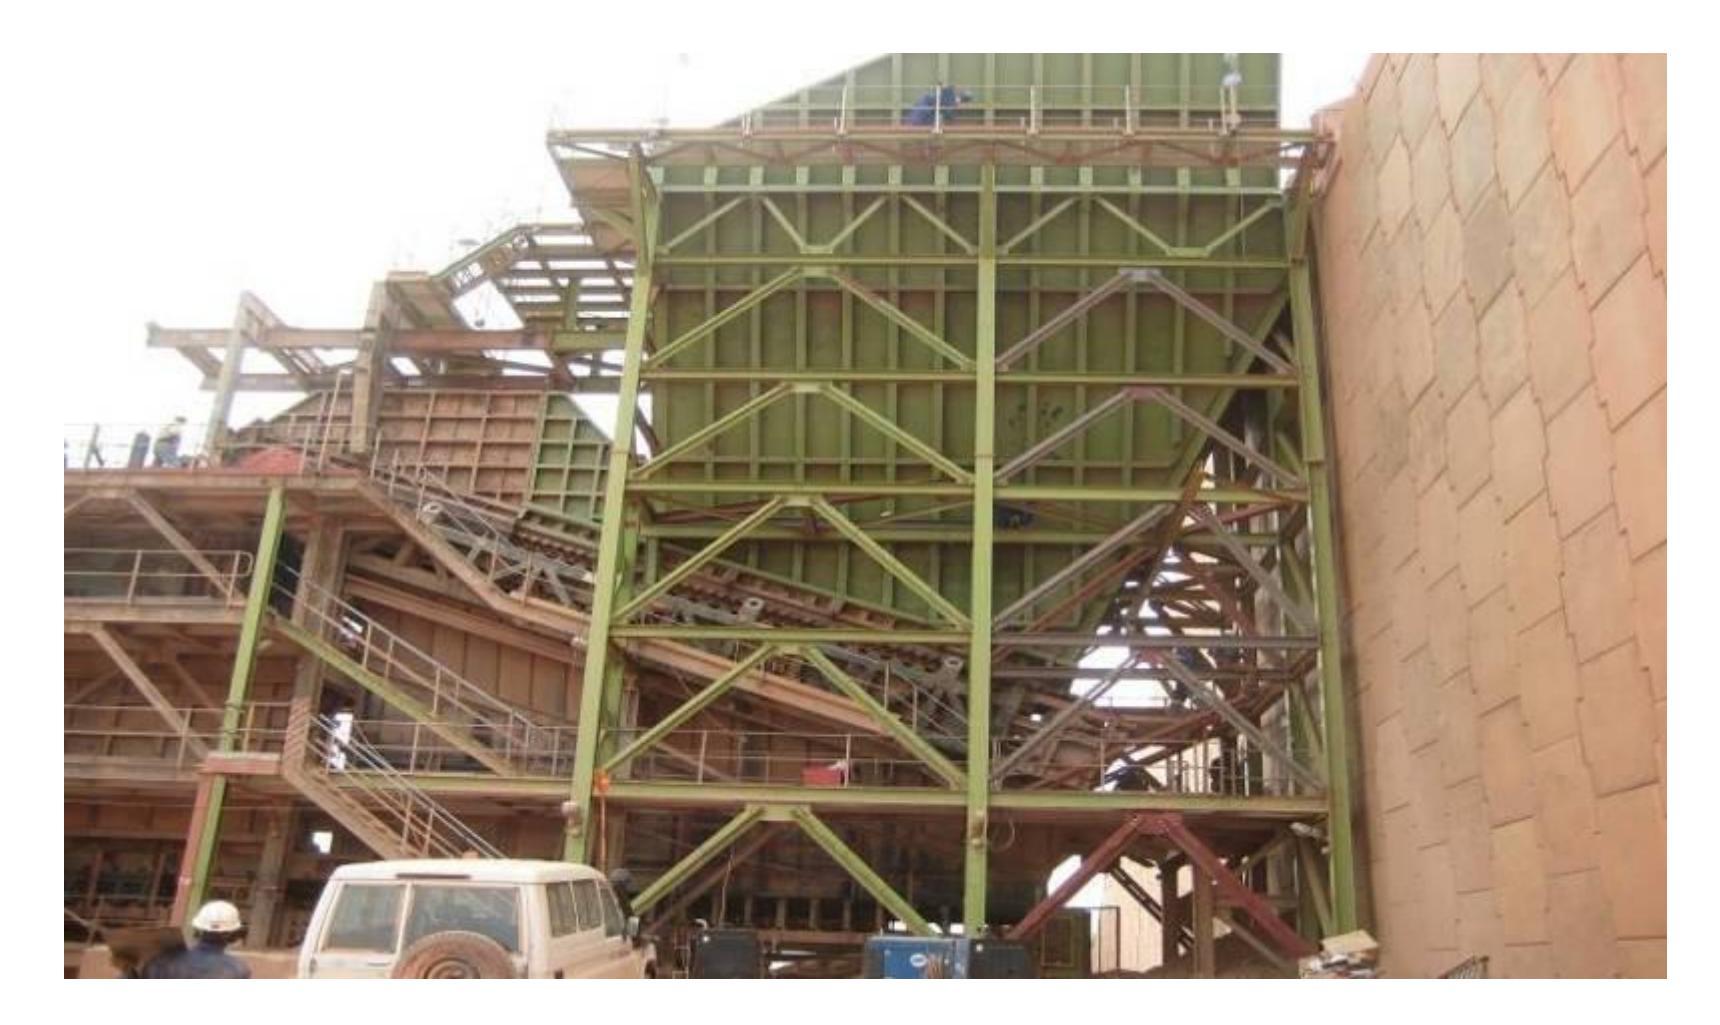
The ROM bin support structures were reinforced to stop movement.

- Both crushers had the bin support structures reinforced to stop movement, which interfered with the apron feeder operation causing through-put interruptions. The work was substantially more at Fayalala.
- Apron feeder major components have been replaced at the Lero crusher.
- Vibrating grizzly replaced at Lero

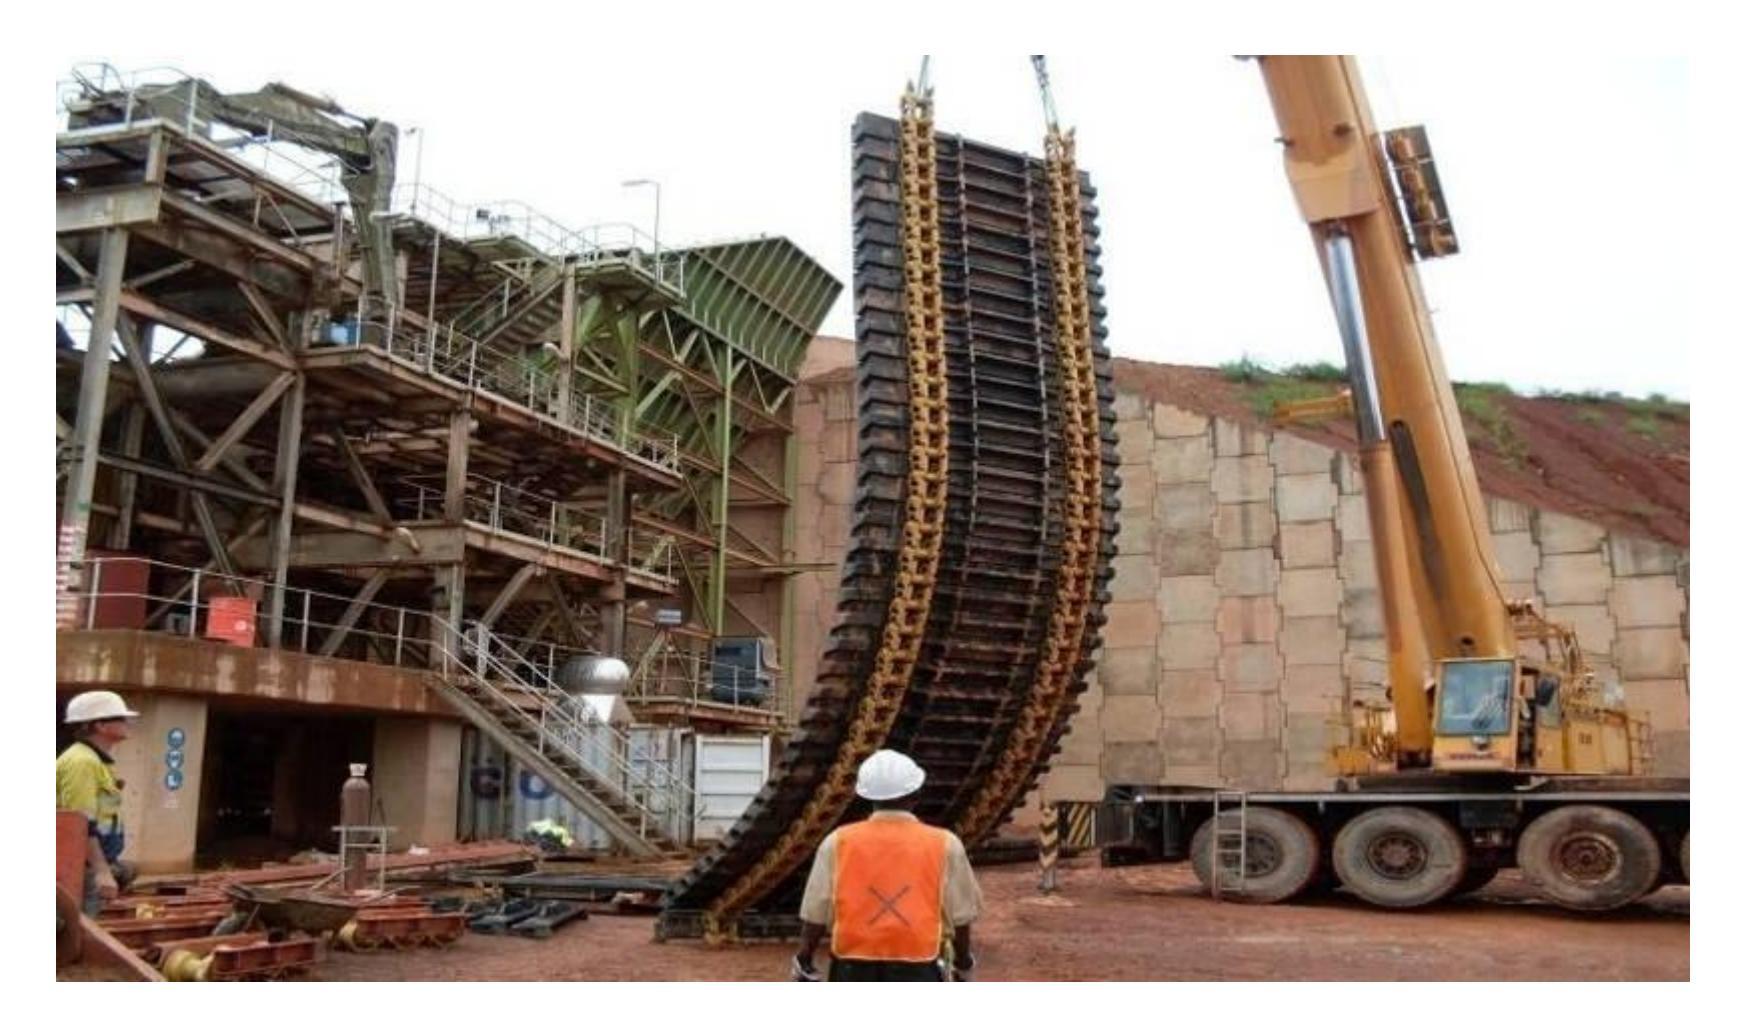
Apron feeder chains & pans have been replaced at the Lero crusher, pans and chains will be replaced in 2010 at the Fayalala crusher.

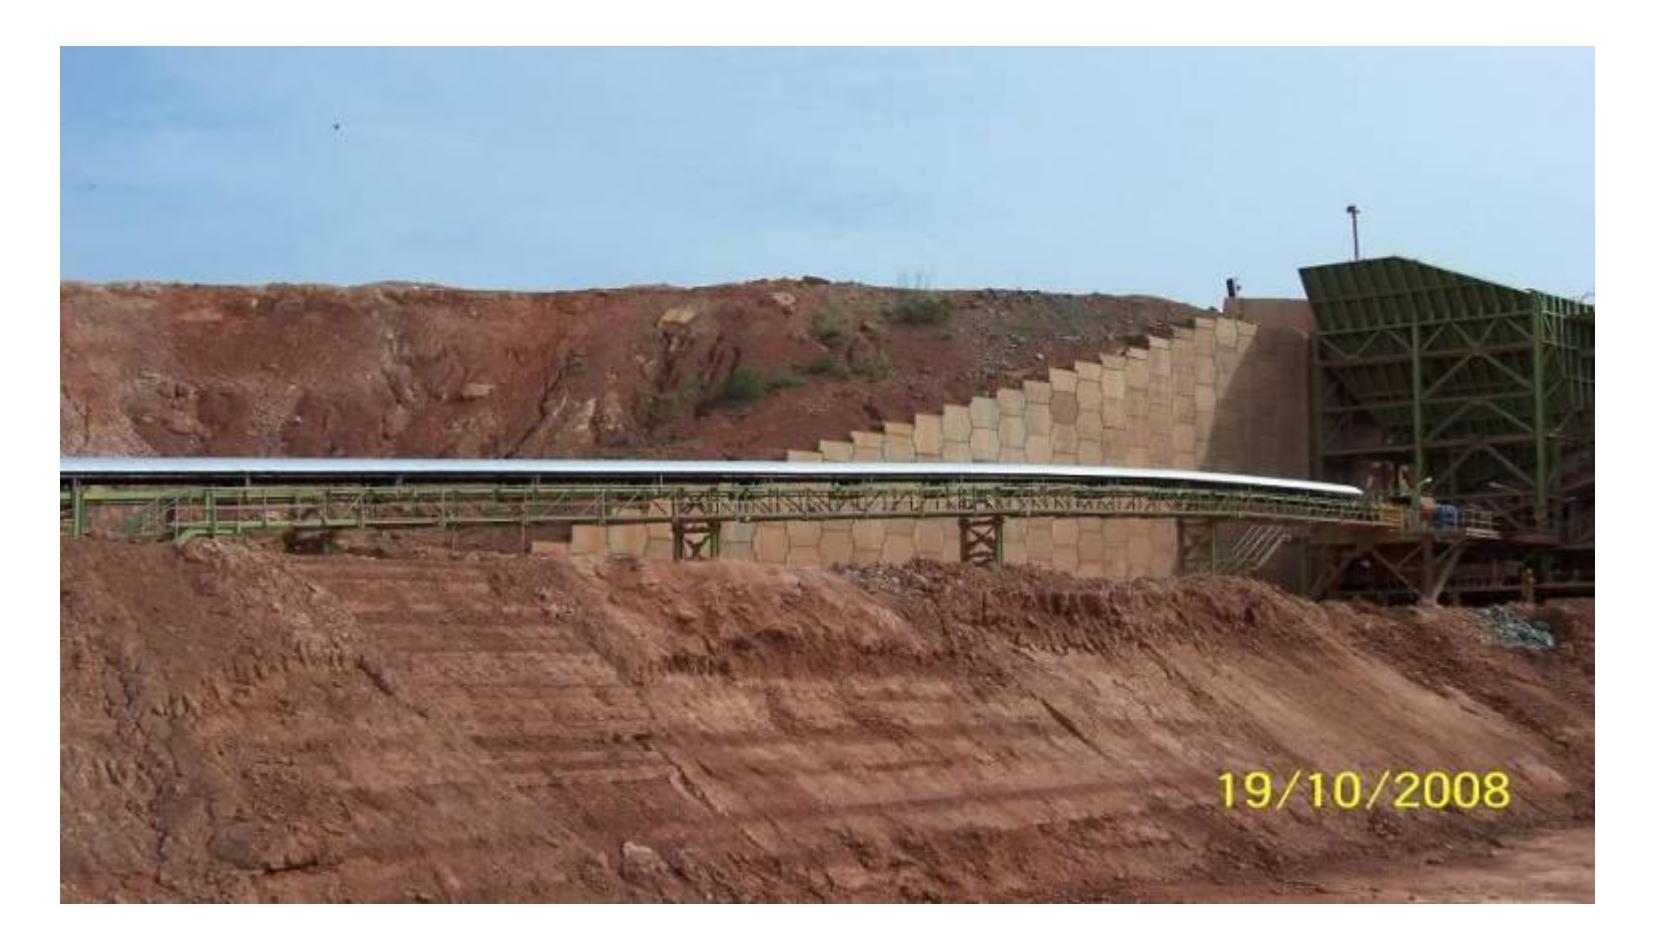
• Covers over belt.

- Replacement of the drive gearboxes as design faults were limiting the performance. The gearboxes were modified to solve lubrication problems associated with bearings. Original gearbox assemblies shall be overhauled in-house and maintained as Insurance Spares.
- Damaged belt renewed.
- Modification to feed chute to reduce jams and damage to belt.
- Cover of belt to reduce saturation of the ore during the wet session.
- Installation of belt tracking frames to reduce belt damage.

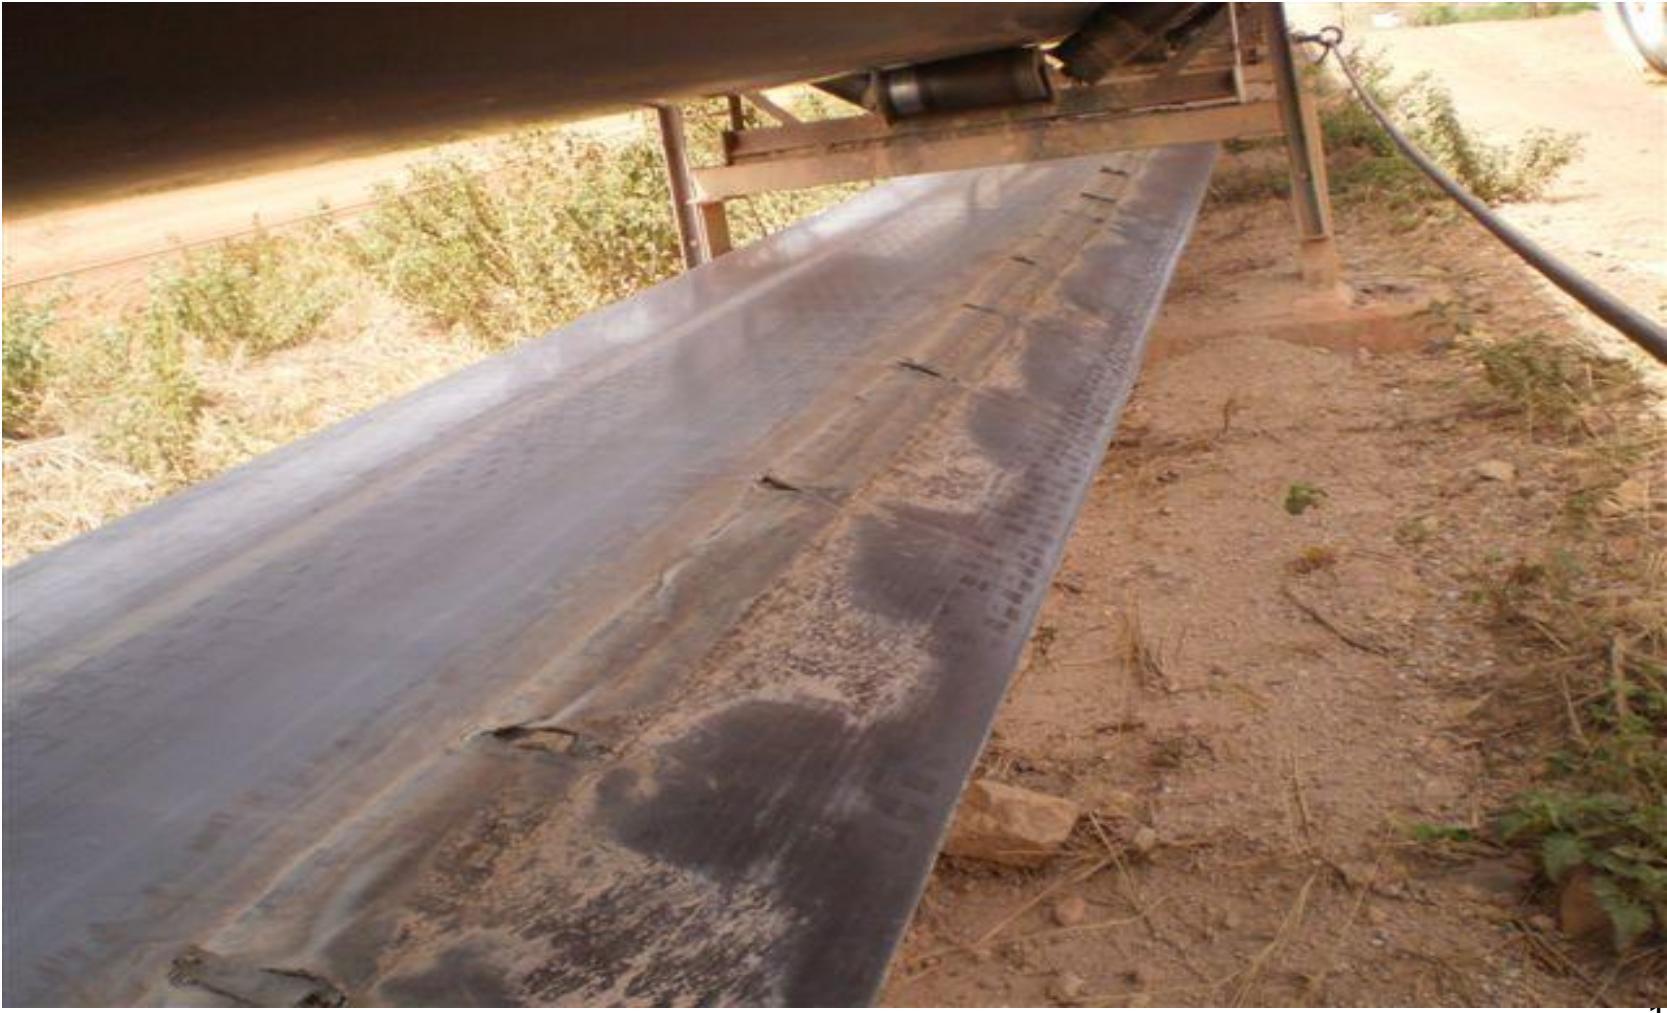
#### CV04 clip repair

- The only remaining concern is the construction of the conveyor system which can be described as cheaply built, with little clearance between carry and return belt support structure. This remains a threat as rock spillage from feed belt onto the returning belt can be trapped within the support frames, resulting in belt damage. However there are no plans to replace this structure due to cost constraints.
- April 2010 a major rip in CV04 of 3572 metres occurred, 1300 metres has been replaced with belt that was in stock, the remaining 2272 metres of damaged belt was clipped at 500mm intervals and also had a Bandage strip glued to the underside to reduce spillage, this bandage strip will be inspected weekly and replaced as required
- Replacement belt is being sourced and expedited to site to replace the remaining damaged section of belt.

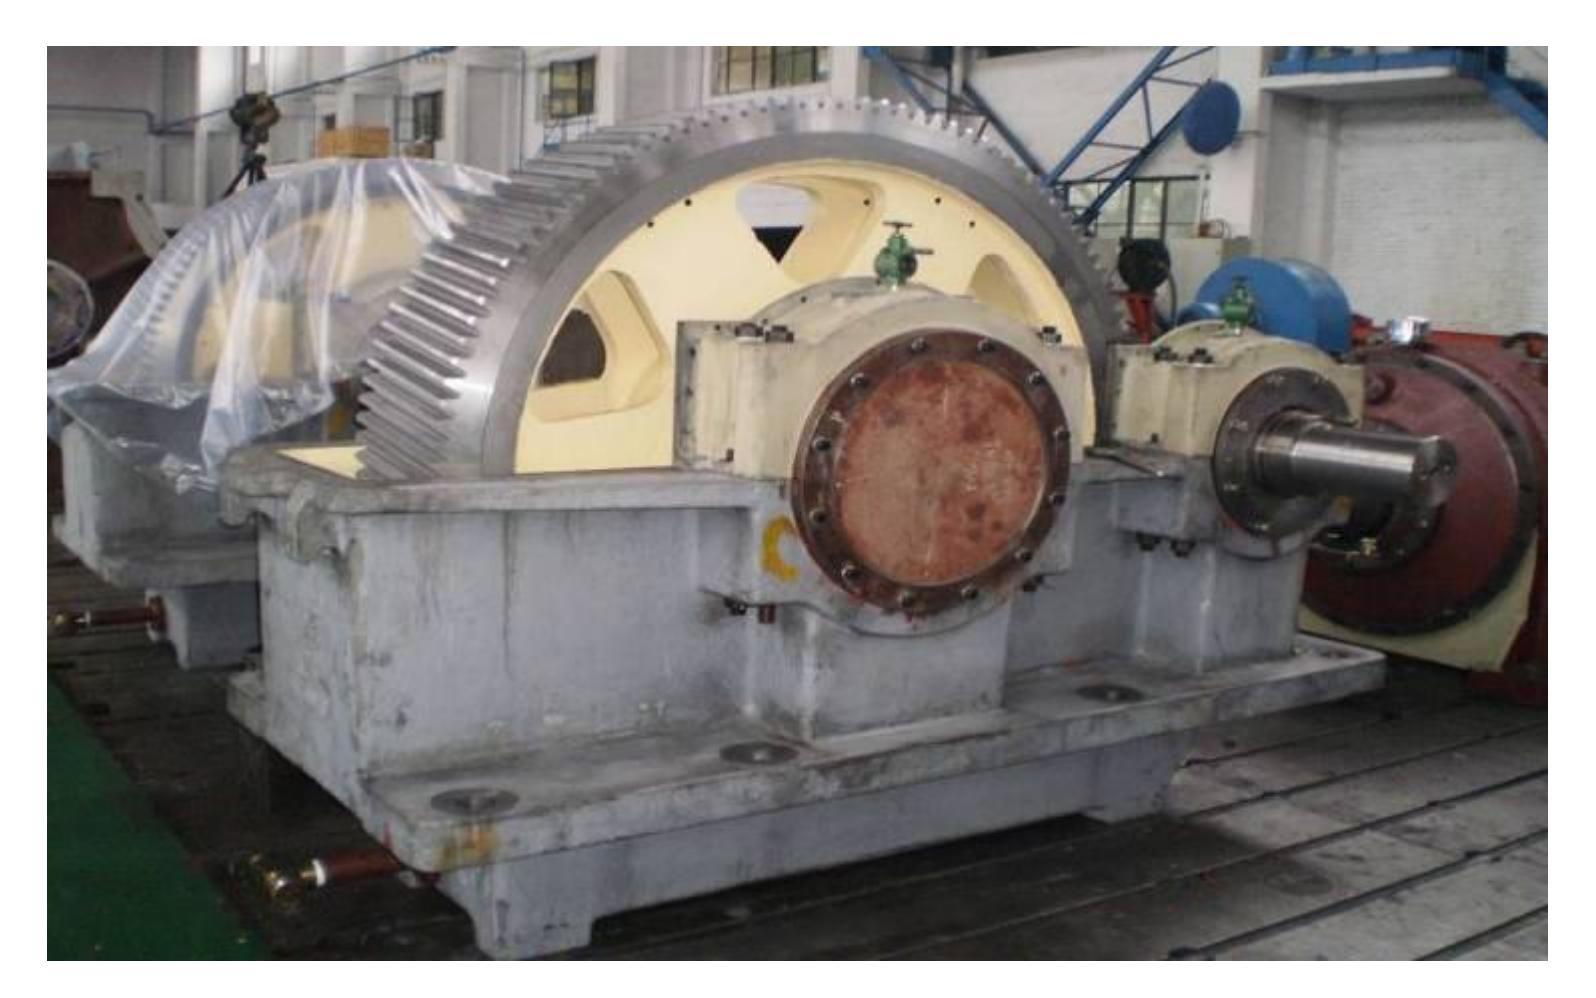
Two spare gearboxes (left and right) are on site.Scheduled to be installed on SAG 1 in July / August 2010.

- The repair is expected to allow the mill to operate until the replacement of the trunnions in **fourth** quarter of 2010.
- Two spare SAG mill gearboxes (left and right) are on site and will be installed on SAG 1 in 2010, as the current unit's service life is unknown. The units removed will be overhauled and changed out on SAG 2. At the completion of this program the two overhauled spare gearboxes from SAG 2 will be held as insurance spares.

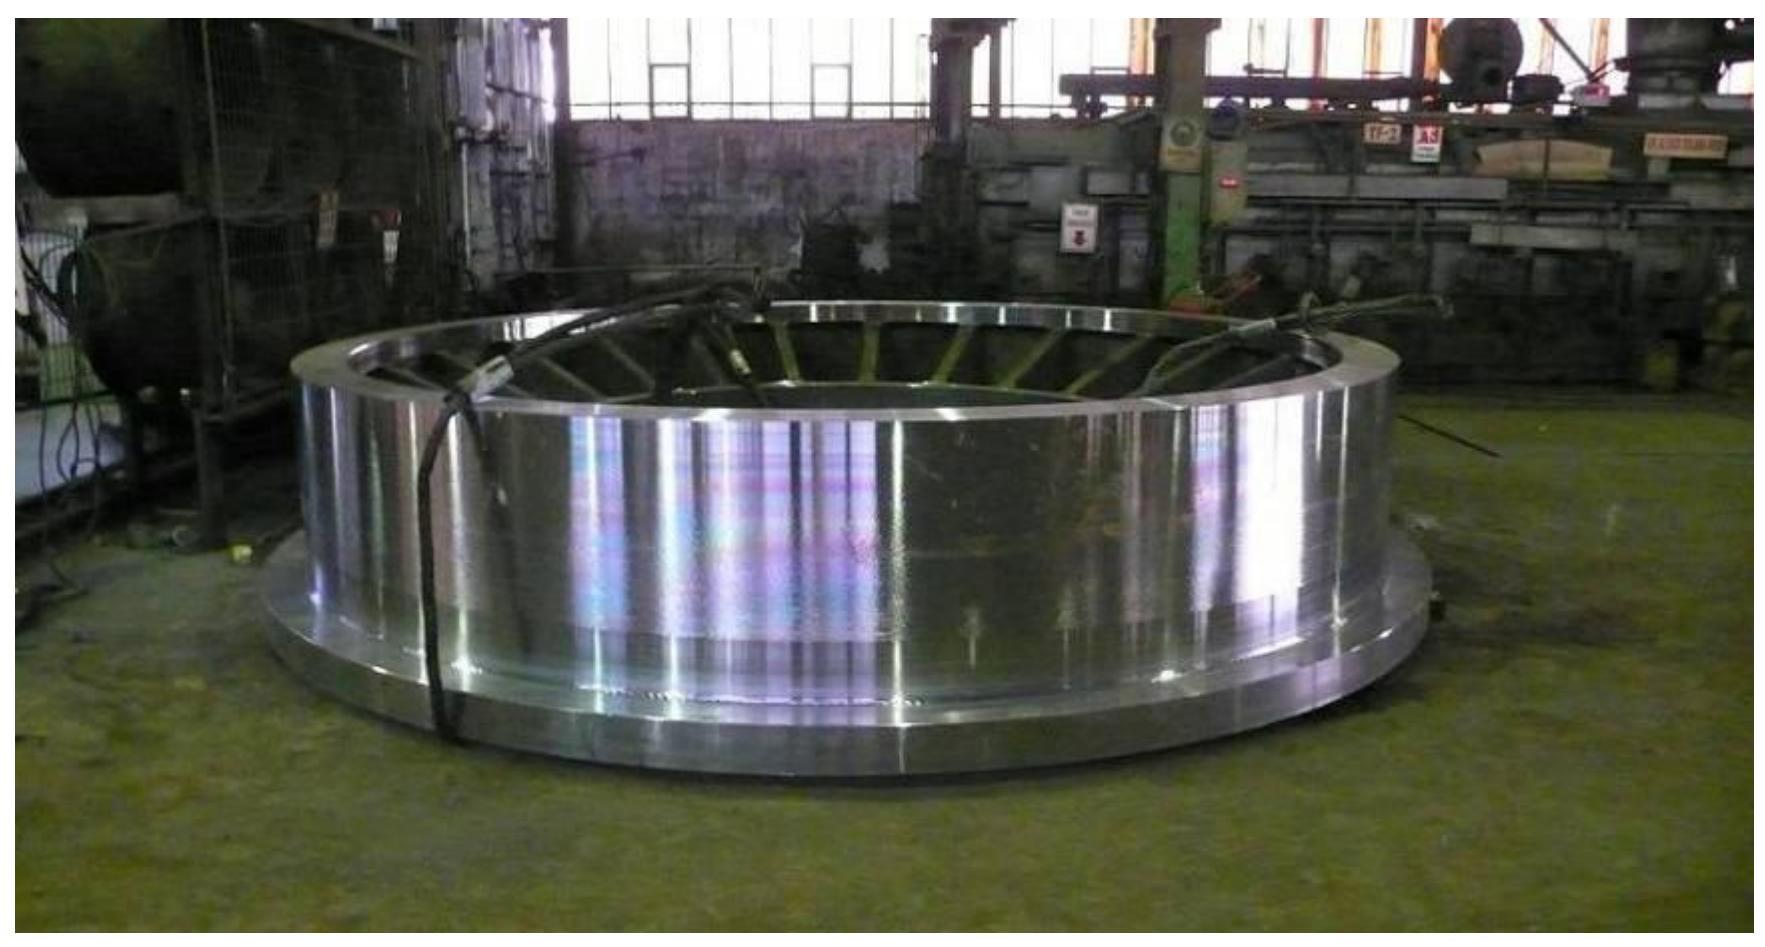
New trunnions from REMAS in Turkey have been completed and ready for shipping. The completed trunnions are expected to be installed in the planned October shutdown. The existing Discharge trunnion will be scrapped due to cracks in journal surface, the Feed end Trunnion will be repaired for Insurance spare.

Casting/forging of the SAG mill trunnions is completed in Turkey.

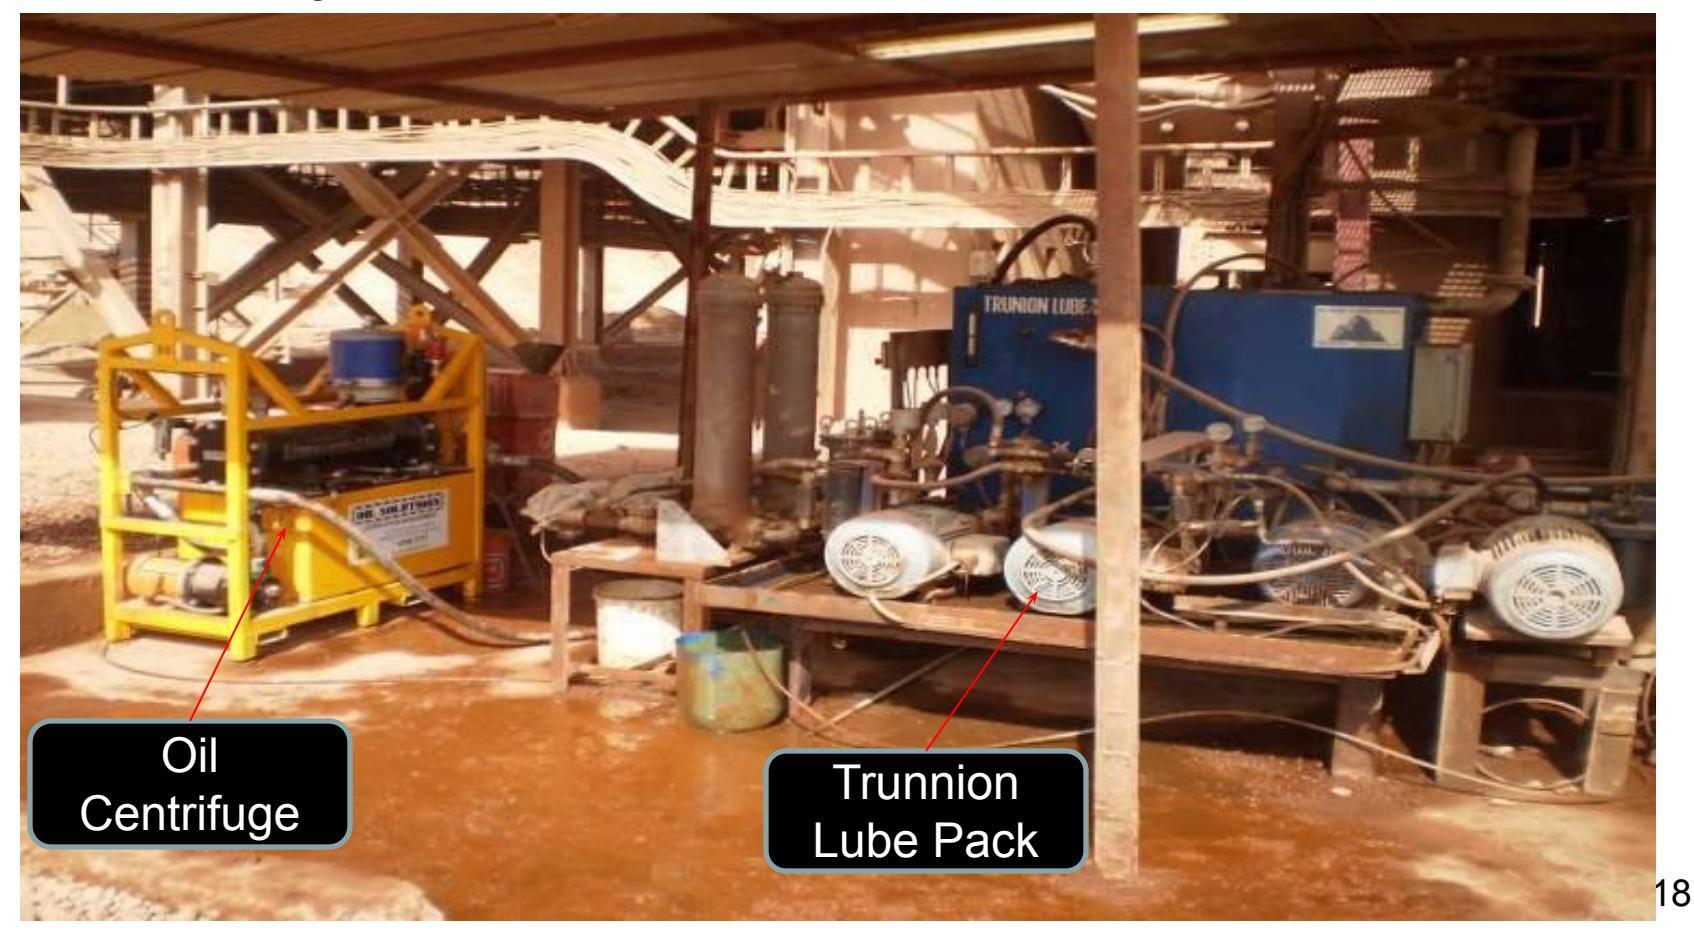
SAG Mill discharge end trunnion bearings need to be replaced every 6 to 8 months due to excessive wear (normally last plus 10 years). The main reason for damage is thought to be loss of pressure to the oil separating the trunnion from the bearing during power outages and contamination of the oil due to poor design of the trunnion seals. A re-engineered seal and an accumulators will resolve these issues in 2010. In the meantime, a centrifuge is used to clean the trunnion bearing oil.

LUBEMASTER Centrifuges have been installed on to both SAG Mill lube packs to assist in keeping the oil cleaner until a solution to the Trunnion sealing is sourced.

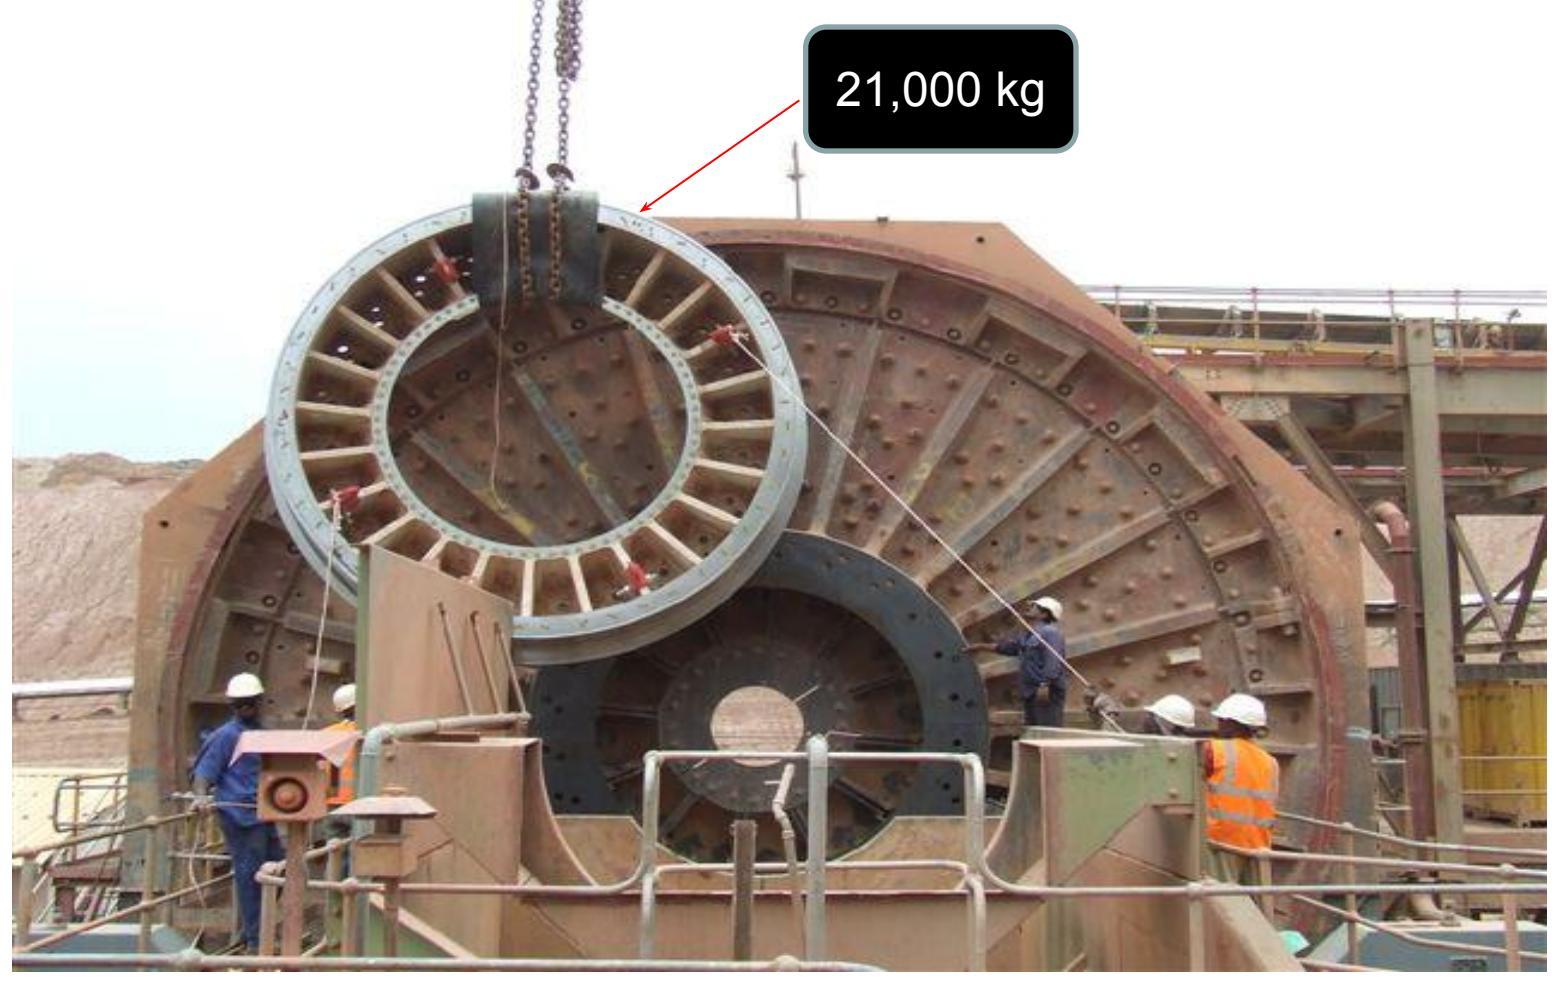
The trunnion for this mill was removed for machining by REMAS in Turkev and returned in May 2009.

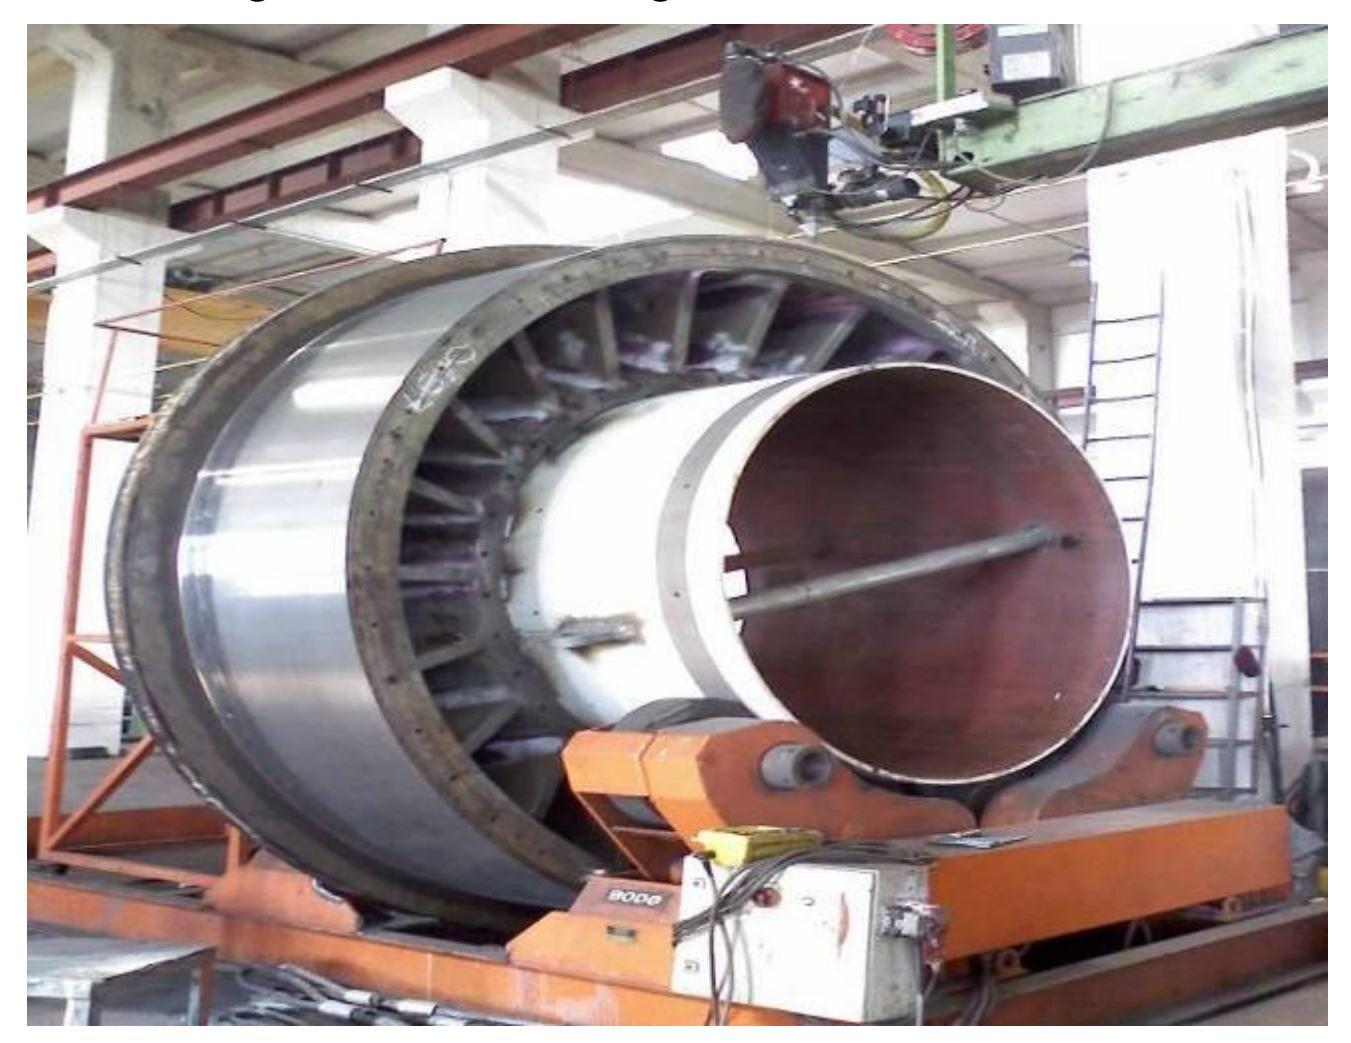
SAG Mill 2, Trunnion being repaired by REMAS in Turkey. After machining, sub-arc welding to rebuild the surface.

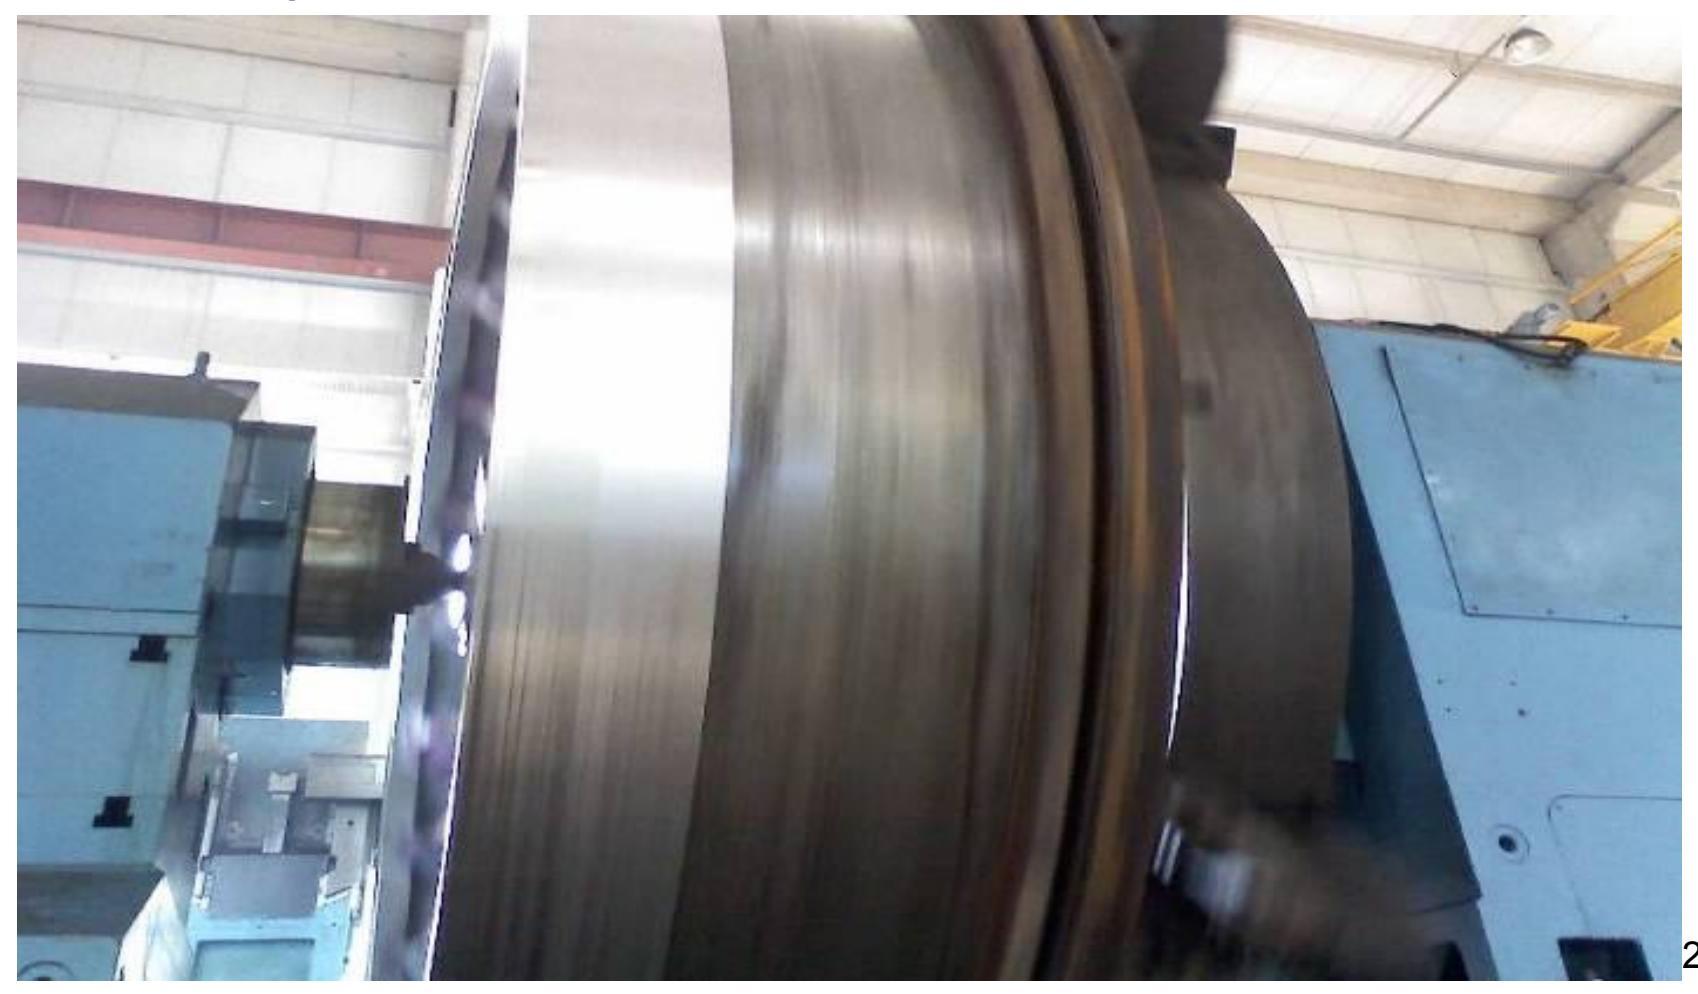
SAG Mill 2, Trunnion being repaired by REMAS in Turkey Machining back to OEM dimensions.

- The trunnion that was repaired by REMAS in Turkey still has a problem with the Thrust face which is causing elevated temperatures, we are working with REMAS for a solution.

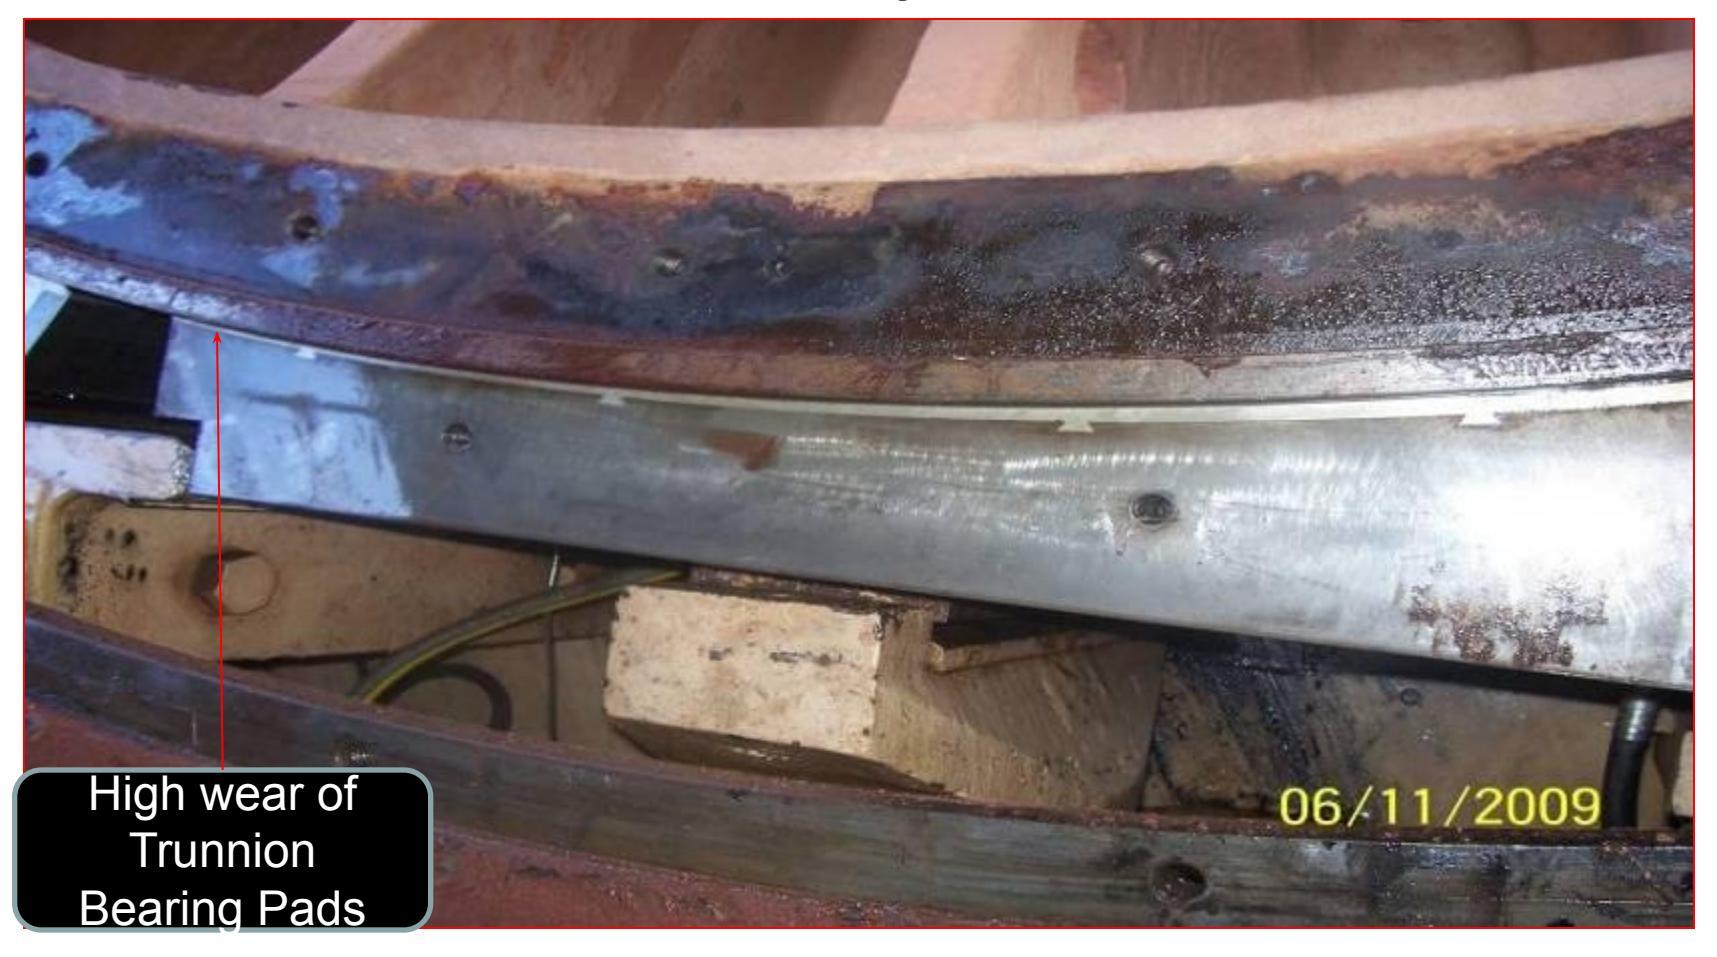
- SAG Mill discharge end trunnion bearings need to be replaced every 6 to 8 months due to excessive wear (normally last plus 10 years). The main reason for damage is thought to be loss of pressure to the oil separating the trunnion from the bearing during power outages and contamination of the oil due to poor design of the trunnion seals. A re-engineered seal and an accumulators will resolve these issues in 2010.

Premature SAG Mill Trunnion Bearing failures remain a concern until new trunnion seals and accumulator for lubricating oil installed.
 November 2009 SAG Mill 2 Discharge End.

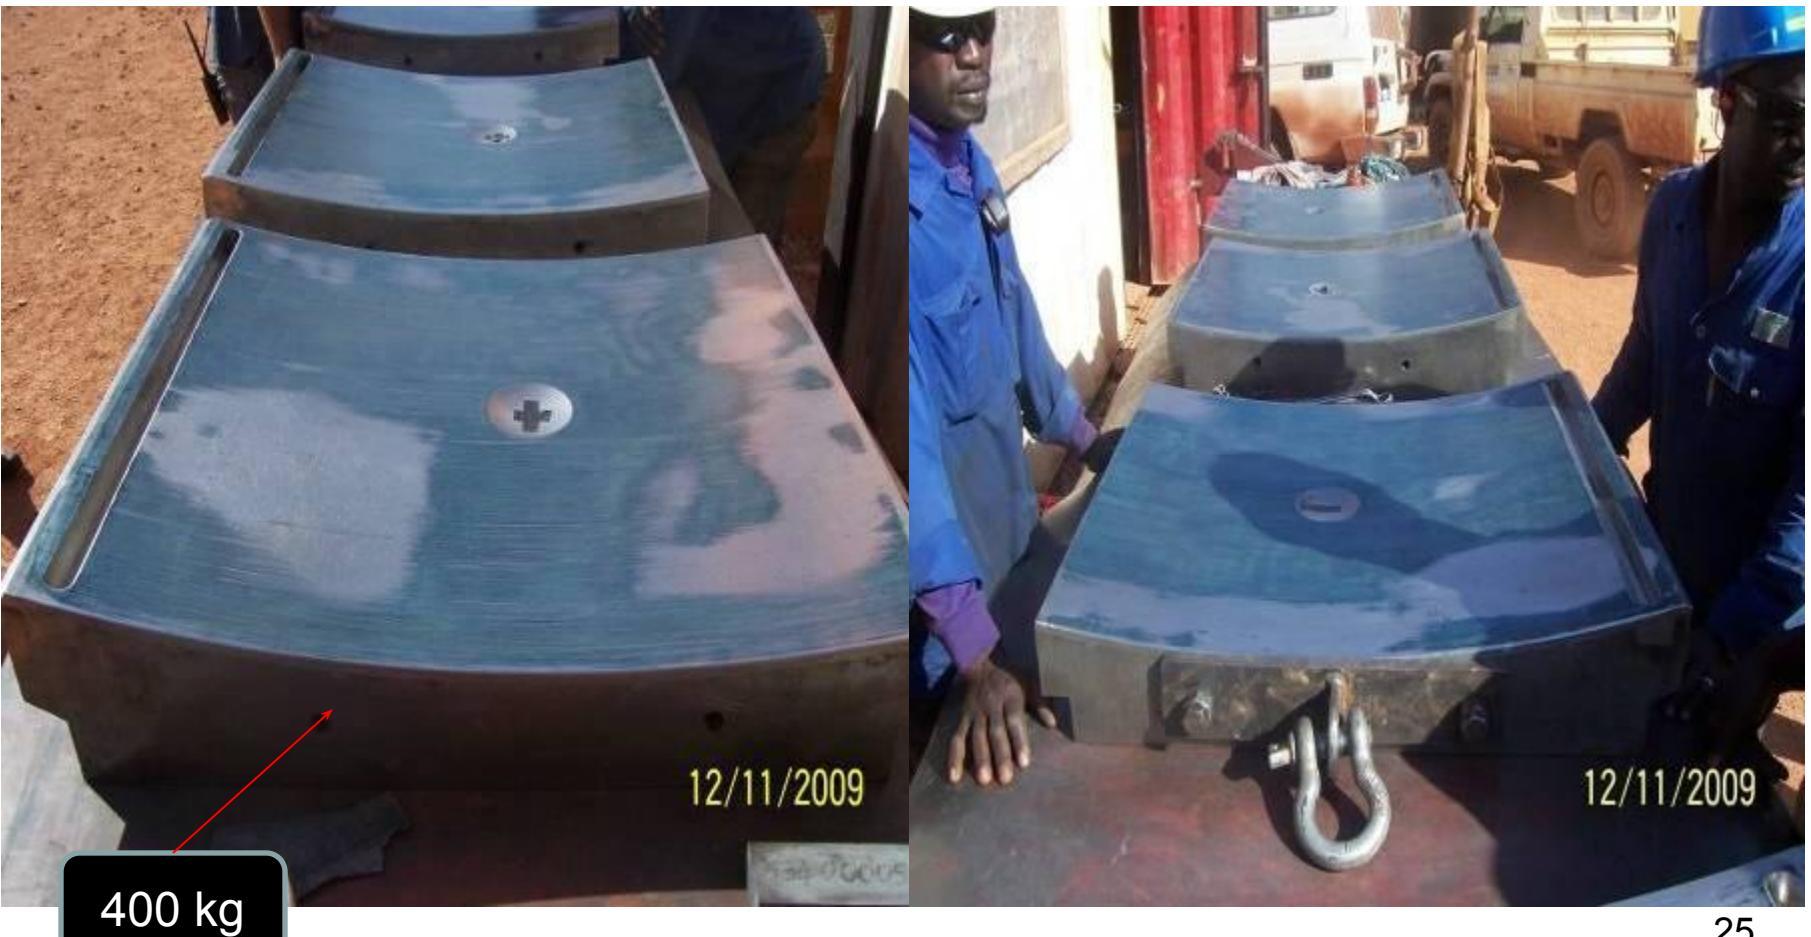
SAG Mill 2 bearings were hand scraped for the best possible contact with the trunnion Journal surface.

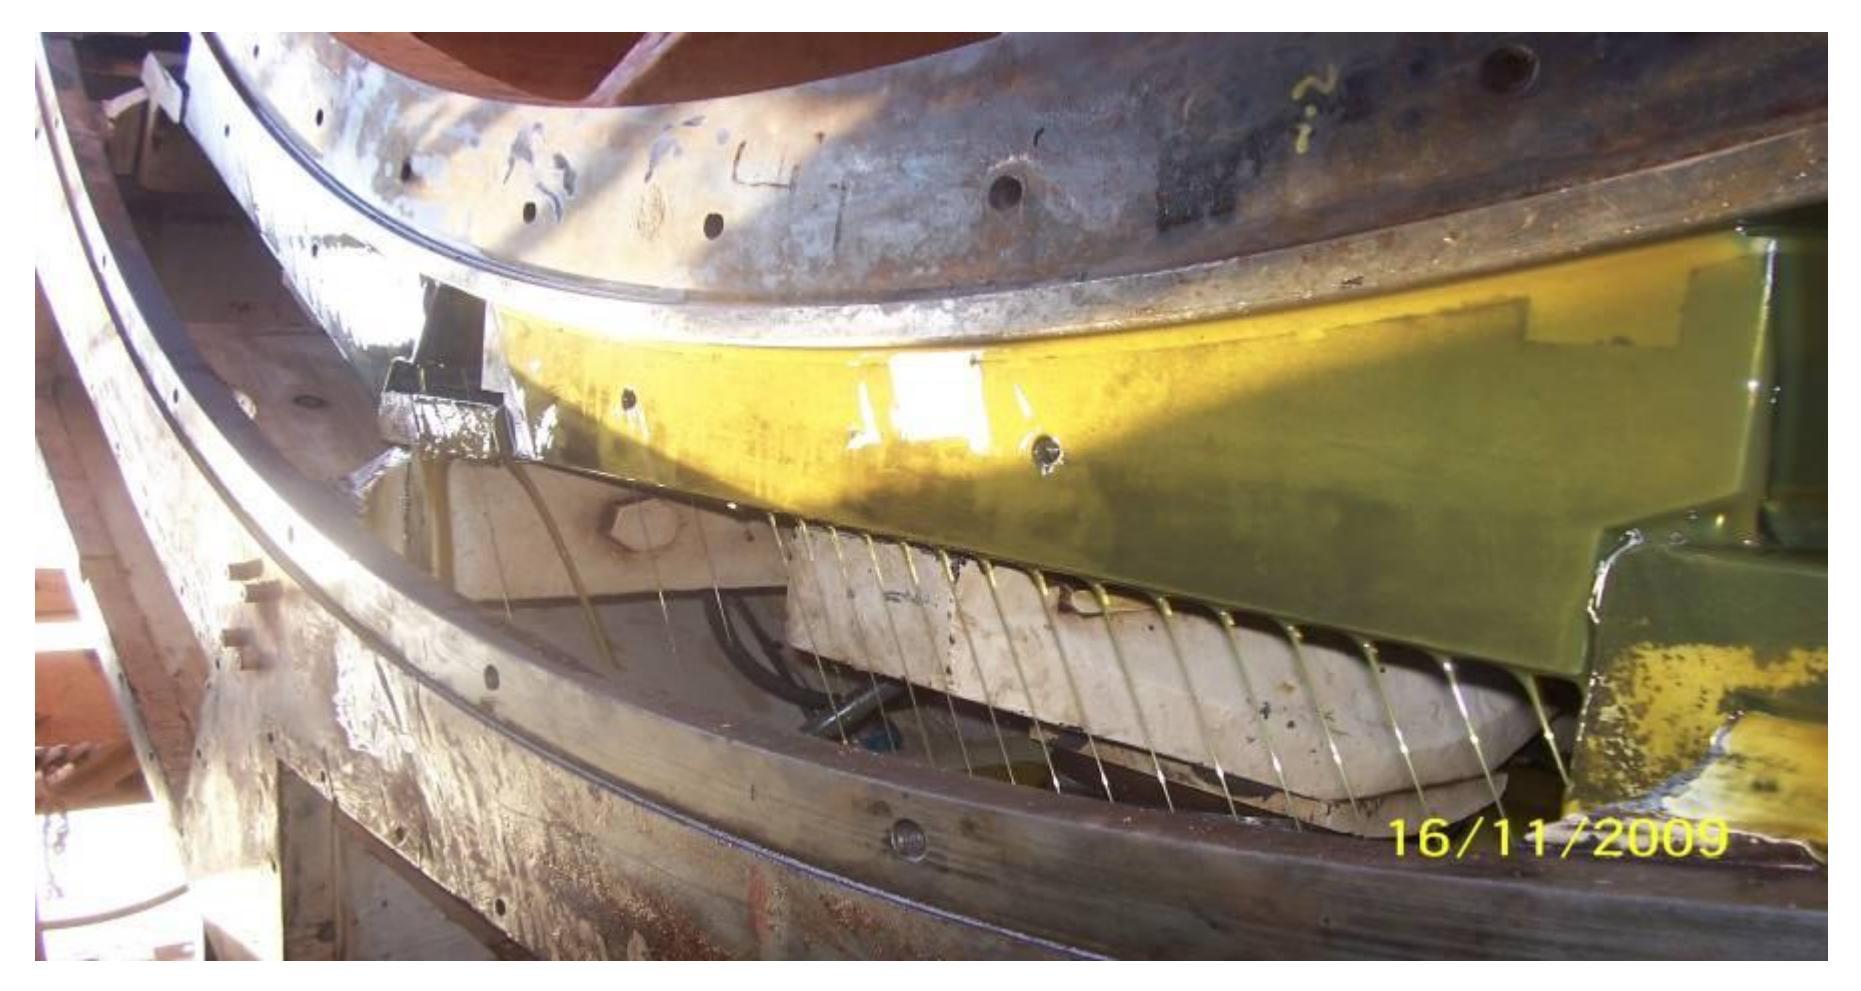
New Bearing Pads after installation showing excellent oil coverage.
