### LEFA Operations - Maintenance March 2010

### **Overview of Current Status**

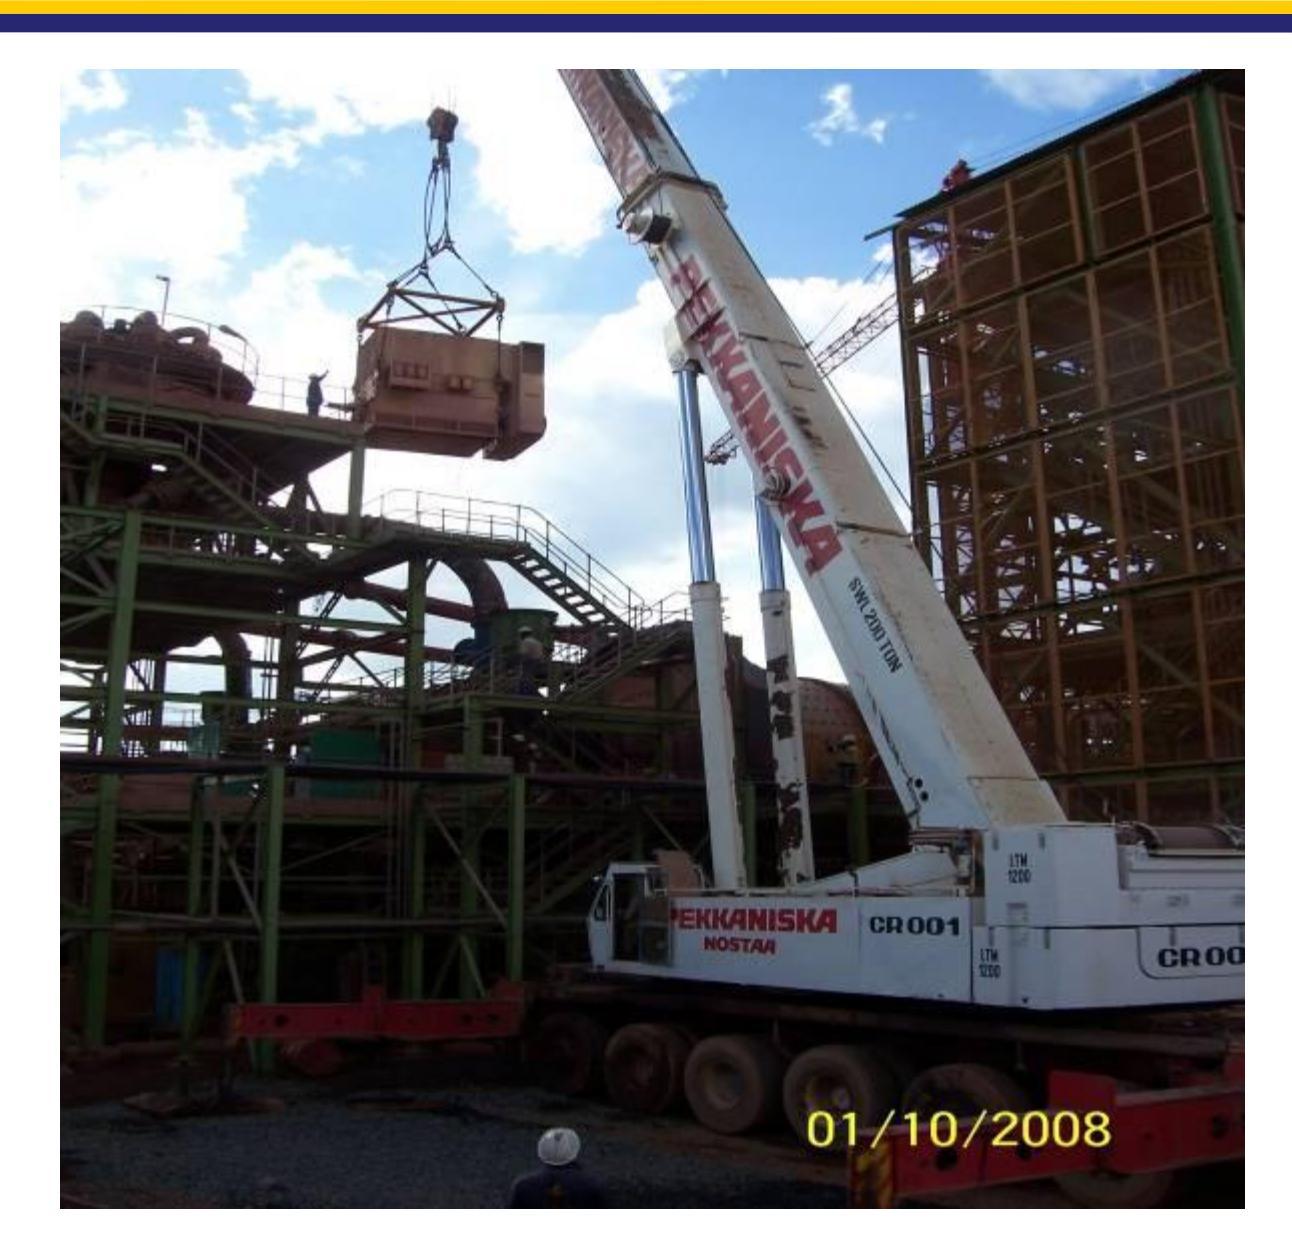
Ball Mill 1 motor being lifted away from the Mill. Motor weighs 28T

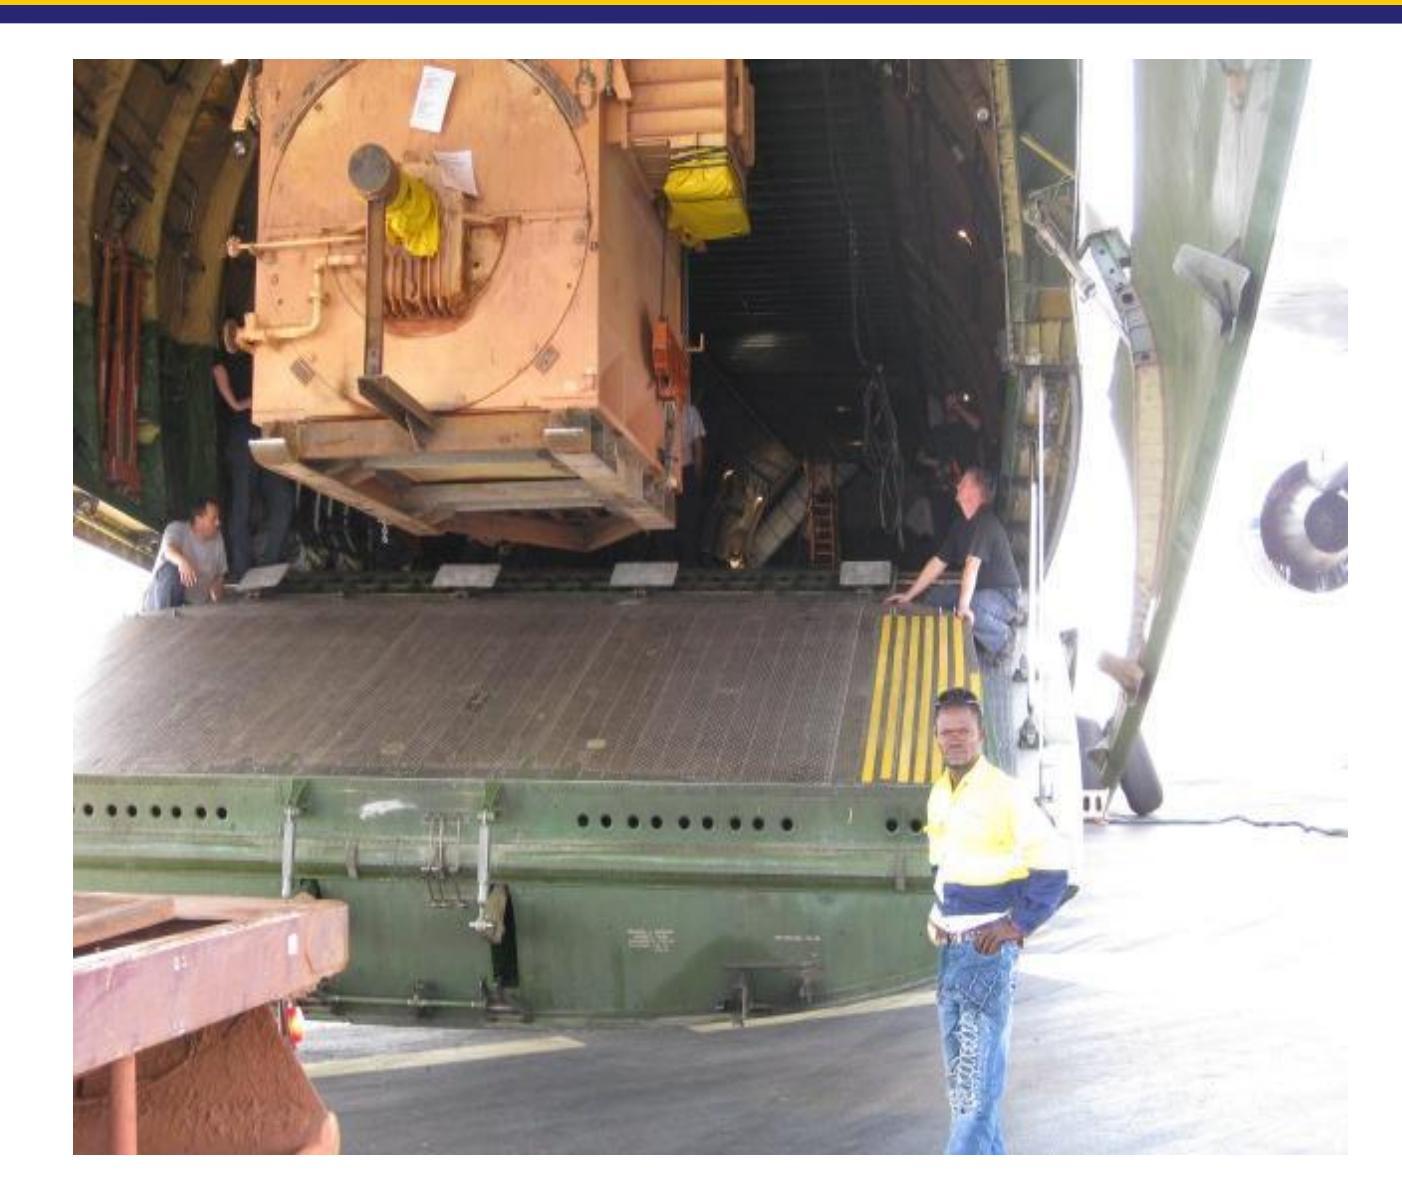
Ball Mill 1 Motor being loaded onto an Antonov Aircraft bound for Antwerp for overhaul.

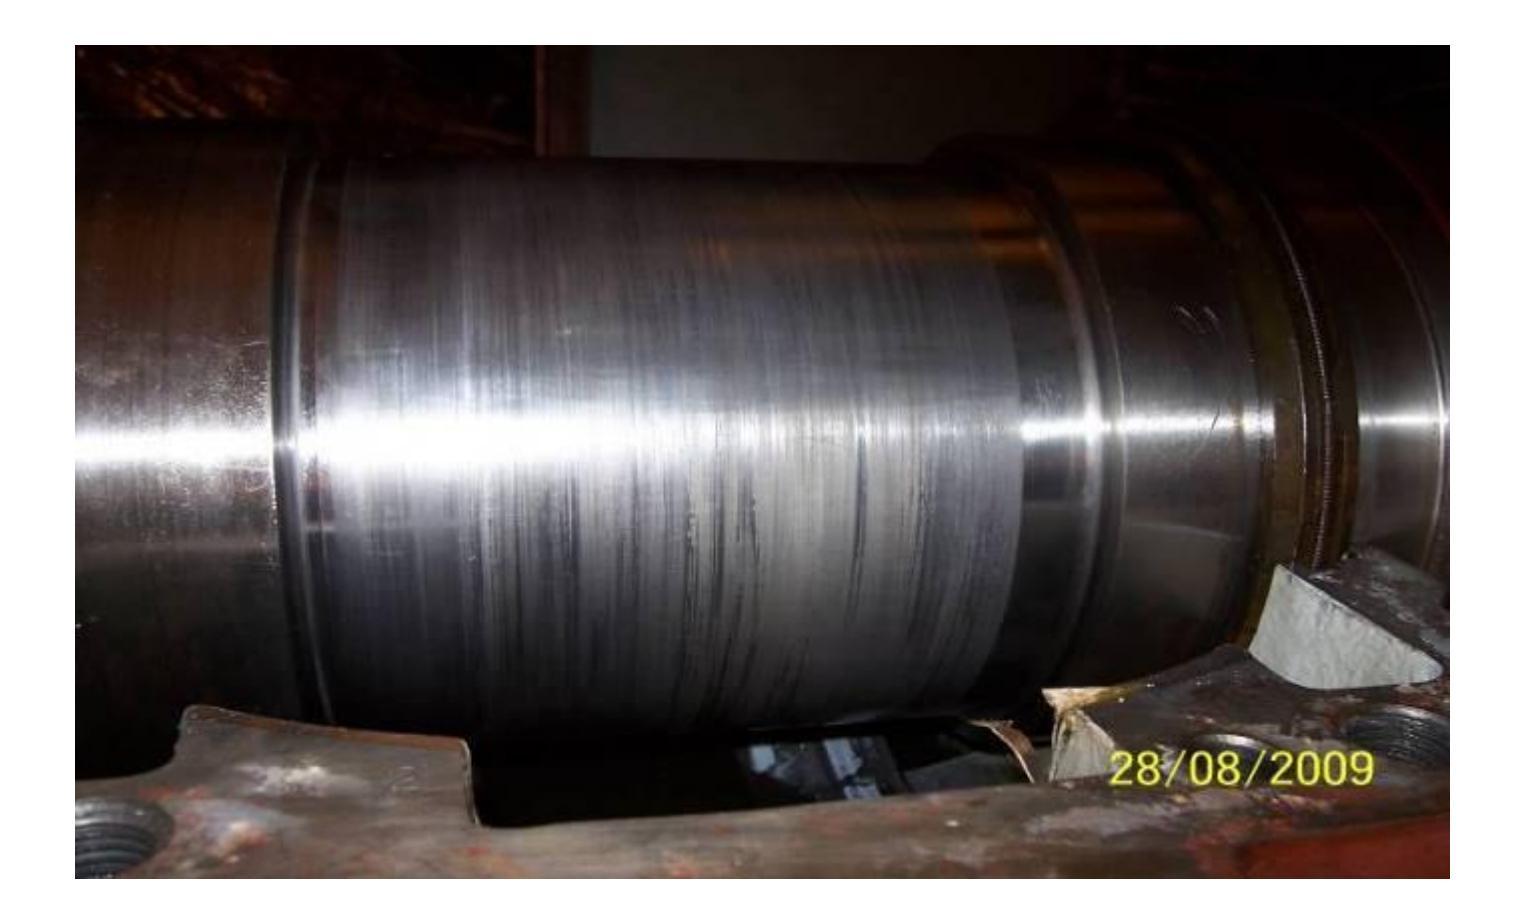
The motor on Ball Mill 2 went down in late August on high temperature on the non drive end. The shaft was inspected and deemed OK and with no evidence of problems with the windings.

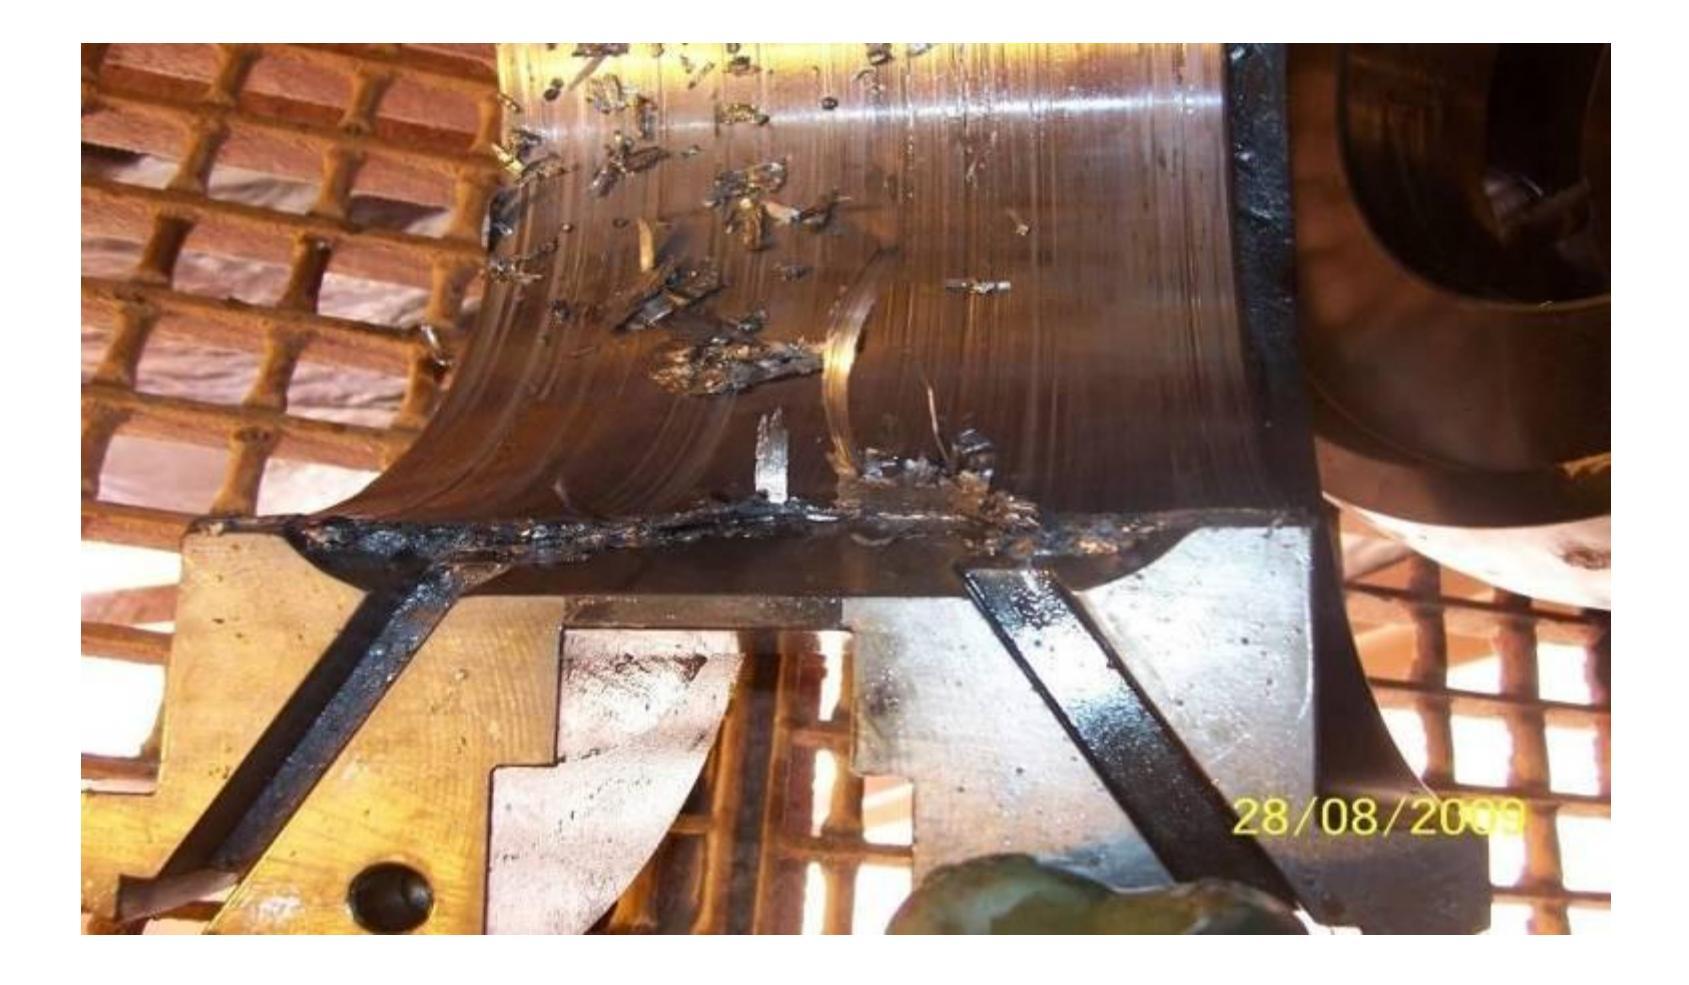
Failed set of white metal bearings. A new set of bearings were installed and operating conditions monitored with no indications impending issues.

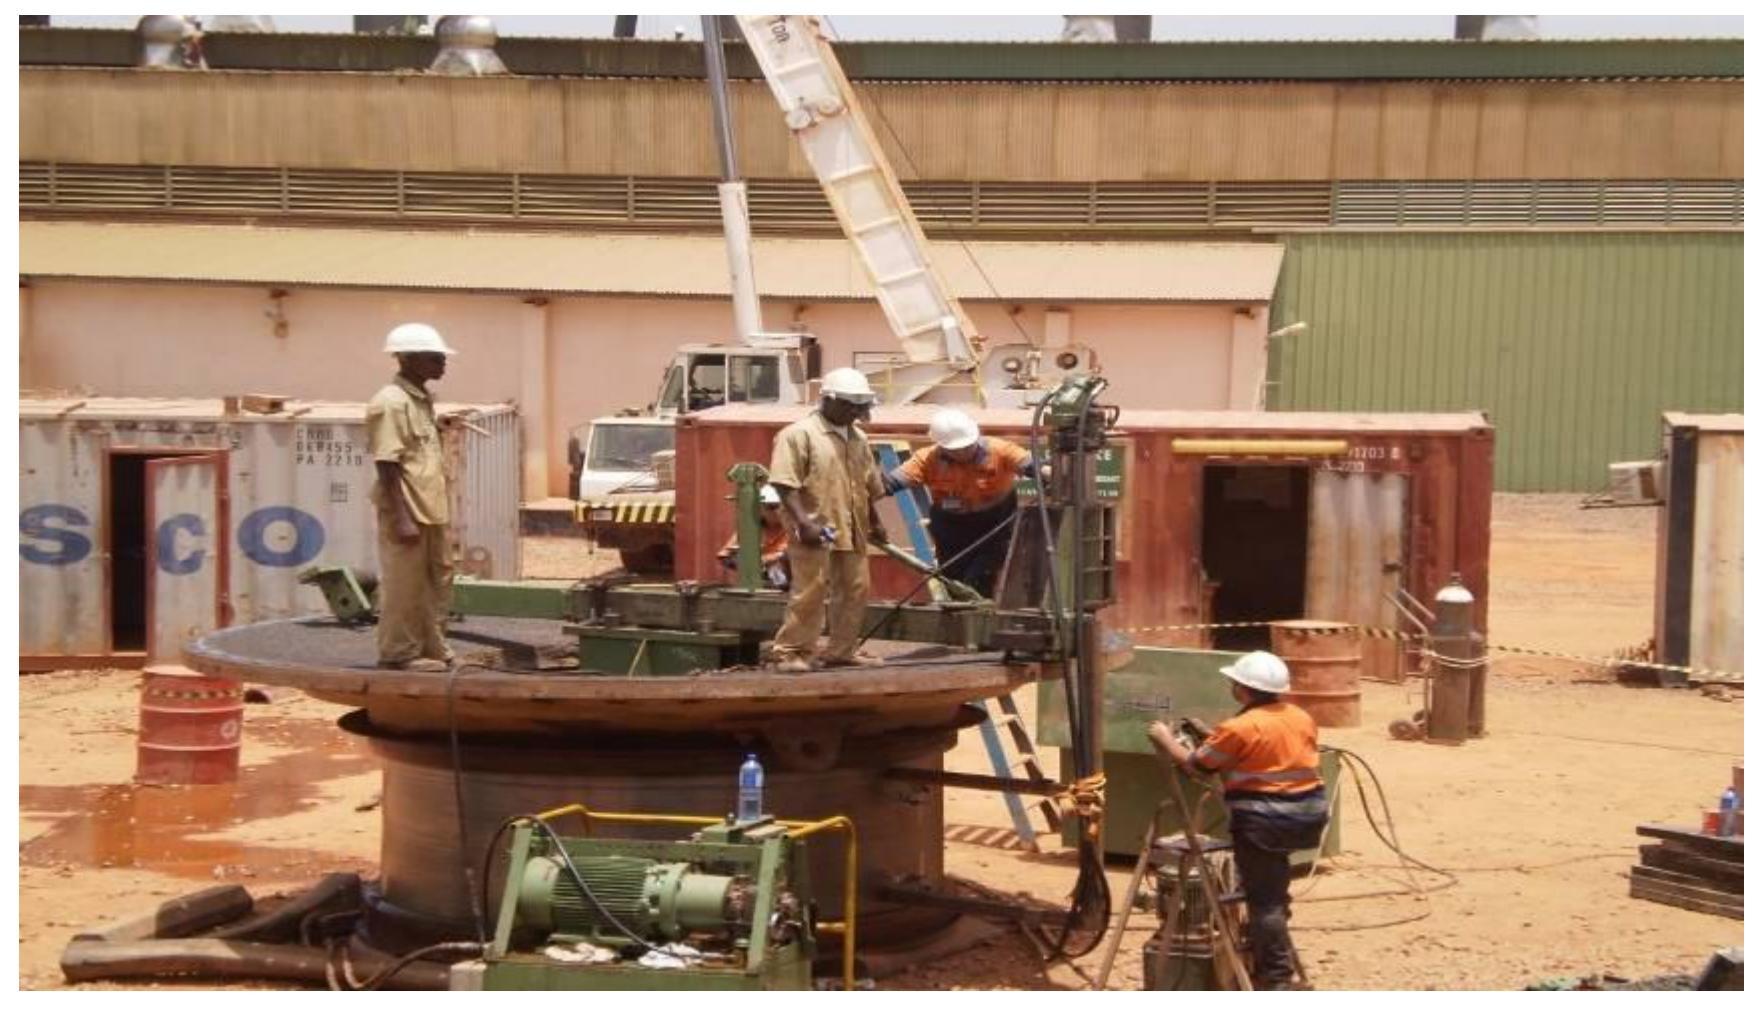
- Ball Mill 2 keeps breaking feed end flange bolts. This requires the mill to be shut down for a couple of days every two months. The end plate mating surfaces and trunnion require re-machining to reduce stress on the bolts. This was done in May 2010 by Hofmann Engineering with good results.

Ball Mill 2 was breaking feed end flange bolts. The end plate mating surfaces and trunnion have been re-machined to reduce stress on the bolts.

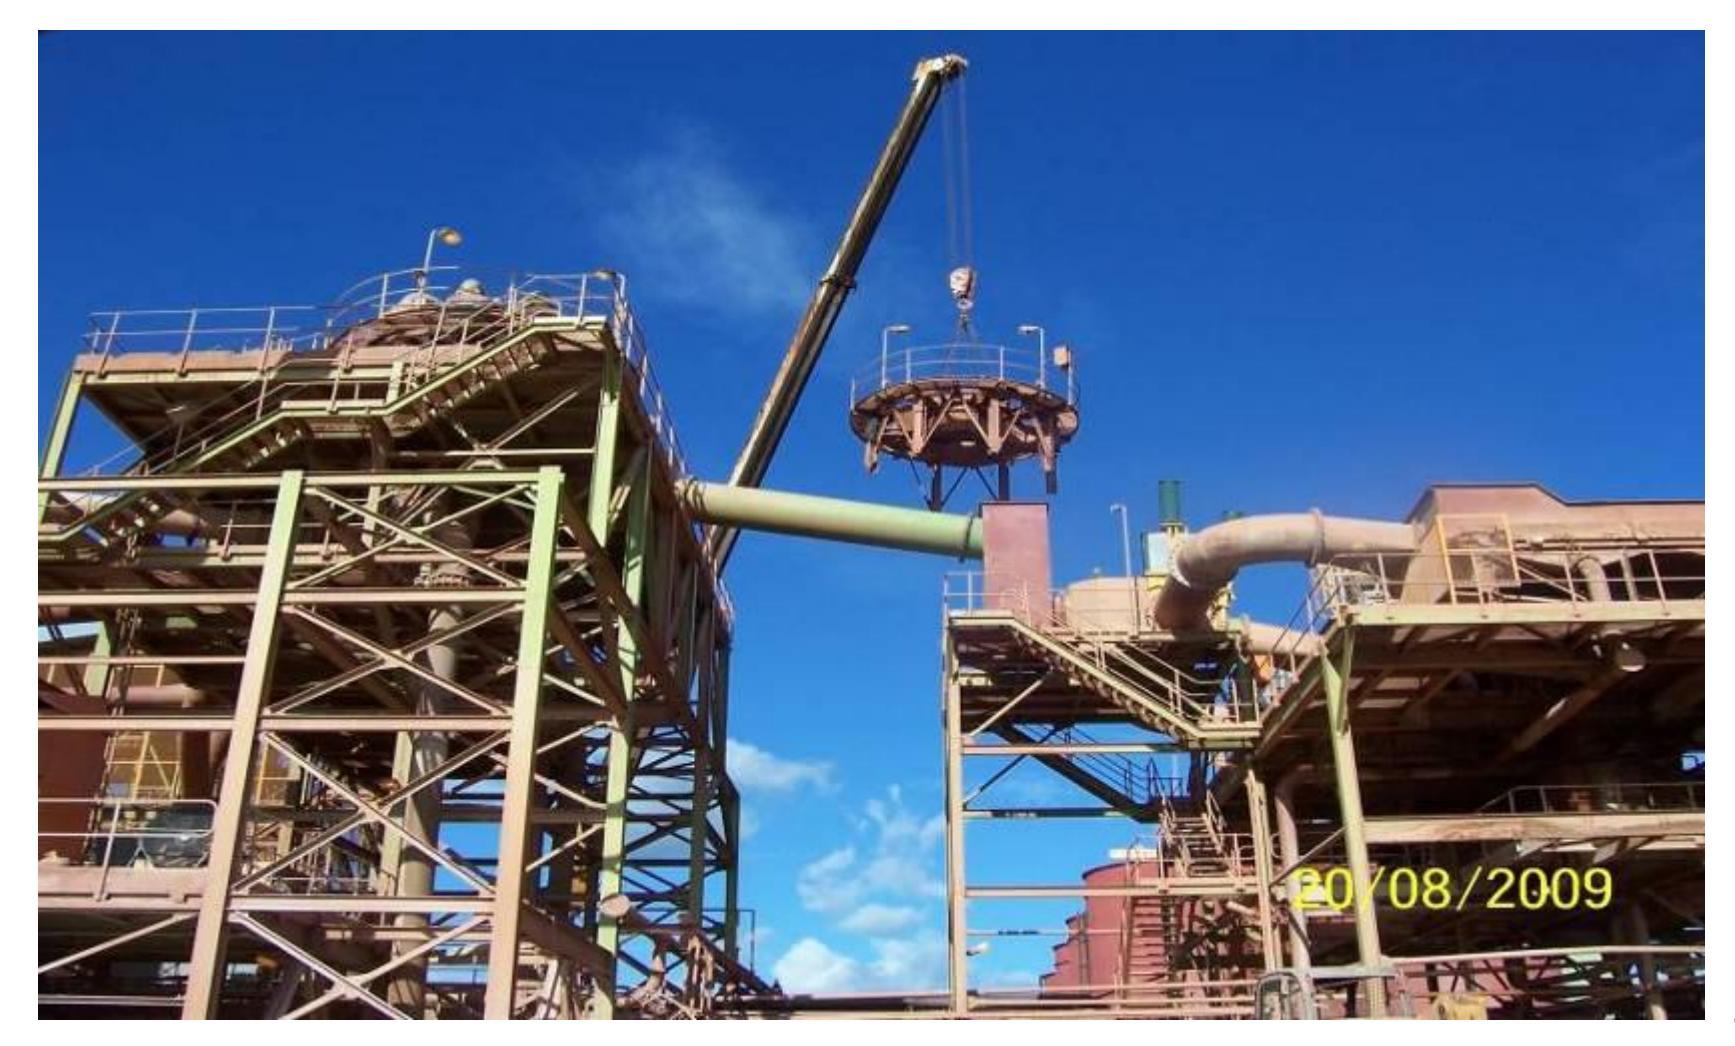
New cyclones cluster being installed in August 2009. New Cyclone Underflow pan before being lifted into position.
