## ▣ Maintenance judgment standard in order to reduce NTF claims of stabilizer link

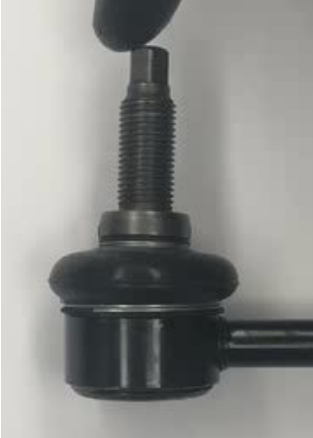
<p data-bbox="285 711 542 739">Unrestored ball stud</p>

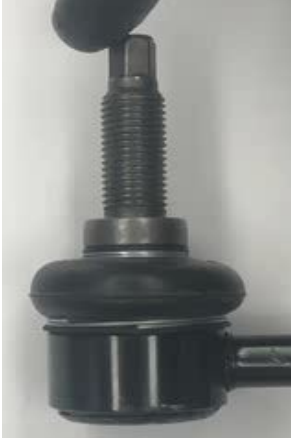
<p data-bbox="623 711 922 739">Partly restored ball stud</p>

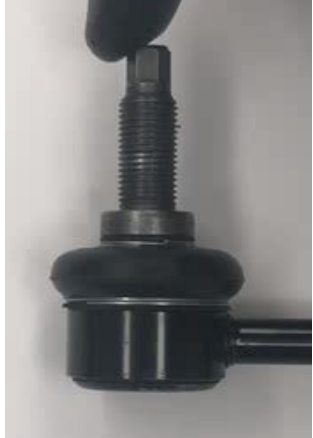
<p data-bbox="980 679 1274 739">Complete restoration of ball stud</p>

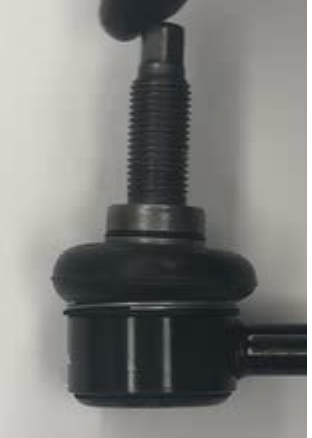
<p data-bbox="1332 679 1626 739">Complete restoration of ball stud</p>

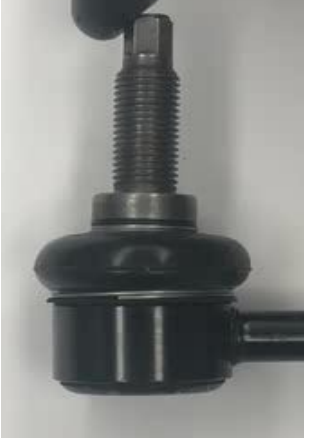
<p data-bbox="1692 679 1987 739">Complete restoration of ball stud</p>
Free play	0.075 mm (OK)	0.113 mm (OK)	0.219 mm (OK)	0.440 mm (NG)	0.516 mm (NG)
Abnormal size in real car	No occurrence	No occurrence	No occurrence	Abnormal noise occur	Abnormal noise occur
