# Alternative Sources of Energy

## Distributed Generation

# 75 kW Microturbine CHP Application

*2301 Midland Avenue, Scarborough has the first Canadian installation of a micro-turbine supplying electricity and waste heat to a building. The gas-fired unit was intended to operate continuously, providing 75 kW electric and 155 kW thermal heat. Natural gas consumption by the building's boilers has been reduced by the application of recovered heat to space heating systems in winter and humidity control systems in summer.*

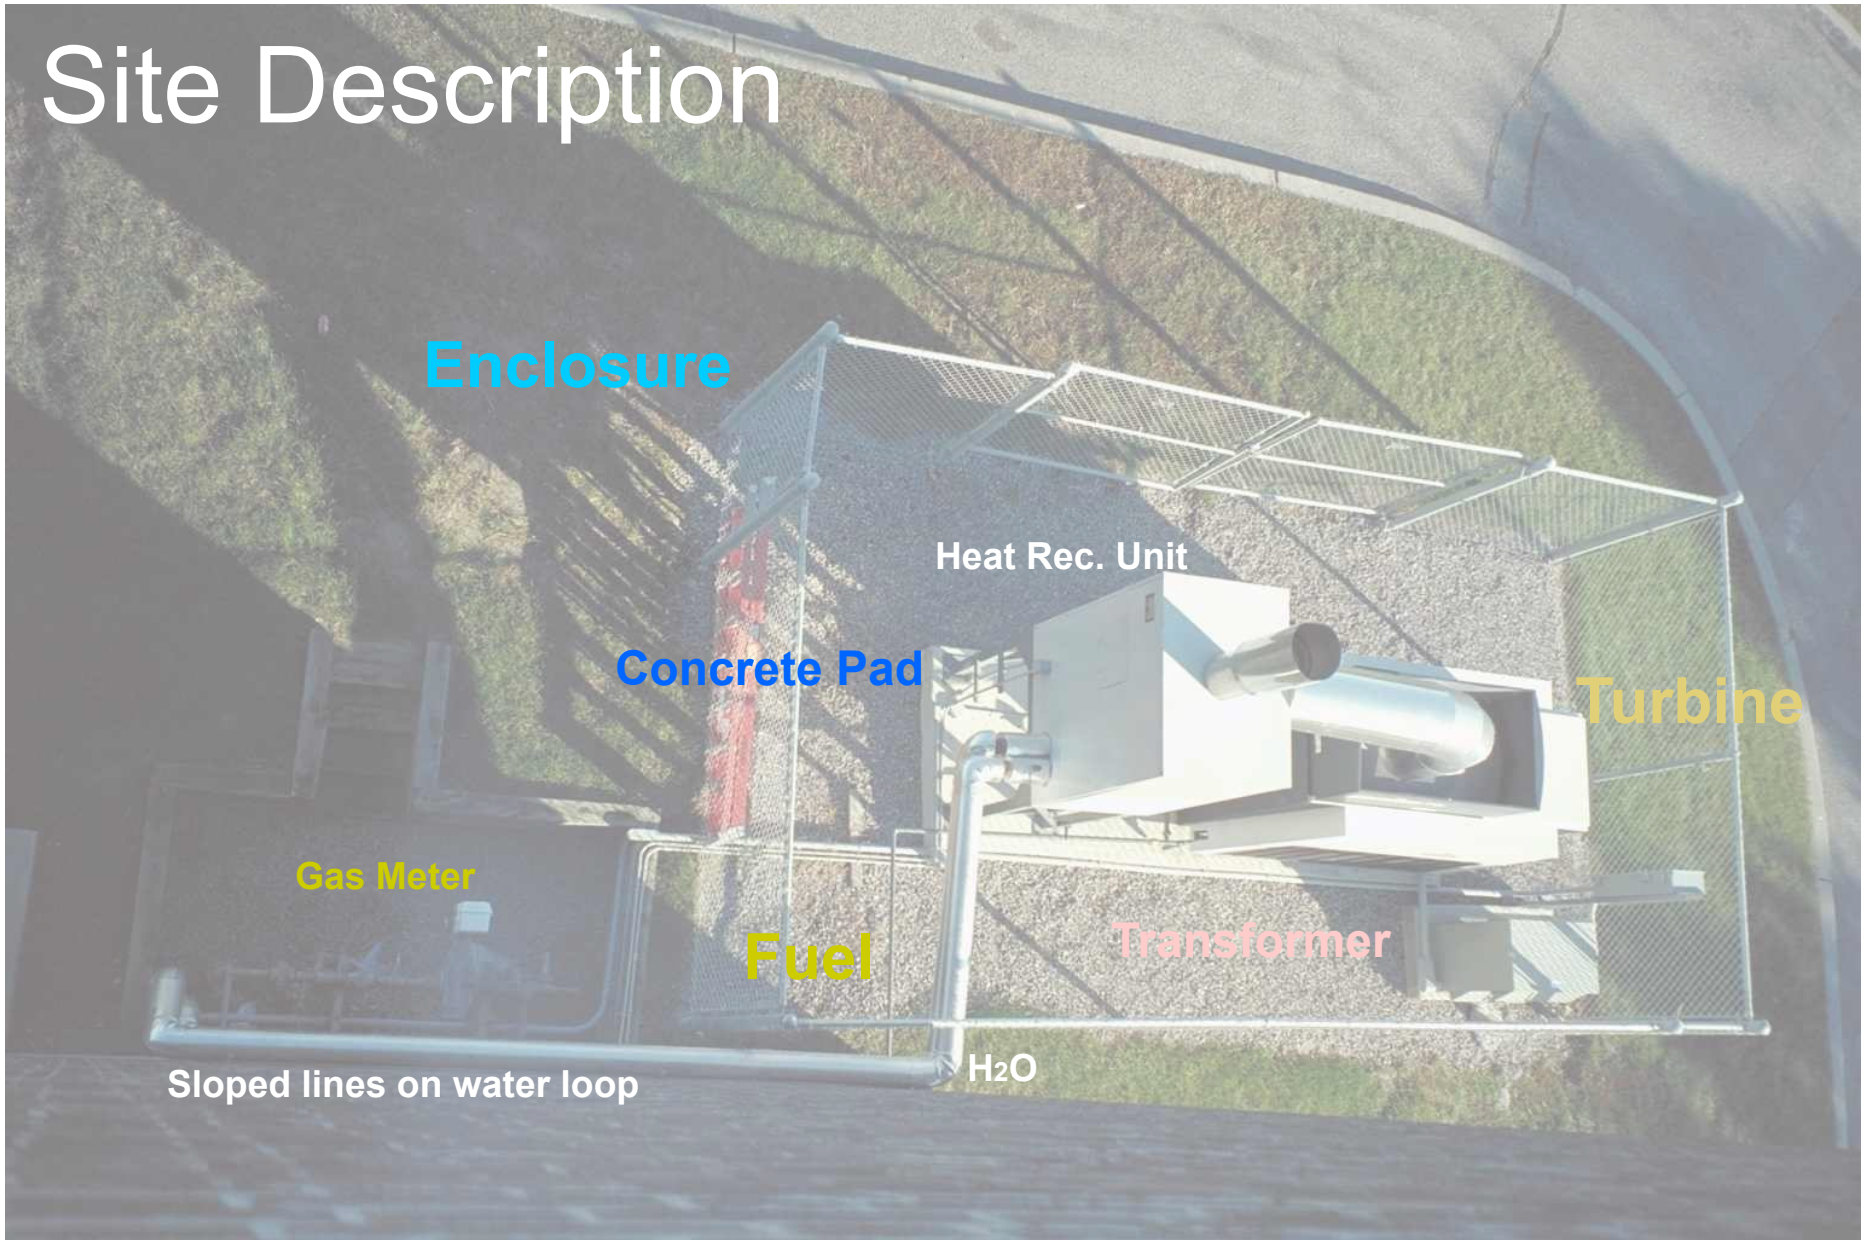
# Site Description

Enclosure

Heat Rec. Unit

Concrete Pad

Turbine

Gas Meter

Fuel

Transformer

Sloped lines on water loop

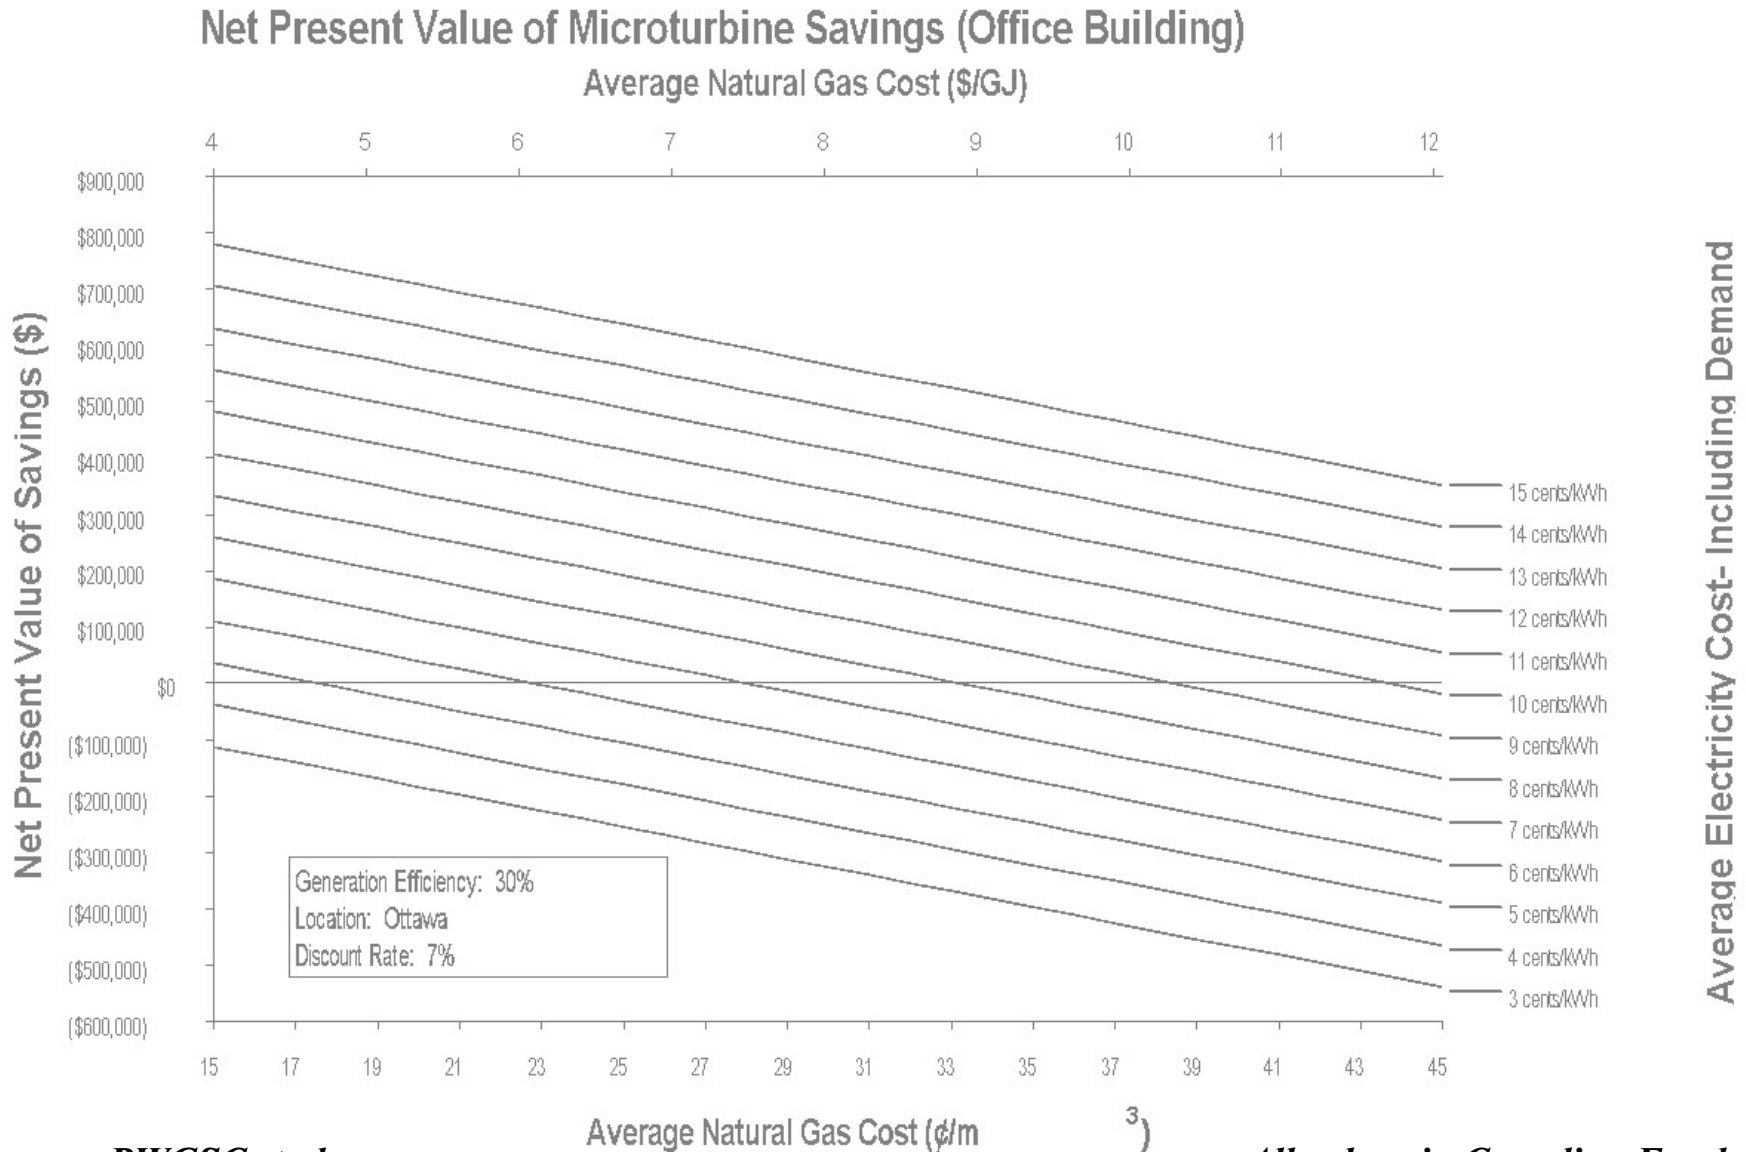
# Reasons for doing the project

Source: PWGSC study

All values in Canadian Funds

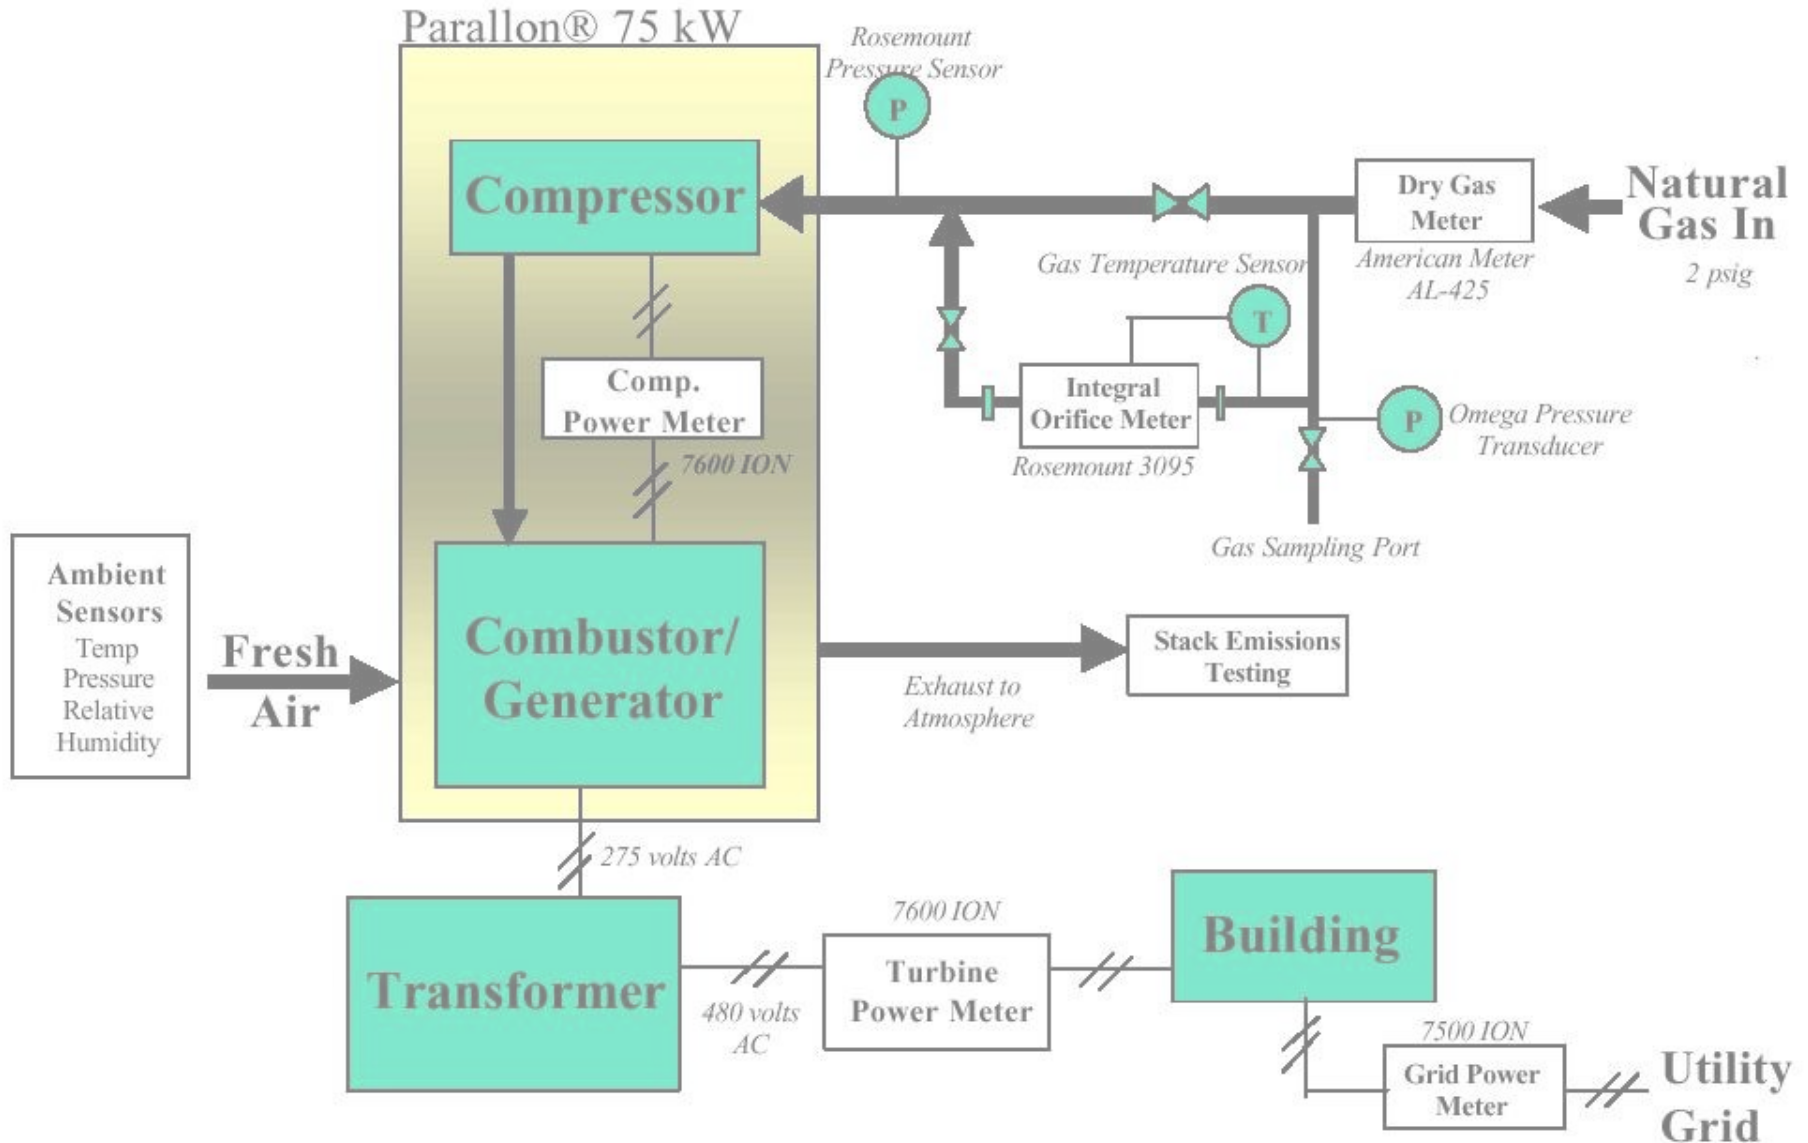
# Schematic of Typical Measurement System

Source: EPA Environmental Technology Verification Report

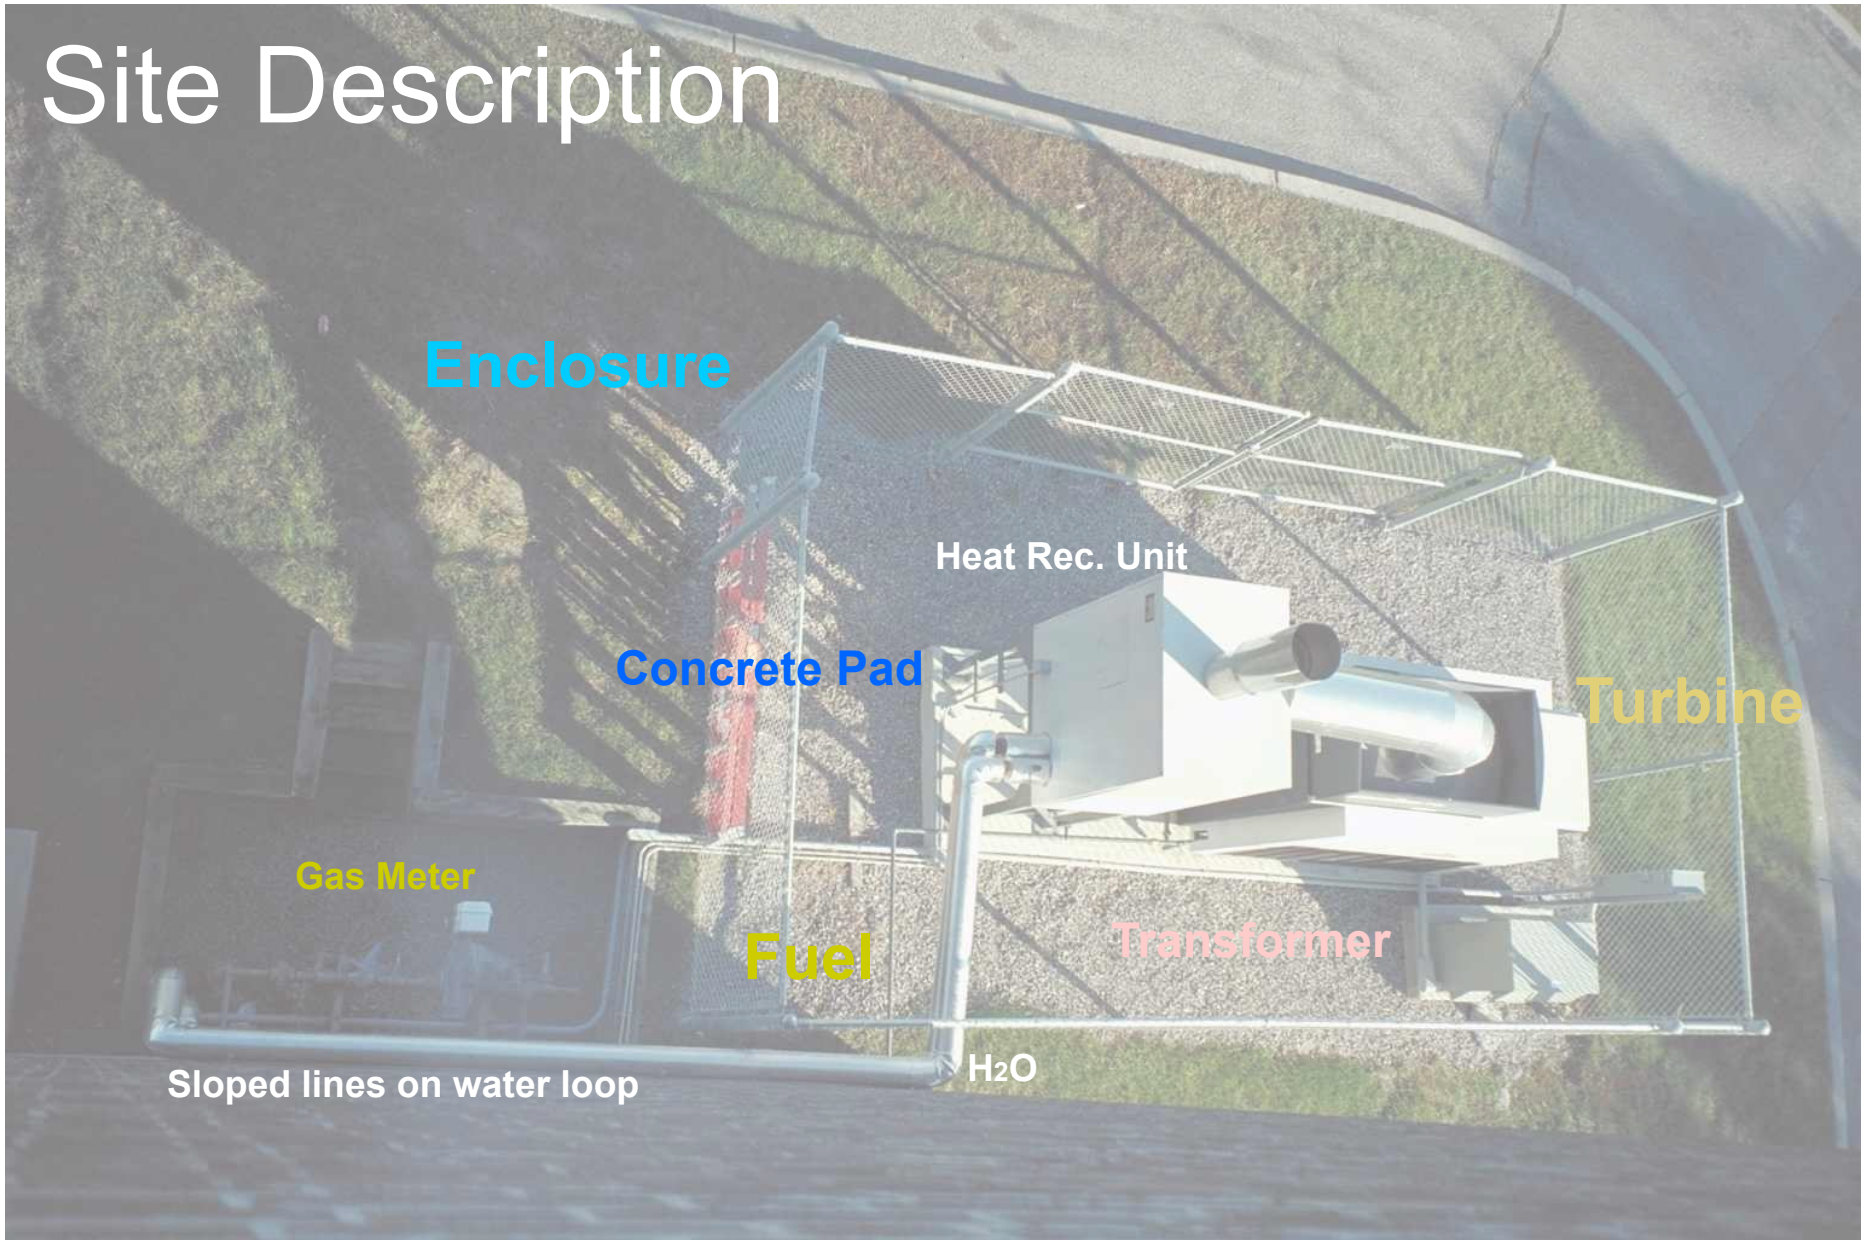
# Site Description

Enclosure

Heat Rec. Unit

Concrete Pad

Turbine

Gas Meter

Fuel

Transformer

Sloped lines on water loop
