Basidigital bone fracture

Accident Date 29.01.2020

COMPANY JSC 'NIPIGAS'

Accident location: AGPP, Sub-Project P2, Non-Licensed Units, section 1-110

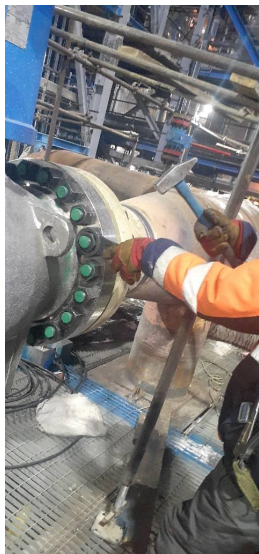
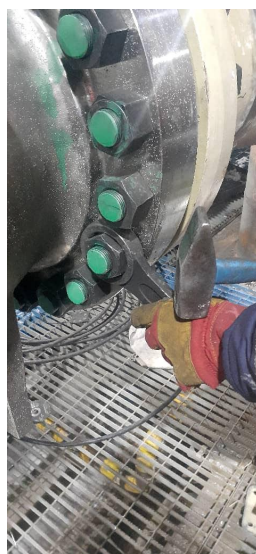
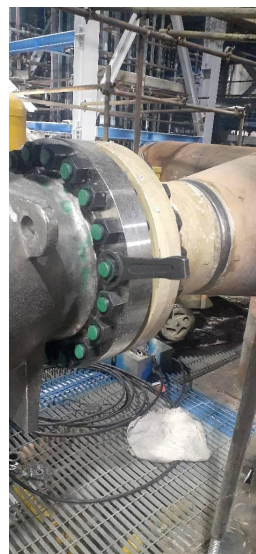
At 03:00 AM at section 1-110, night shift foreman of AK 'Yamata' (s/c by CPECC), struck his left hand at the process pipe while in the course of works using adjustable wrench. On January 30, 2021 at 08:10 AM, the employee sought medical care in the medical aid station at TCF AK Yamata where the medical staff examined and provided medical assistance. The employee was referred to GBUZ of Svobodny to confirm the diagnosis.

Closed fracture of 2nd basidigital bone.

1. Breacj of operational process; the employee used construction hammer when tightening the bolts (hit the wrench).
2. Usage of unserviceable tool, when hitting the hammer head fell out from the hand lever and hit the employee's hand.

1. Familiarise Contractor and Subcontractors' employees with the circumstances that caused this accident, safety time-outs conducted.
2. Do not breach the operational process;
3. Use serviceable tool when working.
