## Basidigital bone fracture

**Accident Date** 29.01.2020

**COMPANY** JSC 'NIPIGAS'

**Accident location:** AGPP, Sub-Project P2, Non-Licensed Units, section 1-110

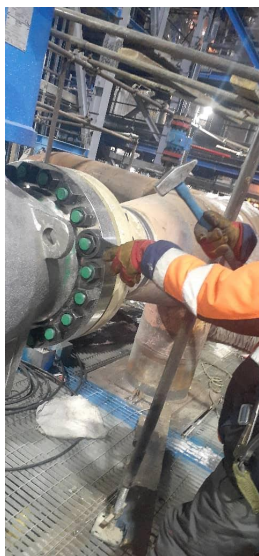
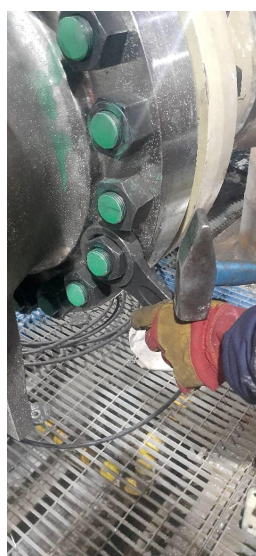
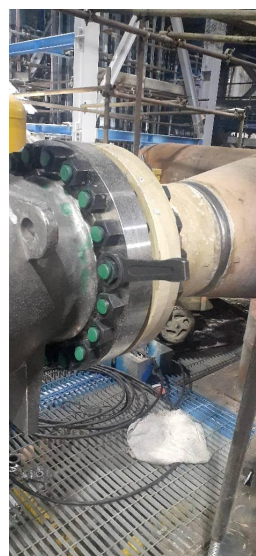
At 03:00 AM at section 1-110, night shift foreman of AK 'Yamata' (s/c by CPECC), struck his left hand at the process pipe while in the course of works using adjustable wrench. On January 30, 2021 at 08:10 AM, the employee sought medical care in the medical aid station at TCF AK Yamata where the medical staff examined and provided medical assistance. The employee was referred to GBUZ of Svobodny to confirm the diagnosis.

Closed fracture of 2nd basidigital bone.

1. Breacj of operational process; the employee used construction hammer when tightening the bolts (hit the wrench).
2. Usage of unserviceable tool, when hitting the hammer head fell out from the hand lever and hit the employee's hand.

1. Familiarise Contractor and Subcontractors' employees with the circumstances that caused this accident, safety time-outs conducted.
2. Do not breach the operational process;
3. Use serviceable tool when working.
