**Furnaces corrosion / prevention to
improve the longevity of campaigns
Th Roustan 2016/10**

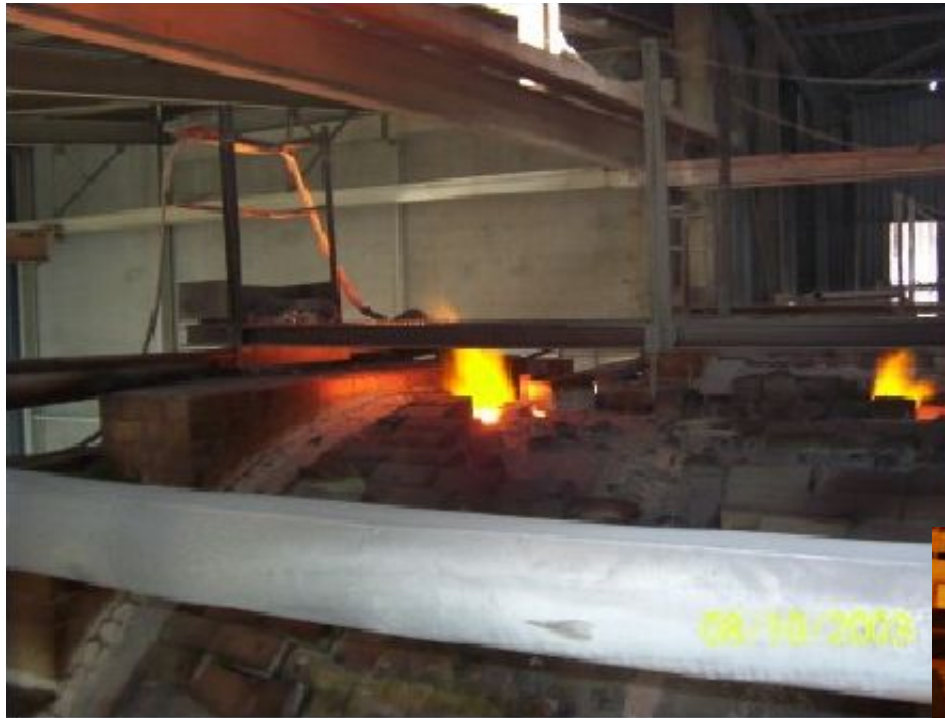
**Flames passage on
regenerator's crowns
(checkers frequently locked)**

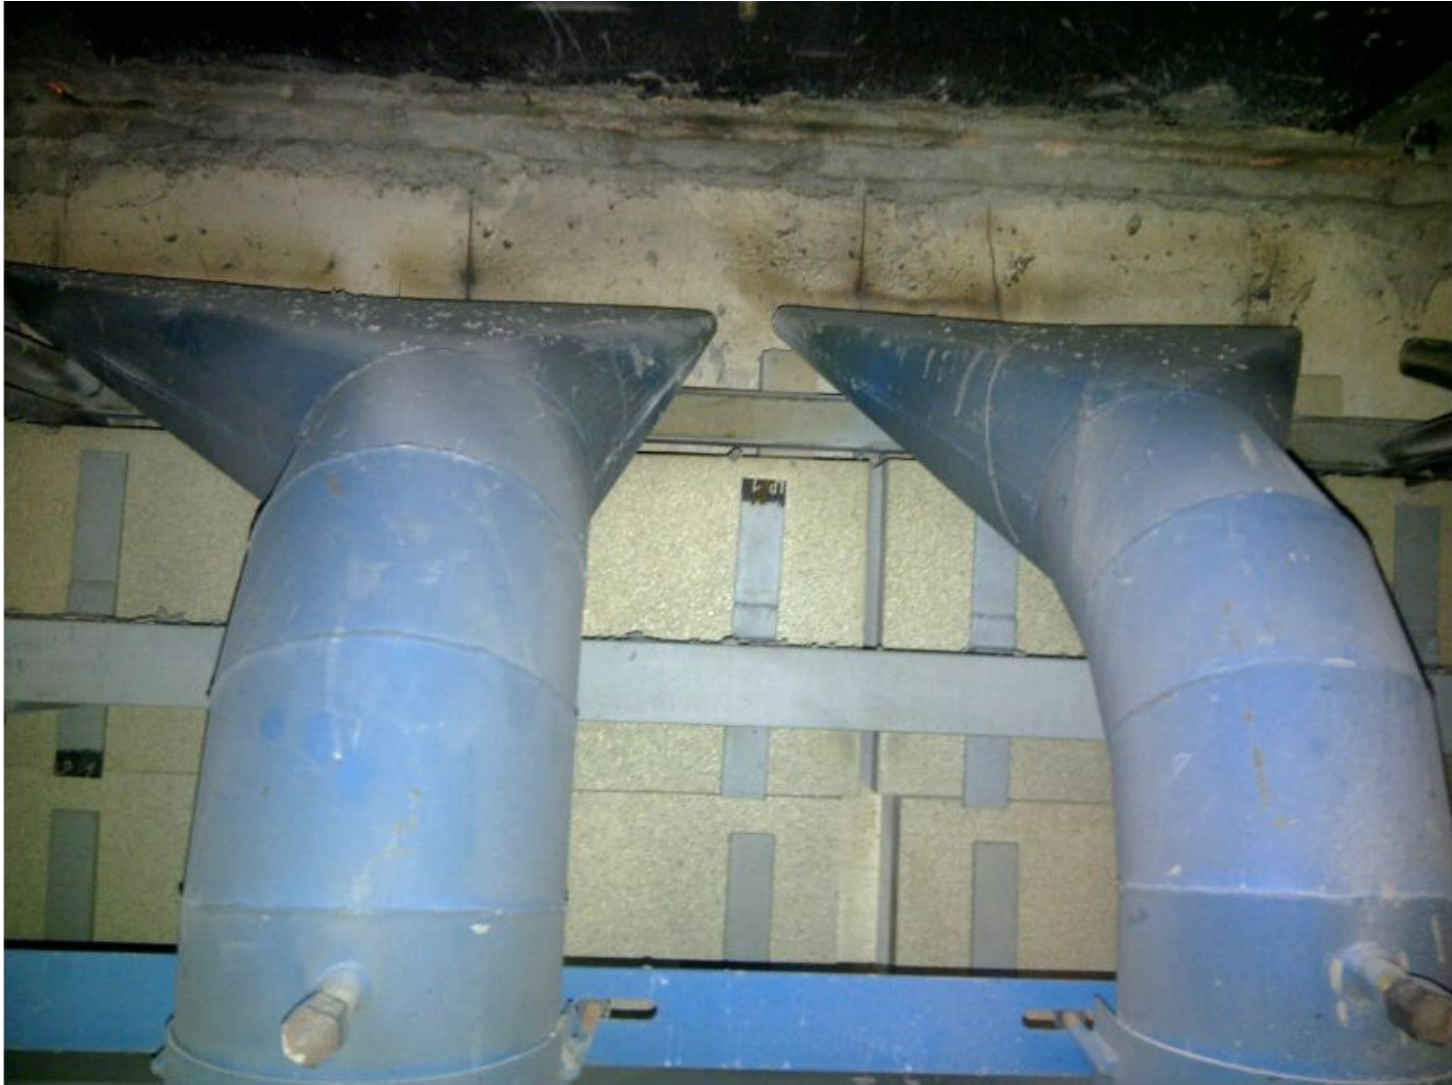
Tank air cooling nozzles

Air cooling
pressure measurement
on nozzles example
In red color insufficient
air cooling quantity
(≥ 700 Pa)

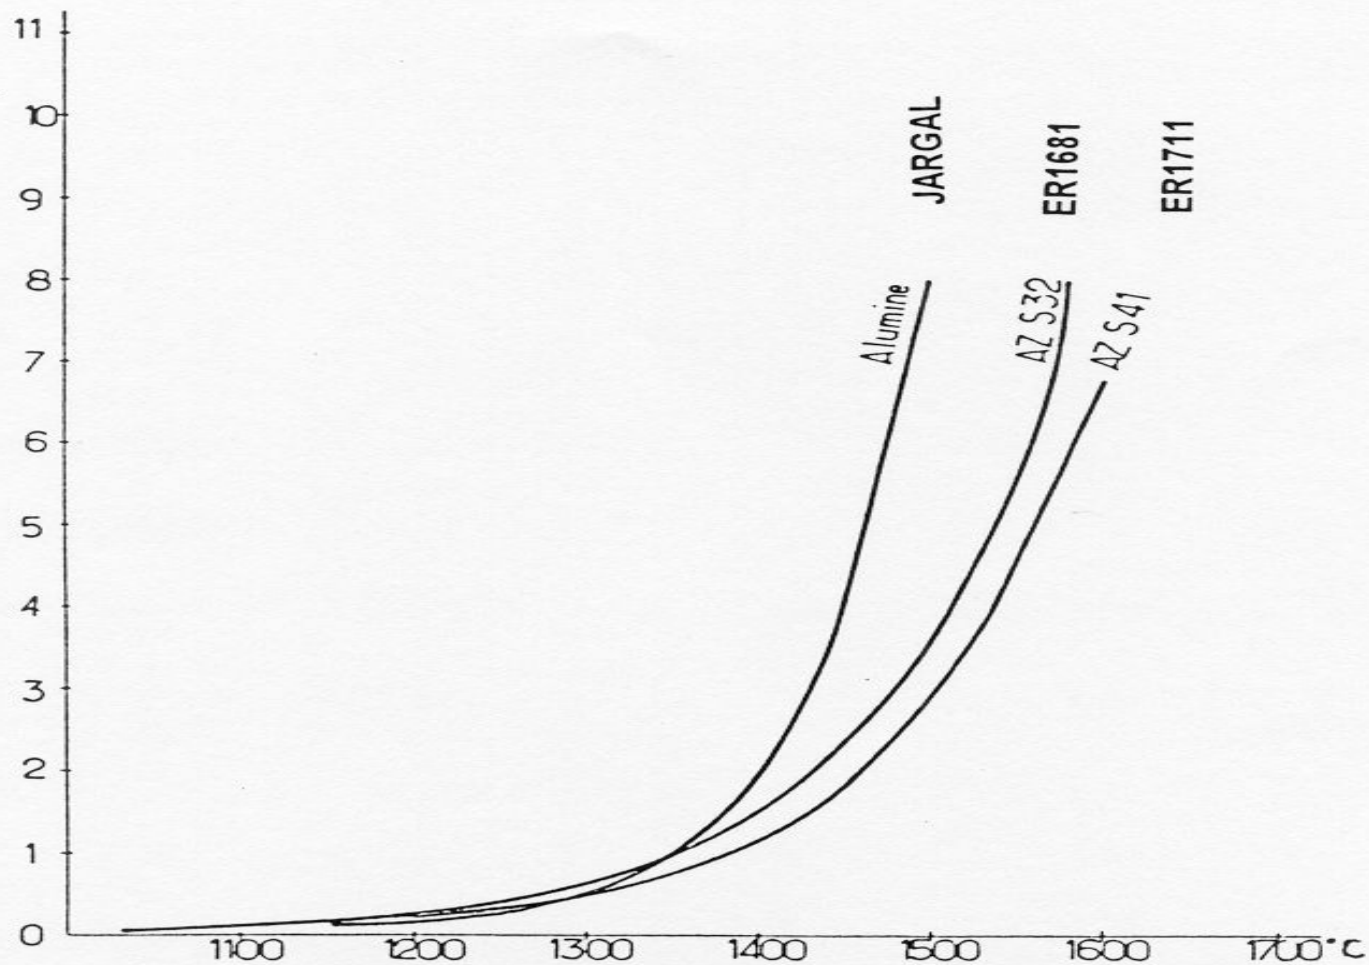
Corrosion Speed evolution with temperature :

Vitesse d'usure en fonction de la température.

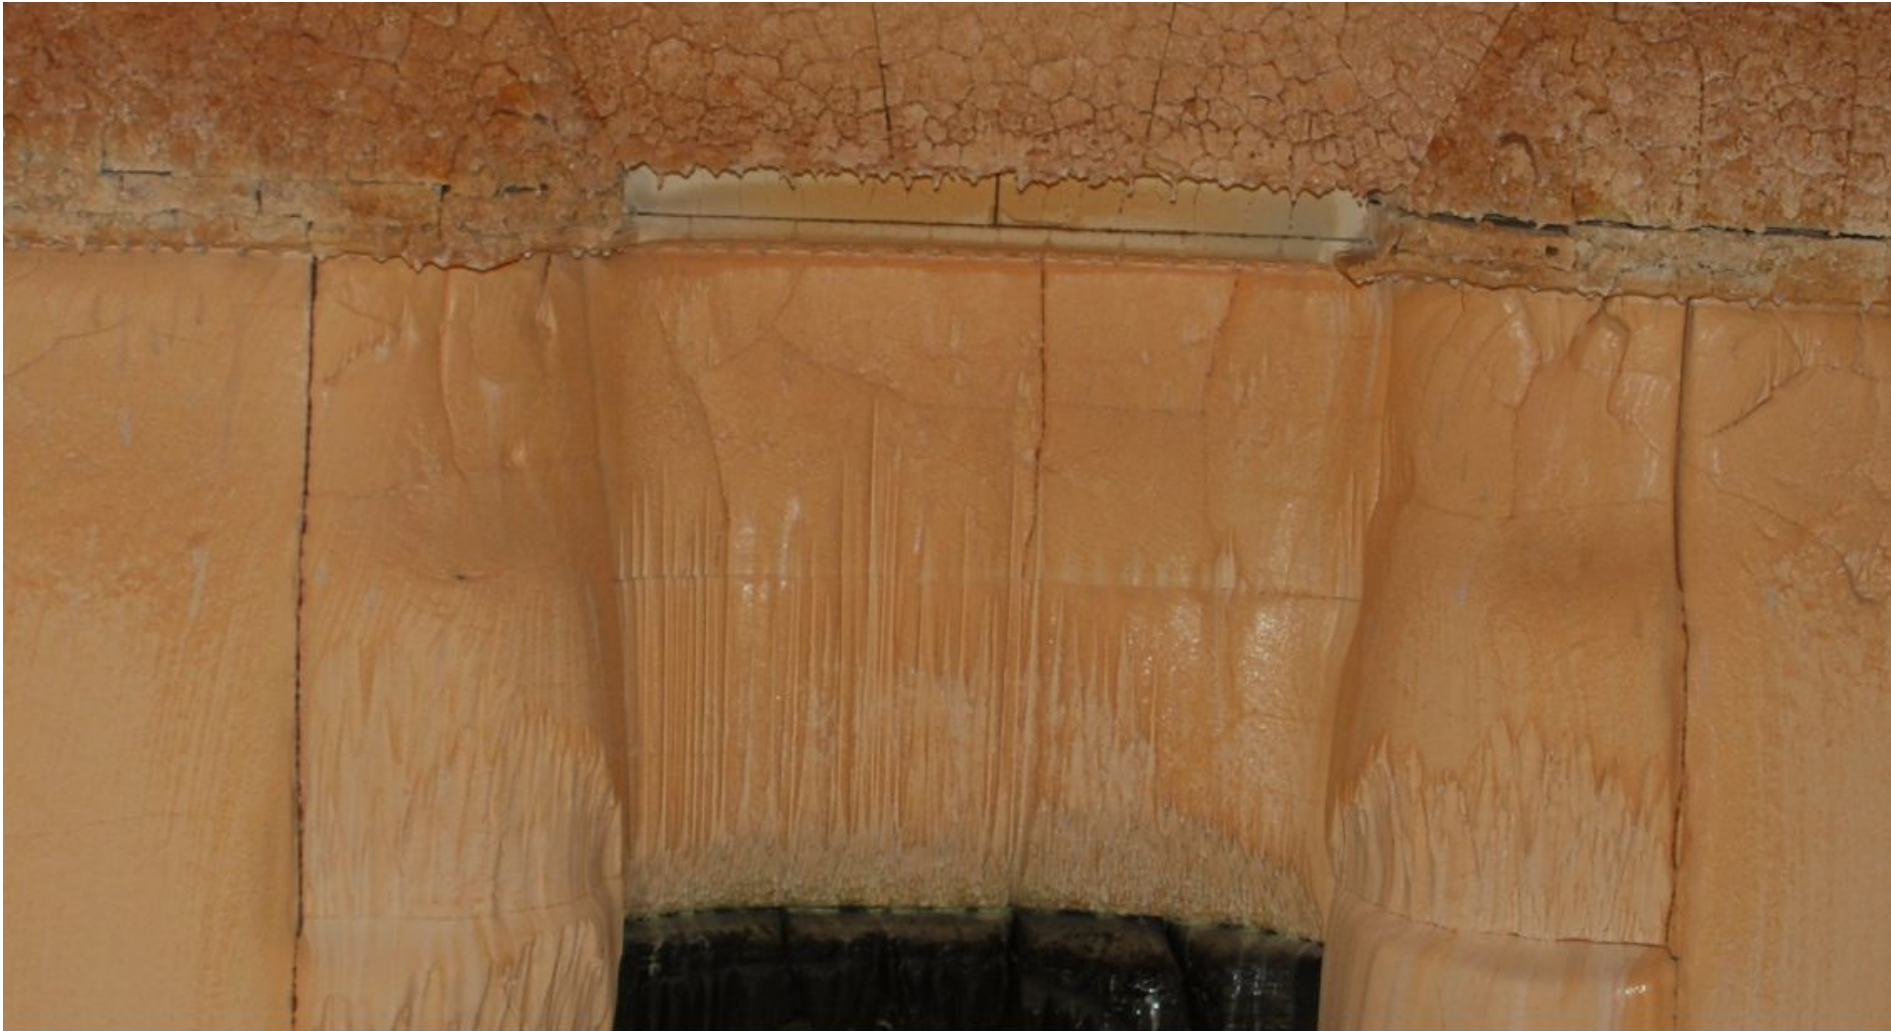
Throat angle blocks after 11 years campaign with efficient air cooling (average air pressure nozzles : 1000 Pa)

Throat angle blocks after 5 years campaign with insufficient air cooling
