# Furnaces corrosion / prevention to improve the longevity of campaigns

## Th Roustan 2016/10

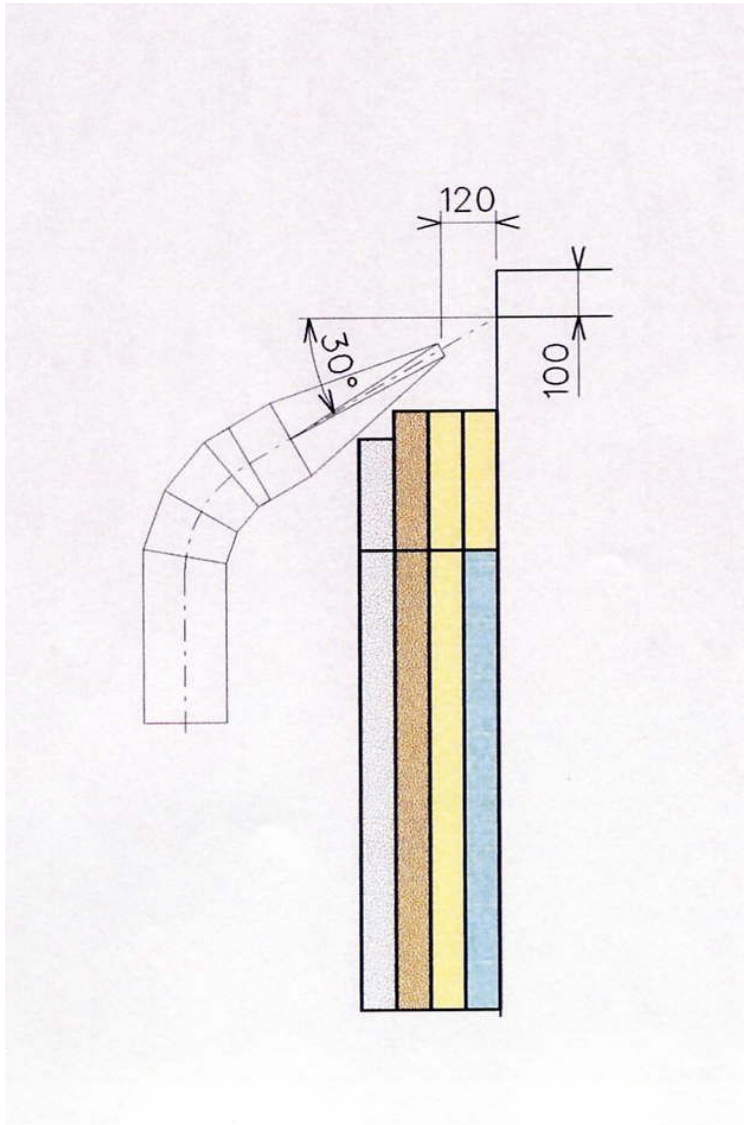
# Tank air cooling preconizations

**When ? From heating up starting, only vertically cracks formation on tank (not horizontally cracks who increasing corrosion ).**

- Impact point : ~100 mm from top tank
- Air quantity :  $\geq 25$  m/s et 1000 l/s/ml

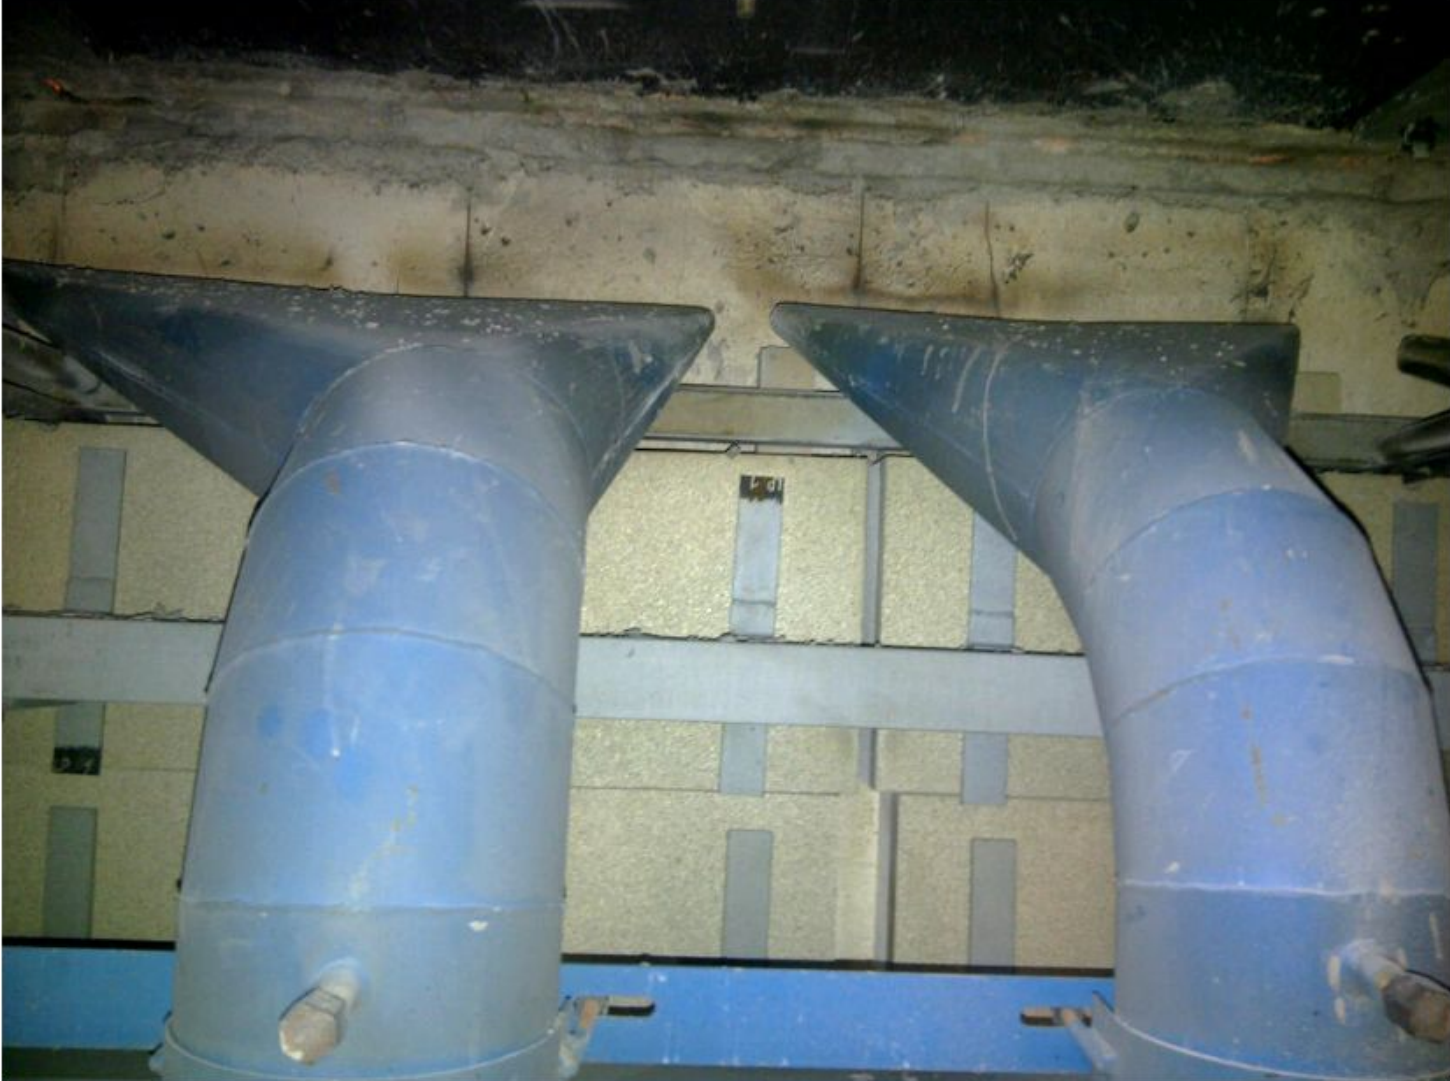
# Tank air cooling nozzles

**Air cooling  
pressure measurement  
on nozzles example**  
**In red color insufficient  
air cooling quantity  
( $\geq 700$  Pa)**

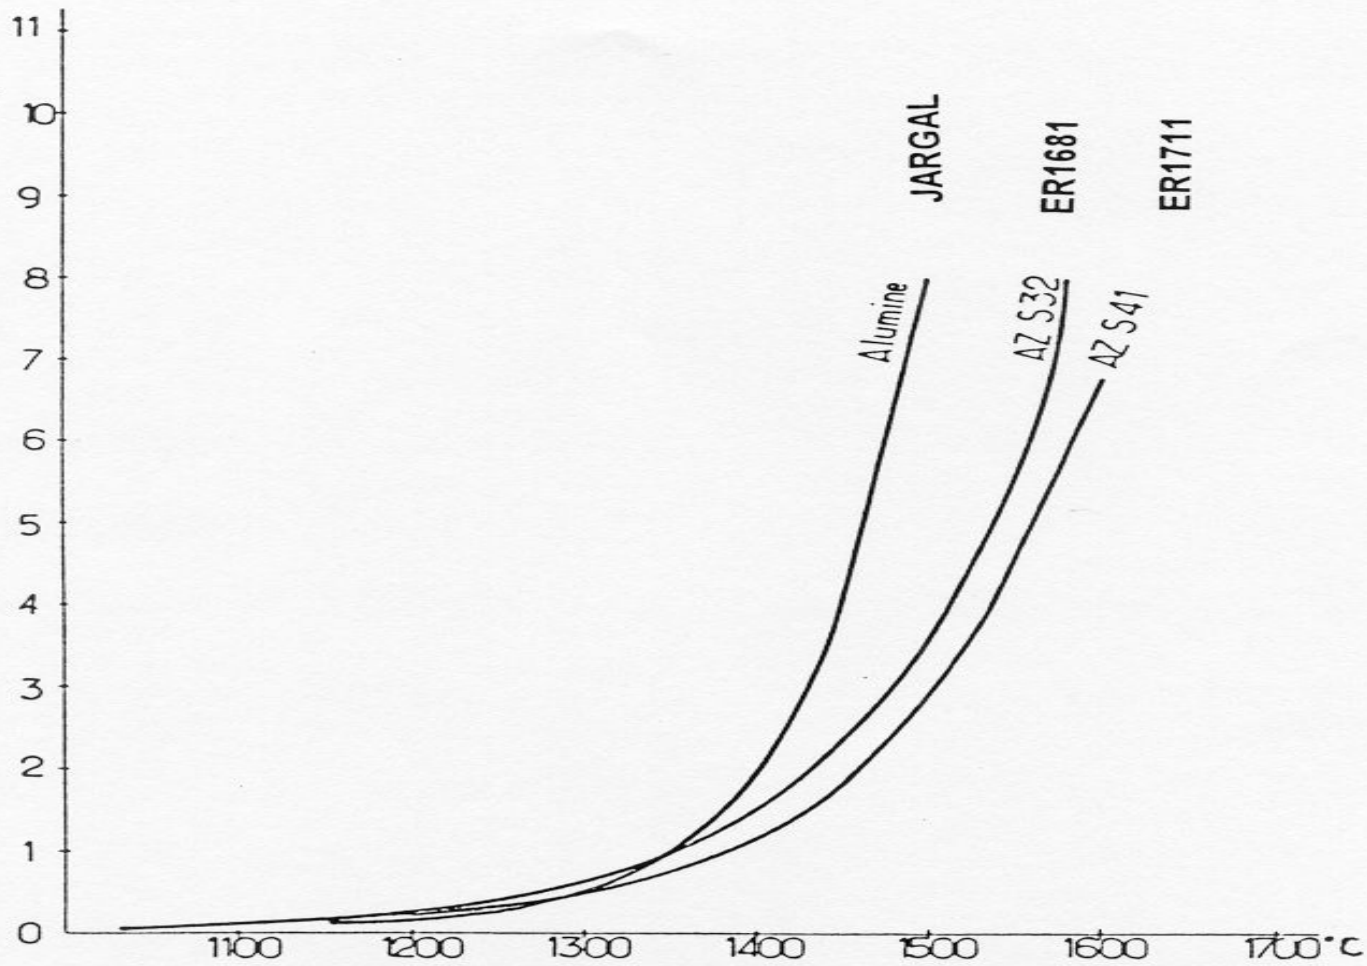
# Corrosion Speed evolution with temperature :

Vitesse d'usure en fonction de la température.
