LEFA Operations - Maintenance March 2010

Overview of Current Status

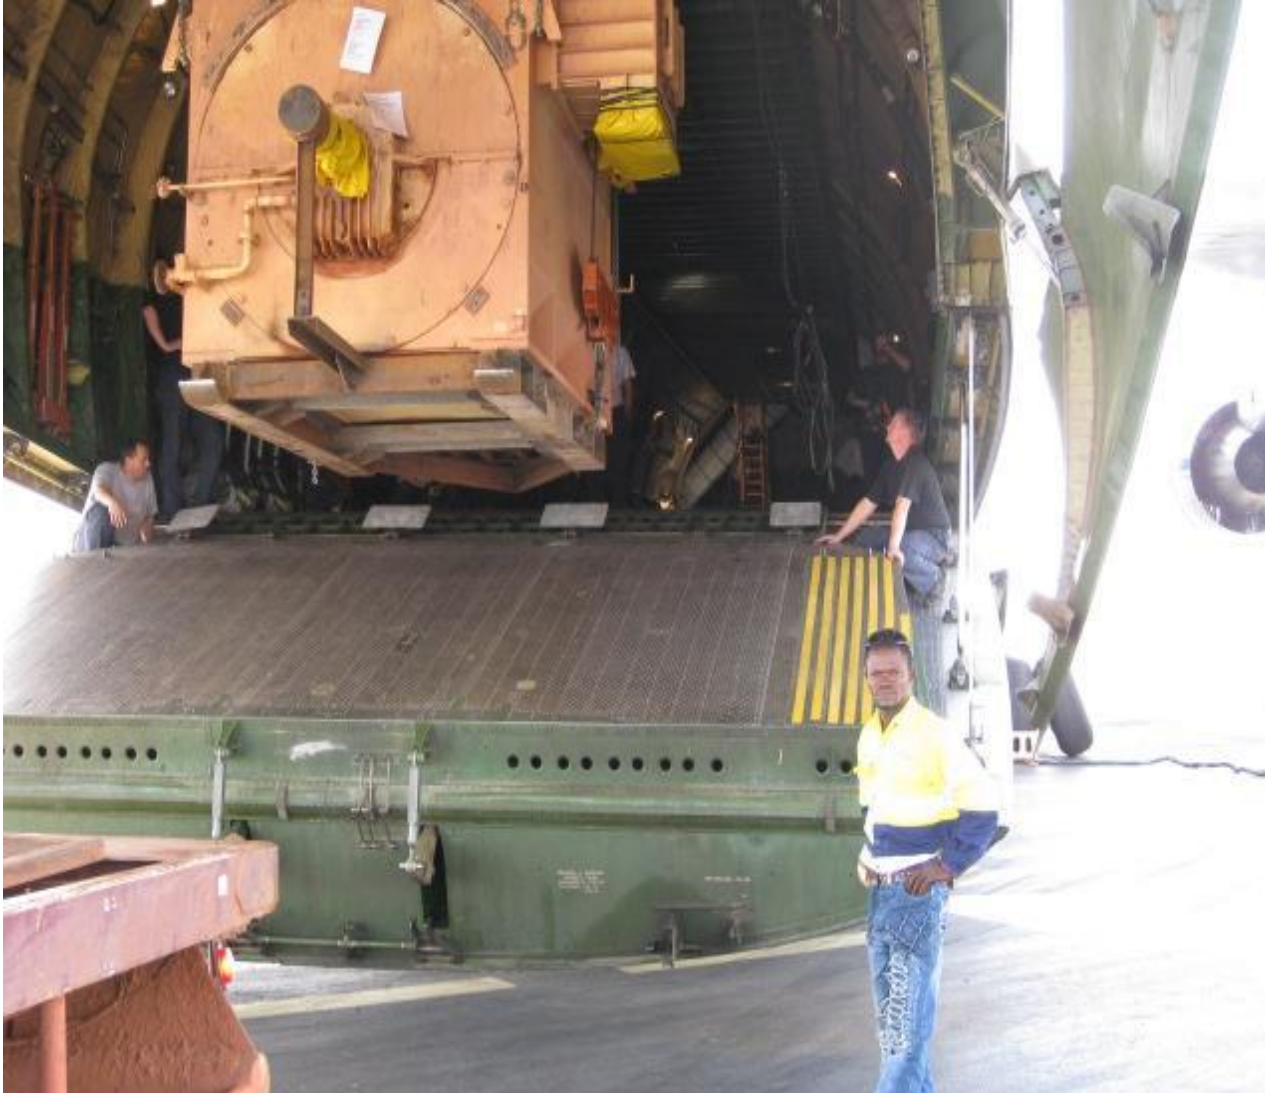
Ball Mill 1 Motor
being loaded onto
an Antonov
Aircraft bound for
Antwerp for
overhaul.

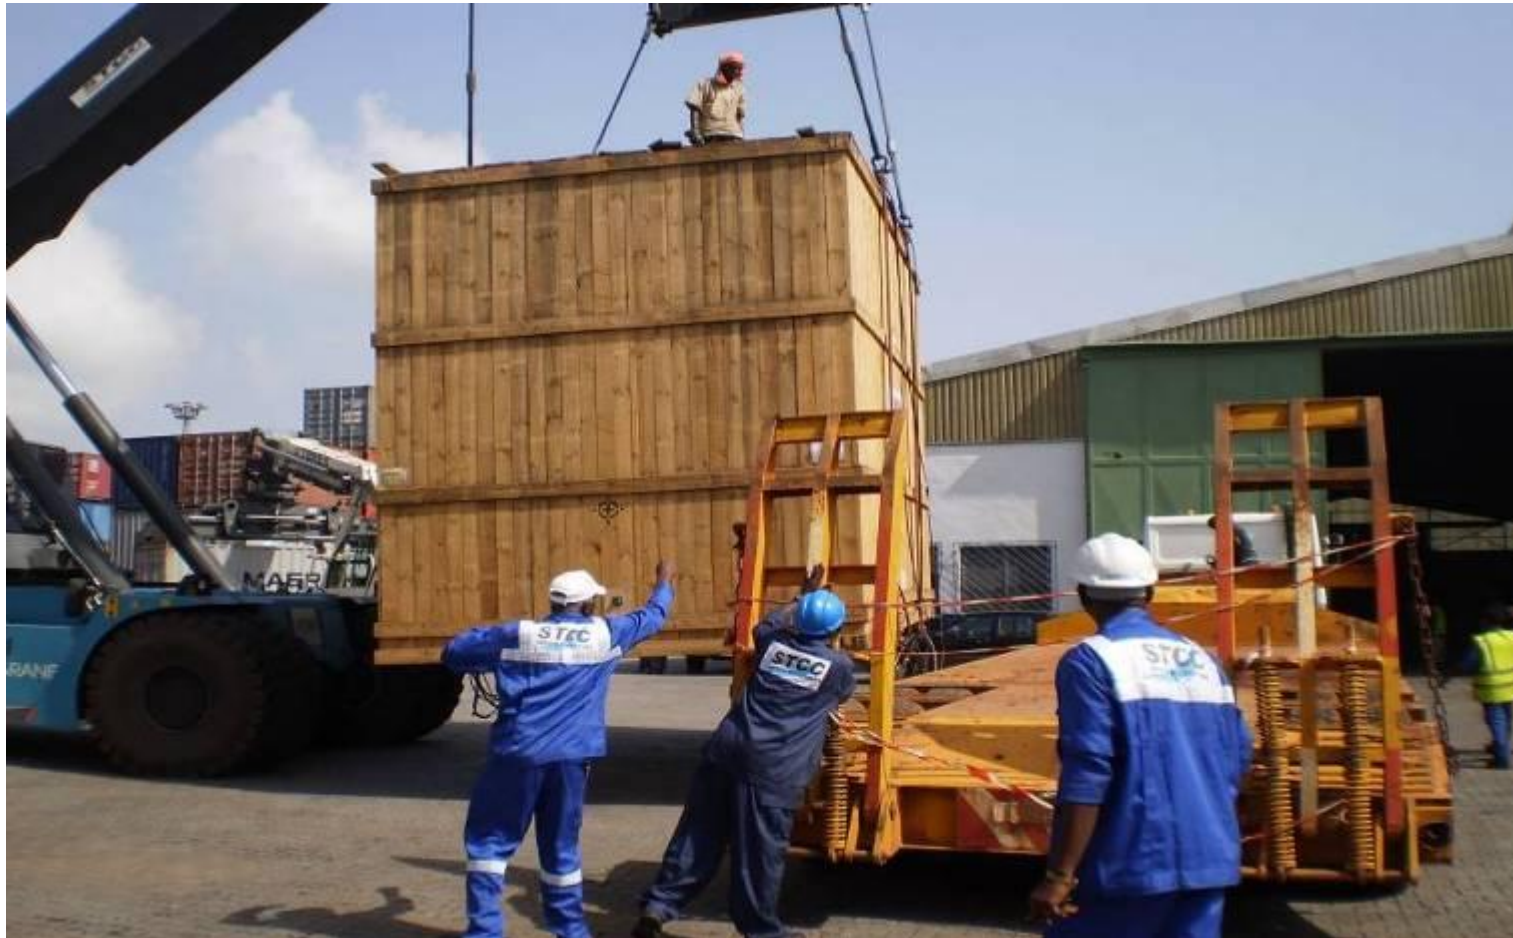
Ball Mill 2

New Ball Mill being loaded onto Truck for transporting to site.

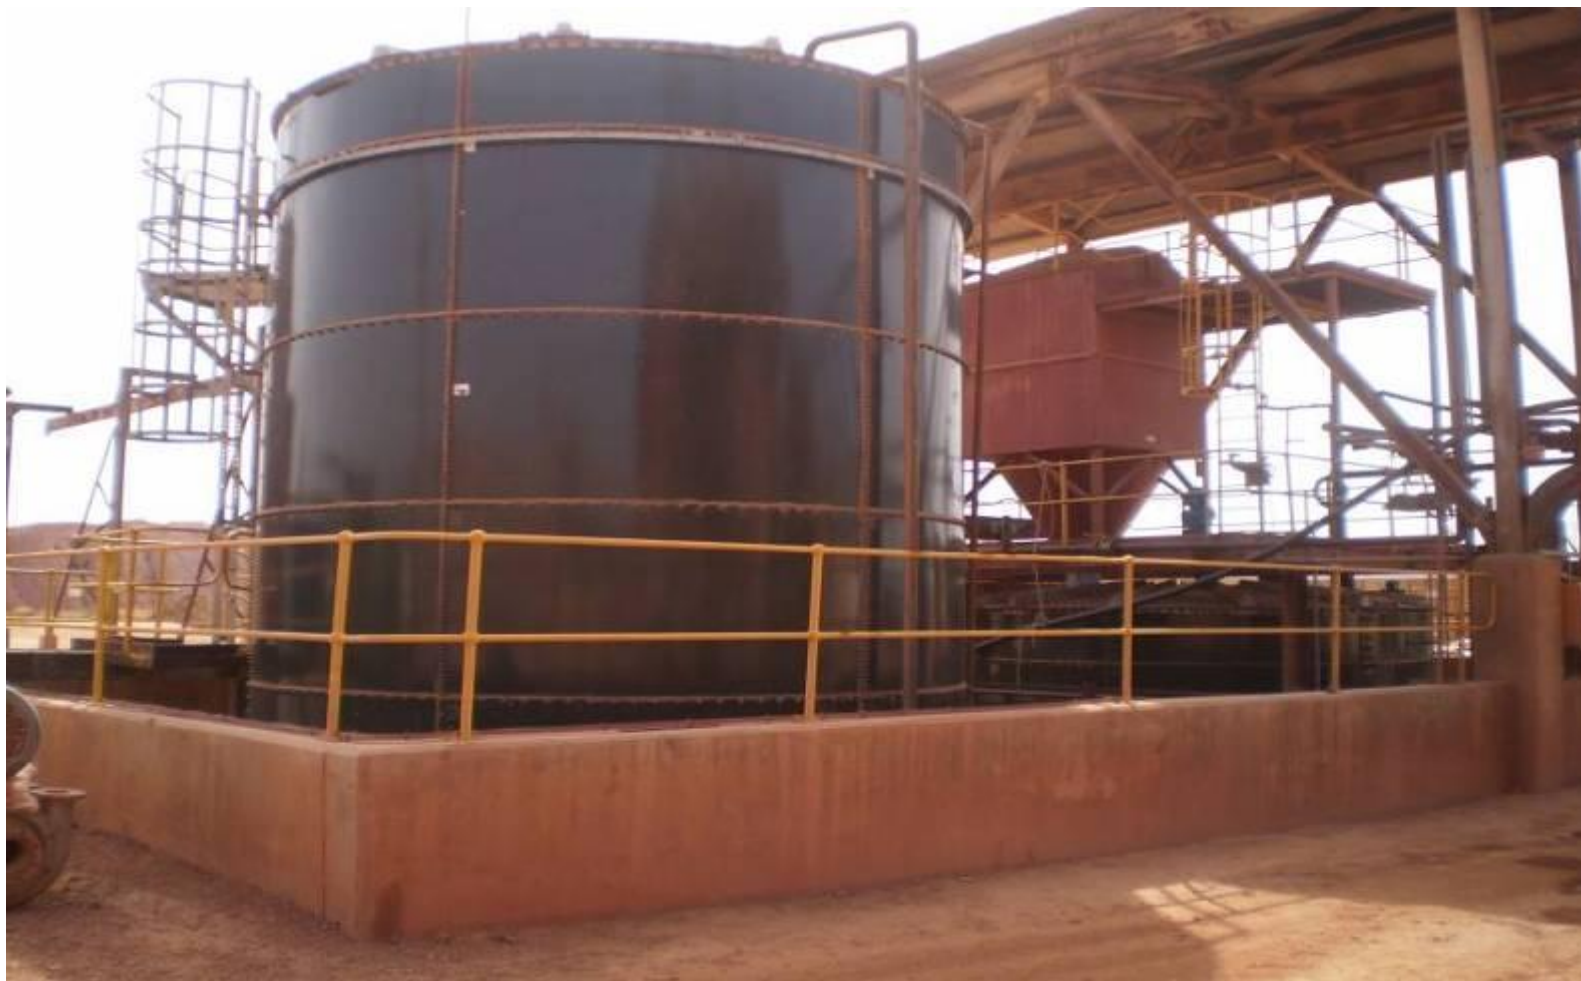
Reagent Mixing

New Cyanide mixing and storage tanks
