LEFA Operations - Maintenance March 2010

Overview of Current Status

LEFA Operations - Process

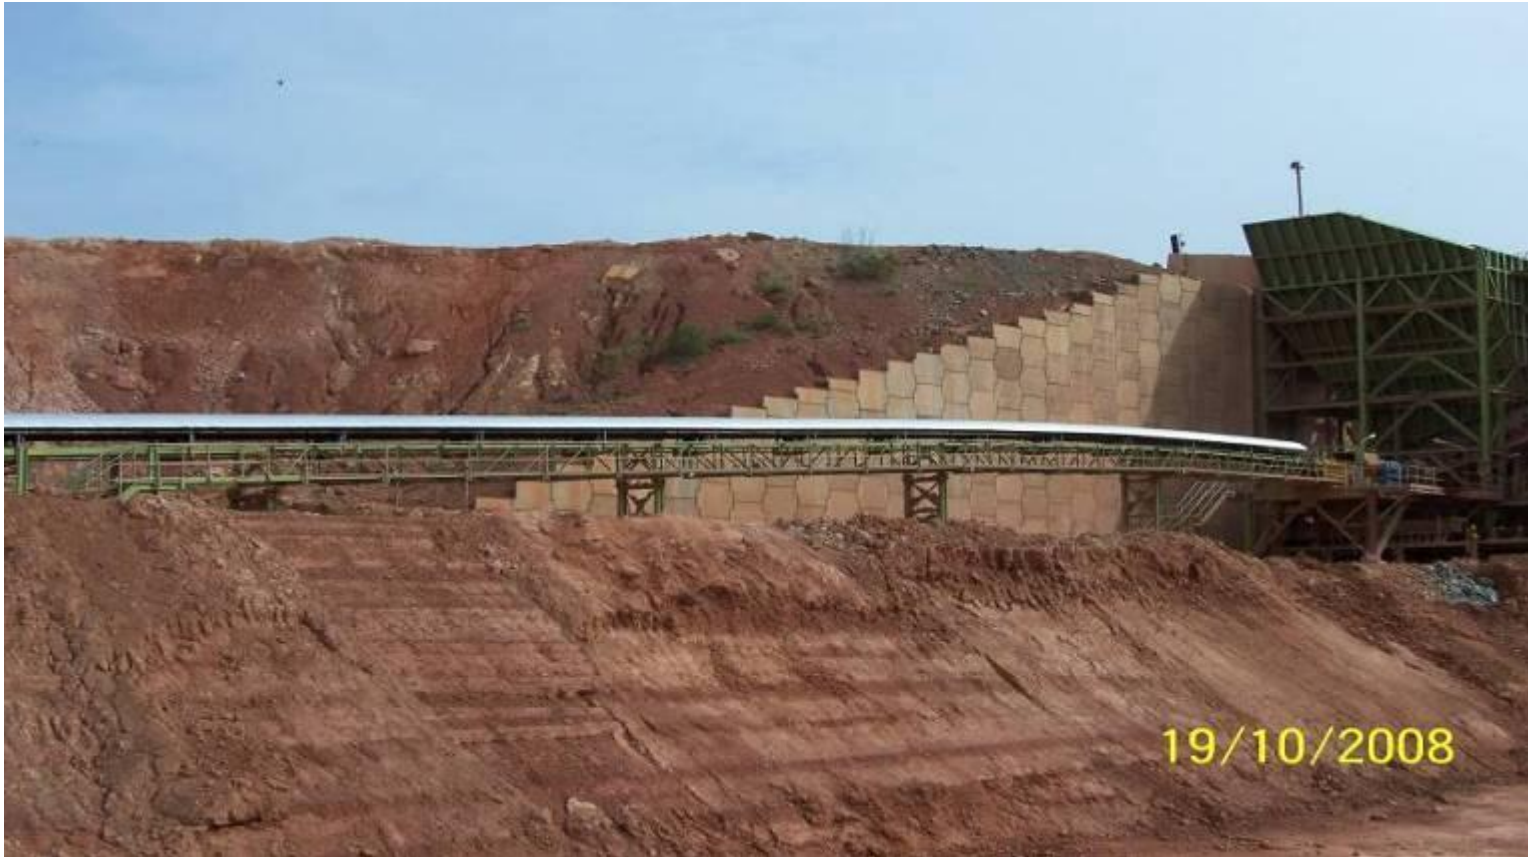
CV4 Overland Conveyor

- Covers over belt.

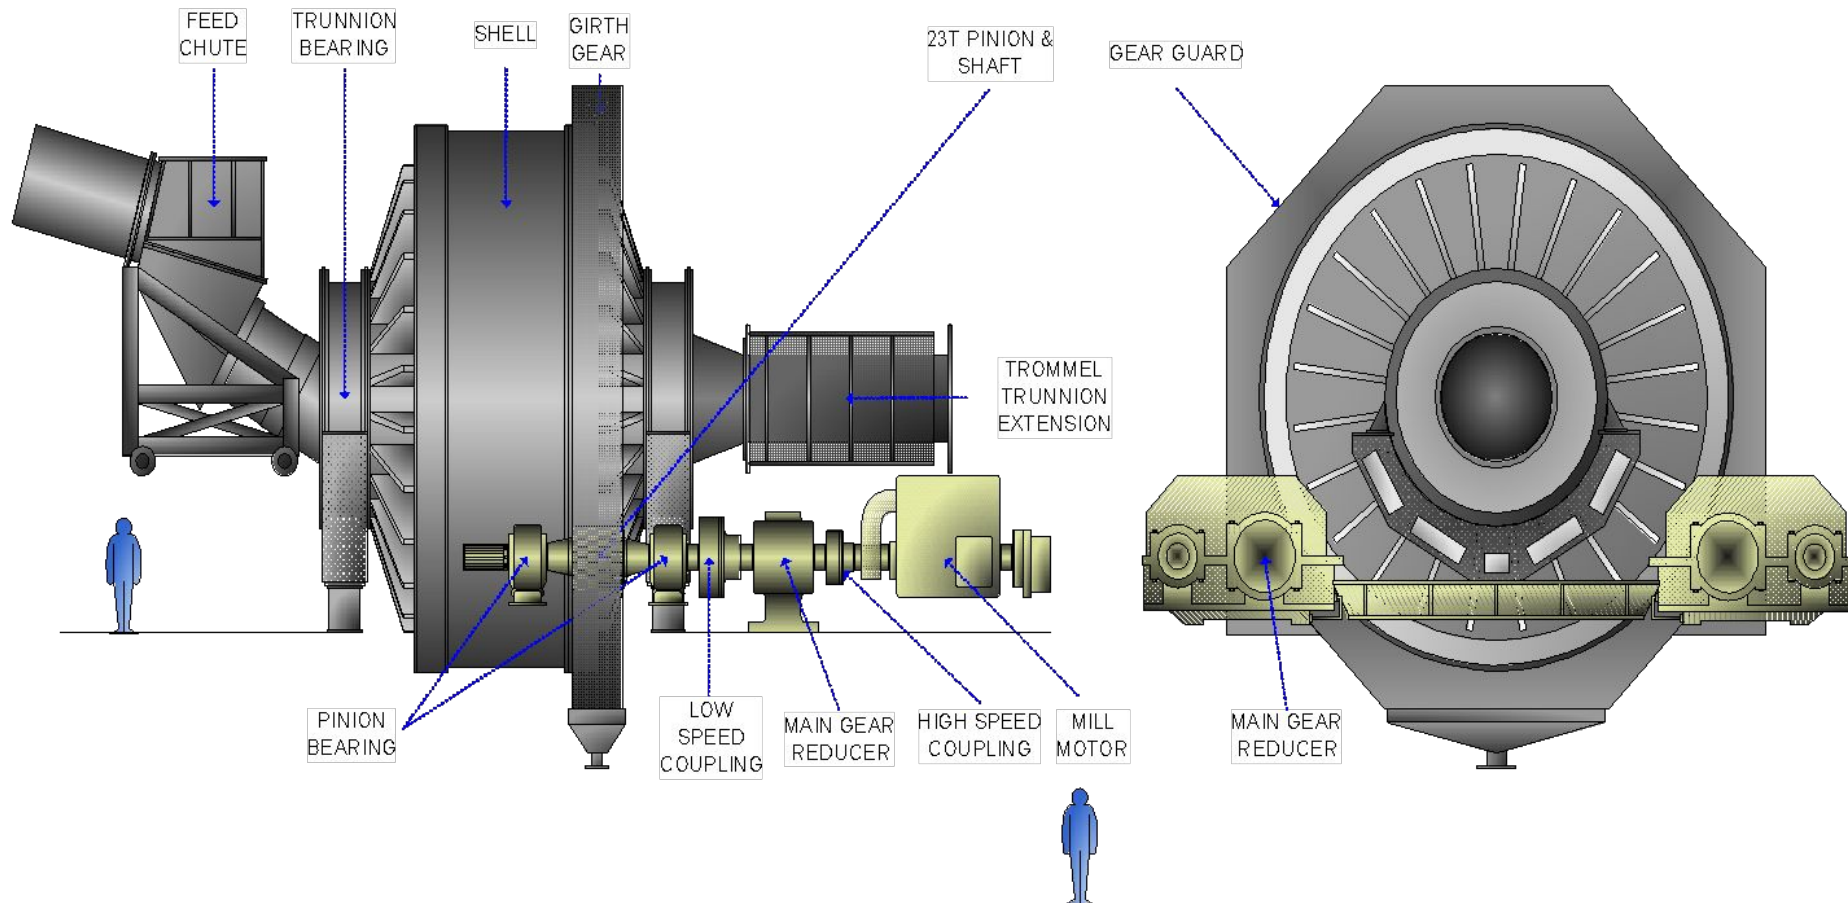
SAG Mill General Arrangement

- Two spare gearboxes (left and right) are on site.
- Scheduled to be installed on SAG 1 in July / August 2010.

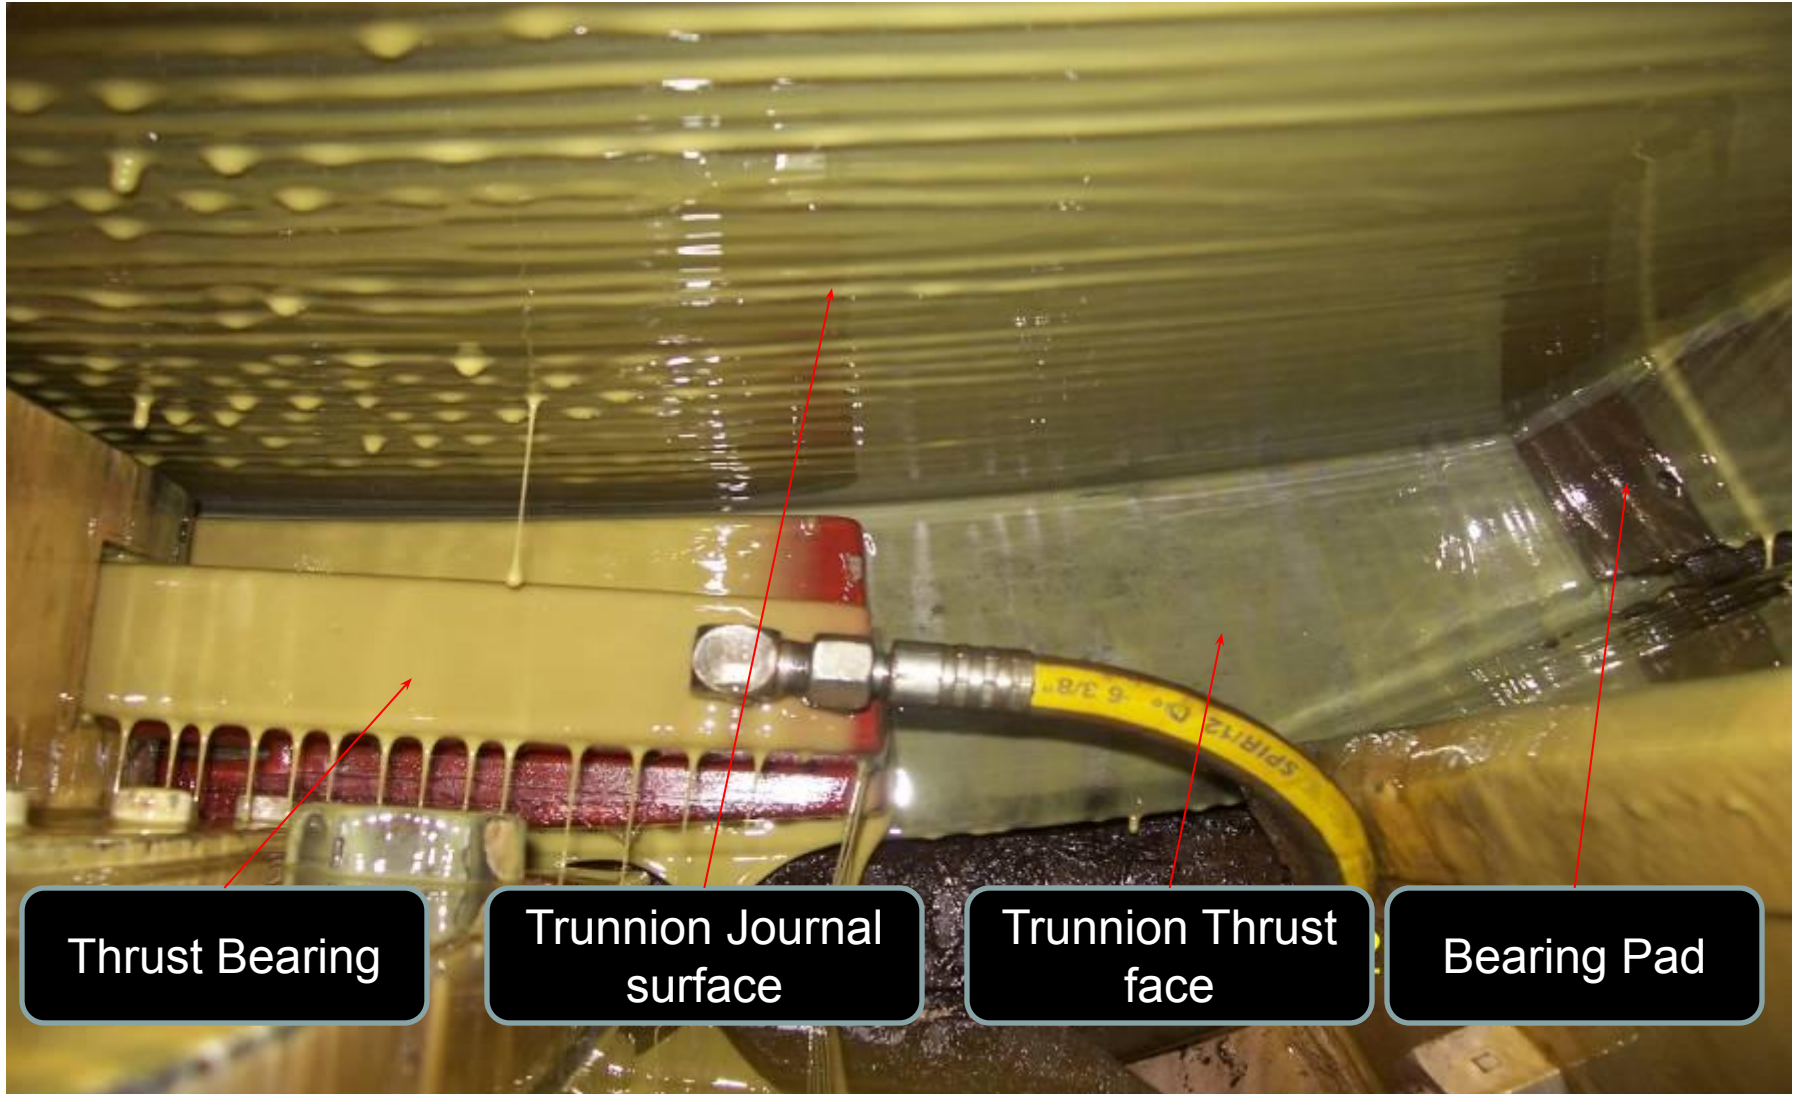
- Premature SAG Mill Trunnion Bearing failures remain a concern until new trunnion seals and accumulator for lubricating oil installed.
November 2009 SAG Mill 2 Discharge End.

Thrust Bearing

Trunnion Journal surface

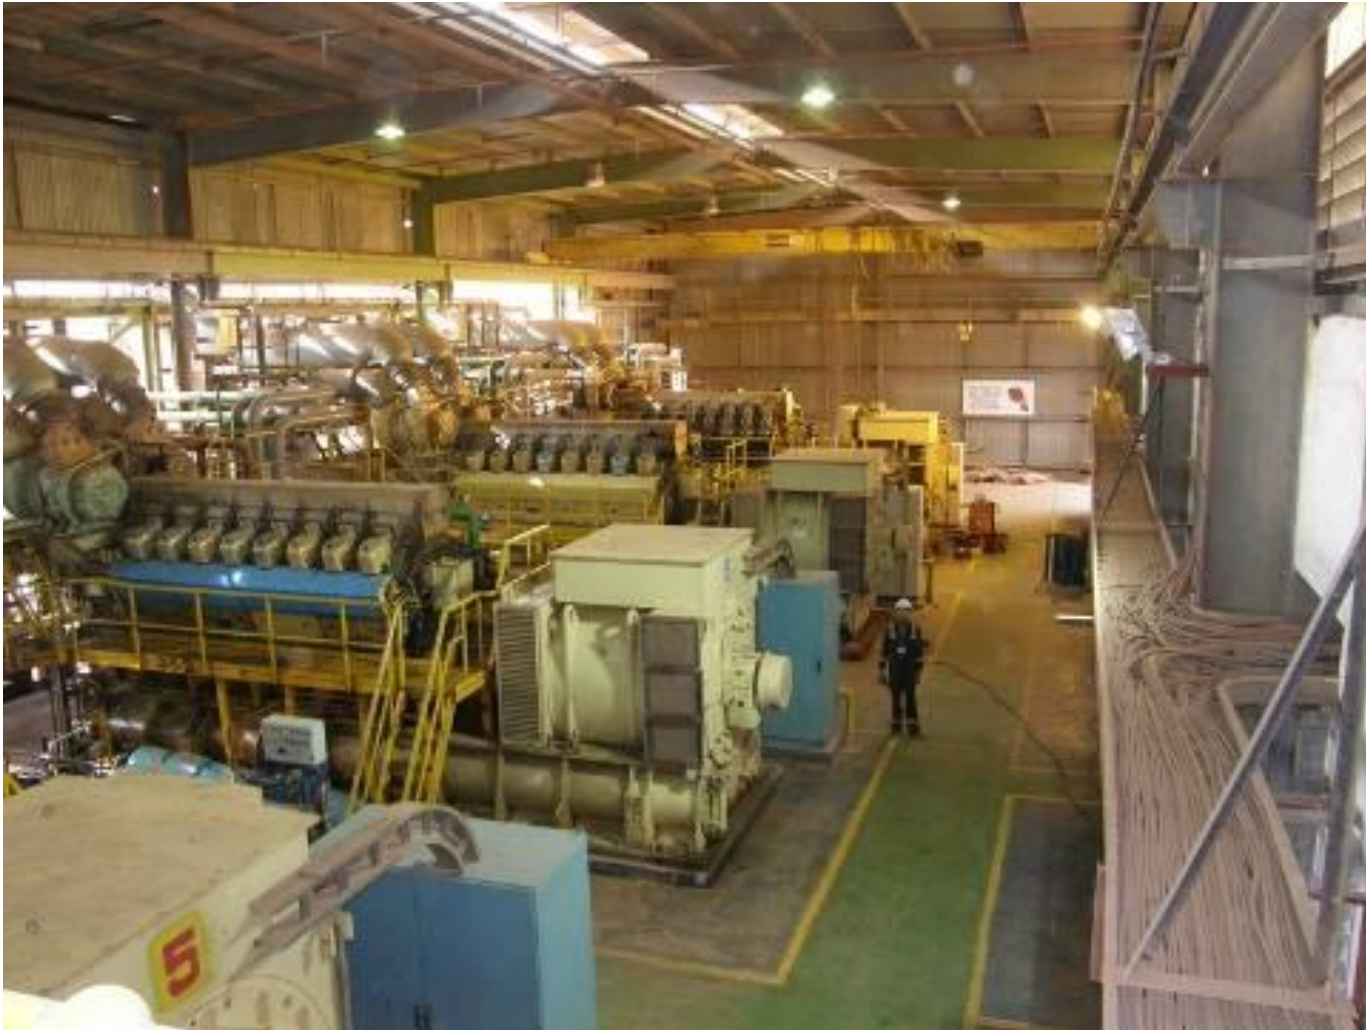
Power generating plant

- Fire suppression for the power generation systems has been **ordered** with an expected cost of in excess of \$600,000 USD **including installation**. As a stop gap measure, 24/7 fire watch is in place, with the emergency response team based at the powerhouse. This remains a vulnerable area for the site, and is classified as a high risk.
- Automatic voltage regulators will be installed by April 2010 improving the reliability of the powerhouse and engine load sharing.

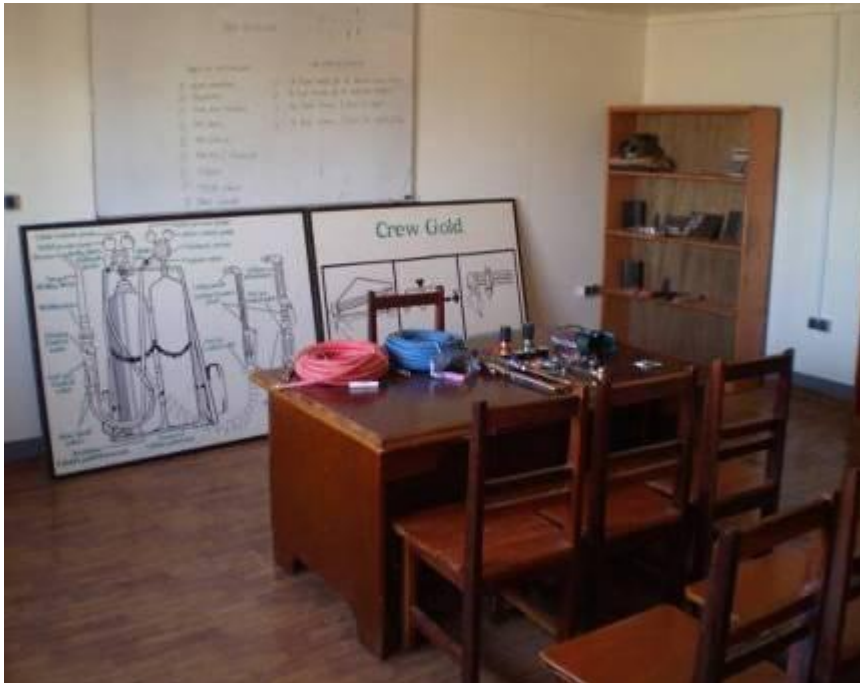
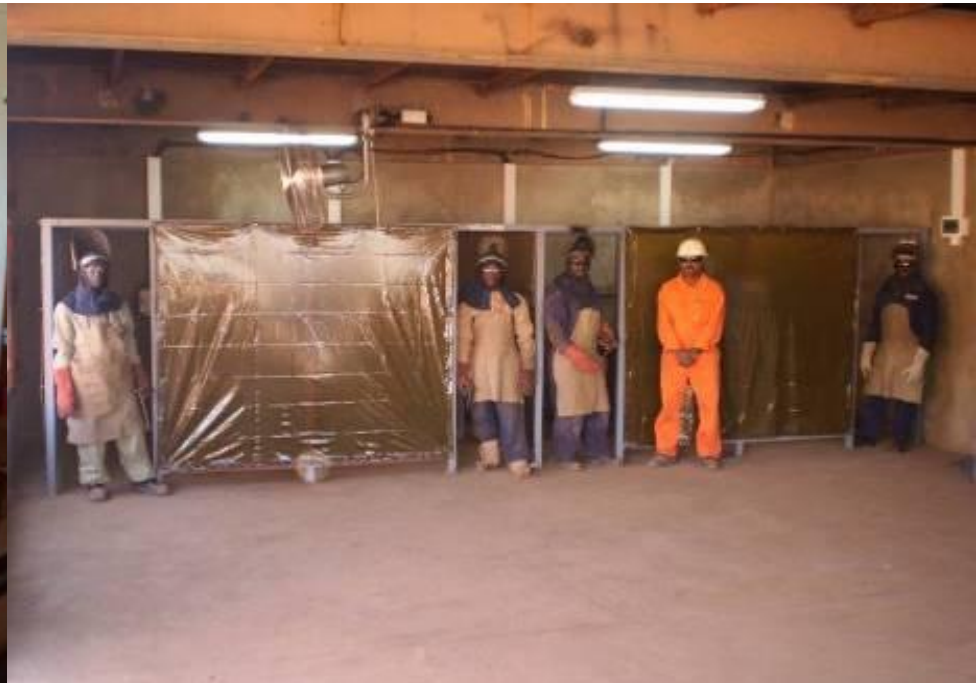
Training of Guinea Nationals

Fabrication training is leading the way with dedicated Trainers.
A training matrix has been developed and will be utilised site wide.
