LEFA Operations - Maintenance March 2010

Overview of Current Status

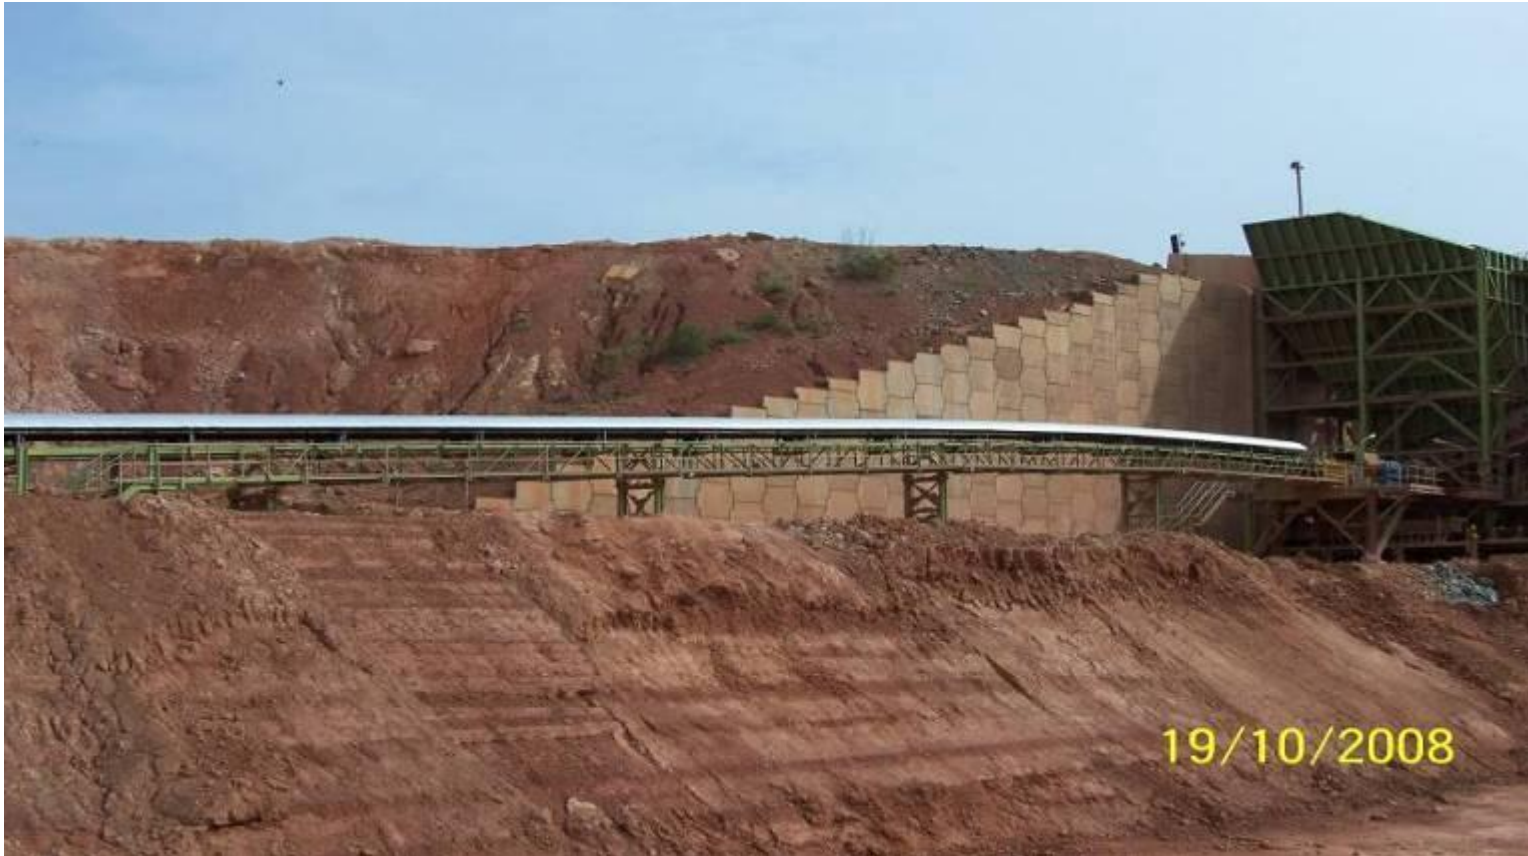
CV4 Overland Conveyor

- Covers over belt.

- The only remaining concern is the construction of the conveyor system which can be described as cheaply built, with little clearance between carry and return belt support structure. This remains a threat as rock spillage from feed belt onto the returning belt can be trapped within the support frames, resulting in belt damage. However there are no plans to replace this structure due to cost constraints.
- **April 2010 a major rip in CV04 of 3572 metres occurred, 1300 metres has been replaced with belt that was in stock, the remaining 2272 metres of damaged belt was clipped at 500mm intervals and also had a Bandage strip glued to the underside to reduce spillage, this bandage strip will be inspected weekly and replaced as required**
- **Replacement belt is being sourced and expedited to site to replace the remaining damaged section of belt.**

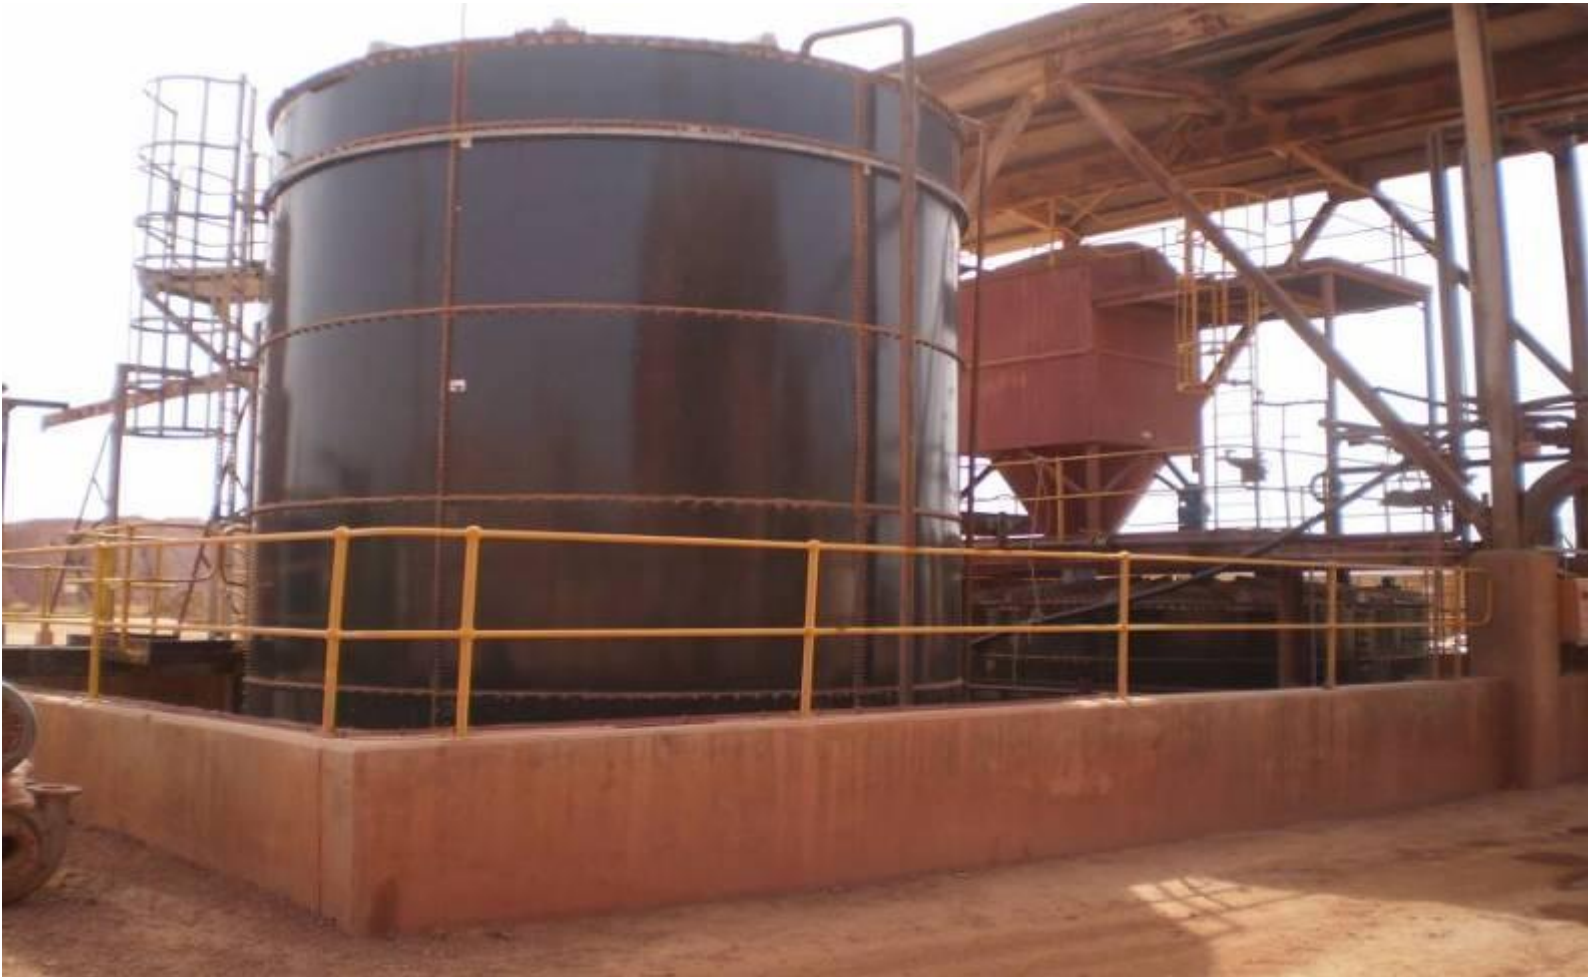
Reagent Mixing

New Caustic tank with Hopper structure being assembled.
