Презентация на тему: «Катастрофа Superjet 100 в Шереметьево»

ПРЕЗЕНТАЦИЮ
ПОДГОТОВИЛ СТУДЕНТ
ГРУППЫ БТП 3-1
ЯХОНТОВ АЛЕКСАНДР

On May 5, 2019, an Aeroflot Superjet 100 crashed while landing at Sheremetyevo Airport. The liner was flying on the route Moscow - Murmansk. When returning to the departure airfield, the aircraft made several rough landings and as a result of the resulting fire received significant damage. 41 people died, 37 survived.

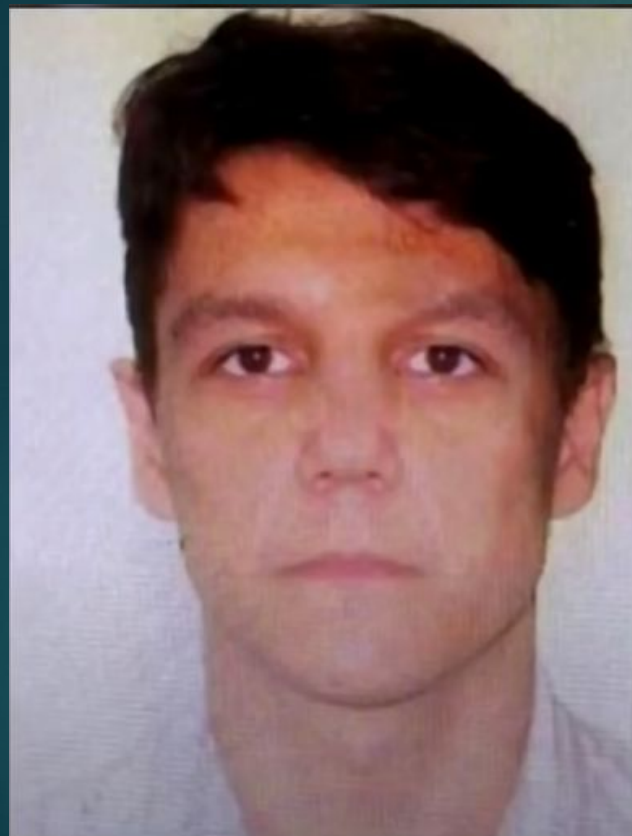
Denis Evdokimov (Pilot)
6800 flight hours.

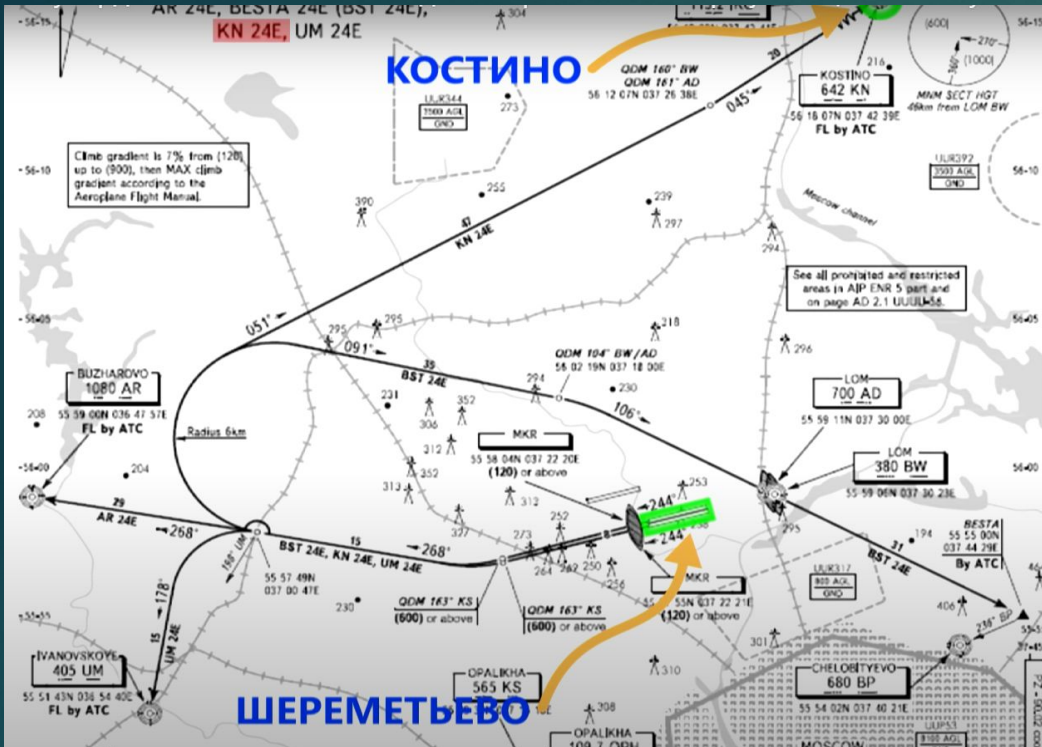
Departure scheme

- ▶ Before departure, the dispatcher transmits weather data to the crew, in which a sufficiently large thunderstorm front is visible.
- ▶ At 17:57, the crew taxis to the runway, takeoff is allowed.
- ▶ At an altitude of 210 meters, the commander turns on the autopilot.

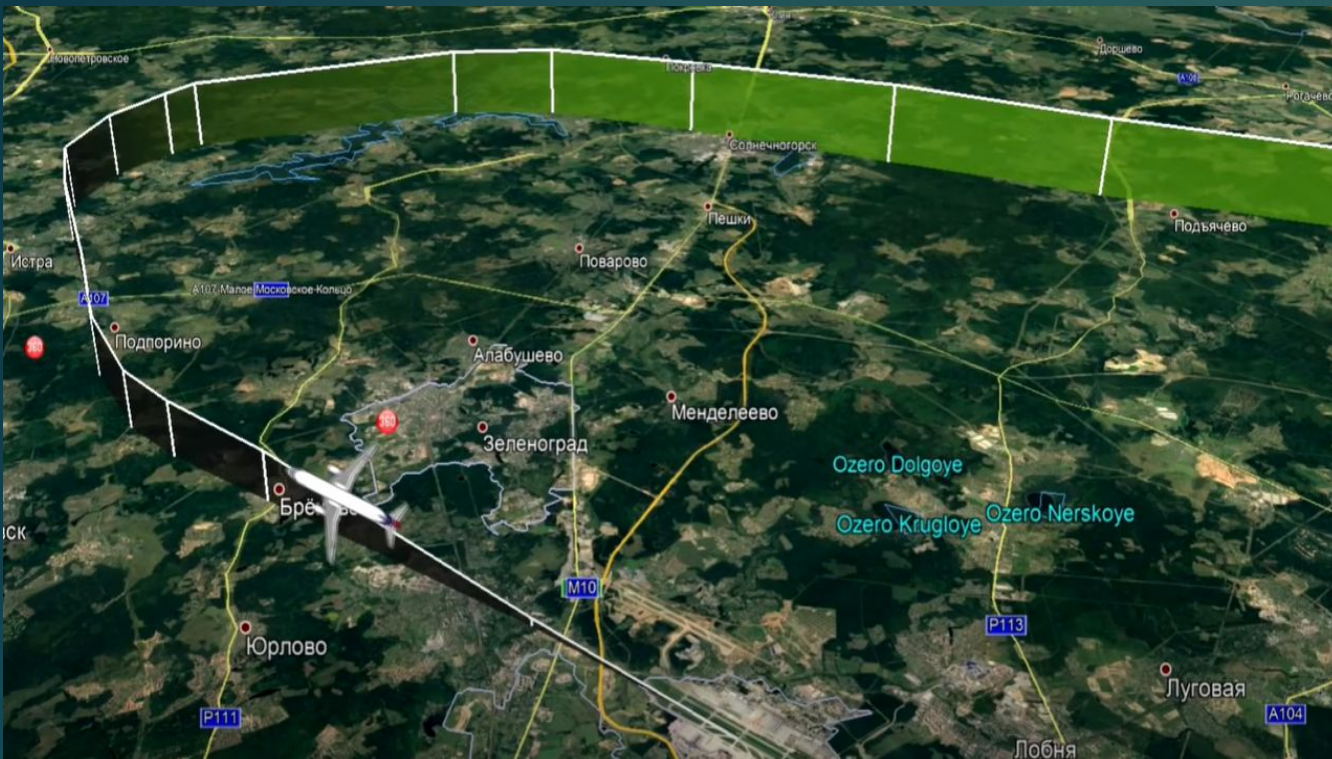
- ▶ After half a minute, lightning strikes the plane, the autopilot turns off and the plane switches to direct mode (direct control) - one of the three regular flight modes of the liner. In this mode, the aircraft can only be controlled by a joystick (sidestick).

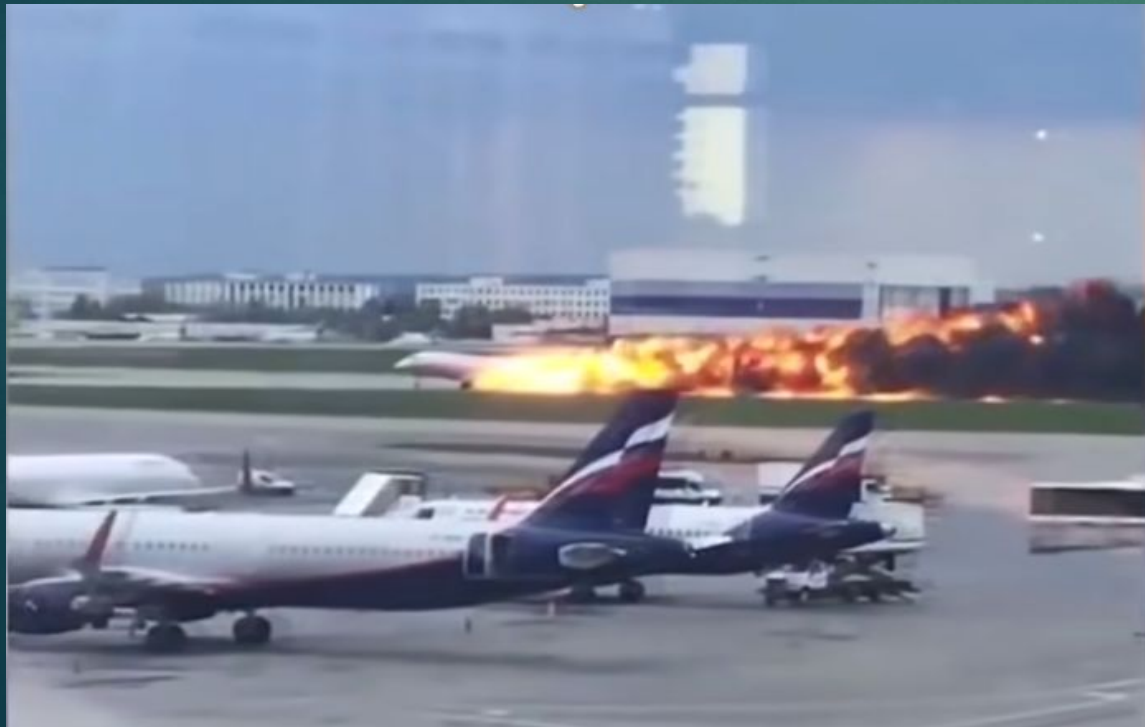
- ▶ The partially destroyed chassis finally breaks down and breaks through the fuel tanks, fuel spills and a fire starts. The dispatcher's command "emergency services to the lane" sounds.
- ▶ The plane turns to the left and stops, evacuation begins and after a minute the engines stop...
