Презентация на тему: «Катастрофа Superjet 100 в Шереметьево»

ПРЕЗЕНТАЦИЮ
ПОДГОТОВИЛ СТУДЕНТ
ГРУППЫ БТП 3-1
ЯХОНТОВ АЛЕКСАНДР

On May 5, 2019, an Aeroflot Superjet 100 crashed while landing at Sheremetyevo Airport. The liner was flying on the route Moscow - Murmansk. When returning to the departure airfield, the aircraft made several rough landings and as a result of the resulting fire received significant damage. 41 people died, 37 survived.

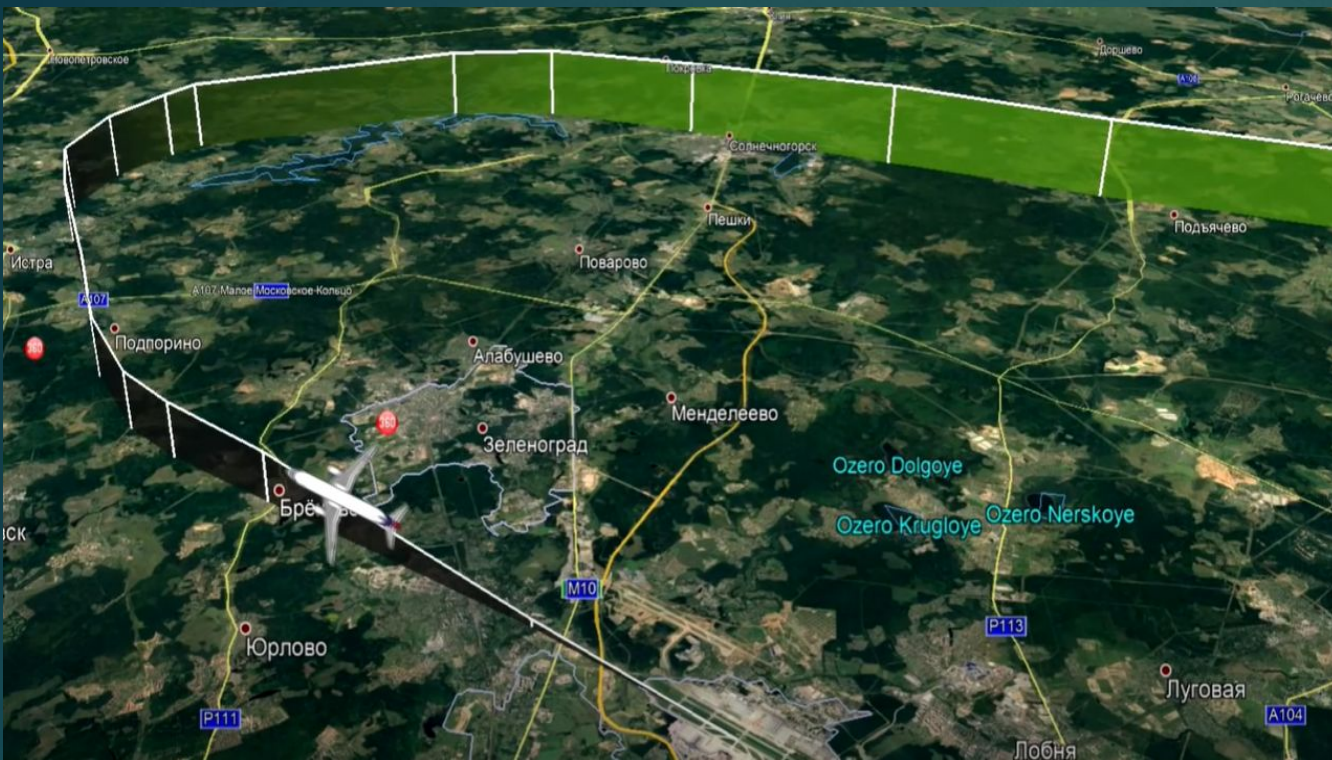
- ▶ After half a minute, lightning strikes the plane, the autopilot turns off and the plane switches to direct mode (direct control) - one of the three regular flight modes of the liner. In this mode, the aircraft can only be controlled by a joystick (sidestick).

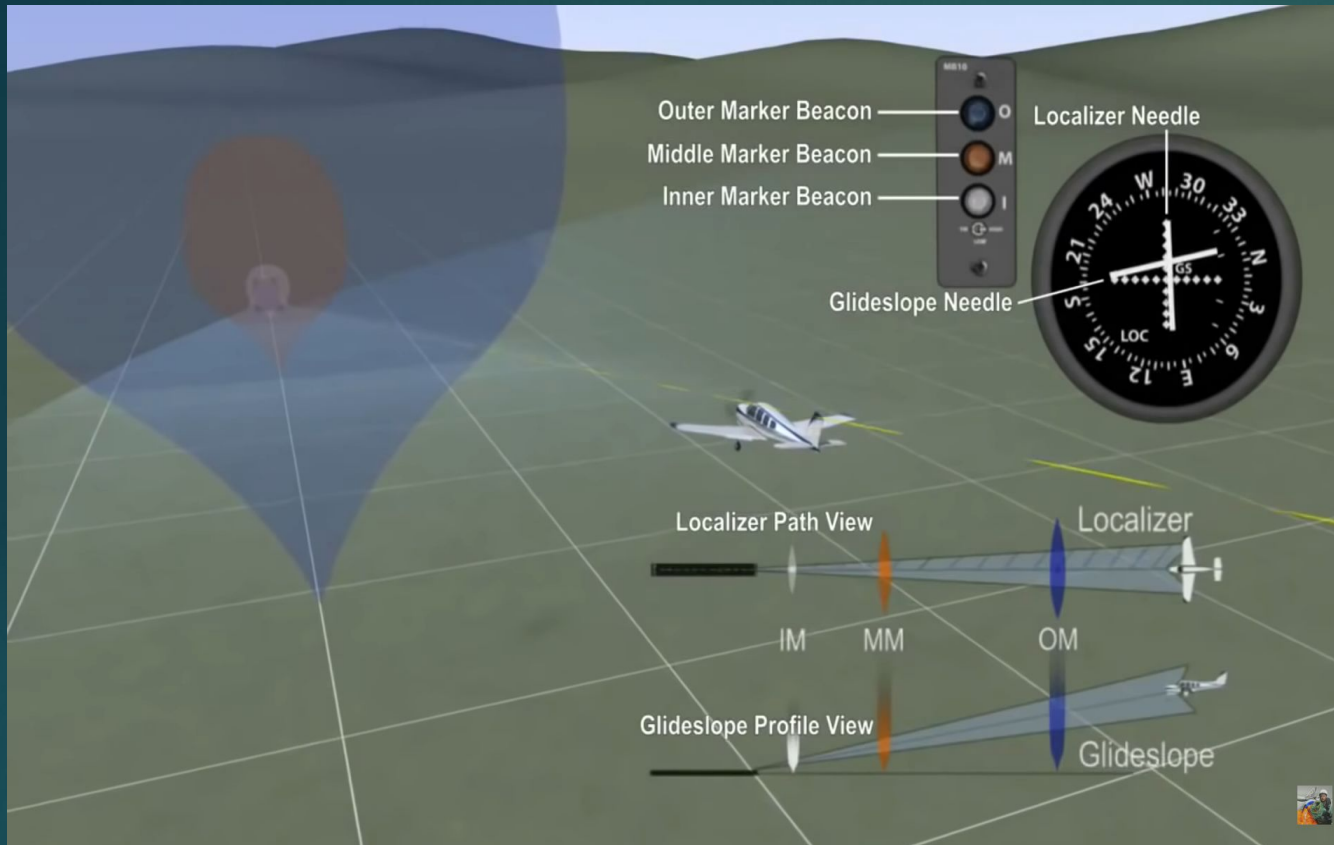
► Missing checklist item

The only ILS view available with Directmode

- ▶ 20 km before the runway, the dispatchers take the plane on a landing course.
- ▶ After 11 km, the entry point to the glide path, it is from there that the final descent to the lane will begin.
- ▶ When asked by the dispatcher about the type of approach, the crew replies that they will enter by ILS (instrumental landing system)
- ▶ Pilots read the map of control checks "on landing", but before that the crew does not perform the map of control checks "on approach".
- ▶ And there was something to discuss, if the commander had done it, then the co-pilot would have understood better what to do and how to help, in fact the crew is not ready to land.

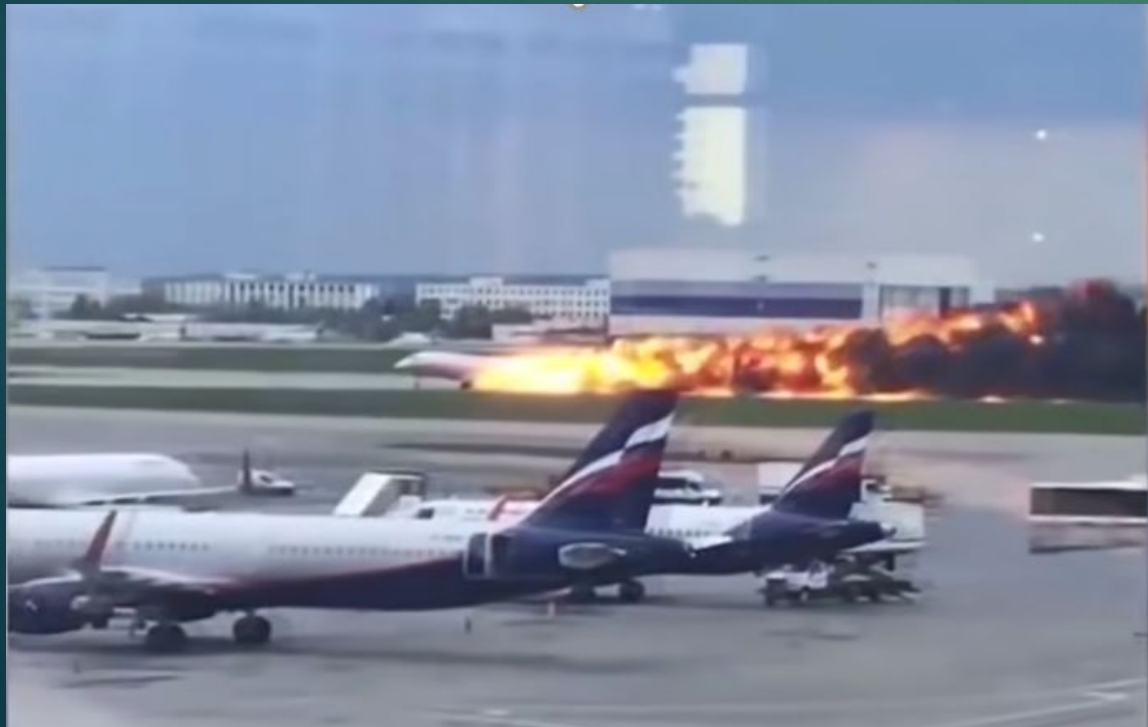
- ▶ The partially destroyed chassis finally breaks down and breaks through the fuel tanks, fuel spills and a fire starts. The dispatcher's command "emergency services to the lane" sounds.
- ▶ The plane turns to the left and stops, evacuation begins and after a minute the engines stop...
