Презентация на тему:
«Катастрофа Superjet 100 в
Шереметьево»

ПРЕЗЕНТАЦИЮ
ПОДГОТОВИЛ СТУДЕНТ
ГРУППЫ БТП 3-1
ЯХОНТОВ АЛЕКСАНДР

On May 5, 2019, an Aeroflot Superjet 100 crashed while landing at Sheremetyevo Airport. The liner was flying on the route Moscow - Murmansk. When returning to the departure airfield, the aircraft made several rough landings and as a result of the resulting fire received significant damage. 41 people died, 37 survived.

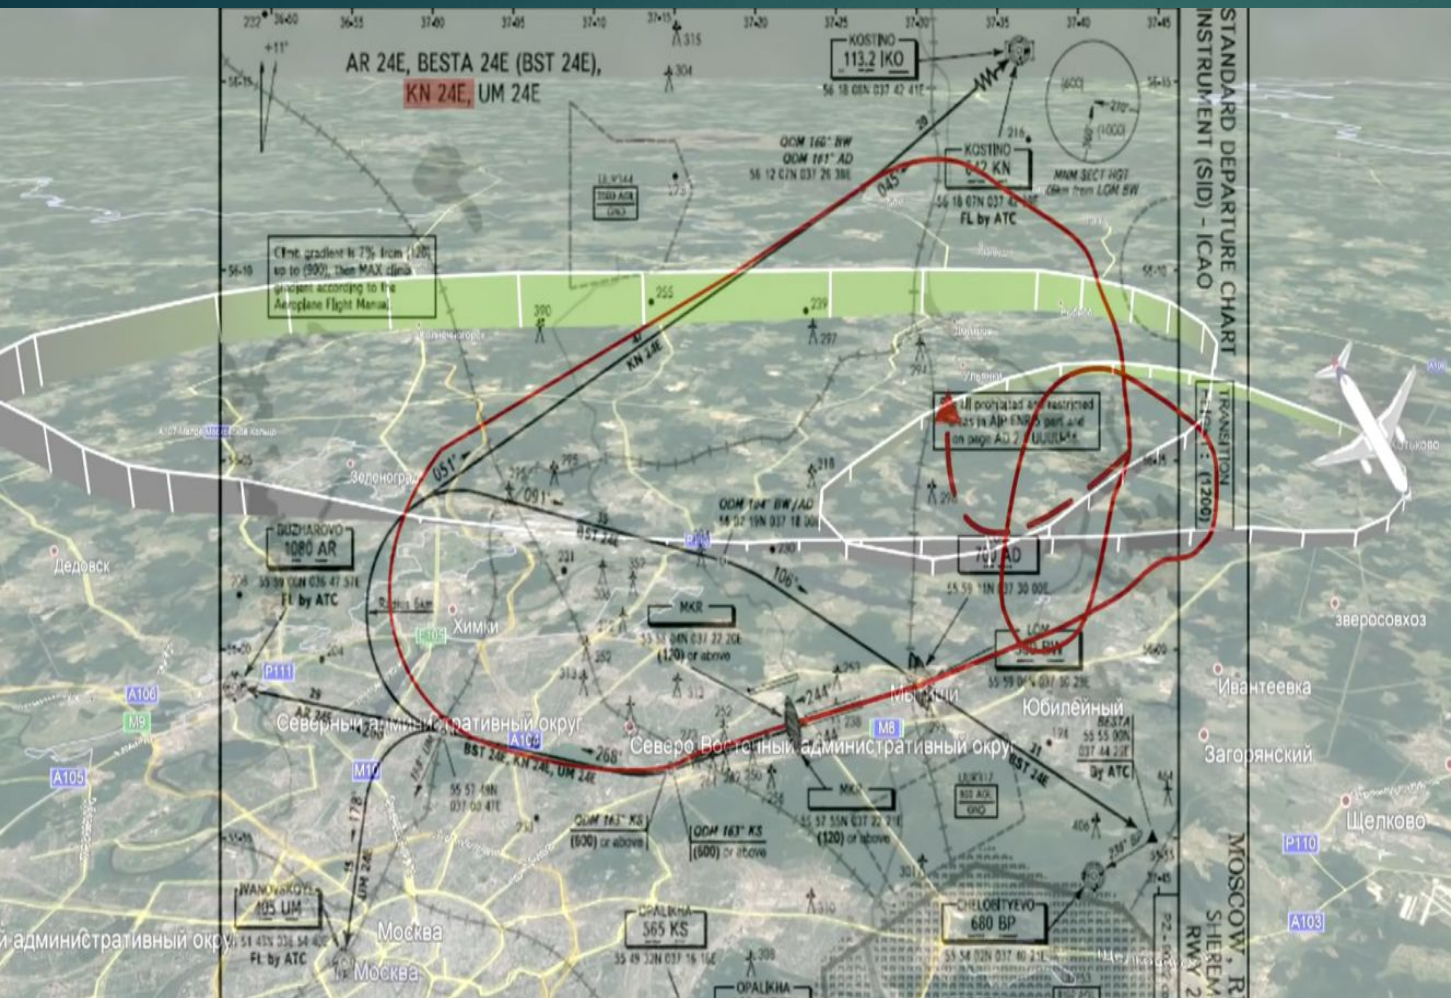
- ▶ The dispatcher allows the landing, but the commander asks for an additional flight in a circle.
- ▶ At this time, the pilot has an idea to go to the waiting area, but this message was not registered on the dispatcher tape recorder, the commander did not return to this issue anymore.
- ▶ The height is 600 meters, it is difficult for the commander to maintain it in manual mode.
- ▶ Deviations exceed 60 meters, this causes multiple triggering of the corresponding alarm.
- ▶ Chassis and flaps are available.

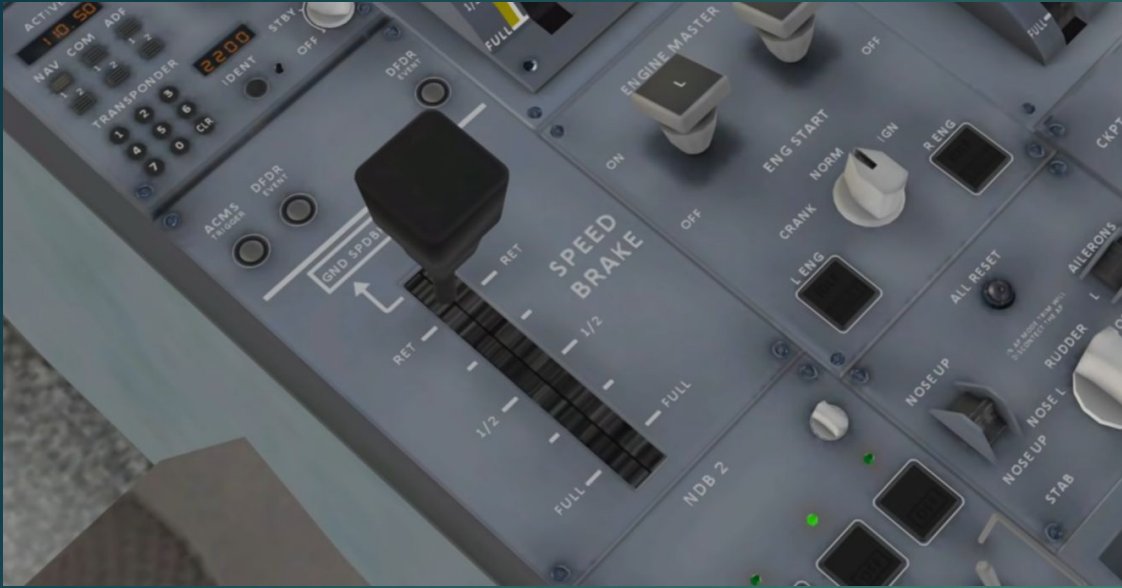
- ▶ The crew reinforces the air brakes (these are flaps on the wing that rise up).
- ▶ In reinforcement mode, when the landing gear touches the ground, they should automatically go up and thereby press the aircraft to the runway, but they are not automatically released in direct mode, and this is what the co-pilot said 9 minutes ago when reading the checklist.
