Презентация на тему:
«Катастрофа Superjet 100 в
Шереметьево»

ПРЕЗЕНТАЦИЮ
ПОДГОТОВИЛ СТУДЕНТ
ГРУППЫ БТП 3-1
ЯХОНТОВ АЛЕКСАНДР

On May 5, 2019, an Aeroflot Superjet 100 crashed while landing at Sheremetyevo Airport. The liner was flying on the route Moscow - Murmansk. When returning to the departure airfield, the aircraft made several rough landings and as a result of the resulting fire received significant damage. 41 people died, 37 survived.

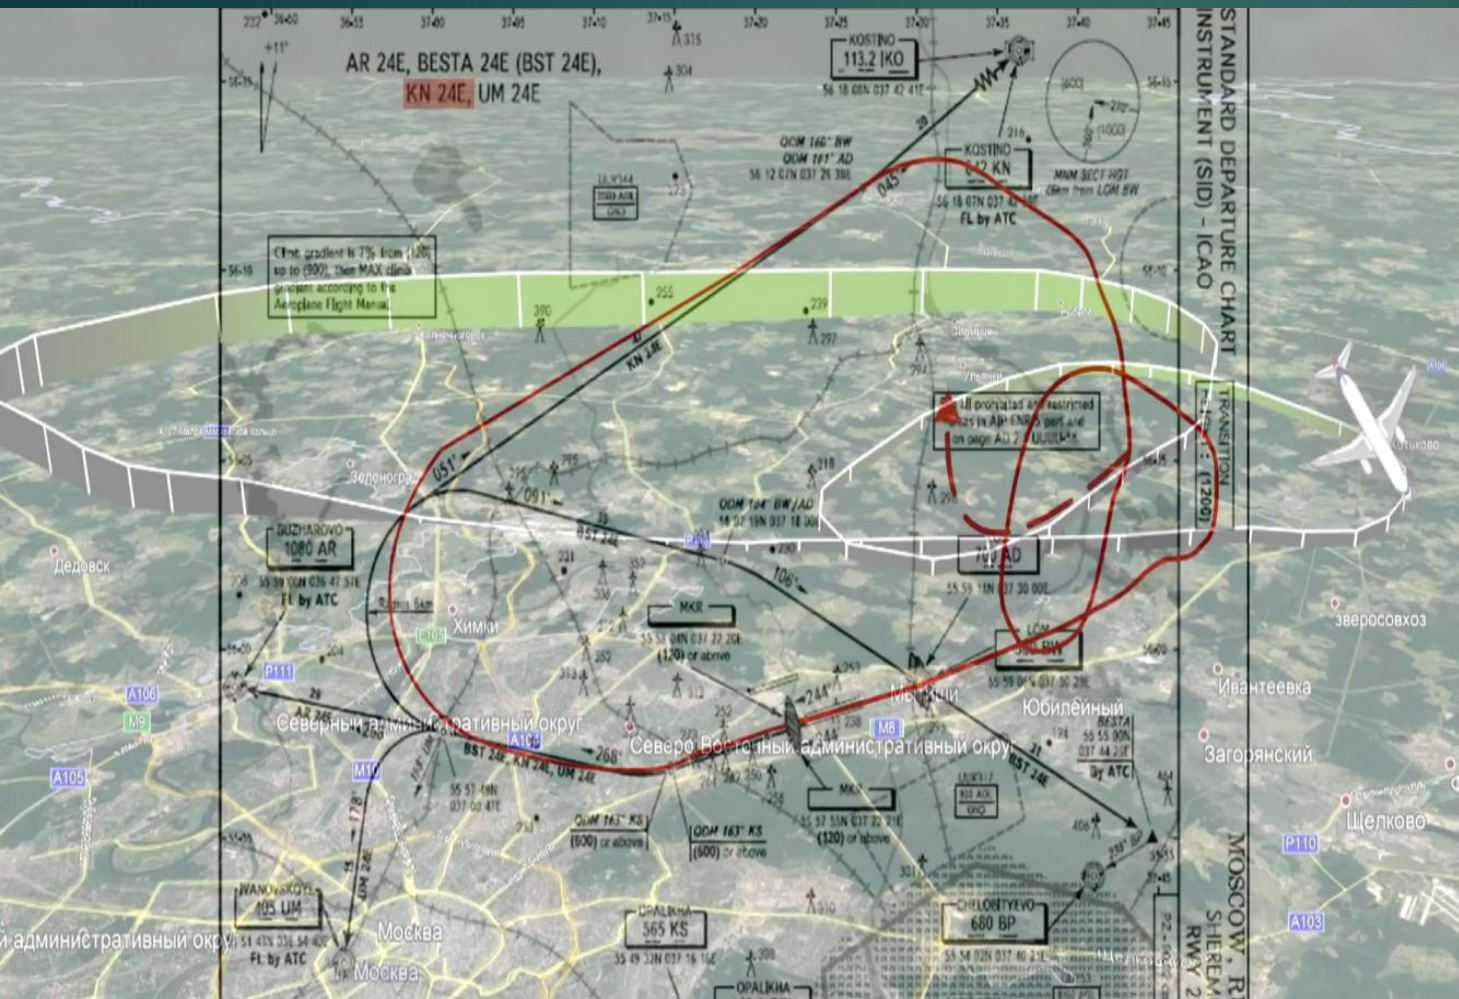
- ▶ The crew performs a checklist with a direct mod.
- ▶ At the same time, the parameter was specified – to pilot smoothly.
- ▶ Speed brake set to full after landing.

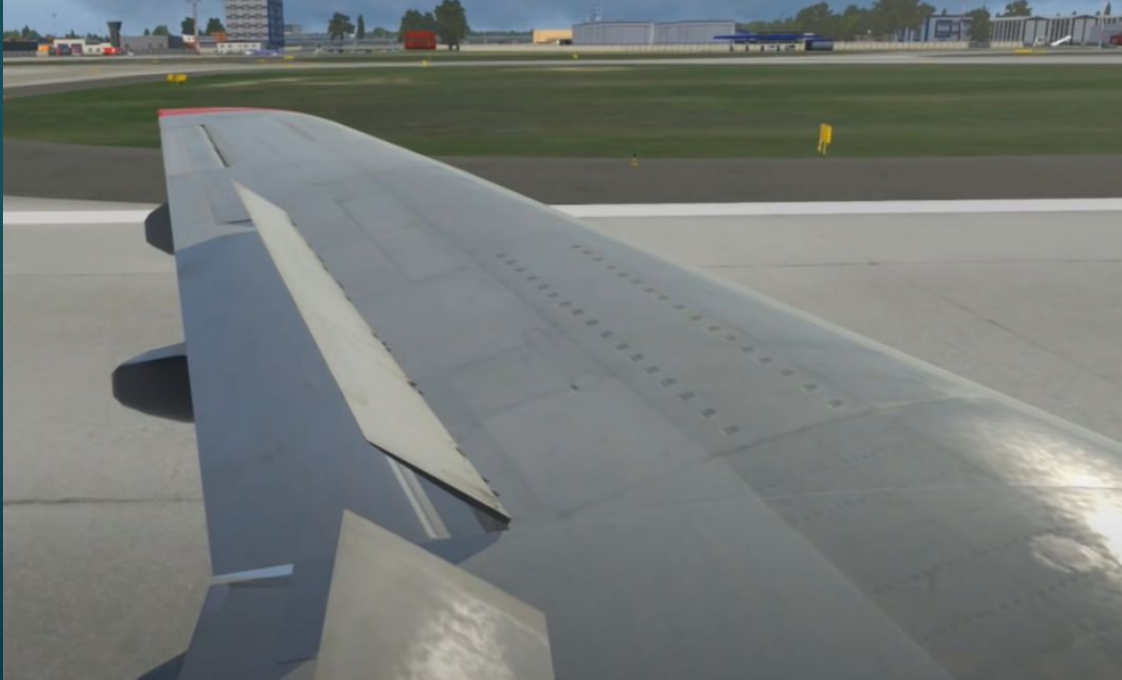
- ▶ The crew reinforces the air brakes (these are flaps on the wing that rise up).
- ▶ In reinforcement mode, when the landing gear touches the ground, they should automatically go up and thereby press the aircraft to the runway, but they are not automatically released in direct mode, and this is what the co-pilot said 9 minutes ago when reading the checklist.
