▣ Maintenance judgment standard in order to reduce NTF claims of stabilizer link

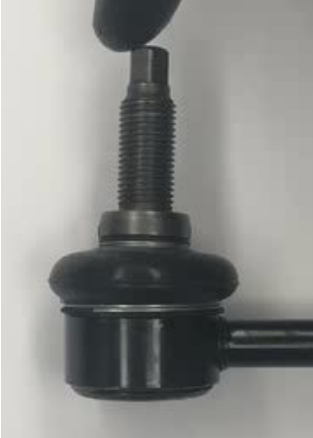
Unrestored ball stud

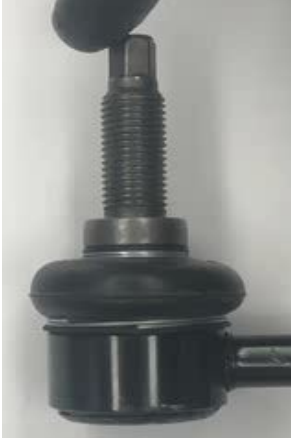
Partly restored ball stud

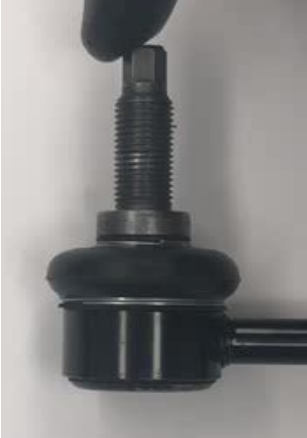
Complete restoration of ball stud

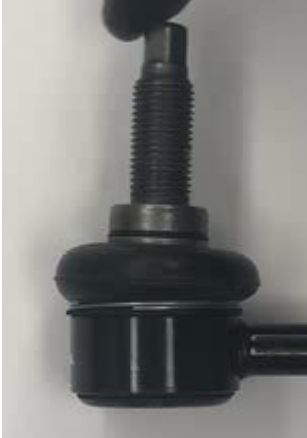
Complete restoration of ball stud

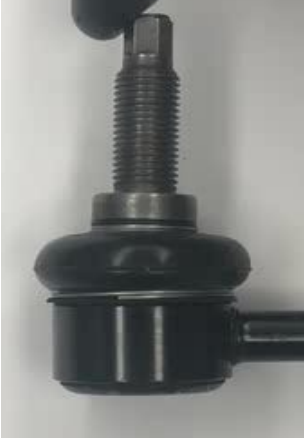
Complete restoration of ball stud
Free play	0.075 mm (OK)	0.113 mm (OK)	0.219 mm (OK)	0.440 mm (NG)	0.516 mm (NG)
Abnormal size in real car	No occurrence	No occurrence	No occurrence	Abnormal noise occur	Abnormal noise occur
