## ▣ Maintenance judgment standard in order to reduce NTF claims of stabilizer link

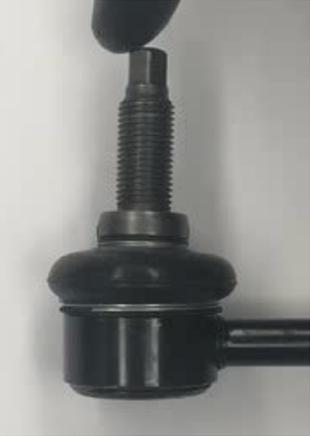
Unrestored ball stud

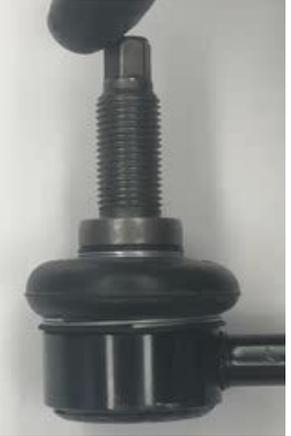
Partly restored ball stud

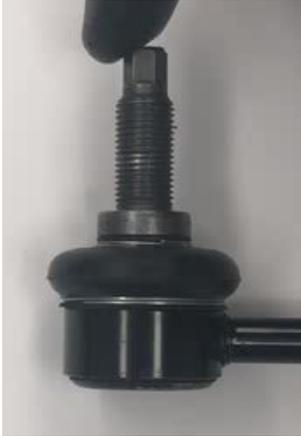
Complete restoration of ball stud

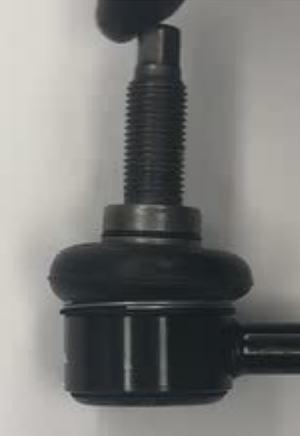
Complete restoration of ball stud

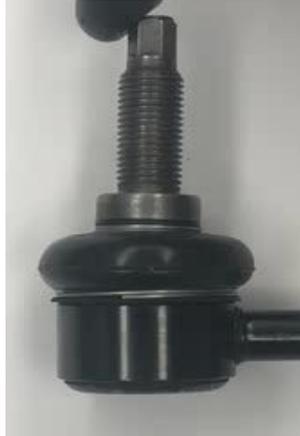
Complete restoration of ball stud
Free play	0.075 mm (OK)	0.113 mm (OK)	0.219 mm (OK)	0.440 mm (NG)	0.516 mm (NG)
Abnormal size in real car	No occurrence	No occurrence	No occurrence	Abnormal noise occur	Abnormal noise occur
