Alternative Sources of Energy

Distributed Generation

75 kW Microturbine CHP Application

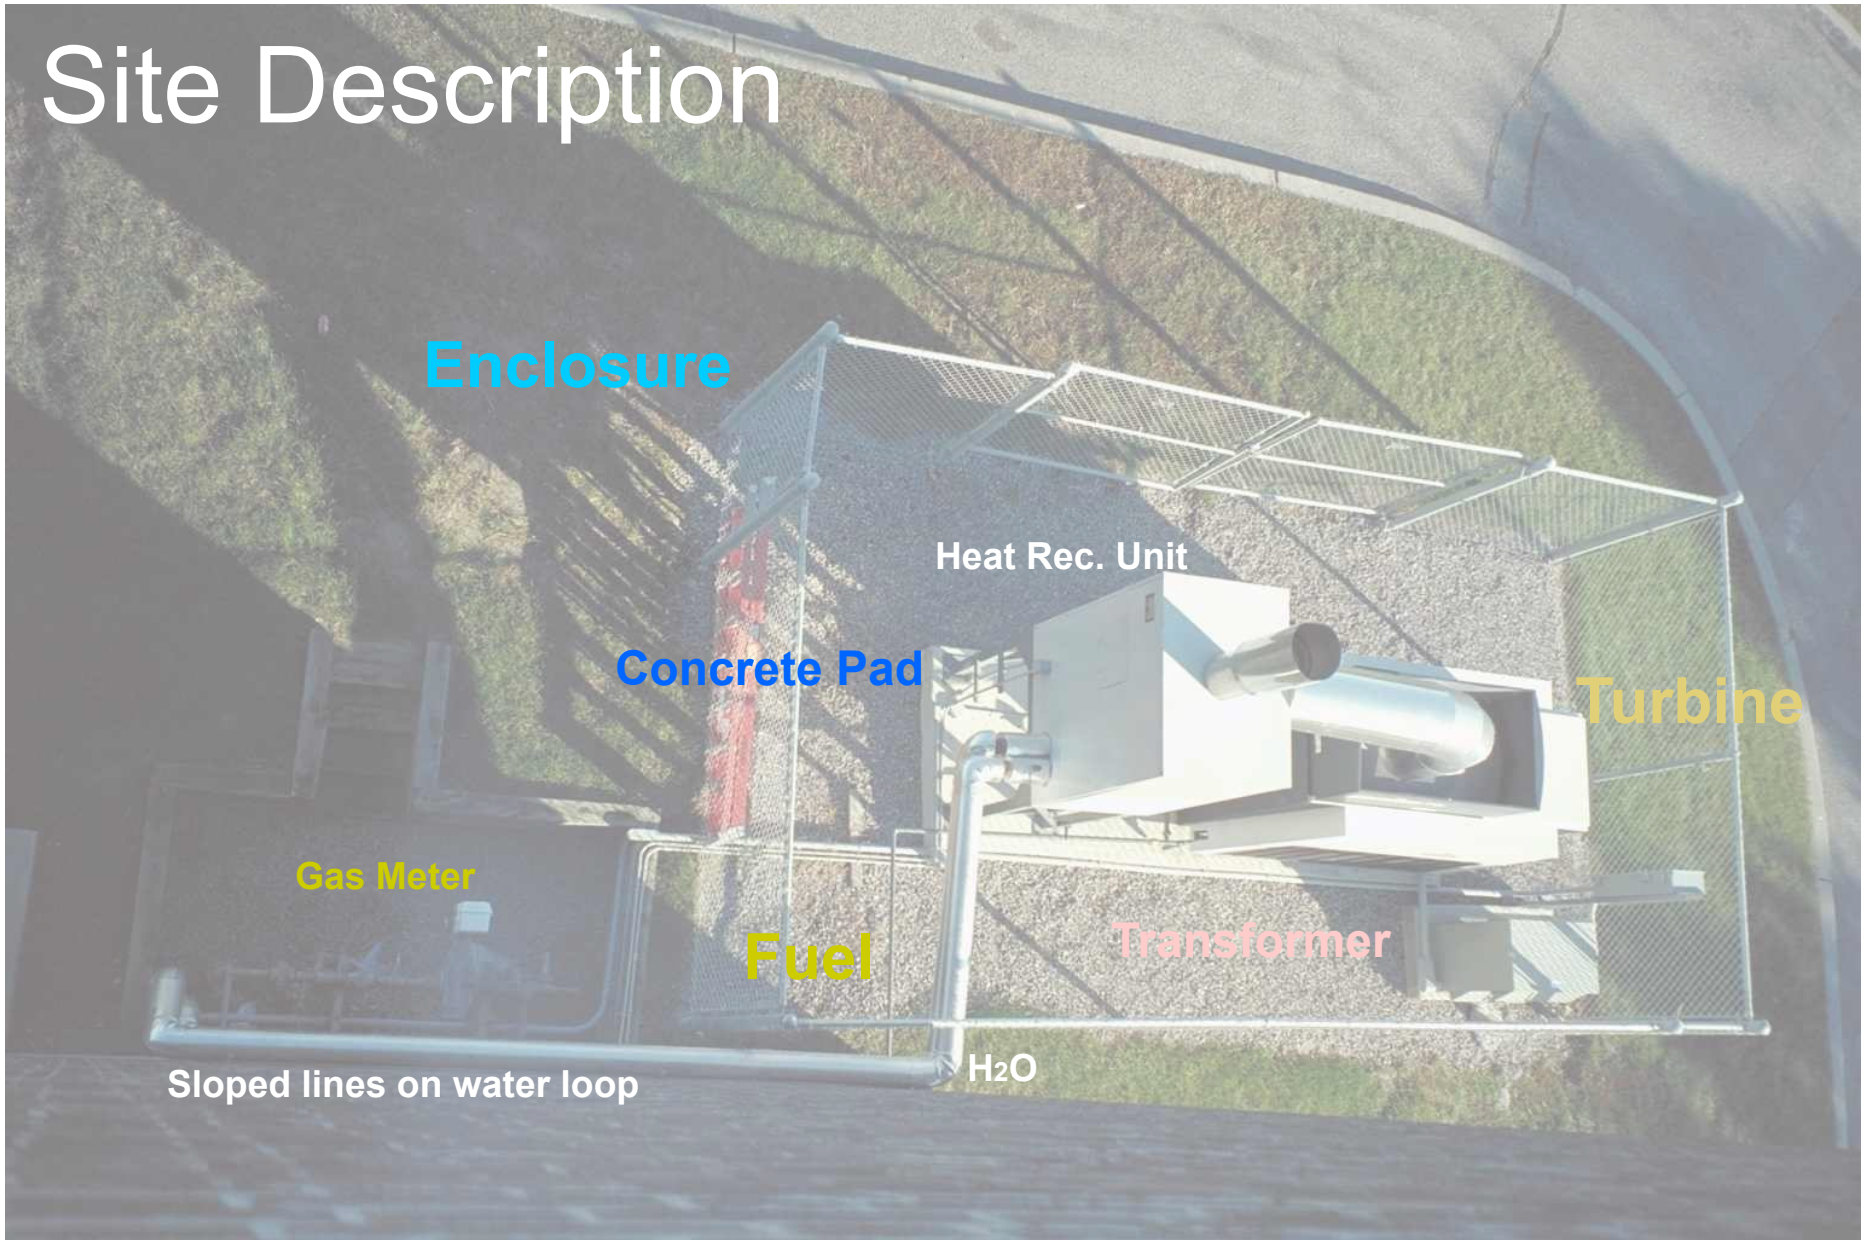
Site Description

Enclosure

Heat Rec. Unit

Concrete Pad

Turbine

Gas Meter

Fuel

Transformer

Sloped lines on water loop

H₂O

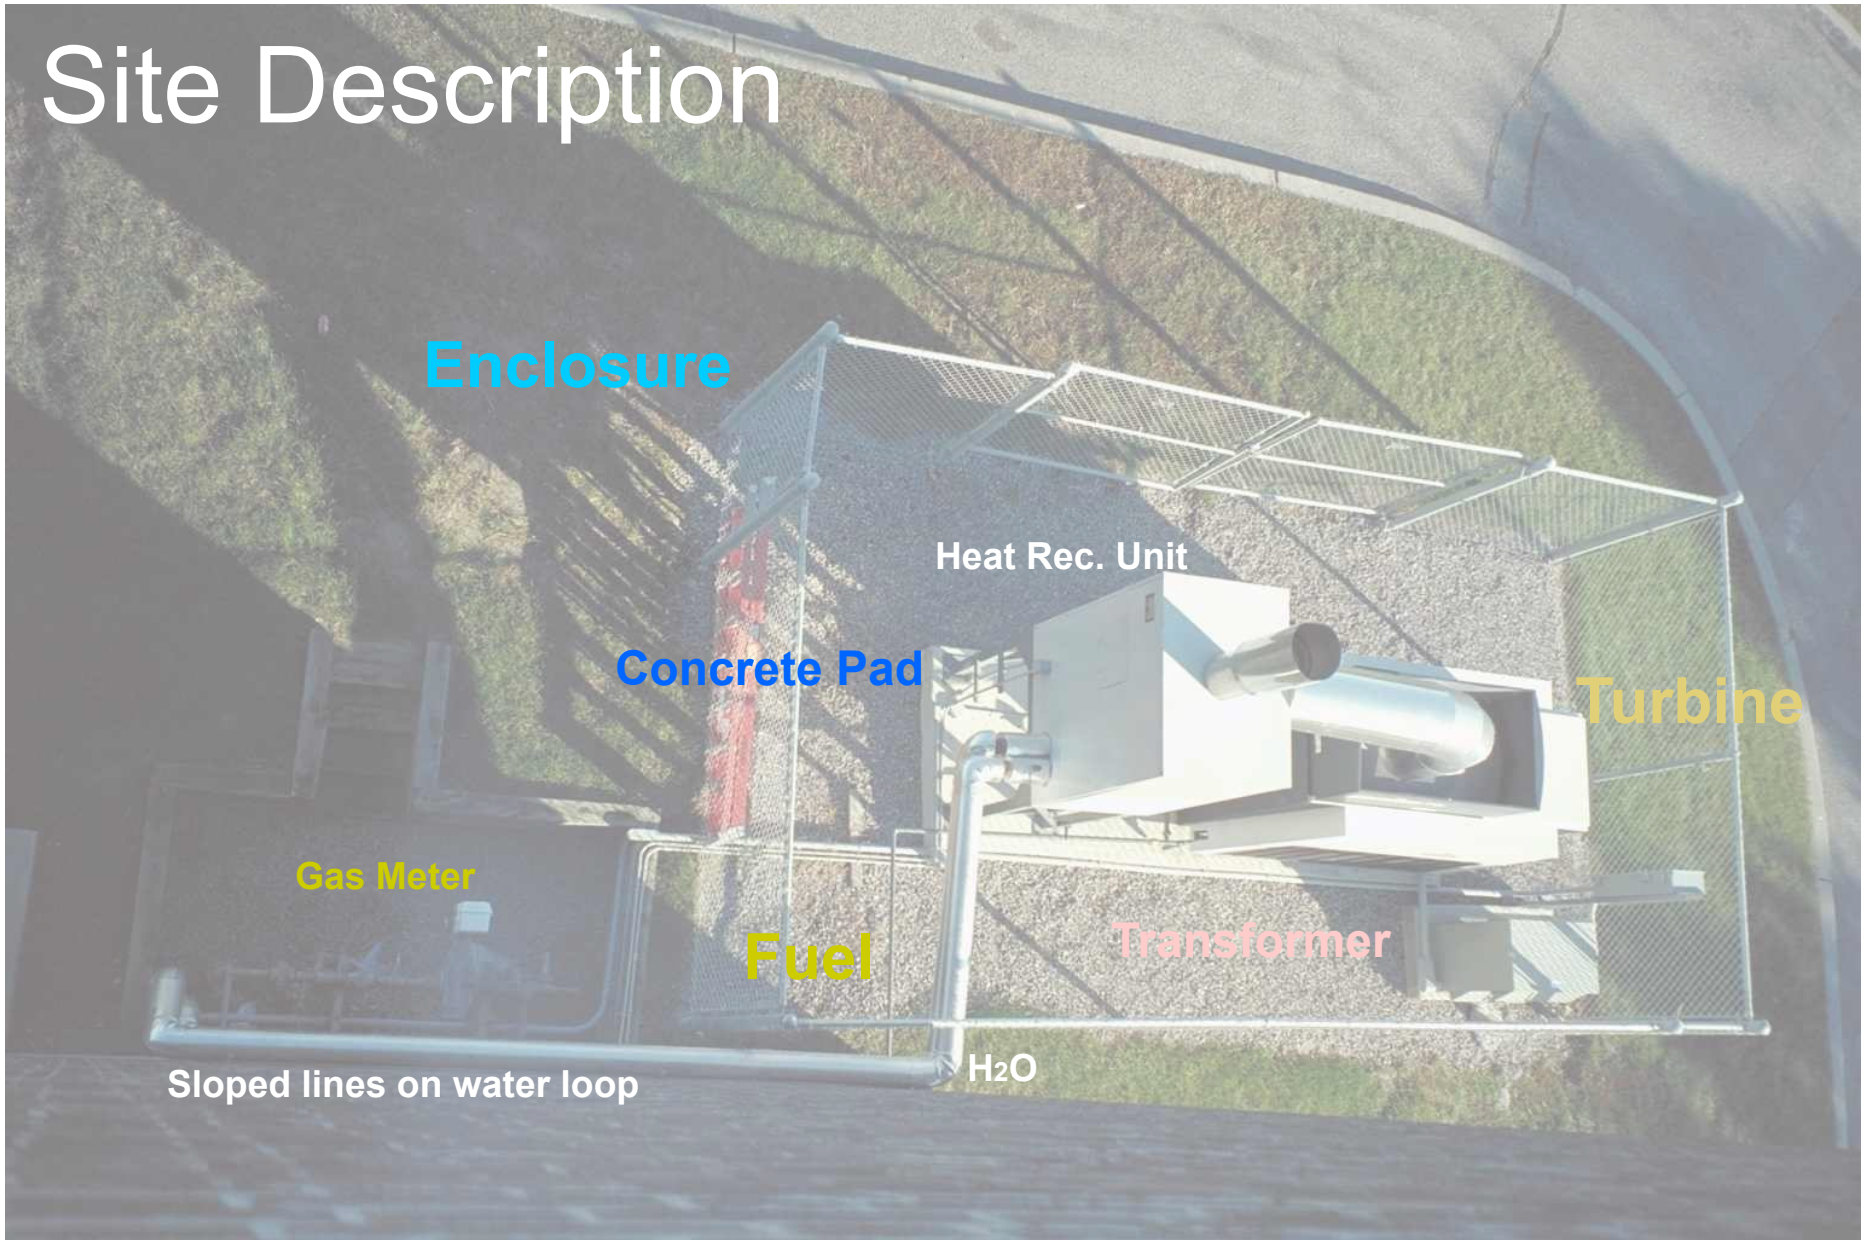
Site Description

Enclosure

Heat Rec. Unit

Concrete Pad

Turbine

Gas Meter

Fuel

Transformer

Sloped lines on water loop

H₂O
