Product : Clothes Dryer  
 Bulletin # : #####  
 Release Date : Dec.16th.2016

• **Subject : Clarification of assembly direction of heater wires.**

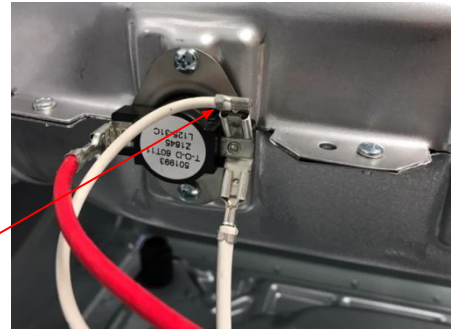
In the following 4 cases, assemble the heater wire from the left side.

Assemble to the left

1. When exchanging main harness due to nP error
2. When main harness is exchanged.
3. When thermostat is exchanged.
4. When heater assembly is exchanged.

If the heater wire is assembled from the right side, there are some concern about wire disconnection. Except for the 4 cases presented above, If you look at the case assembled on the right, assemble it to the left.
